Visual Exploration of the Spatiotemporal Evolution Law of Overburden Failure and Mining-Induced Fractures: A Case Study of the Wangjialing Coal Mine in China

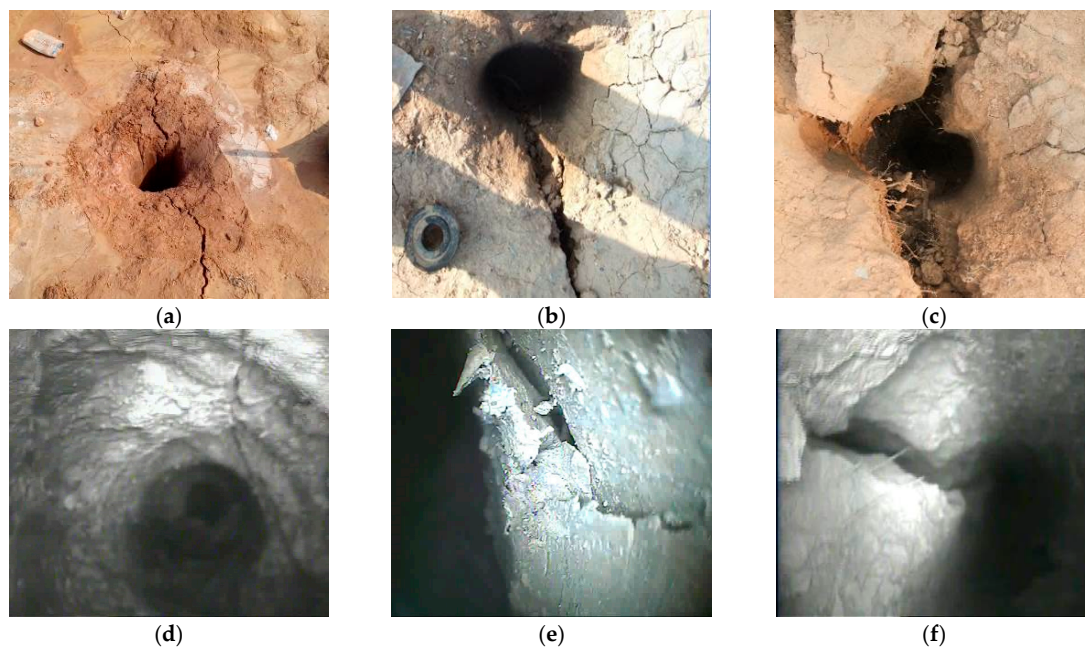
When the working face was 96.7 m away from borehole #1, cracks (Figure 6a) first appeared in the area around borehole #1 and its size increased as the working face moved forward. As a result, the borehole opening was divided in half (Figure 6b). Then, deformation and cracks were observed in the epipedon (Figure 6d), and vertical fractures in the mudstone beneath the epipedon appeared.

When the working face was 29.2 m away from the borehole, the borehole opening deformed and the epipedon deformation was exacerbated with exfoliation of the borehole wall (Figure 6e–f). Meanwhile, vertical fractures appeared on 63–79 m deep bedrocks. Then, the borehole opening deformation (Figure 6c) was exacerbated. The quantity and size of vertical fractures on the bedrocks continuously increased, while horizontal fractures were observed. However, no obvious fractures appeared on bedrocks under 80 m deep.

Figure 6. Observations in borehole #1: (a) crack at the borehole opening; (b) crack propagation; (c) borehole opening deformation; (d) fractures in the loess layer; (e) fracture propagation; (f) exfoliation.

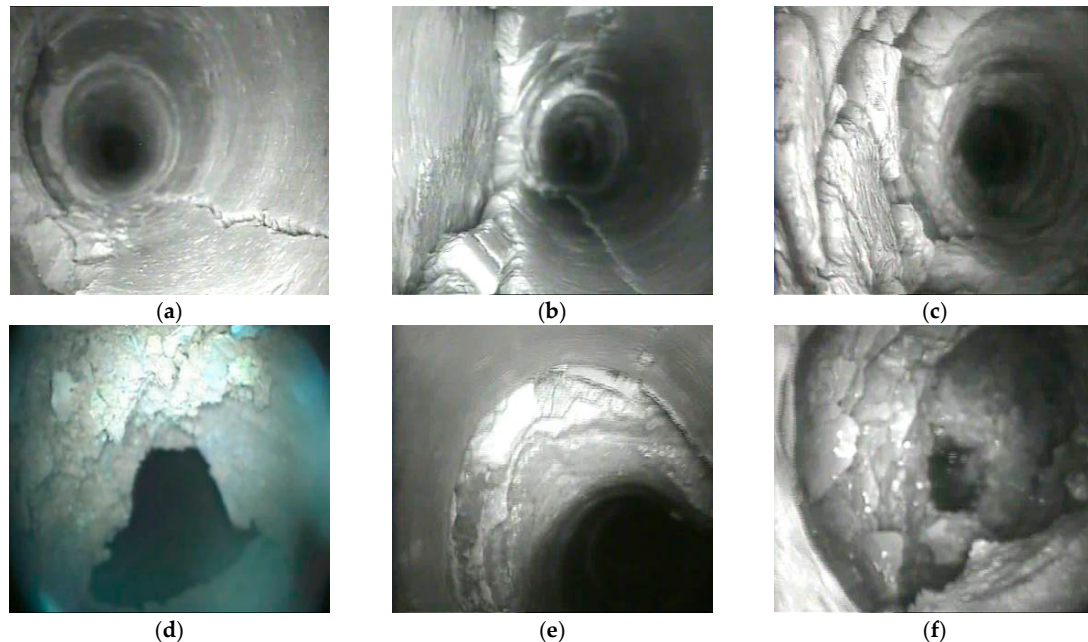
When the working face was 11.9 m away from the borehole, the borehole opening was divided into two parts, with a height difference of 12 cm. Fractures (Figure 7a) were observed in mudstone at depths of 282.3–285.7 m. Shortly after the working face passed the borehole, the loess layer subsided severely above goaf, and the height difference increased to 30 cm. The influence of mining to the fracture propagation in the borehole was significantly increased and the propagation rate of fractures was obviously faster than before.

When the working face was 13.2 m past the borehole, caving of the immediate roof and strata at a depth of 282 m (Figure 7d) was observed. When the working face was 26.5 m past the borehole, failure of the main roof (the first sub key stratum) was observed and the caving height reached 21.6 m. Dislocations (Figure 7e), accompanied by propagation of vertical fractures and irregular fractures (Figure 7b), were observed on strata at depths of 242–261 m, and a bed separation between the second

sub key stratum and the sandstone beneath it was observed. And fractures propagated and severe damages of borehole wall (Figure 7c,f) appeared. When the working face was 42.4 m past the borehole, the second sub key stratum failed. Bed separation, dislocation, and vertical fracture propagation of the stratum above the second sub key stratum were observed. The height of the caving zone increased to 78 m.

Figure 7. Observations in borehole #1: (a) vertical fracture; (b) irregular fracture; (c) damages of borehole wall; (d) strata caving; (e) dislocations; (f) severe damages of borehole wall.

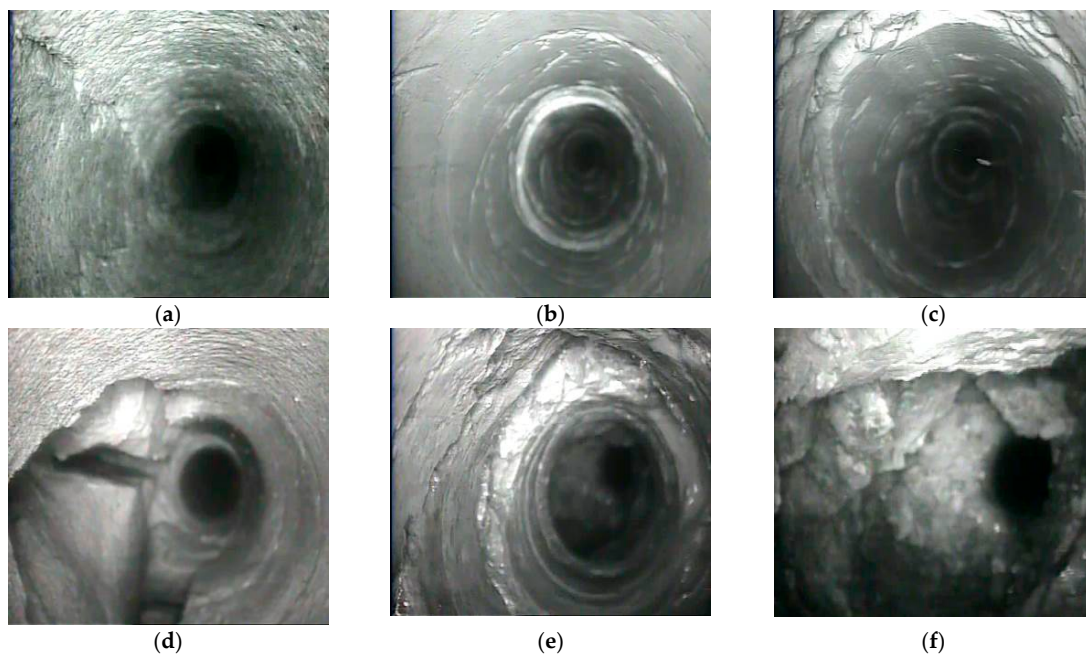
Owing to the delay in movement of the overburden strata, borehole #1' was drilled three months after the working face reached borehole #1. A 50 m seamless steel pipe was inserted to mitigate the influences of severe damages in the loess layer. Discontinuous vertical fractures and partial damages appeared on 60–90 m deep bedrocks, indicating that the tensile strength of the bedrocks was not strong enough to prevent breakage. Most parts of the drill core on 90–160 m deep was undisturbed. Circular fractures were observed on the borehole wall at a depth of 170 m (Figure 8c); the fracture density increased with depth. The results indicated that the fractured zone of Panel #20105 propagated to the fine stone layer at a depth of 173.4 m and a maximum height of 120 m. Drill sticking, accompanied by fractured rock core and wall failure (Figure 8d), was observed in the fine sandstone layer (depth varied from 185.46 m to 200.66 m). Severe dislocations (Figure 8e) were observed in strata at depths between 210 and 220 m. Severe drill sticking and considerable consumption of drilling fluid forced the drilling process to end at a depth of 231 m. The observation results obtained from borehole #1' are shown in Figure 8.

Figure 8. Observations in borehole #1': (a) burial depth of 50–100 m; (b) burial depth of 100–170 m; (c) burial depth of 170–200 m; (d) burial depth of 200–210 m; (e) burial depth of 210–220 m; (f) burial depth of 220–230 m.

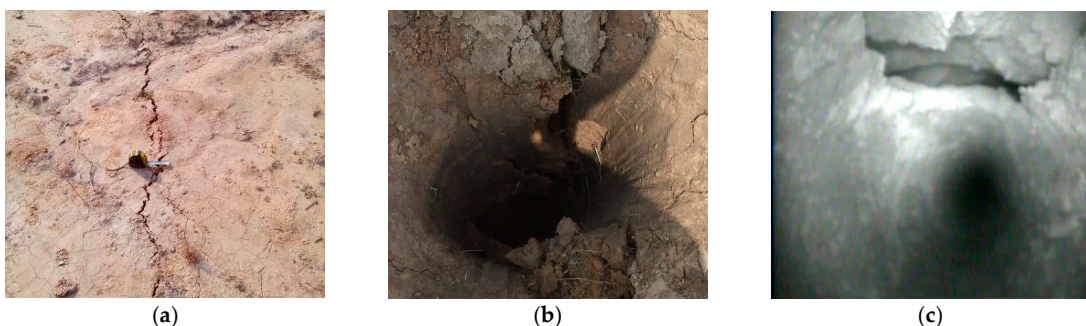
When the working face was 87.5 m away from borehole #2, cracks (Figure 9a) first appeared in the area around borehole #2 and its size and quantity increased as the working face moved forward. Then the epipedon deformation was observed (Figure 9b). Whereafter slight damage appeared near the interface between epipedon and rock. Vertical fractures (width = 1–2 mm) and horizontal fractures appeared at depths of 50–60 m. With the working face advancing, the epipedon deformation was exacerbated with exfoliation of the borehole wall (Figure 9c), and the size of fractures on the bedrocks continuously increased.

Figure 9. Observations in borehole #2: (a) crack near the borehole opening; (b) epipedon deformation; (c) exfoliation of the borehole wall.

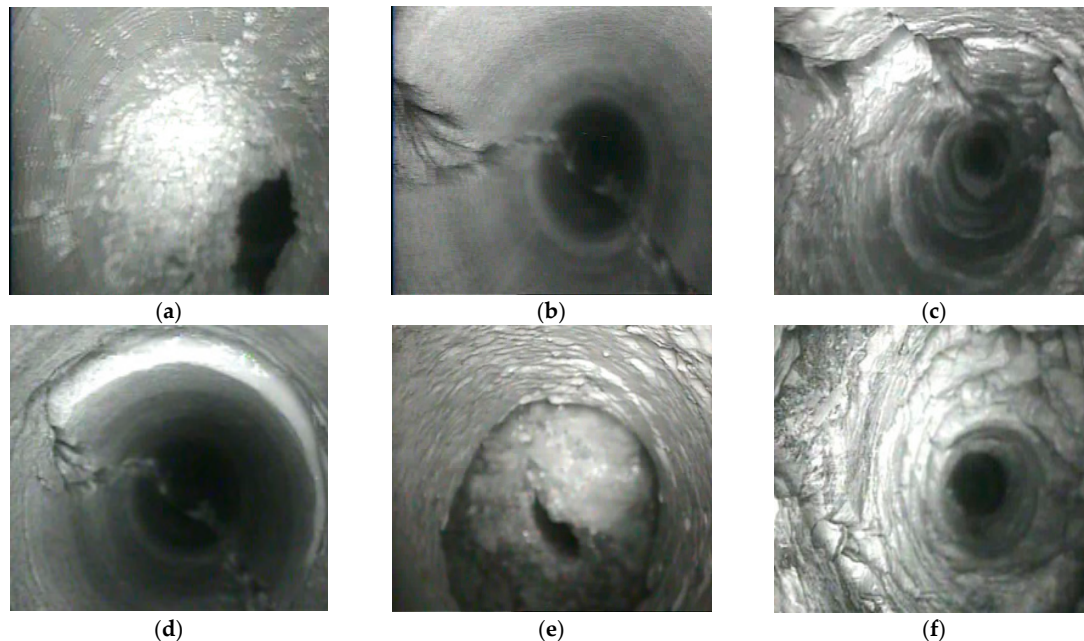
the strength of the main roof was only strong enough to prevent cracking until the longwall face was right under it. After the breakage of the immediate roof and the main roof, the caving height reached 25.5 m (Figure 10a). Propagation of vertical fractures (Figure 10b) and irregular fractures (Figure 10c) accompanied by dislocations (Figure 10d) were observed, and a bed separation (Figure 10e) between the second sub key stratum and the medium sandstone beneath it was observed. As the working face moved forward, fractures propagated and severe damages of borehole wall (Figure 10f) were observed. When the working face was 56.9 m past the borehole, the second sub key stratum failed. Bed separation, dislocation, and vertical fracture propagation of the stratum above the second sub key stratum were observed. The height of the caving zone increased to 82 m.

Figure 10. Observations in borehole #1: (a) strata caving; (b) vertical fracture; (c) irregular fracture; (d) dislocations ; (e) bed separation; (f) damages of borehole wall.

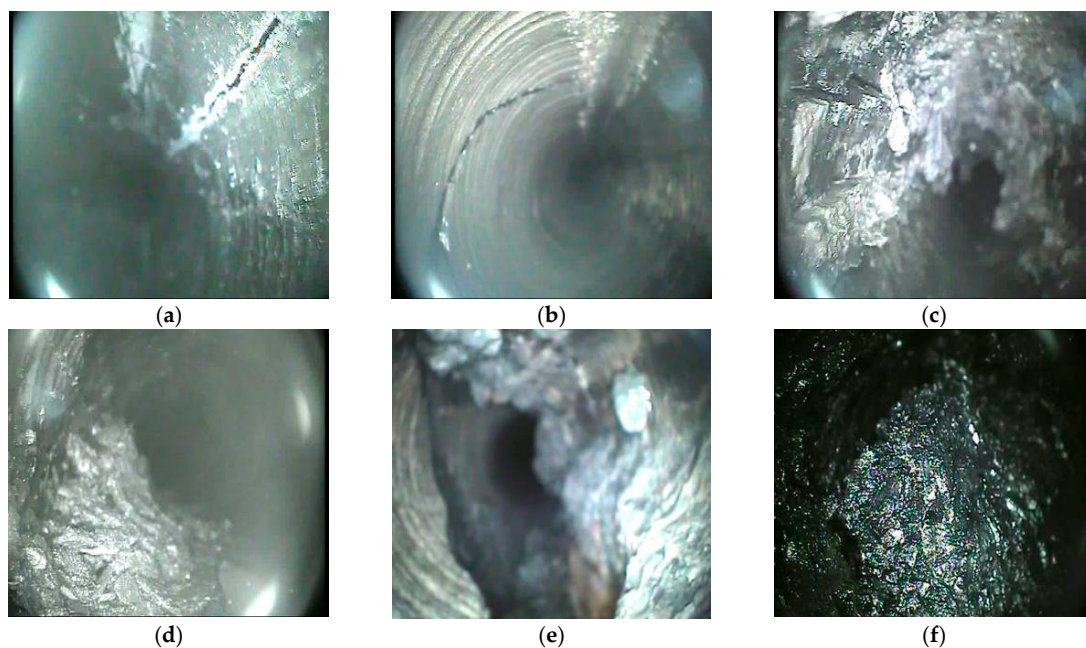
When the working face was 43.5 m away from the borehole opening, axial fractures (length = 3–4 cm, width = 1 mm) first appeared in borehole #3. As the working face moved forward, both density (Figure 11a) and average size of axial fractures increased and local breakage of the coal wall were observed (Figure 11c). When the working face was 19 m away from the borehole opening, the fractures increased up to 20 cm and the height increased to 15–18 m. After that, fracture propagation was significantly accelerated and the maximum fracture exceeded 50 cm. Irregular fractures were observed (Figure 11b), significant wall breakage were observed, and quantity and

size of crushed coal in the borehole increased (Figure 11d). Half of the cross section of the borehole was occupied by crushed coal, indicating that the working face had significant effects from mining activities. Additionally, the fractured zone spread to 20–22 m.

When the working face was 11.1 m away from the borehole opening, severe coal wall damages and considerable crushed coal were observed. The observation borehole was significantly damaged, resulting in severe deformations (Figure 11e). The camera was stuck at the location 1.9 m behind the working face and 14.5 m above the channel roof. Dislocations caused by the roof caving into the goaf were observed on the borehole. The height of the caved zone was 15–18 m. During the six-day idling period, the borehole #3 was blocked by crushed coal (Figure 11f) that was located 20.9 m from the opening.

Figure 11. Observations in borehole #3: (a) axial fractures; (b) irregular fractures; (c) wall breakage; (d) crushed coal; (e) deformations; (f) blocked by crushed coal.

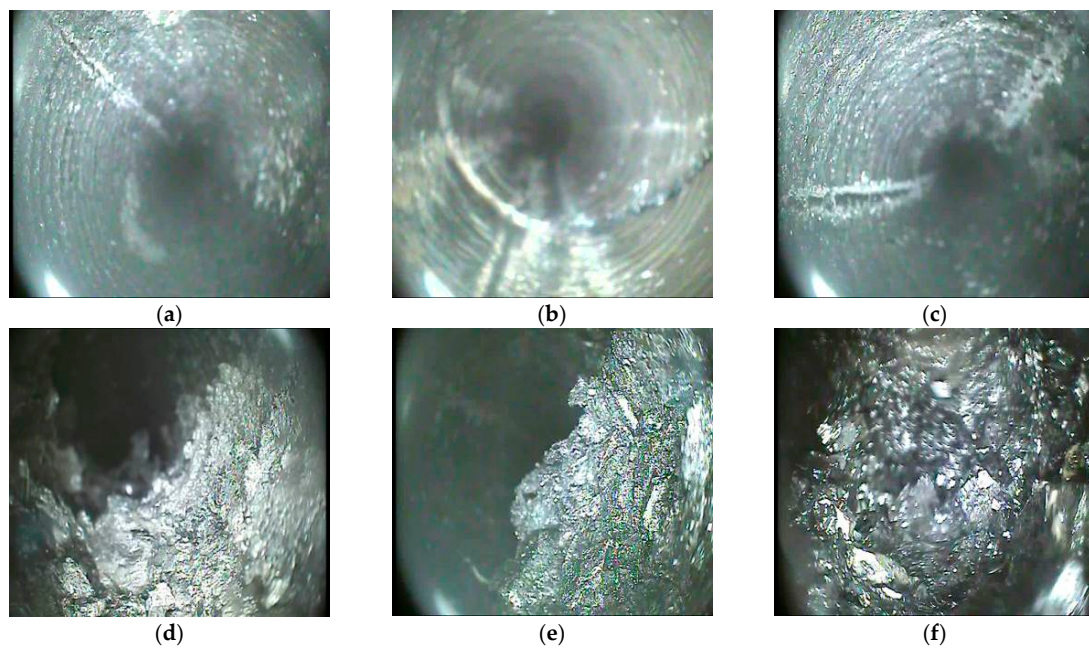
When the working face was 19 m away from the borehole opening, axial fractures were observed in the borehole #4 (Figure 12a). During the four-day idling period, the density of axial fractures increased, while damages of the coal wall were not affected. The propagation of fractures during this period can be attributed to the fact that propagations of mining-induced fractures were slightly behind the roof caving. The height of the water-conducting fracture was 17–19 m.

With the working face advancing, the density of axial fractures increased and the maximum length reached 35 cm. Irregular fractures were observed (Figure 12b) and damages of the coal wall (Figure 10d) were exacerbated. The fractured zone propagated upwards and the height was 20–23 m. Then one axial fractures reached 60 cm in length. Deep fractures propagated along the internal wall (Figure 12c). Observations in the six-day idling period revealed severe damages of the coal wall and considerable crushed coal in the borehole. Deformations of the borehole were observed at a depth of 58.5 m. This location was 7.2 m behind the working face and 29.3 m above the roadway roof. It can be concluded that the borehole was significantly affected by mining activities. The height of the fractured zone reached 25–27 m. When the working face was 5.6 m away from the borehole opening, breakage of the coal wall was exacerbated and the borehole was blocked by crushed coal at a depth of 13.5 m (Figure 12f).

Figure 12. Observations in borehole #4: (a) axial fractures; (b) irregular fractures; (c) fracture propagation; (d) wall breakage; (e) crushed coal; (f) blocked by crushed coal.

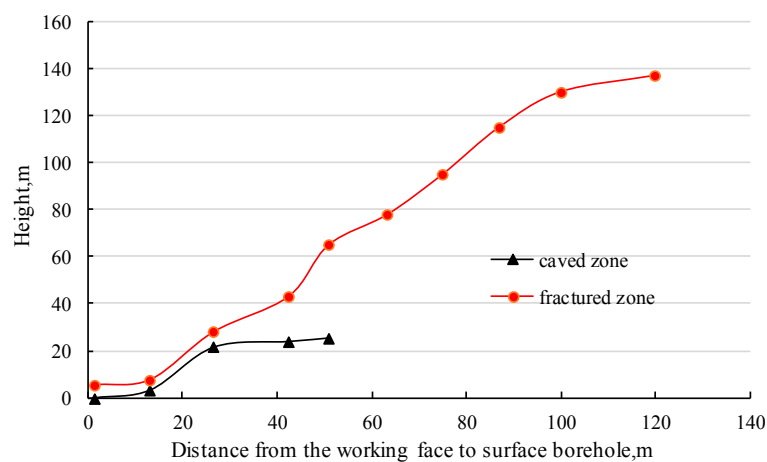
The heights change of caved zone and fractured zone in the boreholes during the mining process is shown in Figure 13. The cutting and caving heights of panel 20105 were 3.0 and 3.2 m, respectively; the height of the fractured zone was 120–137.6 m (see Table 1). The height of the caved zone was 21.6–25.5 m, while the height of the caved zone in borehole #1' was not obtained as it didn't reach the coal seam. The heights of the caved zone and fractured zone in boreholes #3 and #4 were 18.5 and 30 m, respectively. Notably, the measured heights of caved zone and fractured zone appeared to be smaller than the actual values due to the early deformations and blocking in the underground boreholes caused by the abutment pressure. The measured heights of the caved zone and the fractured zone were 2.9–4.11 and 19.35–22.19 times the mining height.

Figure 13. Change of the caved zone and fractured zone in boreholes.

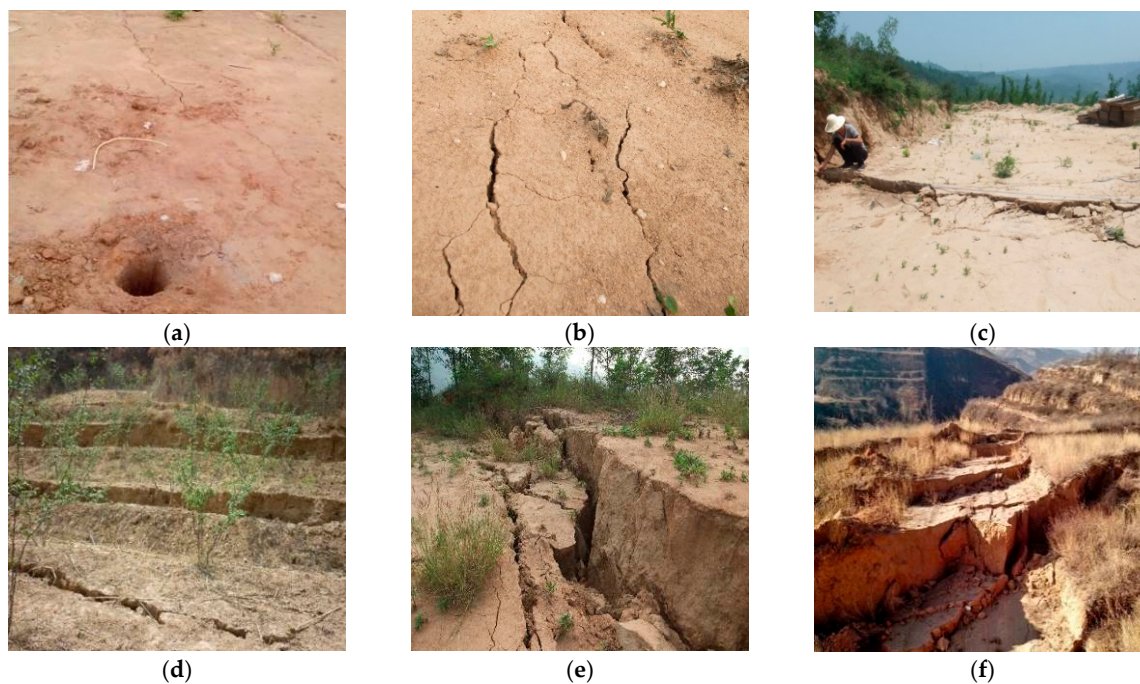
When the working face was 96.7 m away from the surface borehole, fractures that are parallel to the working face inclination were first observed in the vicinity of the borehole. The advance affecting range of mining was approximately 100 m, and the movable basin area significantly exceeded the mining area. Based on the advance affecting range and mining depth, it is deduced that the advance affecting angle was 71° . As the working face moved forward, the quantity and size of cracks increased further.

When the working face was 29.2 m ahead of the surface borehole, step subsidence appeared in the vicinity of the borehole. The ground surface subsided gradually and continuously. After the mining process, severe damages to the ground surface and step subsidence (maximum subsidence = 4.2 m) were observed, and surface cracks were distributed all over the goaf. The inter-fracture and inter-step distances varied from 1.0 to 6.2 m. The process of the surface subsidence around boreholes was shown in Figure 14.

Figure 14. Surface subsidence around boreholes: (a) cracks; (b) quantity of cracks increased; (c) surface subsidence; (d) step subsidence; (e) subsidence increased; (f) final subsidence.
