# Failure Analysis of a Cylindrical Roller Bearing Caused by Excessive Tightening Axial Force

**Abstract:** The premature failure of a cylindrical roller bearing took place during service, with a total operation time of 100 h. The failure cause was analyzed by macroscopic and microscopic observation, metallographic analysis, hardness testing, tightening axial force influence analysis, and test verification. The results show that failure modes of the bearing are contact fatigue spalling, wear, and fatigue fracture. The outer ring, inner ring, rollers, and cages all have suffered relatively heavy damage in the sides corresponding to the bearing side with laser marking. Excessive load, induced by the excessive tightening axial force, derived from the lock nut, is the cause of the bearing failure. The failure mechanism is that excessive tightening axial force caused a great deformation and cylindricity increase of the inner ring raceway, which induced high local contact stress between one side of the ring raceways, as well as the corresponding ends of the rollers, resulting in the bearing failure. At last, measures for prevention of this failure are put forward as follows: controlling

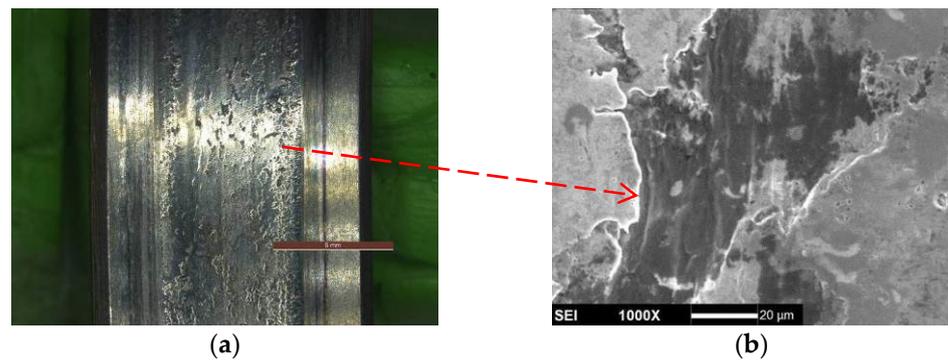
Almost the whole circumferential area of the working track of outer ring raceway was damaged, with the main characteristics of wear and contact fatigue spalling, as shown in Figure 5. The damage, characterized by spalling pits with intermittent distribution on the side with laser marking of the outer ring raceway, was more serious than that of the other side of the outer ring raceway, as shown in Figure 6. There were regular golden and blue-black rings (about 2 mm wide), mainly distributed in the whole circumferential areas on the bearing side, with laser marking (the side with the bearing number engraved on the edge by laser) on the outer diameter surface of the outer ring, while there were blue-black patches on the other side of the outer diameter surface of the outer ring, as shown in Figure 7. These discolouration areas resulted from overheating of the bearing, induced by abnormal wear under high local stress.

**Figure 5.** Wear of the outer ring raceway: (a) macroscopic damage; (b) microscopic damage.

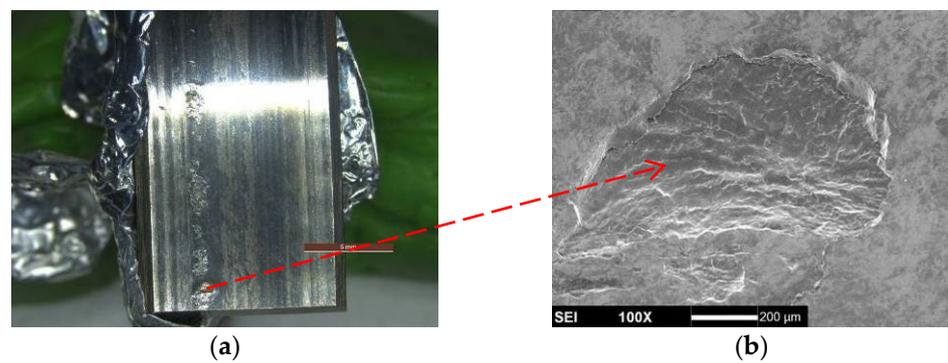
**Figure 6.** Intermittent distributed spalling pits of the outer ring raceway: (a) macroscopic damage; (b) microscopic damage.

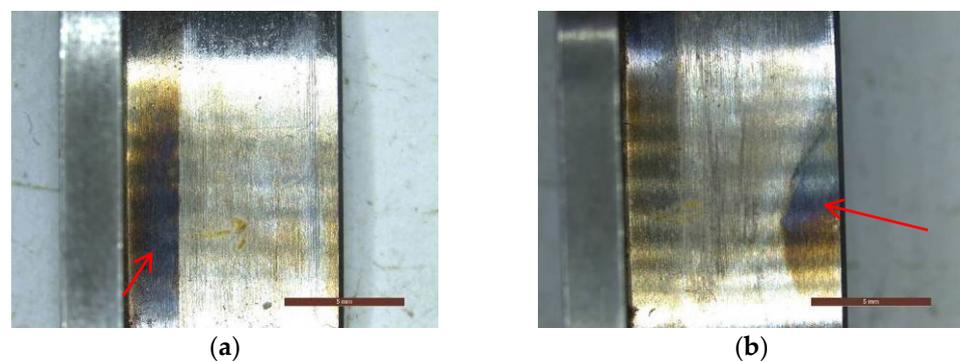
**Figure 7.** Discolouration on the outer diameter surface of the outer ring, as the arrow indicated: (a) discolouration corresponded to the bearing side with laser marking; (b) discolouration corresponded to the bearing side with laser marking.

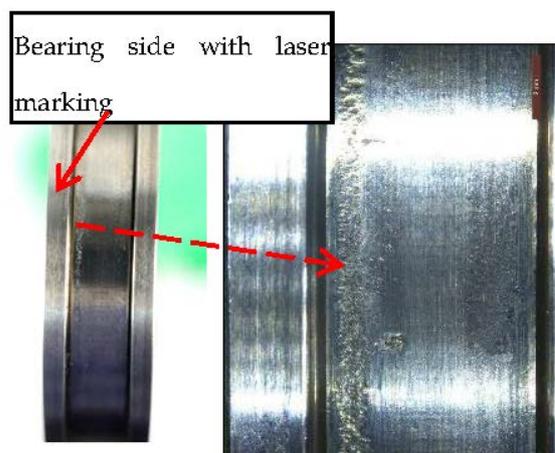
The damage, characterized by spalling pits of the inner ring raceway, was mainly distributed in the areas that corresponded to the bearing side with laser marking, with an axial width about 1 mm, and the circumferential length accounted for 3/4 of the circumference of the outer ring raceway, as shown in Figure 8. The spalling pits showed contact fatigue features with laminar and fan-shaped morphologies, as shown in Figure 9.

**Figure 8.** Macroscopic morphologies of the spalling position of the inner ring raceway.

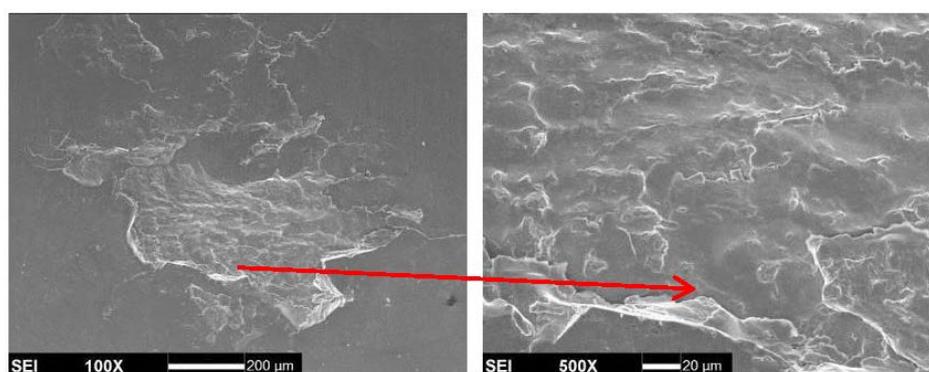
**Figure 9.** Microscopic morphologies of the spalling position of the inner ring raceway.

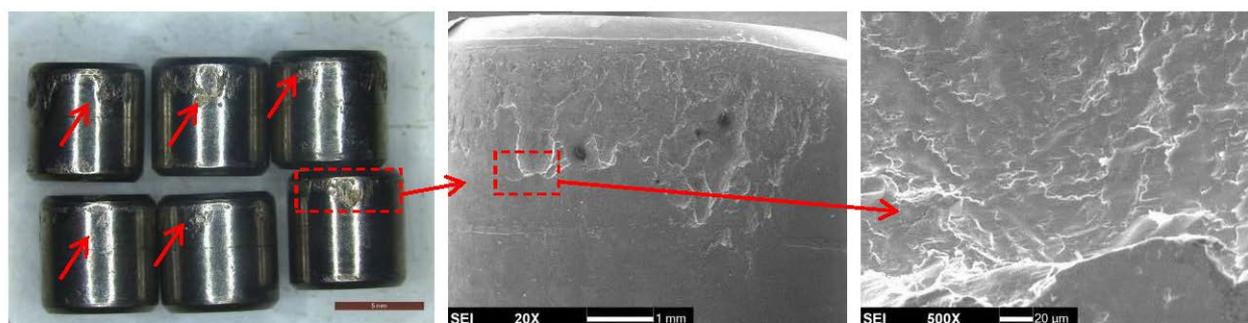
The 20 rollers show a gray-black colour, serious contact fatigue spalling, and wear on the roller surface, which corresponded to the bearing side with laser marking, as shown in Figure 10. Friction and wear of the end face that corresponded to the bearing side with laser marking of the roller are heavier than those of the other end face of the roller, and the discolouration of the end face that corresponded to the bearing side with laser marking of the rollers was also more obvious than that of the other end face of the rollers, as shown in Figures 11 and 12.

**Figure 10.** Surface damages of the rollers.

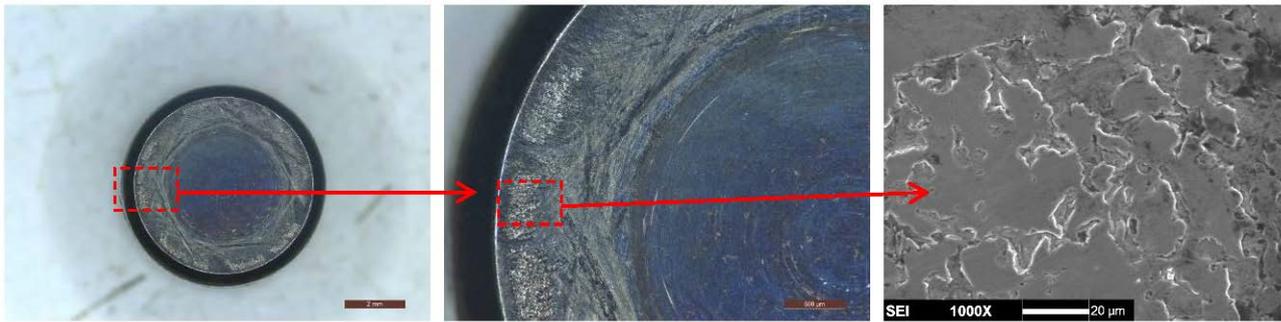
**Figure 11.** Damages of the roller end face that corresponded to the bearing side with laser marking.

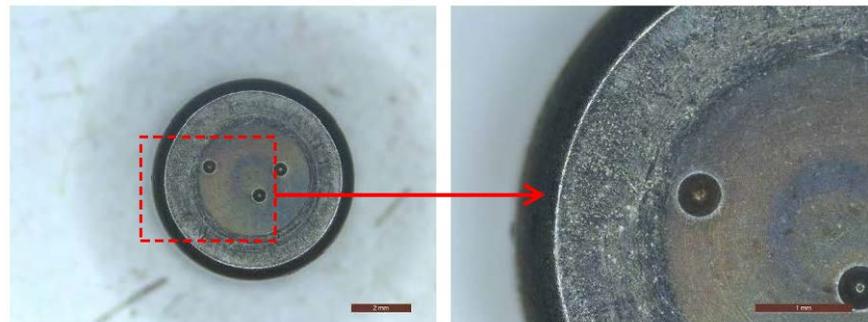
**Figure 12.** Damages of the roller end face, away from the bearing side with laser marking.

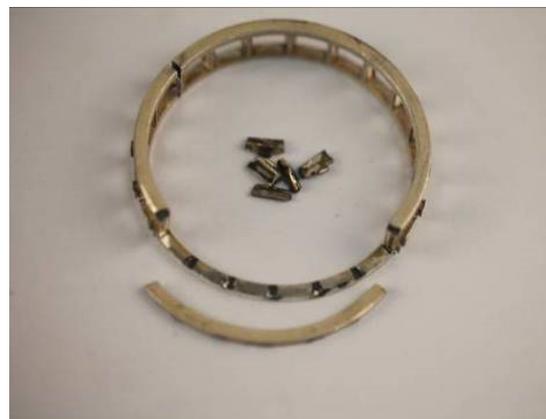
The beams of six consecutive pockets (the pockets are numbered from No.1 to No.6), in the twenty pockets of the cage, were broken at the corners formed by the beam and side beam; the side beams corresponded to the bearing side with laser marking of the six consecutive pockets, separately broken at the corners near the No.20 of No.1 pockets, as well as at the corners near the No.5 of No.6 pockets; the other side beam of the six consecutive pockets were only broken at the corners near the No.20 of No.1 pockets, as shown in Figure 13. Most of the fractures were invisible, due to serious wear. The three fractures (numbered from No.1 to No.3) of the side beam were visible, with a colour of gray-black, and had their origins in the corner surfaces and flat propagation areas, with fracture ridge and fatigue striations, as shown in Figure 14. Additionally, the side beam surfaces showed severe contact wear morphologies, especially in the surfaces corresponded to the bearing side with laser marking, as shown in Figure 15.

**Figure 13.** Macroscopic damage morphology of the cage.

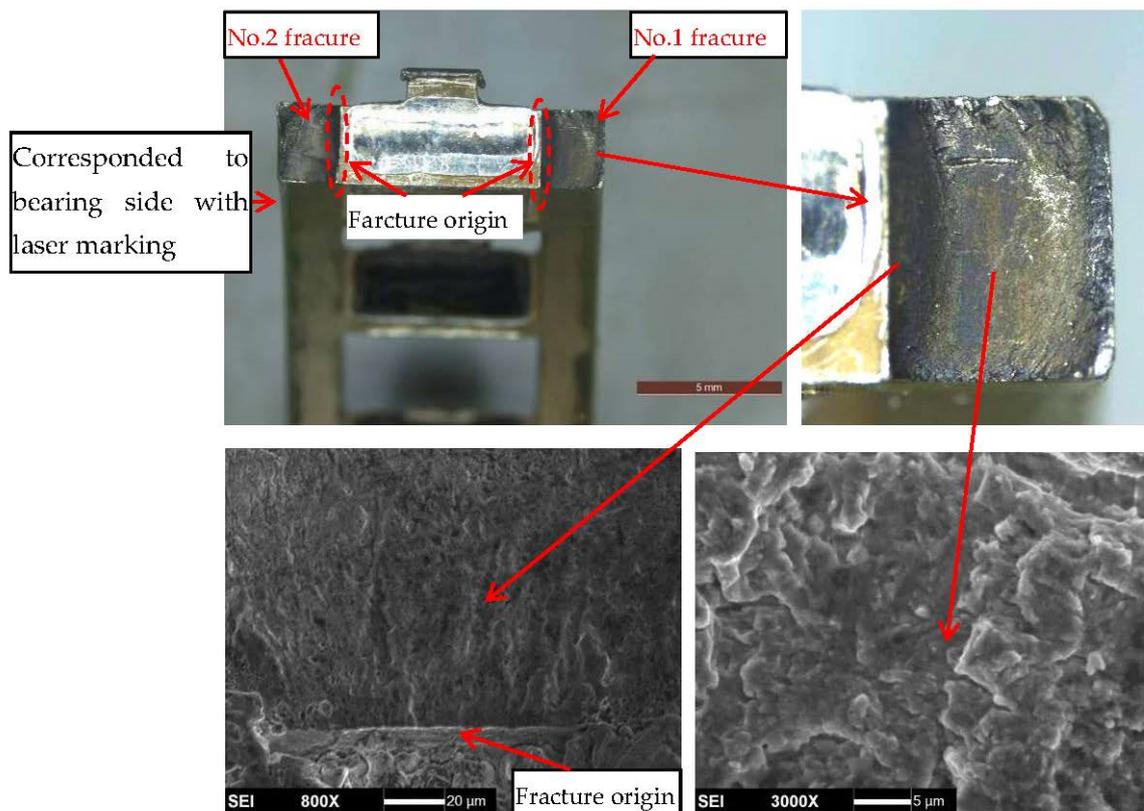
**Figure 14.** Typical morphologies of the side beam fractures.

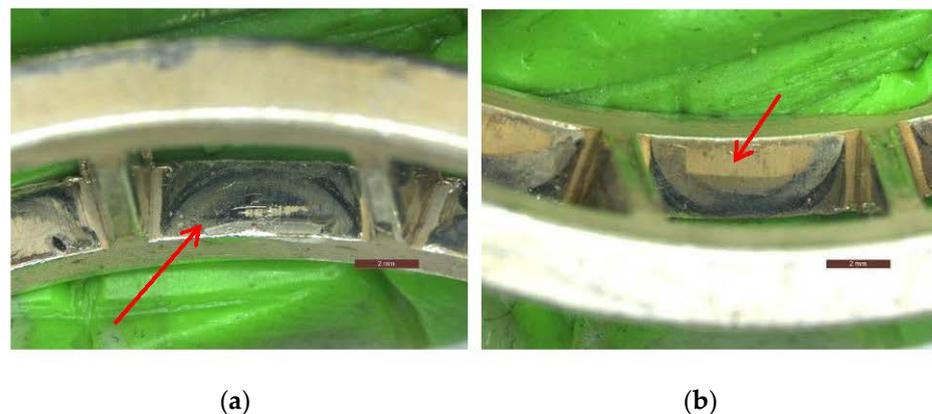
**Figure 15.** Contact wear morphologies of the side beams, as the arrow indicated: (a) wear of the side beam, corresponded to the bearing side with laser marking; (b) wear of the other side beam.

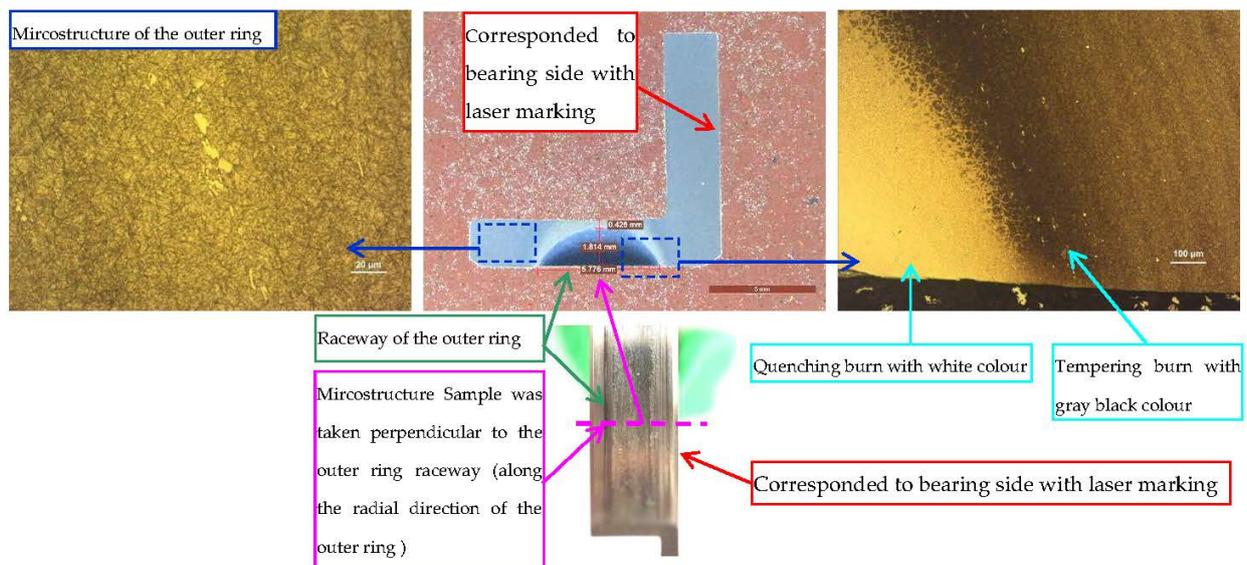
There are serious microstructure burns induced by heavy wear between outer ring raceway and rollers in the outer ring raceway, which exhibit as a white quenching burn and gray-black, high-temperature tempering burn. The burned area, corresponding to the bearing side with laser marking, was heavier than that of the other side. Additionally, the deepest part of the burns was almost equivalent to the thickness of the outer ring. The microstructure of the outer ring was a homogeneous structure and consisted of acicular martensite + carbide. The typical microstructure and burns of the outer ring are shown in Figure 16.

Figure 16. Typical microstructure and burns of the outer ring.

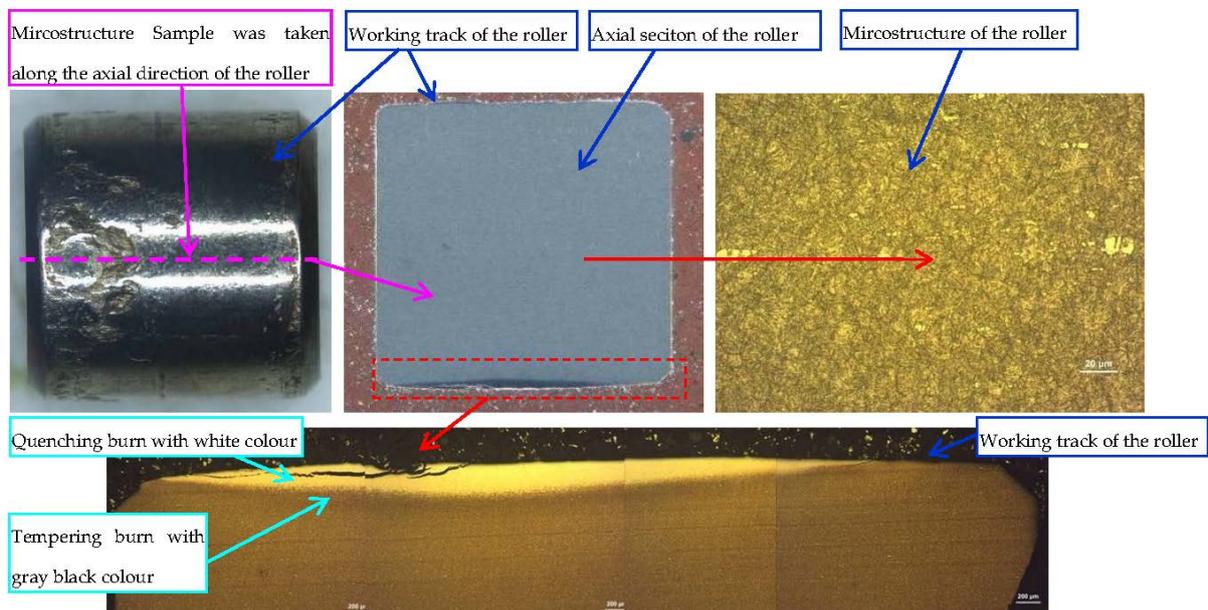
There are serious microstructure burns induced by heavy wear between rollers and ring raceways in the rollers. The burned area corresponding to the bearing side with laser marking was heavier than that of the other side. The microstructure of the rollers was a homogeneous structure and consisted of acicular martensite + carbide. The typical microstructure and burns of the rollers are shown in Figure 17.

Figure 17. Typical microstructure and burns of the roller.

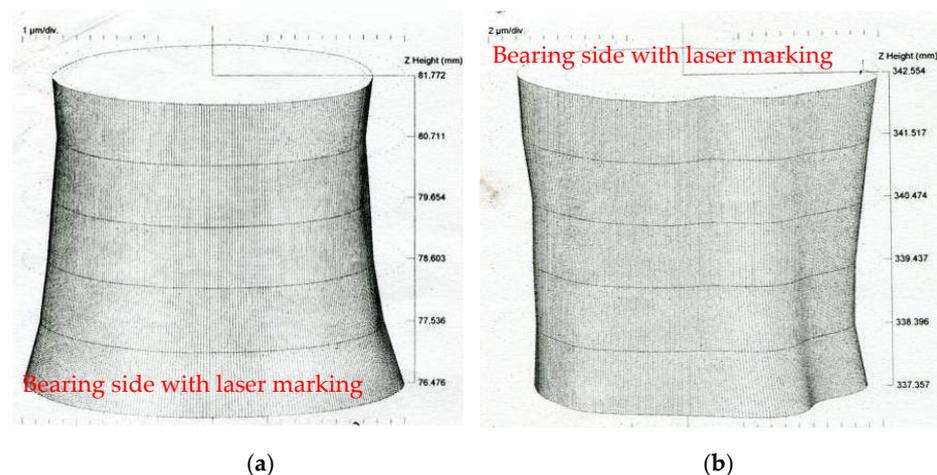
When large interference was used to install the inner ring, the inner ring deformation and cylindricity increase was induced by the large tightening axial force (375 N·m) that was used, which was 3 N·m larger than the maximum tightening torque of the bearing requirement, and the test of the simulating bearing operation was carried out by bearing contact fatigue test equipment. Before the bearing was installed on the test equipment, cylindricity of the inner ring raceway is 2.90  $\mu\text{m}$ , and the cylindricity profile is shown in Figure 19a. After the bearing was installed on the test equipment, the cylindricity of the inner ring raceway increased to 10.98  $\mu\text{m}$ , and the cylindricity profile is shown in Figure 19b. The tightening axial force caused obvious the taper deformation of the inner ring raceway. Additionally, the diameters corresponding to the bearing side with laser marking of the inner ring raceway increased obviously at some positions.

Figure 19. Cylindricity of the inner ring raceway: (a) before installation; (b) after installation.

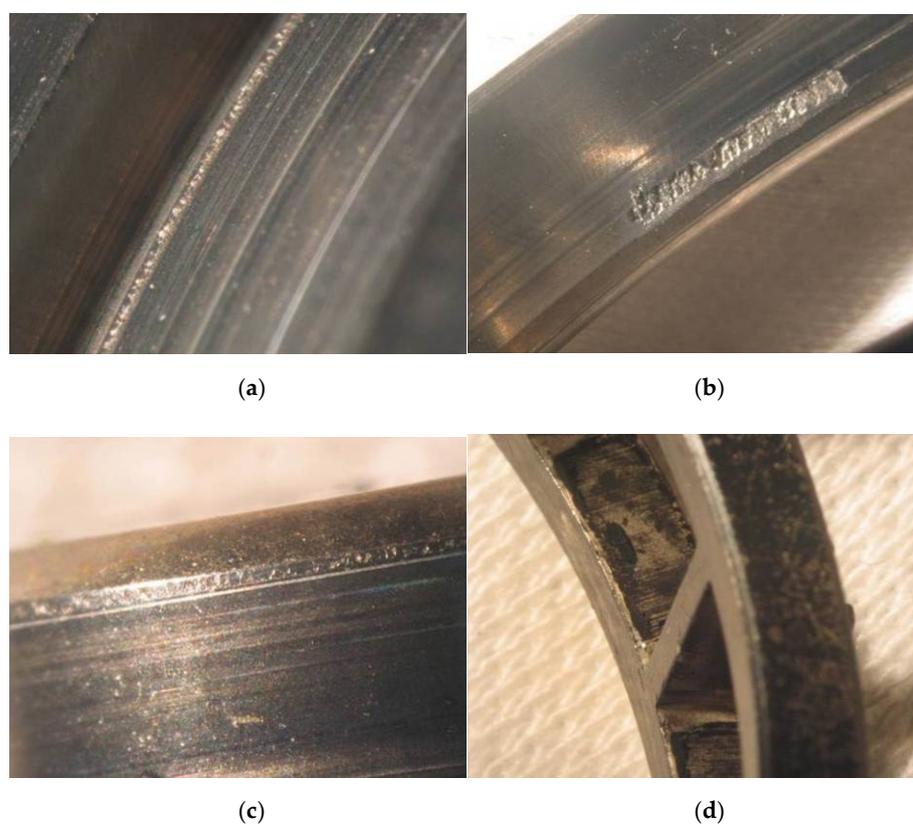
The bearing was disassembled and inspected after a 50-h test. There were obvious circumferential contact marks on the outer race raceway, a spalling area with a circumferential length of about 12 mm, and an axial width of about 1.5 mm in the axial end, which corresponded to the bearing side with laser marking of the outer ring raceway, as shown in Figure 20a. There were obvious circumferential contact marks on the inner race raceway and spalling strips, whose circumferential length separately accounted for 2/3 and 1/4 of the circumference of the outer race raceway, which, in the end, corresponded to the bearing side with laser marking; the damage at the other end was not obvious, as shown in Figure 20b. There were obvious circumferential contact marks on the 20 rollers. Additionally, there were spalling strips on the end surfaces corresponding to the bearing side with laser marking of the 13 rollers, as typically shown in Figure 20c. Damages of the cage were mainly characterized by an uneven wear of the pocket and side beams, as shown in Figure 20d.

**Figure 20.** Damage morphology of the test verification bearing: (a) spalling morphology of the outer ring raceway; (b) spalling morphology of the outer ring raceway; (c) typical spalling morphology of the rollers; (d) wear morphology of the cage.

The severely damaged areas of the working tracks of the outer ring raceway, inner ring raceway, and rollers were located at the working tracks end corresponding to the bearing side with laser marking. This shows that there was excessive local contact stress at the ends of the outer ring raceway, inner ring raceway, and rollers. Additionally, it can be seen that the severely damaged areas of the outer ring raceway, inner ring raceway, and rollers corresponded exactly to the areas with the maximum deformation of the inner ring raceway, by comparing the cylindricity profile of the inner ring raceway and those severely damaged areas. Therefore, the spalling failure of the bearing should be caused by the high tightening axial force.

Controlling the tightening axial force, within the range of the technical requirements, is the basic requirement to prevent such bearing failure. However, the following measures can be taken to reduce the influence of the bearing inner ring deformation induced by tightening axial force.

(1) Convexity increase of the inner ring raceway can offset a certain deformation of the inner ring raceway.

(2) Convexity increase of the rollers can improve the bearing ability to resist the deformation of the inner ring raceway [26].

(3) Size decrease of the grinding undercut of the inner ring can improve the ability of the inner ring raceway to resist deformation [27].
