# Maintenance of Arc Occurrence at the End of the Stator Slot in a High-Voltage Motor

**Abstract:** This study investigates the critical issue of arc-induced partial discharge in high-voltage motor stator windings and proposes a cost-effective, targeted maintenance approach to mitigate these effects. Diagnostic techniques, including insulation resistance tests,  $\tan \delta$  measurements, partial discharge analyses, and UV camera inspections, were employed to identify and assess fault points. A novel partial maintenance method involving felt-pad insulation reinforcement was implemented to address the arc discharge issues. Post-maintenance diagnostics confirmed a significant reduction in partial discharge levels, with an average decrease of over 80%, demonstrating the effectiveness of the proposed approach. Compared to traditional rewinding methods, this technique offers substantial savings in time and cost while enhancing motor reliability. The findings underscore the importance of precise diagnostics and tailored interventions in extending the lifespan and operational stability of high-voltage motors, providing practical insights for industrial maintenance strategies.

This stu

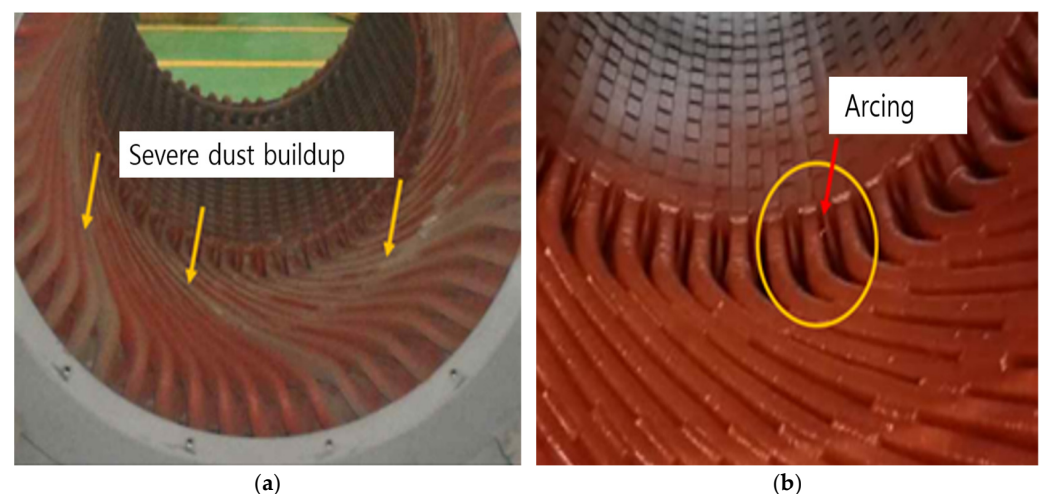
Figure 6 shows that the stator windings of four weather-protected high-voltage motors exhibited similar damage that was attributed to dust accumulation from an external cooling airflow. A visual inspection confirmed dust deposition on the winding surfaces, after which cleaning procedures were carried out.

**Figure 6.** Comparison of stator windings: (a) before cleaning, showing severe dust buildup (indicated by yellow arrows); (b) after cleaning, showing signs of arcing (indicated by the red arrow).

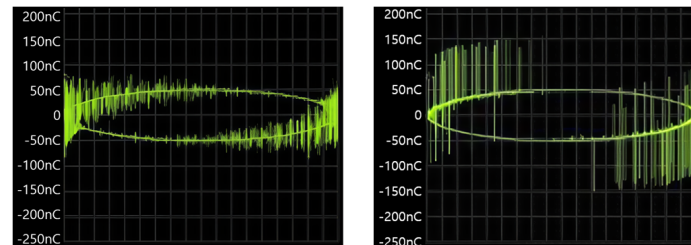
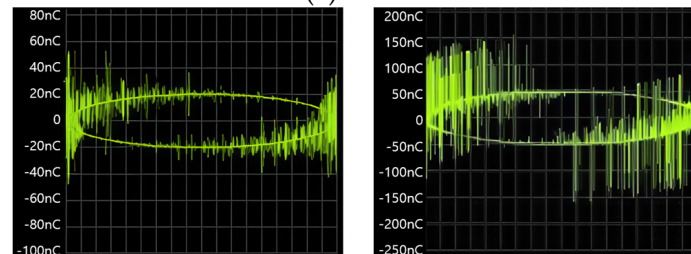
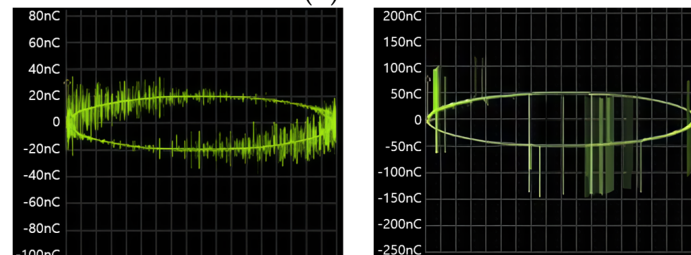
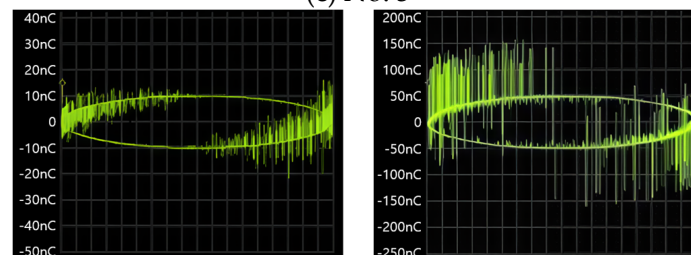
Figure 10 shows pre-maintenance partial discharge patterns at 7.94 kV. The analysis revealed a complex discharge (10% internal, 90% surface) due to arcing between the winding at the slot end and the finger plate, which is visible at both slot ends.

Discharge = 77,000 pC, Discharge = 104,000 pC, Voltage = 6.35 kV, Voltage = 7.94 kV

Discharge = 49,900 pC, Discharge = 104,000 pC, Voltage = 6.35 kV, Voltage = 7.94 kV

Discharge = 33,000 pC, Discharge = 89,000 pC, Voltage = 6.35 kV, Voltage = 7.94 kV

Discharge = 17,000 pC, Discharge = 105,000 pC, Voltage = 6.35 kV, Voltage = 7.94 kV

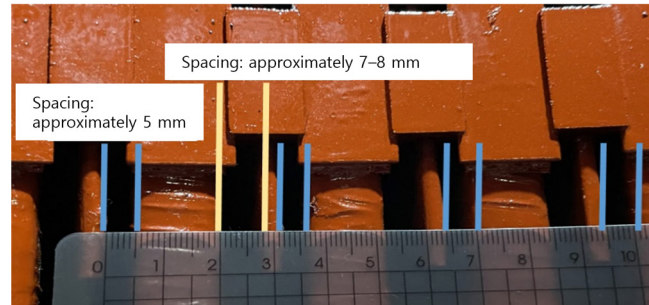
**Figure 16.** Measurement of the gap between the finger plate and winding insulation.

As illustrated in Figure 16, the minimum gap between the finger plate and the winding insulation is measured at approximately 5 mm. Given that the corona onset voltage for alternating current (RMS) is 21 kV/cm, the estimated potential generated due to surface charging on the insulation is calculated to be around 10.5 kV. This value provides an essential reference for evaluating the insulation's ability to withstand high-voltage stress under operational conditions.

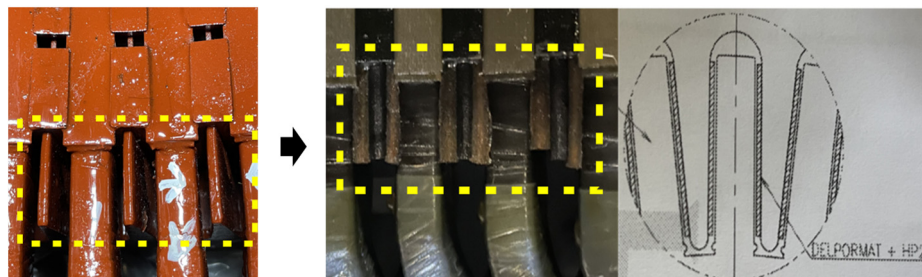
**Figure 17.** Comparison before and after design improvements to prevent arc discharge between the finger plate and insulation.

at the motor's maximum operating voltage of 11 kV. Figure 17 illustrates an example of design improvements to prevent arc discharge between the finger plate and the insulation.

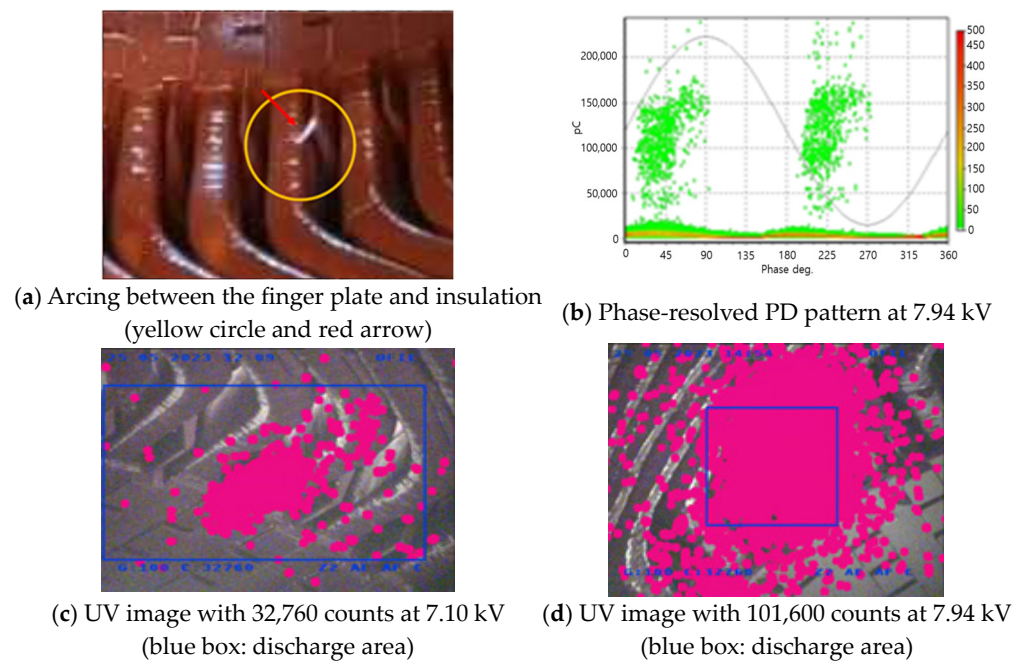
**Figure 19.** Partial discharge value and pattern of the high-voltage motor before maintenance.

As depicted in Figure 19a–d, a UV camera was used to accurately identify the partial discharge locations within the stator winding of a high-voltage motor by measuring the UV counts as the AC voltage gradually increased. At 1.25 times the phase-to-phase voltage (7.94 kV), as shown in Figure 19a, an arc was visually observed between the end winding and the finger plate, with the corresponding discharge pattern illustrated in Figure 19b. UV counts were measured at two test voltages, 7.10 kV and 7.94 kV, with recorded values of 32,760 and 101,600, respectively. These data show a significant rise in UV counts with the increasing voltage, indicating an almost threefold increase at 7.94 kV relative to 7.10 kV. The correlation between higher voltage levels and increased discharge activity provides insight into the insulation performance under elevated electrical stress, highlighting areas at greater risk of insulation degradation.

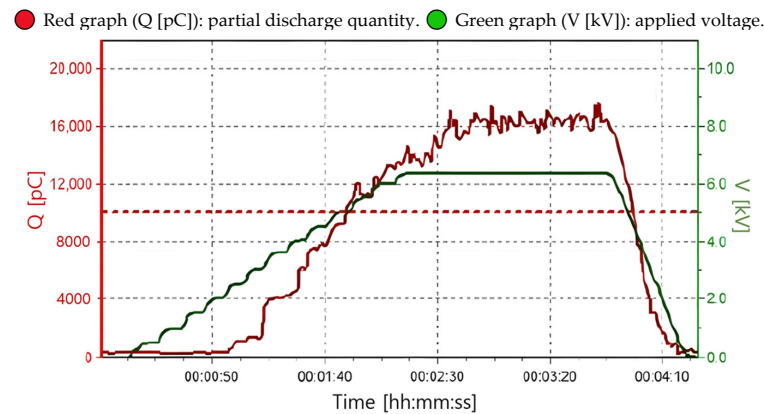
**Figure 29.** Partial discharge level of No. 4 HV motor.

These results indicate that while the maintenance work was effective in eliminating arc discharges, it was not fully successful in reducing the partial discharge magnitude to a satisfactory level. Figure 29 visually illustrates the changes observed after the maintenance work.

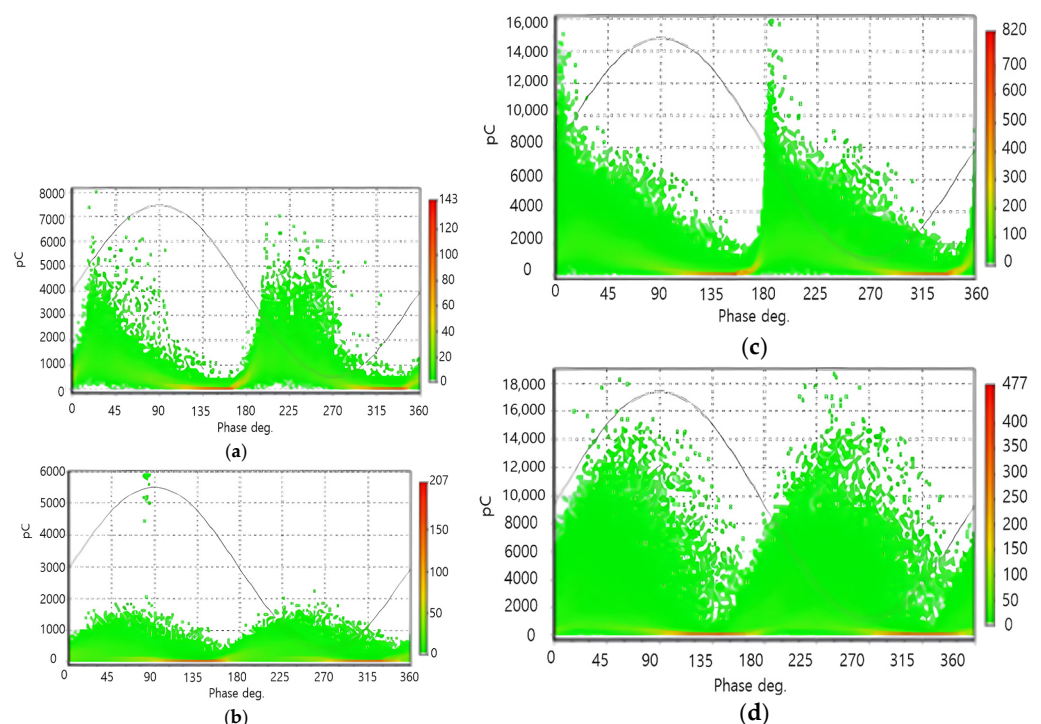
This analysis demonstrates that the combined occurrence of internal and surface discharge serves as a critical indicator for evaluating the condition of high-voltage motors and the effectiveness of maintenance efforts. The PRPD (Phase Resolved Partial Discharge) graph results, used to analyze these partial discharge patterns, are presented in Figure 30.

**Figure 30.** Partial discharge patterns after maintenance work for motors: (a) No. 1 discharge = 9500 pC, voltage = 6.35 kV; (b) No. 2 discharge = 17,000 pC, voltage = 6.35 kV; (c) No. 3 discharge = 11,500 pC, voltage = 6.35 kV; (d) No. 4 discharge = 17,000 pC, voltage = 6.35 kV.
