# Fatigue Failure Analysis of a Speed Reduction Shaft

**Abstract:** The mining industry sector is notable for the severe service loads and varied environmental conditions that it imposes on its equipment and mechanical systems. It has become essential to identify the causes of failures and use the information to avoid similar failures and improve projects. In this paper, a study on shaft failure in a speed reduction box was carried out. A section of a fractured shaft made of hardened austempered steel was analyzed to determine the cause of the break. Fractography was performed to characterize the failure mode on the fracture surface. The microstructural analysis and hardness profile revealed that the shaft was inadequately heat treated, resulting in low resistance microstructures and the development of a thin layer of bainite at the shaft edge. Large amounts of inclusions were found in the fracture region, and the tensile tests revealed that the material had an elongation below the specification. The analyses showed that the combination of factors of a large amount of inclusions present in the low resistance banded structure, and the presence of concentrated pores in that same reg

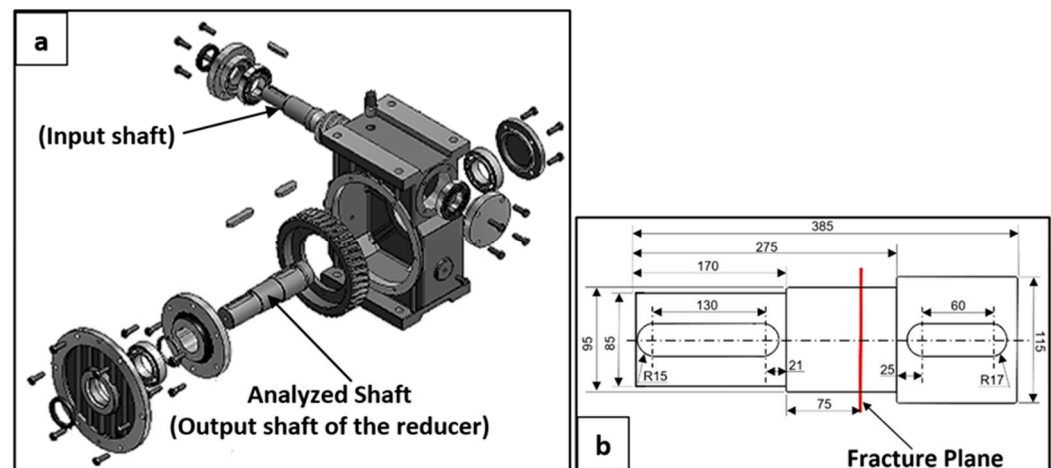
In August 2018, the output shaft of a speed reducer fractured during operation. The shaft was designed to work uninterrupted coupled to the driving drum of a conveyor belt used by a mining company. For normal operating conditions, the design life of the speed reducer was 40 years, however, failure occurred in less than 1 year. Table 1 presents the operational parameters required by the conveyor belt drive drum. The company's maintenance engineer reported that there was no history of premature failure, and before the shaft broke, the speed reducer had undergone a scheduled maintenance. Although the reasons for the failure could be assigned to one or many aspects, such as material selection, a mechanical property, manufacturing process, operating mode, service environment, etc., the main factor should be confirmed when investigating the equipment. Fundamentally, the reduction box system consists of an electric engine, which transmits power to the input shaft of the reduction box, which through internal worm gears, transmits power to the output shaft. A representation of the system is shown in Figure 1a and the fractured output shaft that was investigated is shown in Figure 1b, with details of its dimensions and location of the plane fracture.

**Figure 1.** (a) Reduction box system, indicating the analyzed shaft; (b) dimensions in millimeters of the fractured output shaft and location of the fracture plane.

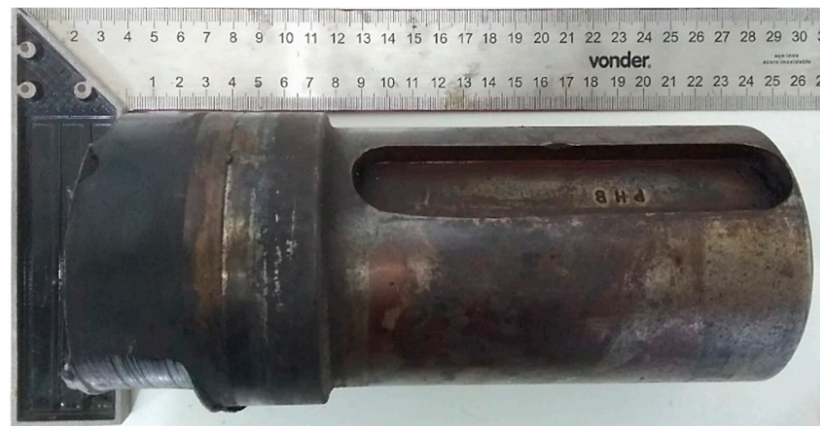
**Figure 2.** Fractured shaft of the speed reducer.

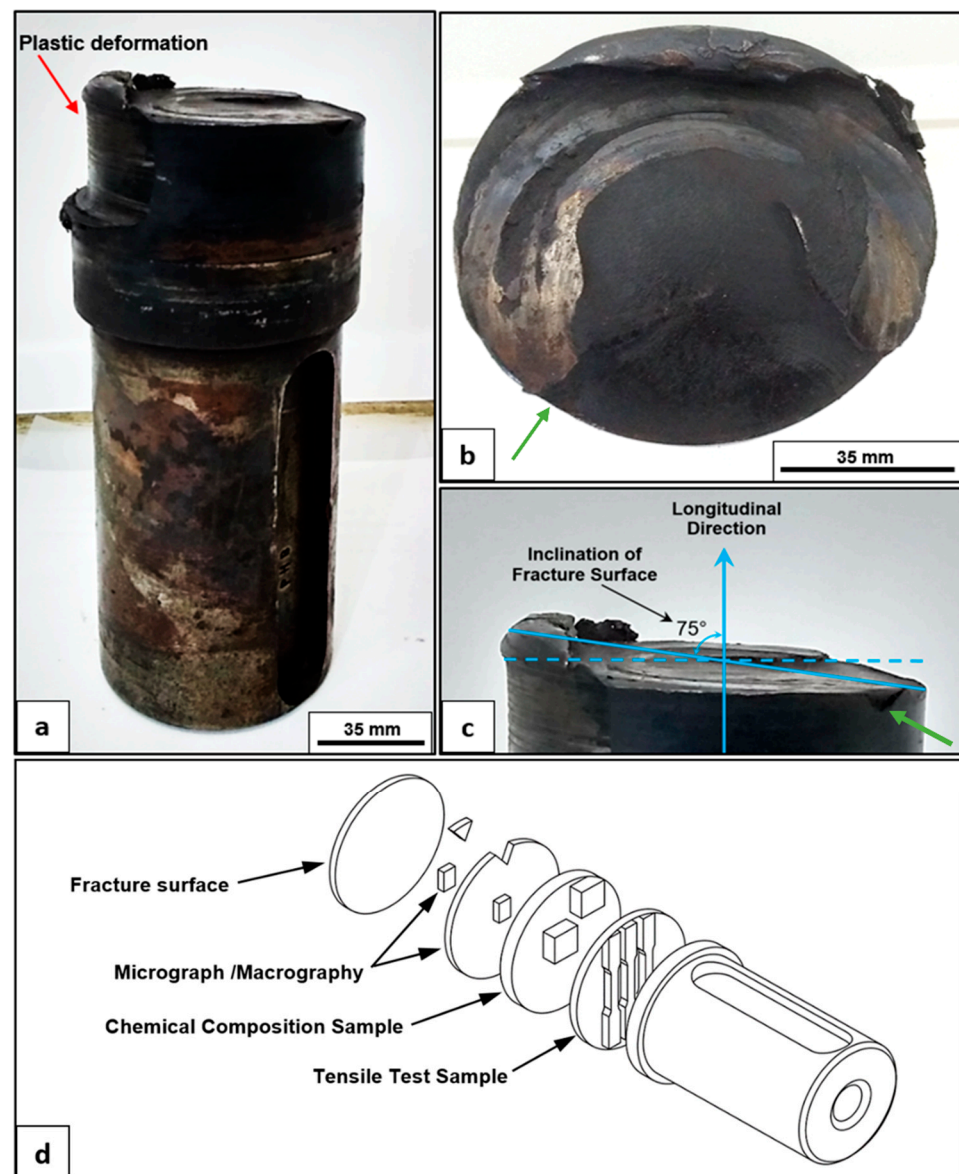
**Figure 3.** Fractured reducer shaft: (a) Side view showing the plastic deformation (red arrow) of the material under the fracture surface, (b) top view (fracture surface before cleaning), (c) fracture surface slope, (d) samples for the characterization and analysis withdrawn from the shaft. Green arrows indicate crack nucleation area.

A visual analysis of the shaft in the received condition was performed to evaluate the conditions of the material after fracture. Figure 3 shows a side and front view of the fractured shaft. In Figure 3a, it can be observed that the shaft underwent plastic deformation on the longitudinal surface, indicated by the red arrow, due to a high overload causing a change in its circumference uniformity [10] and deformation at the region of the fracture. Analyzing the high plastic deformation of the shaft's fit location with the reduction box (red arrow Figure 3a) indicates that when the shaft broke there was an abrupt misalignment of the coupled gears, leading to an overlap of the teeth from the drive and driven gears. Most of the fracture surface (central and border region, near the crack nucleation area; indicated by green arrows) in Figure 3b presents a low cycle fatigue fracture which was similarly reported by Pantazopoulos et al. [19]. The remaining fractured area suffered a plastic deformation and ductile fracture, with an instant rupture caused by shear stress overload, as also observed in [8,20,21].

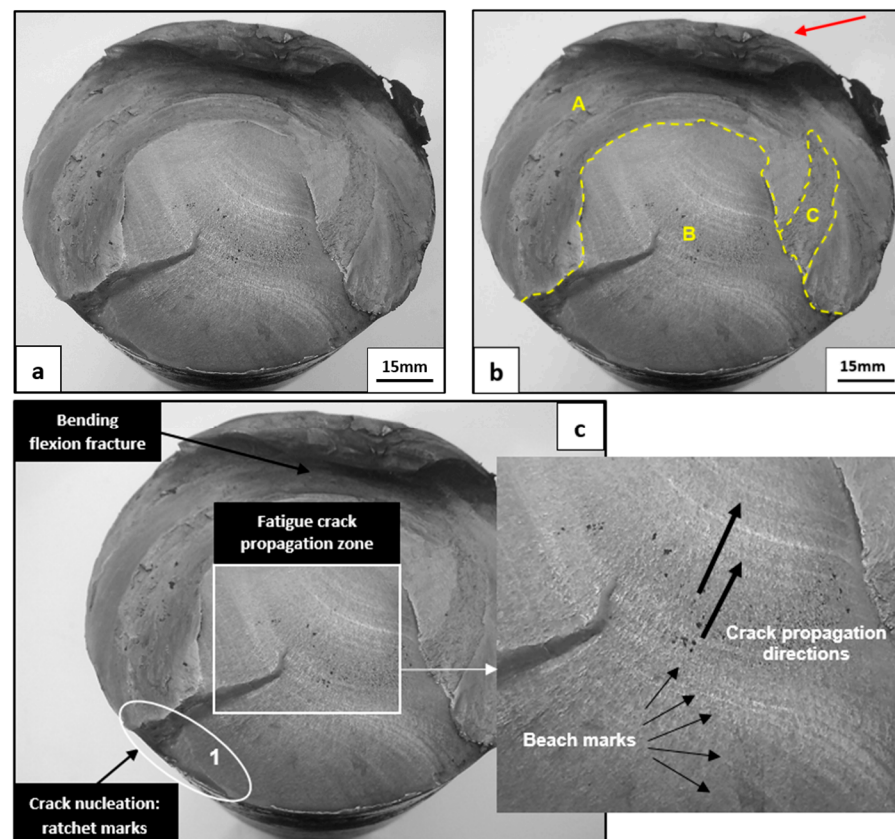
The fracture surface after the cleaning procedure is presented in Figure 4a. The unevenness between the highest and the lowest point at the fracture surface was about 25 mm. The macroscopic pattern of the fracture revealed the occurrence of fatigue fracture morphology caused by rotating-bending loads (Figure 4b,c). The fatigue crack propagation occupied approximately 40% of the total gauge area and the overload failure (60% of the total gauge area) presented a plastic deformation region, as indicated by the red arrow in Figure 4b. The detailed evaluation of the fracture surface allowed the identification of some

characteristics of fatigue failure: (I) ratchet marks (Figure 4c), which indicate the result of multiple origins of fatigue crack nucleation due to the high stress concentration; and (II) beach marks (Figure 4c), which constitute the progression of fatigue cracks, indicating the variation in the crack growth rate. These fractographic features of fatigue fracture were also reported by other researchers [23,24]. The fatigue mechanism was fairly consistent with rotating-bending loading, and the extension of the fatigue zone in the shaft was typical for moderate load conditions [23].

**Figure 4.** (a) Fracture surface after cleaning procedures; (b) zone of fatigue (region B) and the final failure area due to overload (A and C regions), red arrow indicates the final fracture zone; (c) fracture surface details of the reducer shaft.

An important fractographic characteristic was that the main fatigue crack grew from the surface of the shaft (Figure 4c, see white ellipse), following a slightly helical path towards the center. In general, this propagation morphology is associated with flexion/torsion loads on rotating shafts [3–5]. Regarding the beach marks, they showed a very pronounced texture, with a very clear interspacing between the marks. This texture aspect is associated with the low cycle fatigue (LCF) mechanism [5]. In LCF, crack propagation occurs under stresses above the flow limit of the material, promoting failure during a reduced number of cycles [25,26]. In addition, it should be noted that in the case of rotary shafts, such as the one in the present study, each point on its surface is subjected to a tensile stress and, subsequently, a compressive stress, for each revolution carried out [17]. This type of alternate loading explains the nucleation of the crack at the shaft surface and its propagation towards the center [3,5].

The fracture was divided into specific areas called: Zone A, which represents the part of the fracture surface damaged by the overload, and which causes damage, and the micromechanism of rupture modified due to friction of the two shaft halves at the time of break; Zone B, corresponding to the fatigue zone; Zone C, which is also the region of the

overload fracture (Figure 4b) but where the micromechanism fracture was not modified, allowing fractographic analysis.

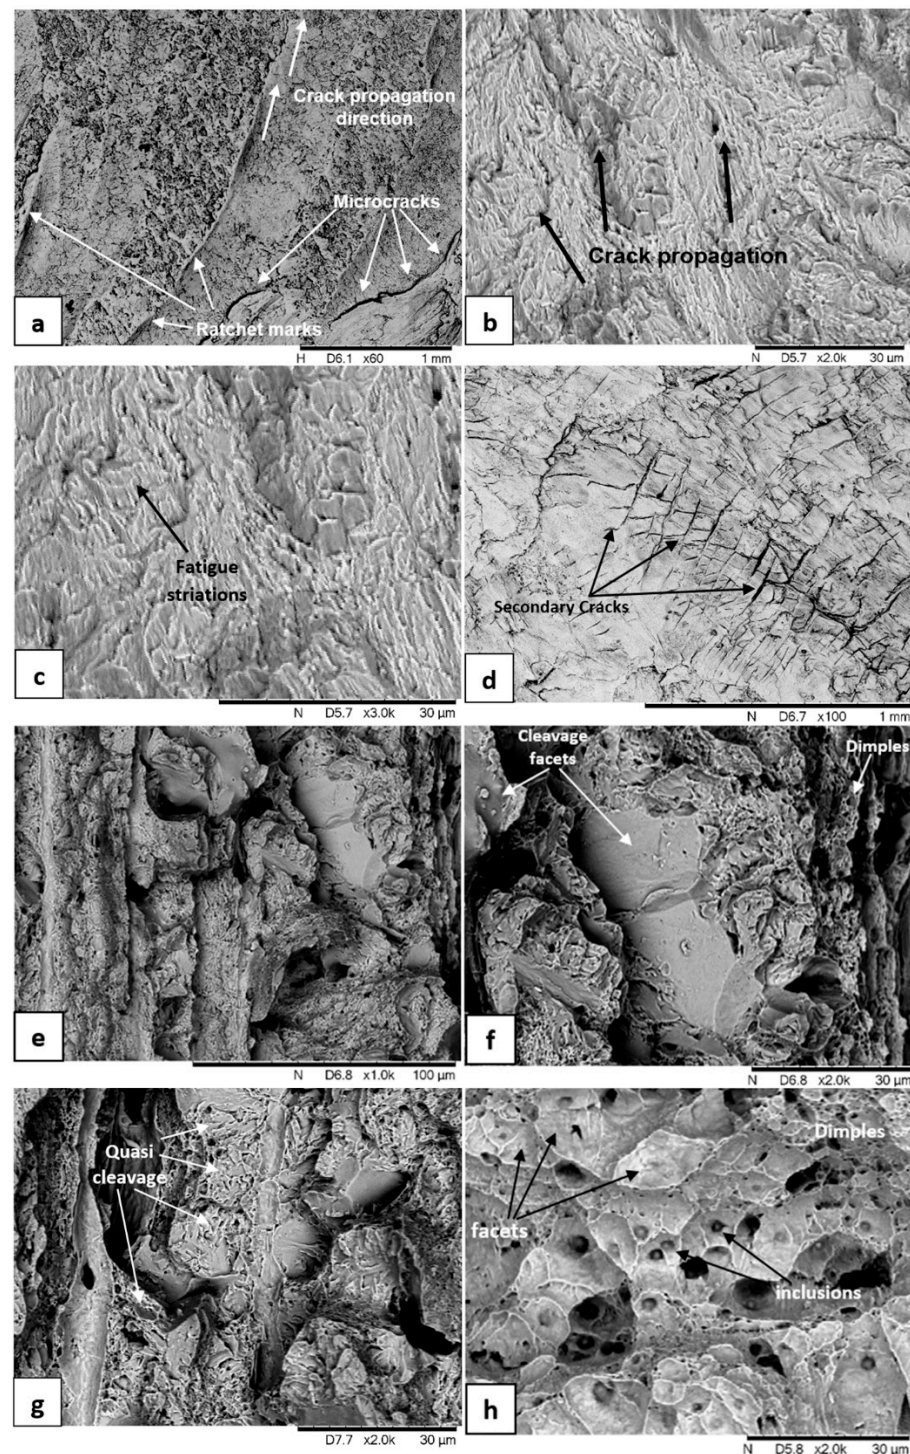
The SEM analysis validated the operation of the fatigue mechanism typical characteristics of cracks nucleation and fatigue growth (Zone B), as shown in Figure 5: (a) ratchet marks showing cracks nucleation, which join to form the main fatigue from the edge shaft; (b) the cyclical propagation of the crack front due to the friction forces between the fracture surfaces; and (c) possible fatigue striations indicating the progress of a crack front after an increment of crack propagation, where each increment of propagation is due to a stress cycle. Zone C, which corresponds to the overload rapid fracture, presented an aspect of gross fracture, and presented secondary cracks, as shown in Figure 5d, caused by high and unbalanced stresses at the moment of component break [12]. An evaluation by SEM revealed quasi-cleavage as the dominant fracture micromechanism of the final overload area of the shaft, according to Figure 5e; in this zone the characteristics of fragile cleavage facets combined with the distribution of ductile areas by dimples (Figure 5f,g), and these characteristics were consistent with transgranular fractures. Another observation was the presence of many inclusions inside the dimples and cleavage facets (Figure 5h), where they had a harmful effect on the material's toughness and accelerated the fracture process, as these act as local stress concentrators [11].

It is worth mentioning that the presence of ratchet marks is strongly related to fatigue [5]. Ratchet marks are small cracks that originate and grow in planes where the maximum shear stress occurs [5]. In addition, these are directly influenced by the intensity of the stress concentration for a given critical section and correspond to Stage 1 of fatigue [5,27]. Observing Figure 4c, it is possible to visualize the ratchet marks region, indicating that in this place there was a stress concentrator (white ellipse 1). However, it should be noted that according to the location of the fracture plane on the shaft (Figure 1b), this position did not contain geometric stress concentrators (e.g., key or diameter change). The fracture plane was reasonably far from geometric discontinuities (Figure 1b). Furthermore, in the visual inspection stage, it was found that the surface of the shaft (Figure 2) had a good surface finish (low roughness). The shades of brown, red, and black colors on the shaft surface were probably only due to the lubricating oil used in the reduction box and to the mining company's environment, which is rich in iron ore. According to Zerbst et al. [9], fatigue cracks always start in places with greater local deformation, such as: macro-notches, machined holes, grooves, section transitions, etc.; however, the stress/deformation concentration will be further increased due to the presence of defects in the material. Therefore, it seems that the steel may have had metallurgical defects generated in its manufacturing processes. This was verified with the microstructural and mechanical analyzes in the next sections.

**Figure 5.** Fracture micromechanism: (a) Ratchet and microcracks bands; (b) fatigue propagation and striations; (c) detail of (b); (d) secondary crack found in zone C; (e) region of quasi-cleavage fracture containing traces of a fragile fracture by cleavage and dimples; (f–h) are details of (e).

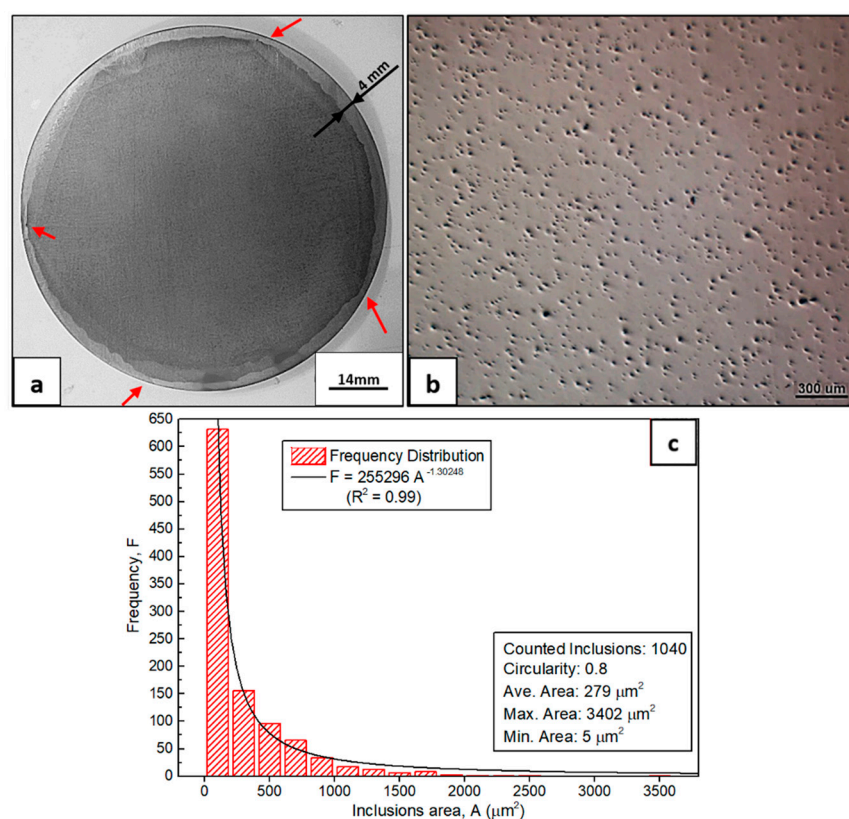
The macrostructure in the cross-section of the shaft revealed a hardened layer indicating that the component was submitted to heat treatment (Figure 6a). The hardened layer was not uniform along the cross-section, and in some places a width with less than 1.0 mm was found (regions indicated by the red arrows). In accordance with the inclusion classification (ASTM E45-13 [15]), numerous inclusions of thin and thick globular oxides (Type D) were present, with a severity of 3.0 for both, and some Type B inclusions (alumina) (Figure 6b) were observed with a severity of 0.5 (as shown in Table 3). Figure 6b was obtained close to the shaft edge. Such a large number of inclusions is not desirable, because they can act as stress-concentration areas, which can lead to crack nucleation [10]. The stresses in the vicinity of an oxide inclusion are potentialized because of their size [11]. According to Figure 6c, the inclusions presented an area frequency distribution, which was very close to an exponential distribution. In addition, the average circularity of 0.8 indicates that the inclusions approached a spherical shape; circularity equals 1, a perfect spherical form. This result is in agreement with the inclusion classification analyzes (Table 3), which showed a strong presence of globular oxides. In this sense, it is also likely that the cir-

**Figure 6.** (a) Non-uniform hardened cross-section shaft layer. Red arrows indicate the hardened layer with a width less than 2 mm; (b) inclusions present in the shaft; (c) frequency distribution of the inclusions areas at the subsurface of the shaft.

Thus, using the mean and maximum area values of the analyzed inclusions (Figure 6c), the mean and maximum inclusion size was 19 and 66 μm. From observing Figure 6c, it is evident that the vast majority of inclusions had an area smaller than 500 μm<sup>2</sup> (size of 25 μm). Therefore, the critical parameter of inclusion size was verified [29], related to the threshold value for the propagation of fatigue cracks. This critical value was around 50 to 100 μm [30]. However, when the inclusions were just below the surface, inclusions smaller than a 45 μm fracture were responsible for fatigue [31].

In order to prevent the reported type of failure, the level of cleanliness of the steel is very important. A good practice would be to follow the specifications of the ASTM E45-13

standard [15], trying to reduce the size of the non-metallic inclusions to values below the critical size. Another important factor is the design/execution of the heat treatment to harden the material. A heat treatment based on the TTT diagram of the alloy must be strictly followed, as well as the use of appropriate equipment and instrumentation for monitoring and controlling the component's heating and/or cooling operations. Finally, a more frequent maintenance plan for speed reduction boxes is recommended, in addition to monitoring the growth of cracks, with inspections using non-destructive tests.

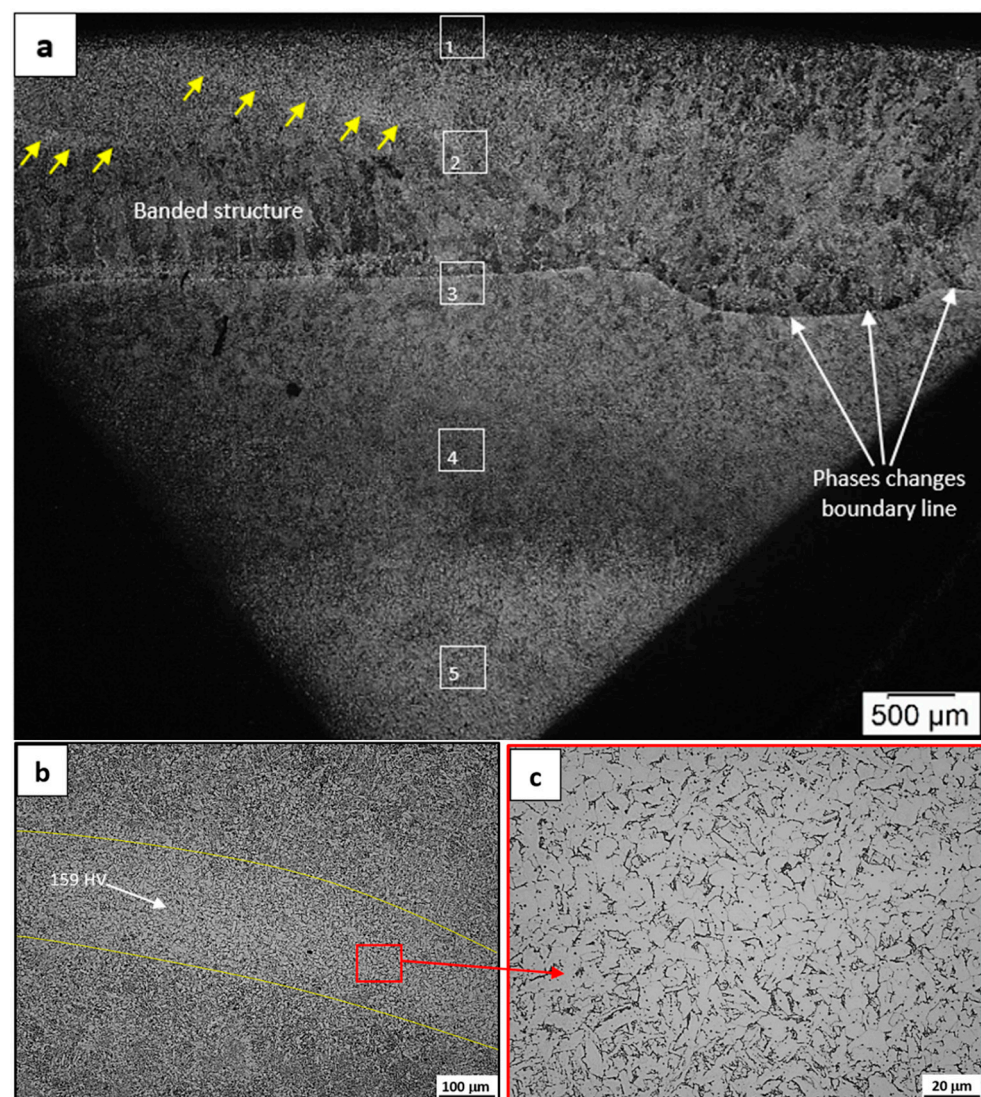
An overview of the hardened surface layer metallography of the shaft is shown in Figure 7. It presented a gradual variation of the microstructure up to the first 4000 μm; after that depth, the microstructure remained unchanged, without any significant changes until the core of the shaft. The microstructural characterization was performed in the regions indicated as 1 to 5. Region 1, corresponding to the shaft surface, indicated the presence of a 200 μm bainite layer, where the first 100 μm presented an upper bainite matrix with small

sites of polygonal ferrite, and in the subsequent 100  $\mu\text{m}$ , the bainite was irradiated at the limits of the old austenite grain border in the polygonal ferrite matrix (Figure 8a–d). The shaft edge has a microhardness of  $478 \pm 12$  HV. However, due to the suffered overload, this region presented a highly elongated granulation zone. Additionally, no signs of decarburization were observed (Figure 8a,d). The presence of a distorted granulation may have led the material to exhibit residual tensile stresses on the shaft surface and controlled the development of microcracks and fatigue cracks.

Region 2 shows a pattern of banded structure that extends up to the phase boundary line (Figure 7). Figure 8e presents a quasi-polygonal ferrite matrix [32] in a dark color, and the white Widmanstätten ferrite in white, arranged in bands (Figure 8f,g). The matrix of quasi polygonal ferrite has grains with a non-uniform distribution and irregular shapes (Figure 8h). The matrix presented a microhardness of  $216 \pm 14$  HV, and the Widmanstätten ferrite, a microhardness of  $165 \pm 9$  HV. Additionally, in a banded structure zone, some tracks of polygonal ferrite were nucleated with a small amount of pearlite within the limits of the ferrite grains and the microstructure is detailed in Figure 7b,c. The microstructure also exhibited a low microhardness, with a value of  $159 \pm 11$  HV.

**Figure 7.** (a) Optical micrograph of the transversal section showing the microstructural change from the surface to the shaft core. Yellow arrows indicate the localization tracks of polygonal ferrite nucleated with a small amount of pearlite; (b) detail of (a); (c) polygonal ferrite and pearlite nucleated in the area of the banded structure.

Considering the characteristics of the structure arrangement in bands and the low microhardness due to the two phases (polygonal ferrite and pearlite, Figure 7c), just beneath the high resistance surface layer in region 1, it is evident that this microstructure is inadequate for this type of application. The heat treatment aimed at increasing the superficial resistance of the shaft material was poorly executed.

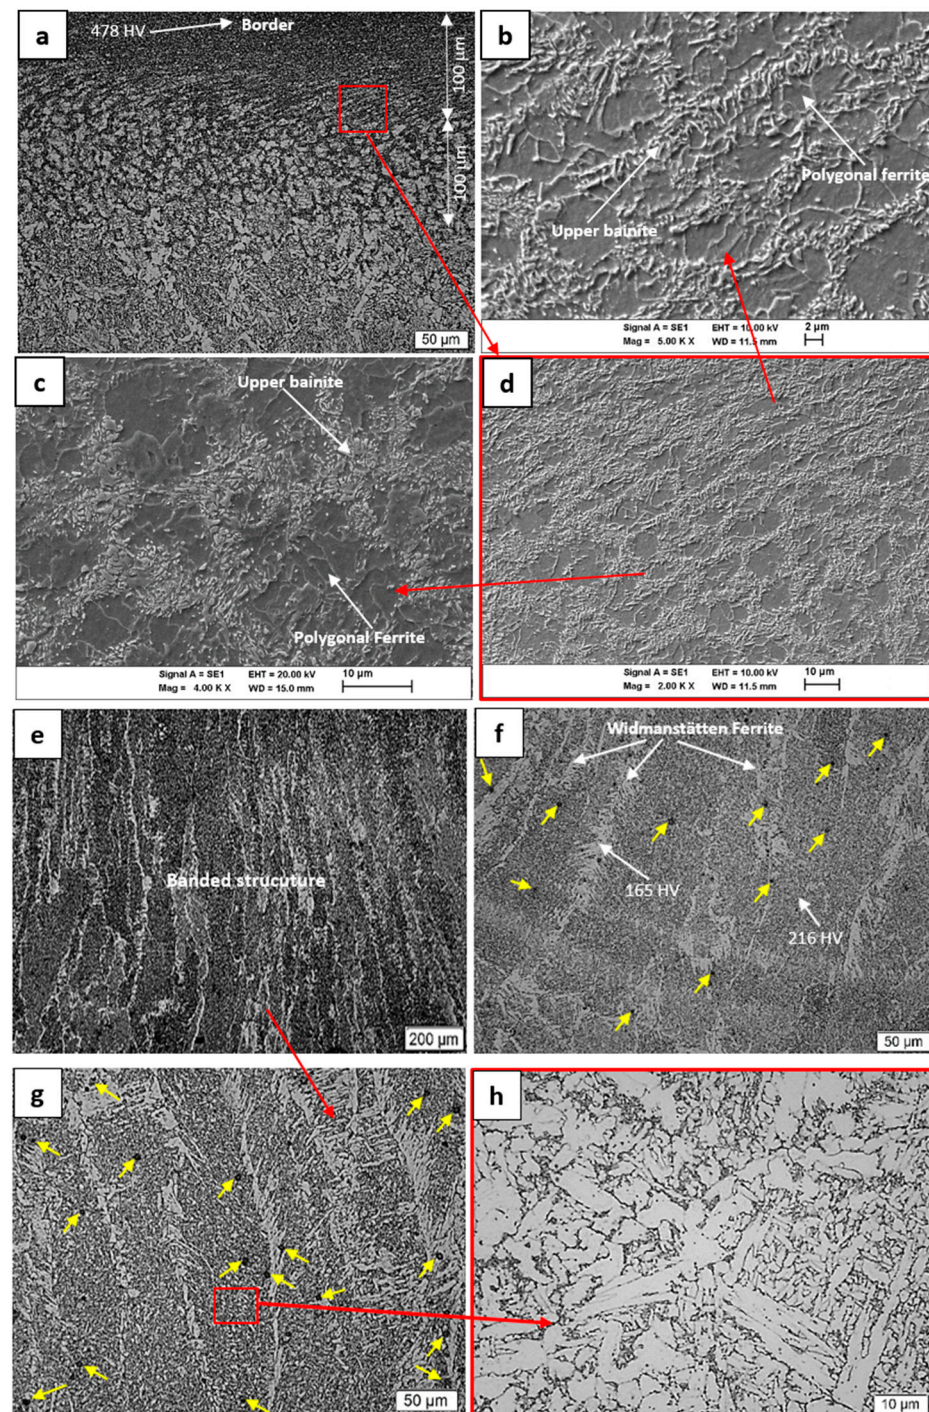
**Figure 8.** (a) Distribution of the upper bainite layer showing elongated grains; (b) detailing of the grain distortion in the first 100 µm; (c) distribution of the upper bainite in the boundaries of the old austenitic grain; (d) detail of (a); (e) banded structure; (f,g) detail of (e) showing the distribution of inclusions in the matrix; (h) detail showing the matrix; (g) large magnification of the matrix. The yellow arrows indicate inclusions distributed in the matrix.

It is important to mention the existence of the high amount of inclusions distributed in the matrix (indicated by the yellow arrows in Figure 8f,g). The chemical composition of these inclusions was evaluated by EDS, although it is a semi-quantitative technique. Figure 9 shows the SEM image of an inclusion indicating the points of analysis and the spectrum. Large amounts of manganese (Mn), silicon (Si), sulfur (S), aluminum (Al), and oxygen (O) were detected in the inclusion, and the results are summarized in Table 4. The presence of these elements indicates that the inclusions were composed of oxides and sulfides formed by these elements. The high iron content observed in the analysis was due to the interference of the ferritic matrix during the analysis in SEM.

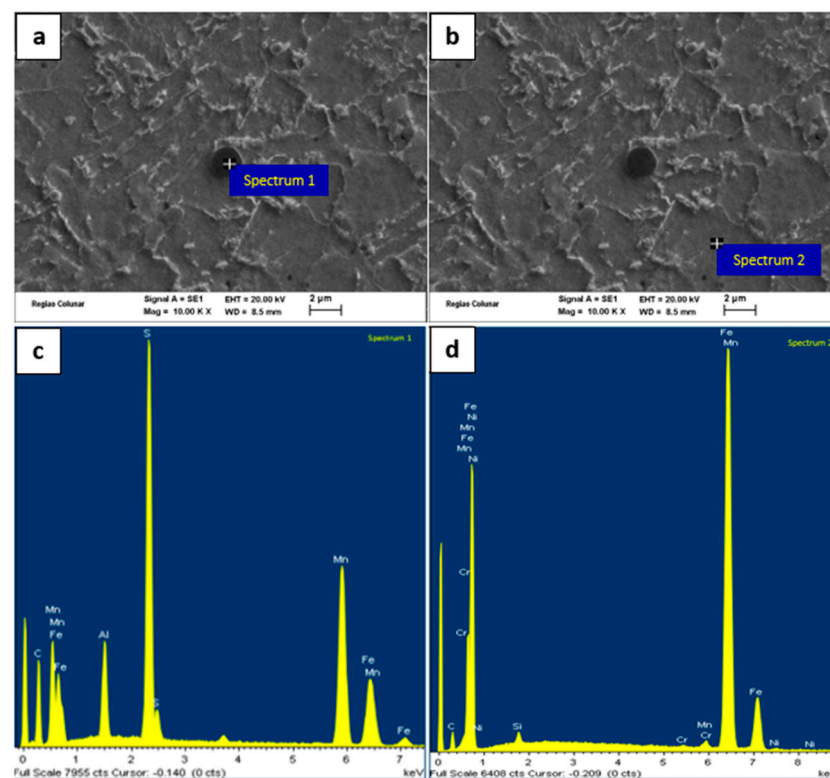
**Figure 9.** EDS analysis of inclusion present in the banded structure for region 2: (a) spectrum 1 corresponds to the analysis results shown in (c); (b) spectrum 2 corresponds to the analysis results shown in (d).

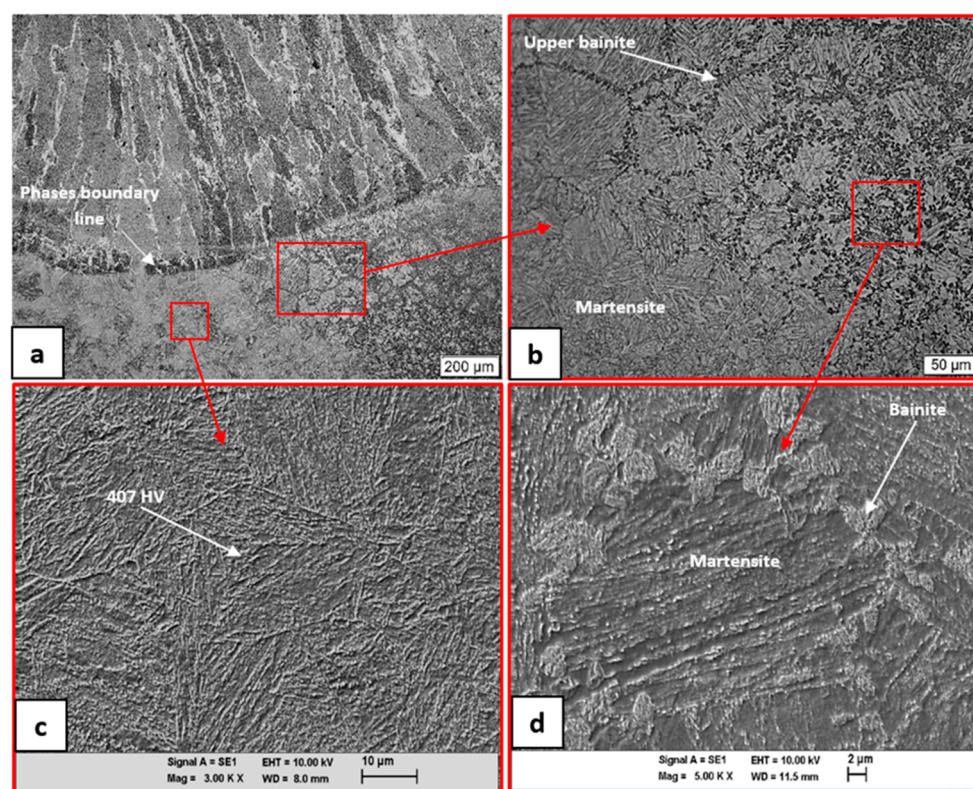
The microstructure located in region 3 is shown in Figure 10. It represents the transition of a banded structure to the microstructure formed by a martensite matrix, with some upper bainite colonies in the old austenitic grain boundary (Figure 10a,b,d). The martensite matrix presented a microhardness of  $407 \pm 31$  HV (Figure 10c). Considering the width of the layer of this microstructure in the shaft material, it indicates that the nucleation of the banded ferrite structure above the boundary line of phases undesirably emerged and was caused by poor heat treatment, since the constituents of the banded structure commonly nucleate through diffusion mechanisms. Thus, it can be stated that the heat treatment carried out in the shaft was austempering, and thermal oscillations probably occurred in the isothermal bath temperature during the treatment. It is recommended to use an appropriate heat treatment to ensure the uniformity of the hardened layer microstructure, through an increase of the bainitic phase layer extension by isothermal treatment or carburizing, since steel SAE 4320 has a low carbon content.

**Figure 10.** (a) Phase transition of the banded structure; (b) martensite with some colonies of upper bainite; (c) martensite microstructure; (d) detail of (b).

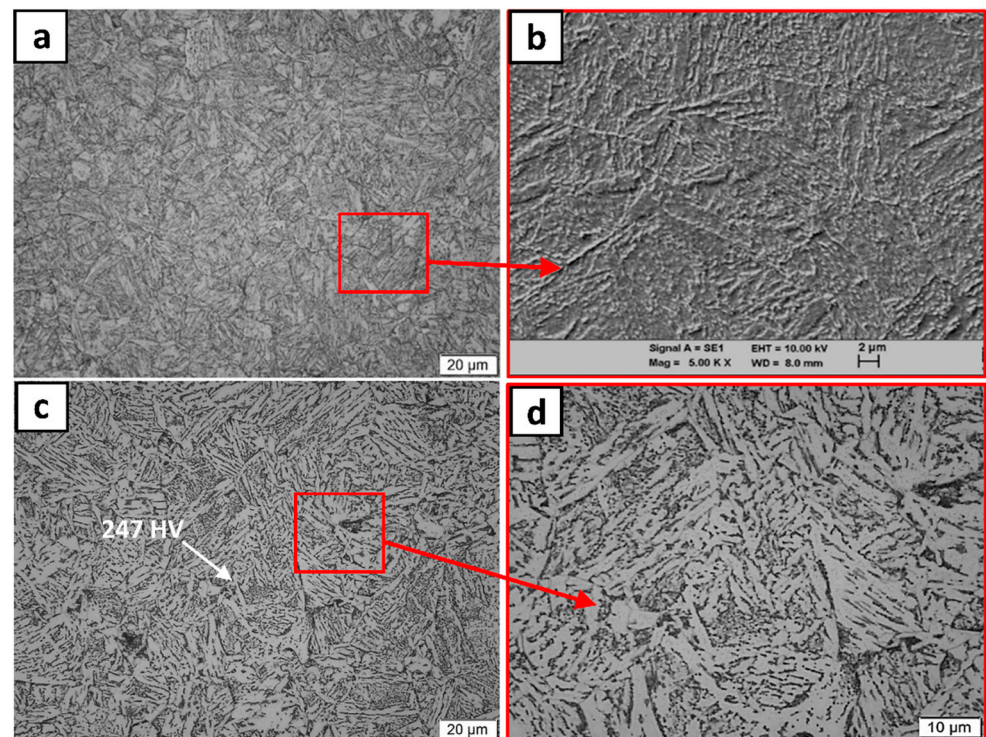
After the phase boundary line in region 4, bainite colonies disappeared and give way to only martensite phase (Figure 11a,b). Region 5 comprises the microstructure around the shaft core, which consists of ferrite–acicular (light gray) and pearlite (dark) (Figure 11c,d); the pearlite is dispersed in the boundaries of the grains and as plates within the ferrite matrix. The structure presented a microhardness of  $247 \pm 11$  HV, which is a normal value for a shaft core for this type of application.

**Figure 11.** (a) Martensite; (b) enlarged detail of (a); (c) acicular ferrite and pearlite in the shaft core; (d) enlarged detail of (c).

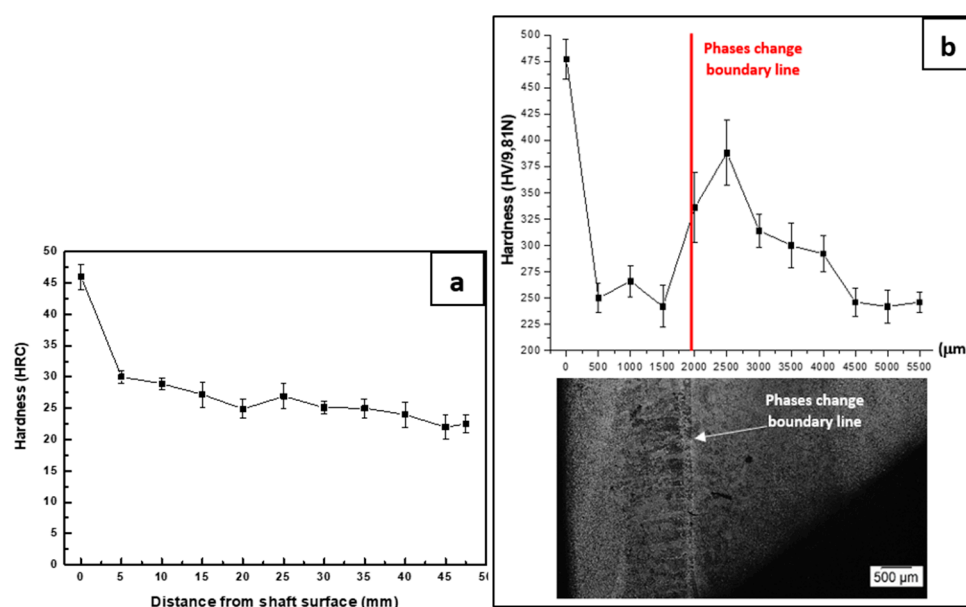
The sample for the hardness test was extracted from the material of the fractured shaft to determine the hardness profile from the shaft surface as shown in Figure 12a. The average surface hardness was 47 HRC, which is high in comparison with the core, which was 22.5 HRC. These results were consistent with the microstructures observed for each region of analysis, confirming the hardening treatment execution. The core hardness was adequate, but an even greater hardness on the surface would be desirable since this confers increased resistance to fatigue and to crack nucleation.

**Figure 12.** (a) Hardness profile of the shaft cross-section; (b) distribution of the microhardness along the hardened surface layer of the shaft.

The microhardness test was performed along a track of indentations at intervals of 500 μm in the hardened surface layer of the shaft, to assess the behavior near the phase boundary line, as shown in Figure 12b. The results of the graph show a sudden drop in the hardness at the 1500 μm position regarding the microstructure of polygonal and Windmanstätten banded ferrite before the phase boundary line. These results were consistent with the microstructures analyzed in the previous topic and indicated that the transition phase had a low resistance.

Therefore, according to Figure 12b, it is evident that during the service conditions of the shaft, there was a deformation mismatch between the high hardness microstructure at its surface (0 μm—Figure 12b) and the soft phases just beneath it. Similarly, it is also possible to state that there was a non-homogeneous deformation in the phase contour line (approximately at 2000 μm, Figure 12b), which separated the regions of the material with low hardness (left of the red line) and with high hardness (right of the red line). In view of the great difference in the hardness of the microstructures, there was a high possibility of crack growth occurring at their interfaces, due to the mechanism of decohesion of the structures [34–37]. In the present study, interface decohesion may have been caused by the more pronounced local deformation of the soft constituent, as reported in the literature [38,39].

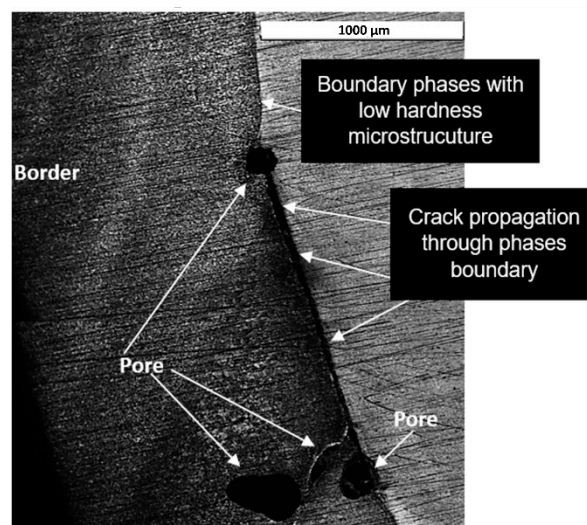
It should be noted that the other defects resulting from the manufacturing process of the shaft had a significant contribution to the reduction of the fatigue life. Figure 13 shows a grown crack between two pores, which were located at the phase contour. Chan [40]

stated that fatigue strength and fatigue life are reduced in the presence of pores and when increasing their size. In addition, some studies have shown that fatigue cracks can also be initiated on or near pores [59,60]. Furthermore, Fan et al. [61] reported that relatively large pores, as well as less widely spaced pores, concentrate large plastic stresses that promote localized deformations which accelerate crack nucleation. Besides the presence of the pores, cracks at the phase contours may increase due to the formation of layers of microstructures with very distinct mechanical properties, caused by inadequate heat treatment [33–36]. Finally, fatigue failure was also strongly induced by the large number of inclusions spread along the surface region of the shaft being 42% above the  $\phi_c$ . Once the crack had nucleated, the cyclic loading inherent during the working regime of the shaft led to the continuous growth of the crack until the complete collapse of the shaft.

**Figure 13.** Crack propagation between two pores along the boundary line of low hardness phases.
