# Study on the Root Causes and Prevention of Coating Cracks in the Cargo Hold of a Product Carrier

**Citation:** Yi, M.-S.; Seo, K.-C.; Park, J.-S. Study on the Root Causes and Prevention of Coating Cracks in the Cargo Hold of a Product Carrier. *Metals* **2022**, *12*, 1688. <https://doi.org/10.3390/met12101688>

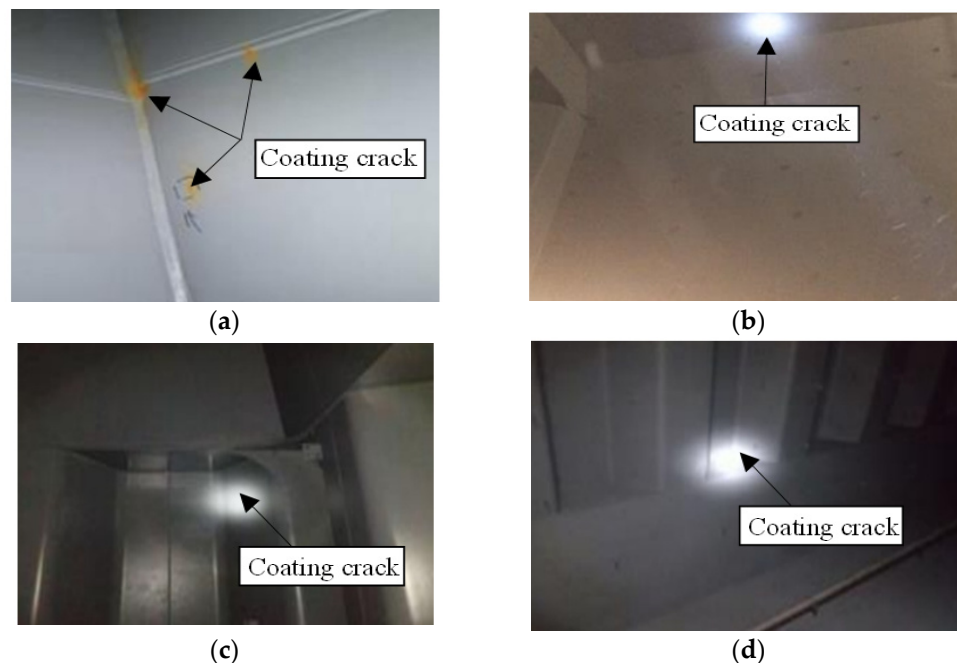
According to the tank test, coating cracks occurred at various locations in the cargo hold. The most common locations are listed below, with examples shown in Figure 3.

- Ceiling at the connection between the center bulkhead and the main deck;
- Upper and lower stool and corner brackets; and
- Typical web welding toe.

These are the locations where structural stress is high during tank tests. Although the maximum stress is low, a coating crack may be generated. In most cases, impurities are added during coating, which may result in a thicker coating than that recommended by standard specifications. Basically, the tank test is conducted to evaluate the safety of structural members and is performed under more conservative conditions than the actual loading pattern. Therefore, coating cracking easily occurs under tank test conditions.

**Figure 3.** Coating crack survey results in the cargo hold: (a) low stool; (b) typical web section deck; (c) upper stool (bottom); (d) lower stool (bottom).

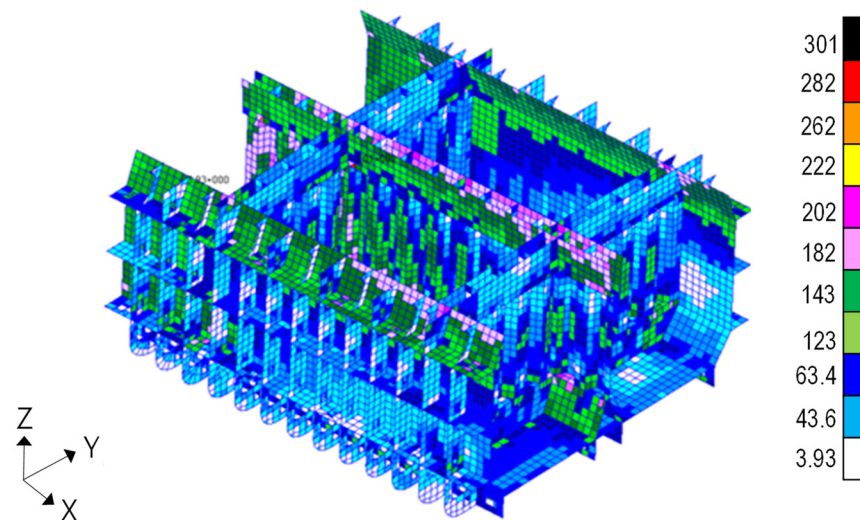
In order to clarify the coating crack failure, we performed cargo hold analysis using coarse mesh modeling in order to identify a critical location that exceeds 70% of the allowable stress, as shown Figure 11.

**Figure 11.** Von Mises stress contour of the inner cargo structure under hogging combinations.

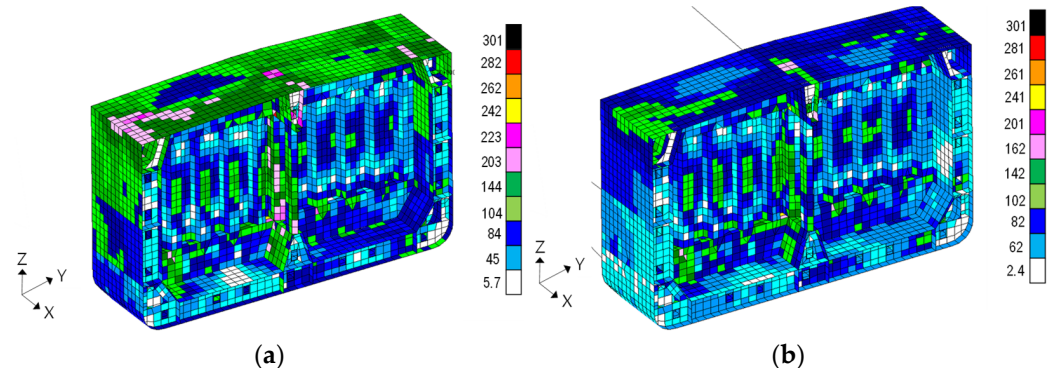
In the cargo hold analysis, the stress value was verified in advance of determining the critical location, as illustrated in Figure 11. In particular, there are various connections in the corrugated bulkhead, where coating cracks often occur; therefore, the value should be carefully examined according to the geometric shape, as well as the location. Figure 12 shows a comparison of the stress results according to hull girder loads, namely hogging and sagging conditions. The maximum stress values are similar, but the stress patterns differ.

**Figure 12.** Detailed stress contour between the center bulkhead with stools and inner structure in the cargo hold. (a) Hogging combination. (b) Sagging combination.

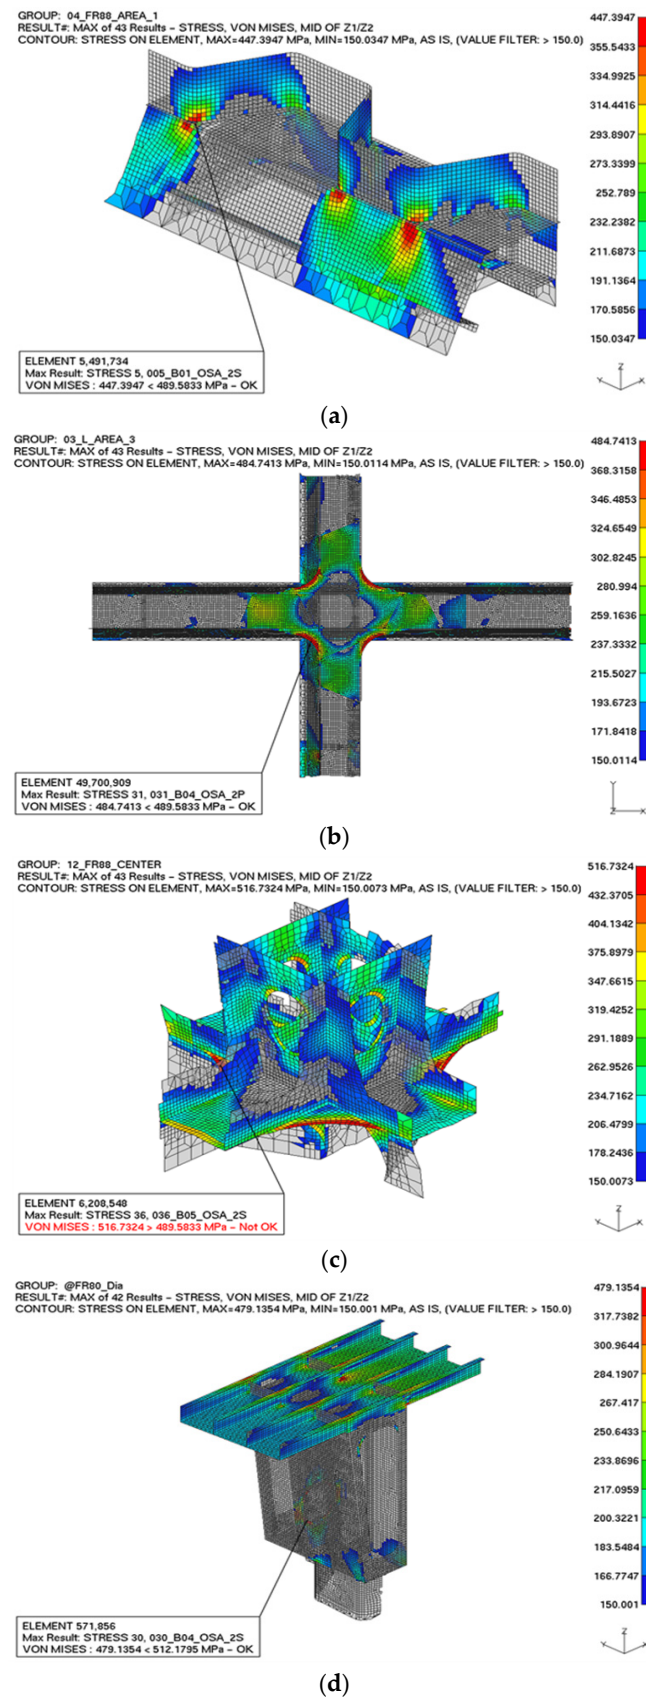
Figure 14 shows the stress contour according to the locations determined by tank test loads. High-stress zones are generated at the joint between the bulkhead and the stool, the bracket connection end, and at the joint between the upper stool and the deck. The steel materials used for the cargo hold structures SS400 mild steel and AH32 and AH36 high-tensile steel. The allowable stress is applied variably (AH32, 489.5 MPa; AH36, 512.2 MPa) because the yield stress of the materials differs, according to the locations where coating cracking frequently occurs. According to the FE analysis results, plastic strain rates of coating were calculated for each location and summarized, as indicated Table 2. The coating strain is 0.3% or less at most locations, and the RISK index is in the low category. In other words, the RISK of damage to the coating is quite low under structural deformation conditions. Among the locations, the maximum coating strain of 0.75% occurred in the connection between the upper stool and the corrugated bulkhead. In the investigated target product carrier, no coating crack occurred due to structural deformation during the tank test. In this study, it was assumed that the coating was successfully installed without any defects.

**Table 2.** Summary of the coating strain and RISK index according to location.

| Structural Component | Coating Strain (%) | RISK Index |
| Deck transverse web | 0.33 | Medium |
| Lower stool-bracket | 0.40 | Medium |
| Upper stool-bracket | 0.41 | Medium |
| Upper stool bottom | 0.75 | Medium |
| Ceiling-upper stool top | 0.34 | Medium |

**Figure 14.** Maximum von Mises stress results with varying critical locations using a very fine meshing model: (a) lower stool–corrugated bulkhead connection; (b) center bulkhead–bracket connection; (c) upper stool–bracket connection; (d) upper stool–main deck connection.

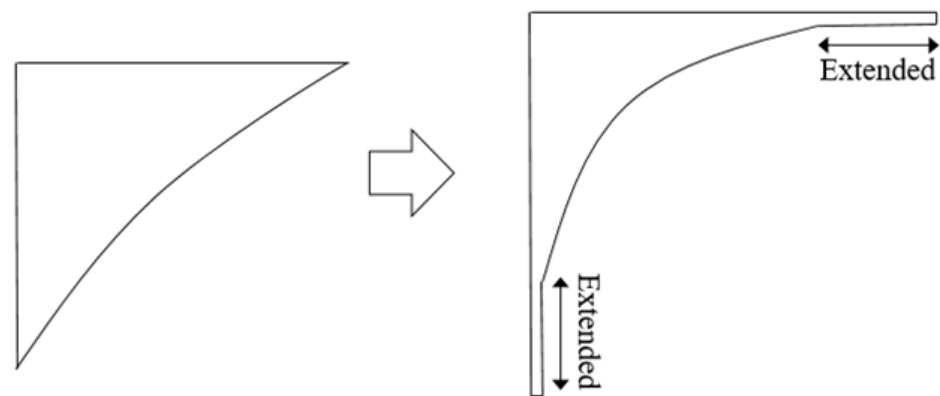
**Figure 15.** Corner bracket design change with extended toe.

During the commissioning process of the product carrier, a tank test is conducted to verify the safety of the structural members. In general, seawater is injected into the tank to the PORT (port side), the STBD (starboard side) is emptied, and the same pattern is maintained in the ballast tanks. These conditions represent a severe combination that is unlikely to occur under actual operating conditions of the vessel. Therefore, tank test procedure is adjusted to simulate the actual operating conditions and divided into a loading pattern. In addition, the difference of cargo density should be considered in the tank test process. In order to reduce the probability of coating cracking, the shape of the bracket is changed to a position of maximum stress from toe to center so hotspot stress can be dramatically reduced by increasing the weld toe, as indicated in Figure 15.

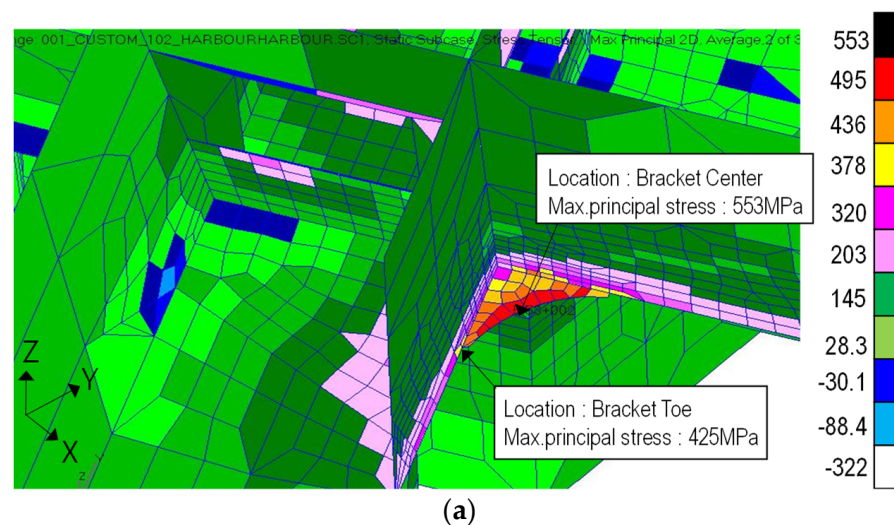
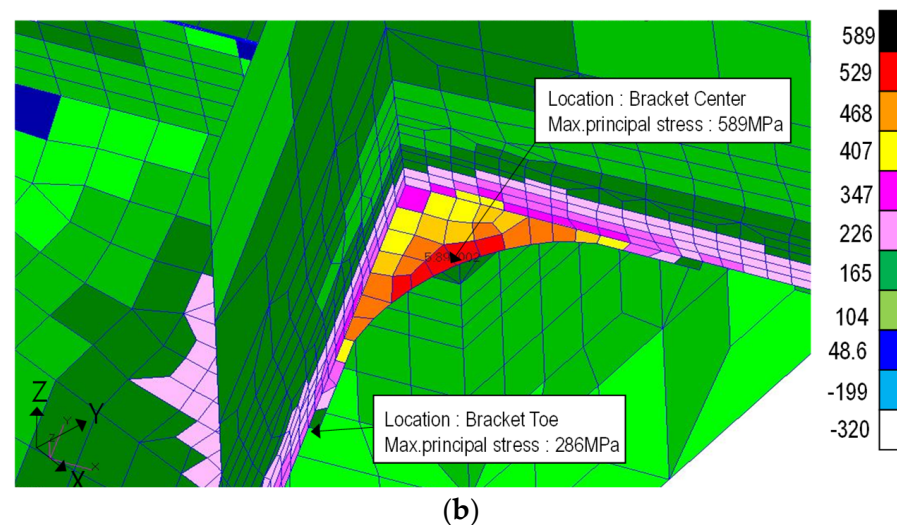
The principal stress result is shown Figure 16a,b according to change in the bracket design. In case of a change in the shape at the weld toe, the stress at the center of the bracket increases by about 6%, whereas stress at the weld toe decreases by approximately 50%. Because the critical location where cracks occur in the coating is the end of the weld toe, modification of the shape is an effective method to reduce coating cracking.

**Figure 16.** Principal stress result following a change in bracket design. (a) Maximum principal stress of the initial bracket model. (b) Maximum principal stress of the modified bracket model.

An additional method of smooth grinding is applied on the welding toe, where high stress is concentrated because cracks occur more easily where the coating is thicker due to the characteristics of coating failure.
