Failure Analysis of Bank-Wall Side Boiler Tube in a Petrochemical Plant

Keywords: bank-wall side boiler tube; low carbon steel; under deposit corrosion; hydrogen attack; thermal fatigue

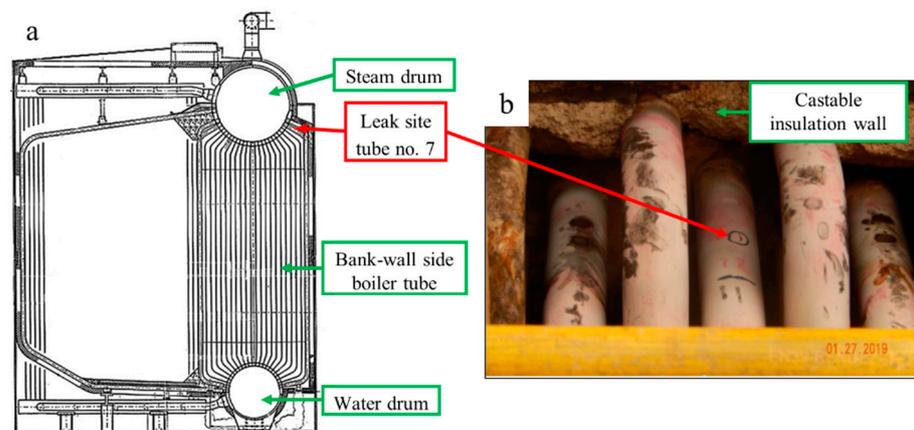
This work presents a failure case study of the bank-wall side boiler tube, which is in tube number 7 (Figure 1b). The tube was part of the petrochemical plant's boiler and failed in January 2019 after 23 years of service, which is generally designed for 25 years.

Figure 1. (a) Schematic illustration of bank-wall side boiler tube and (b) location of the failed boiler tube.

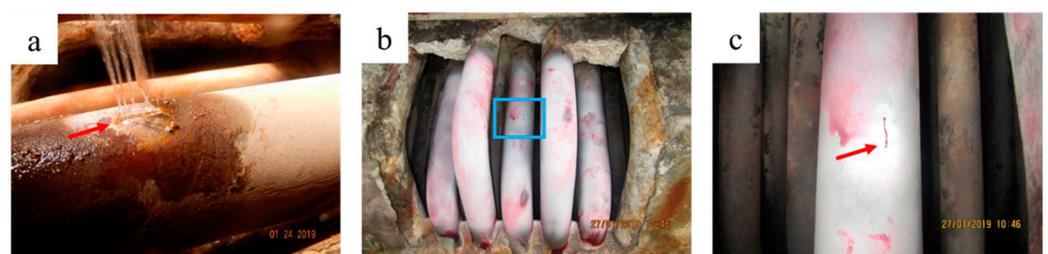
The leak's location was inspected by hydrostatic and dye penetrant tests. The revelation of the tube leak location by a hydrostatic test is shown in Figure 2a. Further examination by a dye penetrant test was conducted to find surface cracking on the neighboring tubes (Figure 2b,c). The inspection results show that the leak only occurred in one tube (red arrow in Figure 2a,c), with no surface cracks on the other neighboring tubes (Figure 2b). The leak occurred on the top side of the tube, which is partially embedded in the furnace wall's castable heat insulation.

Figure 2. Leak location inspection in the boiler tube using (a) hydrostatic test and (b,c) dye penetrant tests. The blue rectangle in (b) indicates the observation area of (c). the red arrow in (a,c) indicates the leak location.

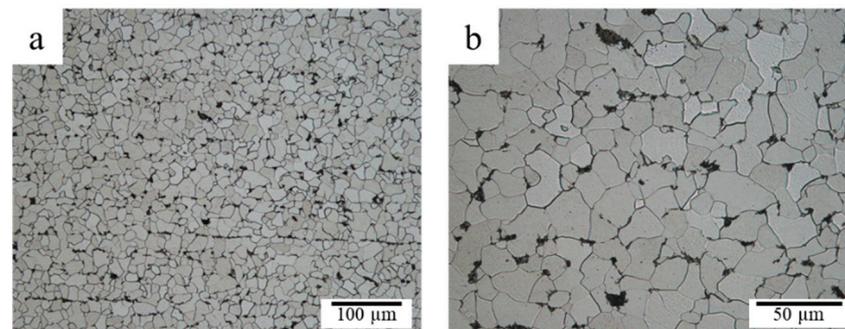
material had been heat-treated and slowly cool (normalizing or annealing) [20]. Chemical composition, tensile properties, and microstructure conform to ASTM A178 Grade A [16]; thus, the tube material agrees with boiler technical specifications.

Figure 3. Microstructure images of the uncracked parts of the tube at (a) low and (b) high magnifications.

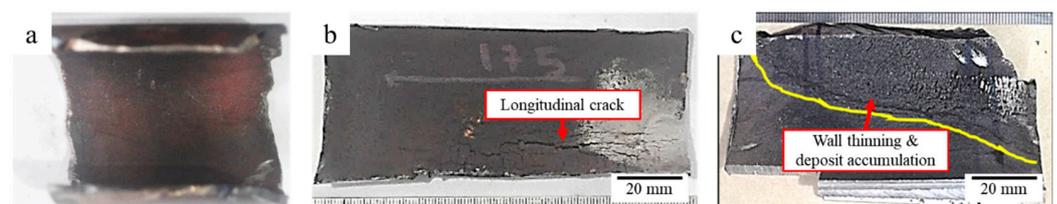
The leak boiler tube was removed from its location by a disc cutter, where the top part had to be sliced into two pieces because of space limitations during onsite cutting. Figure 4 shows the inner bottom side and two parts of the inner top side. The inner bottom of the tube had a thin reddish surface deposit, and there was no sign of corrosion attack or surface cracks (Figure 4a). The inner top of the tube shows some longitudinal cracks (Figure 4b) and a trace of wall thinning and deposit accumulation (above the yellow line in Figure 4c). Therefore, the top part of the tube had two failure modes: Longitudinal crack and corrosion; there is no significant wall thinning and bulging. Detailed examination of the defective surface will be conducted by stereomicroscope, SEM, and optical microscope.

Figure 4. Visual observation of the inner part located at (a) the bottom and (b,c) the top of the leaked boiler tube.

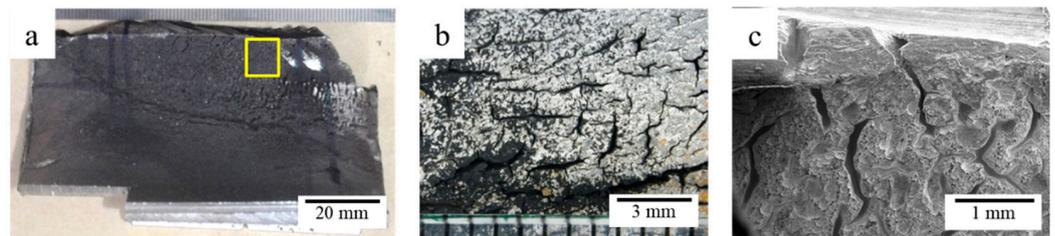
cracking surface were observed. Microstructure analysis will be performed on one of the leak-fractured surfaces to obtain a detailed crack propagation mode. Figure 5a shows the location of observation in the corroded part. The presence of longitudinal and transverse blistering cracks (fissuring) on the surface can be seen clearly in the stereograph (Figure 5b) and SEM micrograph (Figure 5c), respectively.

Figure 5. Fractography of corroded surface at the inner part of the top of the leaked boiler tube. (a) observation site (indicated by a yellow rectangle), (b) stereograph, (c) SEM micrograph.

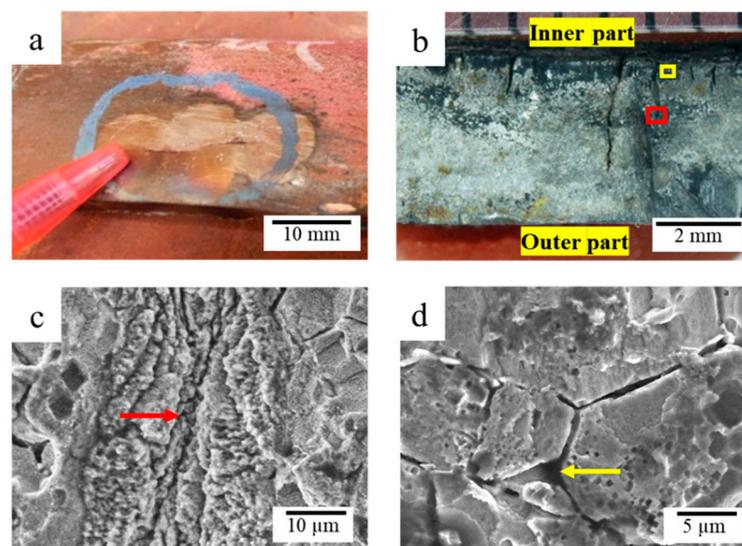
At the leaking area of the failed tube, the longitudinal crack was through-thickness, so the crack was observed not only in the inner part but also in the outer part of the tube (Figure 6a). Fractography analysis was conducted by splitting the longitudinal crack at the leaking area (Figure 6a) into two parts. Cross section stereographs image of one of the fractured surfaces is shown in Figure 6b. A sticky deposit that covered the original fractured surface was partially removed by cleaning. However, the black and thicker deposits underneath the inner tube's surface could not be removed and remained in the specimen (Figure 6b). The fracture appearance shows a brittle-like surface with some transverse fissuring cracks, which had been propagated outward to about 75% of the thickness (Figure 6b).

Figure 6. (a) visual observation of the outer part of the leaked tube showing longitudinal leak location, (b) cross-section stereographs of the fractured surface, SEM image of: (c) transgranular cracks that were observed at the red rectangle area in (b), and (d) intergranular cracks were observed at the yellow rectangle area in (b). Red arrow in (c) and yellow arrow in (d) indicated the occurrence of transgranular cracks and intergranular cracks respectively.

SEM examinations were conducted to observe the fractured surface in more detail and determine the micro-crack propagation mode. SEM image at the red rectangle area in Figure 6b revealed that many transgranular cracks were observed in the fractured surface (red arrow; Figure 6c). While SEM image at the yellow rectangle area in Figure 6b showed

that many intergranular cracks (cracks propagated through grain boundaries) and corrosion attack trace produces micro-crack along grain boundaries were observed in the fractured surface (yellow arrow; Figure 6d). Based on the fracture appearance (brittle-like fracture) and crack morphology (intergranular and transgranular), there are four possibilities of crack origin: creep, hydrogen attack, thermal fatigue, or copper diffusion to grain boundaries. These possibilities will be studied further by microstructure and EDS analysis.

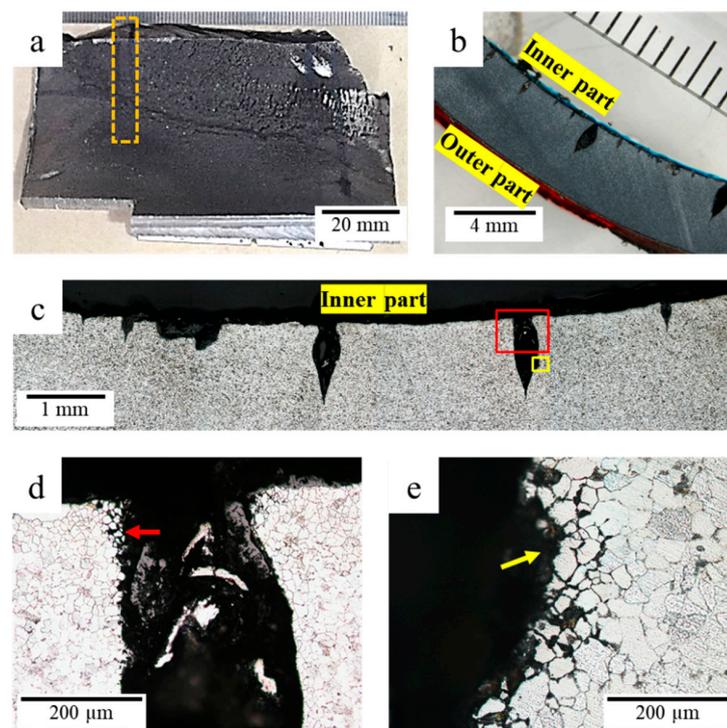
The stereograph (Figure 7b) and optical micrograph (Figure 7c) of a cross-section taken from the sampling location (orange rectangle in Figure 7a) showed that several sharp and blunt microcracks were present in the leak site. The sharp cracks were typical cracks due to thermal fatigue, where the crack interface was oxidized due to high-temperature exposure, and the oxidation products filled the crack [21,22]. Thermal fatigue failure occurs because of temperature fluctuation, creating thermal stress for crack initiation and propagation [23]. Further investigation on the origin of crack initiation was determined by observing the microstructure in one of the selected cracks (Figure 7c). Observation at higher magnification revealed that the intergranular cracking and grain separation caused the crack initiation, as shown at the initial crack of the initiation site (red arrow, Figure 7d) and near the crack tip (yellow arrow; Figure 7e), respectively.

Figure 7. Macro and micrographs of the corroded inner surface. (a) Sampling location, (b) stereograph of cross-section, (c) low magnification micrograph and observation site for further study (indicated by a red rectangle for the crack initiation site and yellow rectangle for near the crack tip), high magnification micrograph at (d) crack initiation site and (e) near the crack tip. Red arrow in (d) and yellow arrow in (e) indicated the occurrence of intergranular cracking and grain separation at the initial crack and near the crack tip respectively.

The result confirmed that creep was not the root cause of crack initiation because creep voids and spheroidized carbides in the crack interface's vicinity were not present [24]; therefore, two other remaining root causes shall be considered. The other possible root causes are hydrogen attack and copper diffusion to grain boundaries. The hydrogen attack might initiate cracking, as shown in Figure 7e, by the presence of the decarburized layer and intergranular crack (yellow arrow in Figure 7e) around the crack interface [25].

Pearlite around the interface will be vanished and become a decarburized zone, as shown in Figure 7c. Trapped methane gas along the grain boundaries will create high pressure and break the grain boundaries to form fissures/micro-cracks along the grain boundaries [33]. Once enough fissures/cracks are formed, they begin to link (coalesce), severely weakening the tube wall and rupturing it even at normal working pressure.

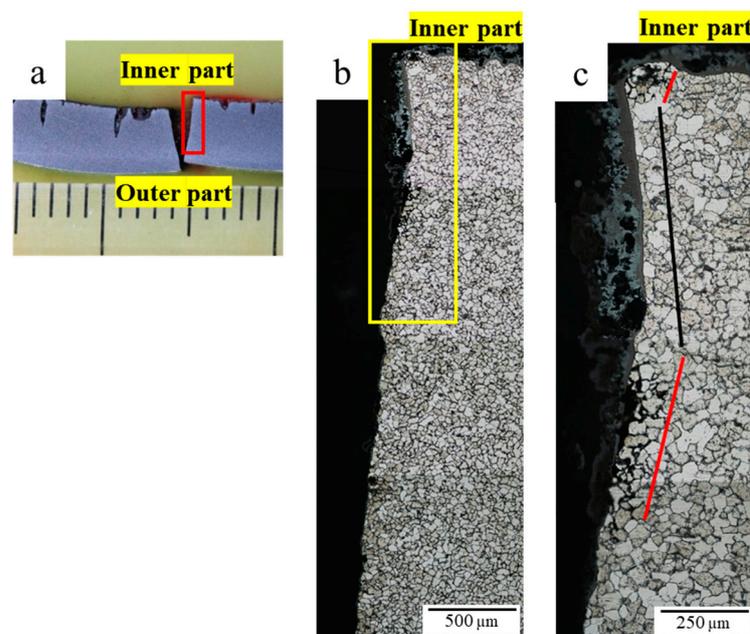
The cross-section micrographs at the leak site's crack interface were examined to observe the root cause of crack initiation and the propagation mode. Figure 8a shows the stereomicrograph of one of the crack surfaces where several thermal fatigue cracks with different lengths were present and started from the inner tube diameter. These findings indicated that multiple crack initiation occurred on the inner diameter before the leak. The micrographs of the crack surface at low and high magnifications are shown in Figure 8b,c, respectively. The pearlite phase around the crack interface was decomposed; however, spheroidization of cementite did not occur yet, because no spheroidized carbides were observed. It can also be seen in Figure 8b,c that the crack was initiated by intergranular cracking on the inner diameter of the tube. The crack was stopped temporarily and followed by transgranular cracking.

Figure 8. (a) stereograph of the leakage site and micrographs at (b) low magnification (at the red rectangle area in (a)), (c) high magnification (at the yellow rectangle area in (b)) showing the intergranular (red line) and transgranular (black line) cracks at the leak interface.

It can be concluded that the crack initiation was due to a corrosion attack and was followed by thermal fatigue. The corrosion attack and thermal fatigue produced intergranular and transgranular fractures, respectively. The origin of corrosion attack and thermal fatigue will be explored by studying the origin of deposit formation and thermal cycle during deposit accumulation.

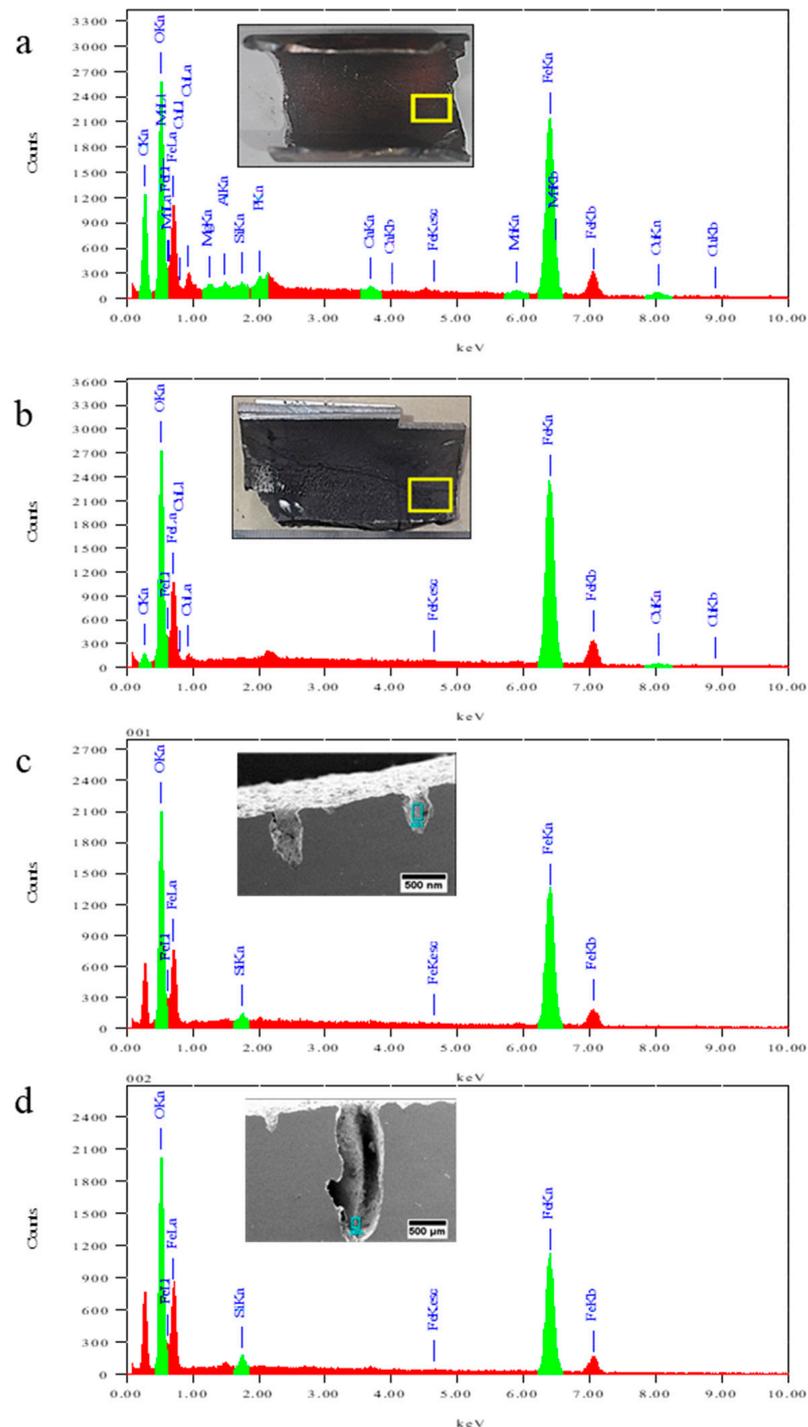
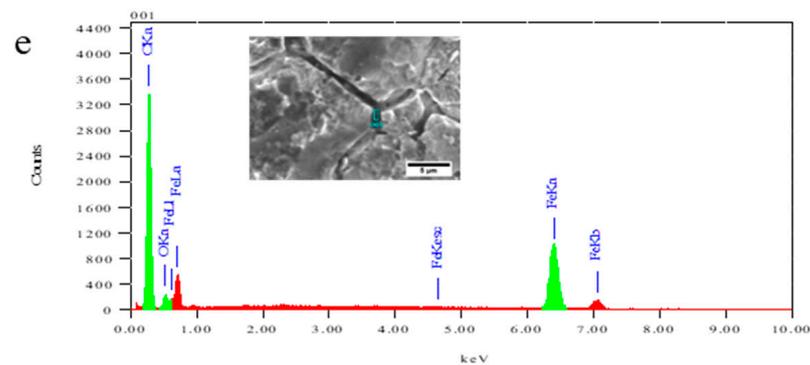
The EDS results and summary of elemental composition for each testing location (indicated by yellow and blue squares) are shown in Figure 9 and Table 4, respectively. EDS analysis result on the inner surface of the bottom part, which is an uncracked part and covered by a homogeneous and dense deposit structure (Figure 9a), showed that the original elements of the carbon steel tube (Mn, Si, Fe, P, and S) and its oxide layer (O) were observed in this area (Table 4). Interestingly, a significant amount of copper (2.16%) was observed in the deposit, not the elements of the carbon steel tube or its oxide layer.

Figure 9. EDS analysis results of deposit at (a) the bottom and (b) the top surface of the tube; inside (c) the short crack and (d) the long crack; (e) on the grain boundary. Green and red peaks in EDS results indicated the X-Ray from K-alpha and K-beta emission respectively. Yellow rectangle in inset of (a,b), and blue rectangle in inset of (c–e) indicating the EDS examination area.

EDS analysis result of the deposit at the corroded area, which is located on the inner surface of the top part of the tube (Figure 9b), revealed that the elements of the oxide layer (Fe and O) were dominant in this deposit (Table 4). Copper was also observed in this area, but its content (1.56%) was less than copper content in the bottom part (2.16%). Further discussion with the company revealed that the upstream surface condenser brass tubes were corroded [6,7]. The presence of copper deposits in a considerable quantity might be originated from these corroded brass tubes and the corrosion product mixed with boiler feedwater. The bottom's deposit contains more copper than the top surface because water scale deposition preferentially occurred on the tube bottom. It is noteworthy that the deposit analysis on the inner bottom and the inner top surface was performed on as-received samples without a cleaning process (inset of Figure 9a,b). Thus, the presence of carbon in both samples originated from the black deposit that covered the surface of both samples.

Further EDS examinations were performed on the inside of the short crack (Figure 9c), long crack (Figure 9d), and grain boundary (Figure 9e) that were found around the leakage interface. EDS results unveiled that only Fe, Si, and O elements were found at the crack interface (Table 4), implying that the crack was filled by oxidation products, which is one characteristic of thermal fatigue was occurred in the leak site [21,22]. Since copper was not found at the crack interface and the grain boundary (Table 4), it can be concluded that copper on the surface was not penetrated the cracks and did not contribute to the formation of intergranular cracks. Thus, the intergranular crack formation was solely due to the hydrogen attack. It is worth noting that the deposit analysis on the short crack's inner side, the long crack's inner side, and the grain boundary were performed on samples after being mounted in polyester resin, followed by grinding and polishing. Thus, it is reasonable that the grain boundary sample has high carbon content (Table 4) because of polymer infiltration on the gap/cracks that were located on the surface, such as the crack in the grain boundary.

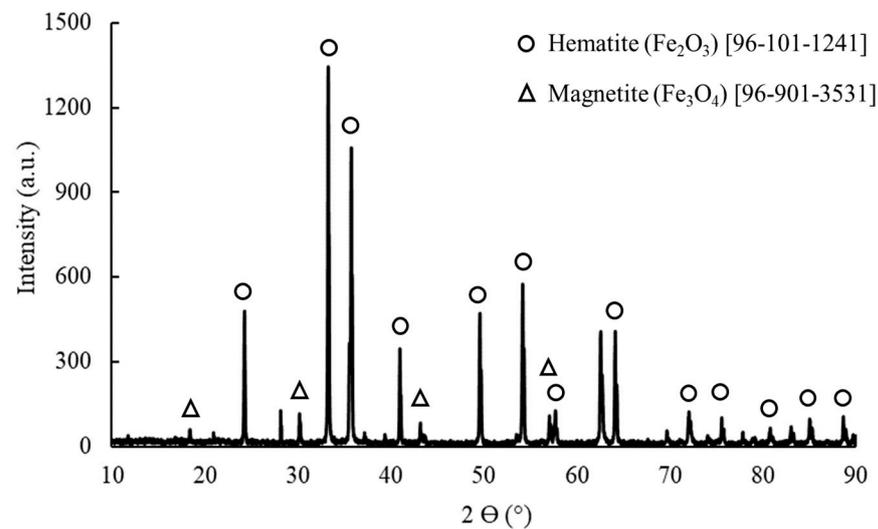
Additional characterization was performed on the corroded surface's deposit using the X-ray diffraction (XRD) method to determine its compound type. As seen in Figure 10,

the XRD result shows that the corrosion deposit on the inner surface was dominated by hematite (Fe_2O_3), with a small amount of magnetite (Fe_3O_4).

Figure 10. XRD result of corrosion deposit.

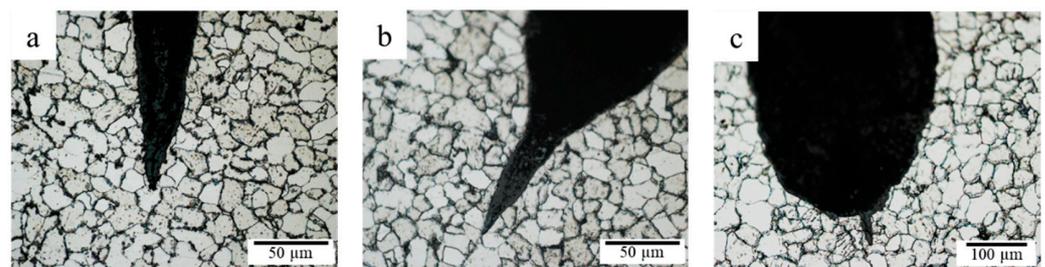
Cracks morphology observed in a failed boiler tube consists of sharp and blunt crack tips. Figure 11 shows three different transgranular crack tips on the cracked boiler tube that will affect the crack propagation rate differently. Even though the crack morphologies are different, the failure mechanism for the three different cracks is the same (thermal fatigue and corrosion). However, it differs in the sequence of mechanism and proportion. The sharp crack (Figure 11a) was mainly caused by thermal fatigue. When the crack propagation is overwhelmed by corrosion, the crack site might be attacked and making it slightly blunt (Figure 11b). Moreover, if it is dominated by corrosion, the crack might become blunter, as seen in Figure 11c.

Figure 11. Three types of crack tips morphology in the boiler tube.

Considering the hoop stress from the operating condition (49.7 MPa) is significantly lower than the yield strength of the tube material (273 MPa; Table 3), and it is a static stress from the operating condition. Therefore, hoop stress is not considered a factor for thermal fatigue. The presence of sharp crack tip in the sample (Figures 7c and 11) and the cracks were filled by oxidation product (Table 4), which are the typical characteristic of the occurrence of thermal fatigue, implying that thermal stress is the main driving force for crack propagation in this case. Thermal cyclic was developed when temperature decreased during water splashed and increased after water evaporation. Crack propagation occurred when the stress intensity factor at the crack tip exceeding the threshold stress for crack propagation [34] and stopped when the stress intensity factor was less. The stress intensity factor increases sharply with decreasing crack tip radius because the locally applied stress increases.
