Failure Analysis of Duplex Stainless Steel for Heat Exchanger Tubes with Seawater Cooling Medium

Abstract: The present paper describes a study case of the failure investigation of duplex stainless steel (UNS S31803) on the tube and tube sheet sections of BEM TEMA-type shell and tube heat exchanger with seawater as the cooling medium. The heat exchanger's shell design pressure was 22.6 MPa at 422 K, and the tube design pressure was 1 MPa at 339 K. Although UNS S31803 offers high strength, high resistance to chloride-induced SCC, and high resistance to pitting attack in chloride environments, the heat exchanger in this study experienced some material degradation after 28 months of use; 102 out of 270 tubes failed, 26 tubes leaked and were plugged on both sides, and scale plugged 76 tubes. The examination in this study case revealed the formation of white-colored biofilm inside the tubes; XRD examination revealed that the film contained CaCO_3 . Using microstructural examination on the inner surface of the tube, the austenite grains were shown to have been preferentially attacked; this phenomenon is typical in duplex stainless steel which fails due to crevice corrosion. According to

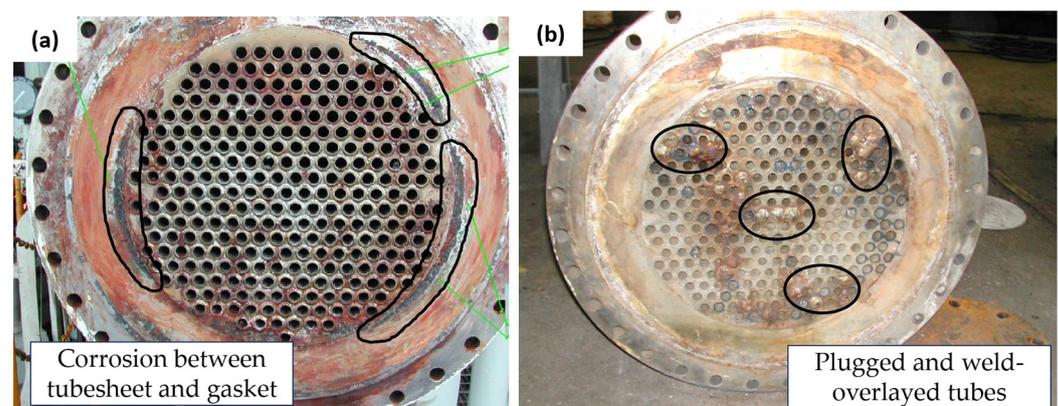
Visual examinations were conducted on two heat exchangers. Figure 3a is the photograph of the heat exchanger on the platform; defects were found on the welded section between the tube and tube sheet (the circled section shows the defects of the tube sheet under the gasket area); further examination of this defect is shown in Figure 4a,b. The tube sheet of the heat exchanger at the warehouse (Figure 3b) contained some leaked tubes. The circled section shows that some leaked tubes were plugged and weld-overlaid. For further examination, the heat exchanger at the warehouse was cut into several sections, including the tube sheet and gasket interface, tube sheet inlet sections, and the tube itself.

Figure 3. Failed heat exchangers' appearance: (a) tube sheet of heat exchanger on the platform; (b) tube sheet of heat exchanger at the warehouse.

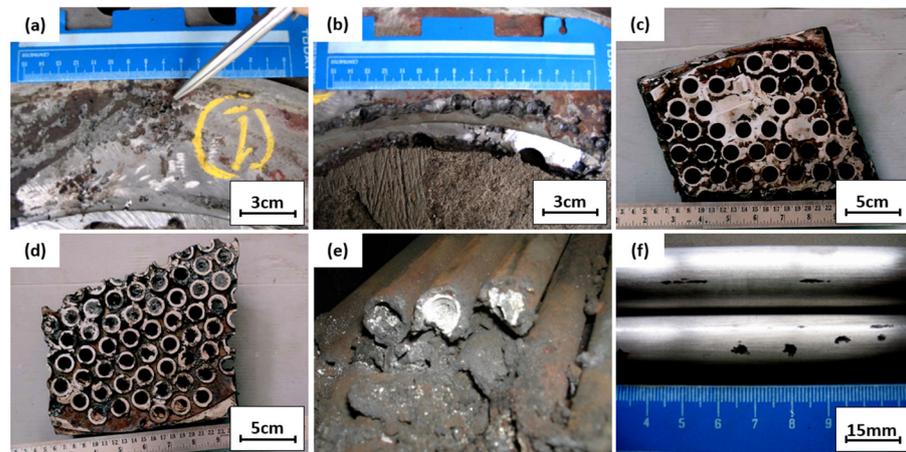
Figure 4. (a,b) Tube sheet and gasket interface; (c,d) tube sheet inlet sections; (e) lateral section of tubes; (f) tube surface condition.

Figure 4a,b show the further examination of Figure 3a. Pitting defects under the gasket can be seen at the tube sheet interfaces; this defective surface was examined further to determine the root cause of pitting defects. Figure 4c,d show the pieces of the seawater inlet tube sheet. As practical information, when corrosion was found on the tube sheet, a plug was applied to the corroded tube, and the tube sheet was repaired by overlaying the tube sheet. Figure 4e shows a cut and plugged tube on the outlet side; white scale deposits were observed inside the tubes. Two pieces of the plugged tubes were cut for laboratory examinations to examine the crack locations. The outer surface of the tube was cleaned with fine emery paper and observed visually with a dye penetrant and magnifying glass. There was no crack observed on the outer surface of the tube. Some shallow pitting was observed on the outer surface close to the outlet. However, this pitting started from the outer surface, and some could be removed with emery paper. Figure 4f shows the defective tube's surface appearance. For further examination, the tube was cut longitudinally and the appearance of the tube's inner surface conditions was assessed; this examination was conducted on the plugged tube, an unplugged tube, and a standard tube without defects.

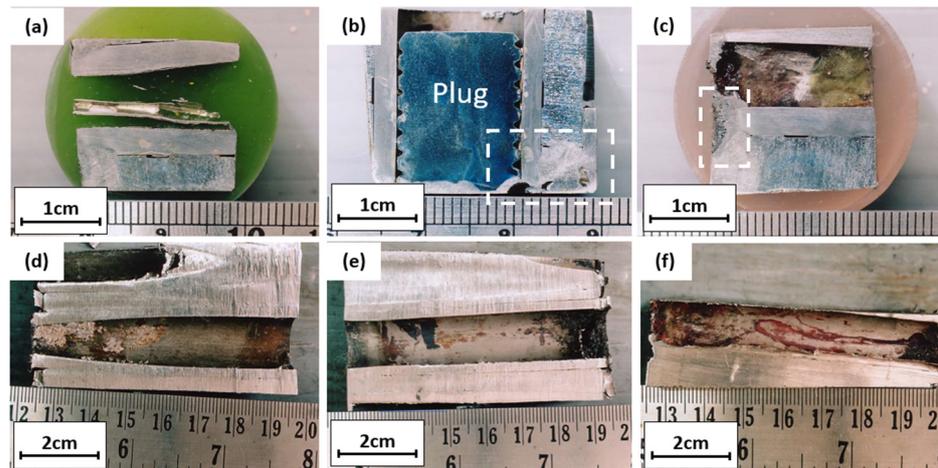
The cross-section of the tube with no defects in Figure 5a shows that a weld overlay joined the tube and tube sheet; the overlay of the tube sheet protected it from corrosion and sealed the possible gap between the tube and tube sheet. No defects like corrosion or leak was observed in this tube, and the weld overlay sealed the gap between the tube and tube sheet well. Figure 5b,c are macro photographs of the plugged tube, and the tube was initially cold expanded on the tube sheet. Corrosion occurred on the tube sheet and has been repaired by weld overlay. Figure 5d,e are pictures of the plugged tube's inner surface. Heavy deposits under the plug were observed, and some deposits along the tube indicated the presence of a biofilm that may promote microbiologically induced corrosion. Figure 5f is the cross-section of the unplugged tube. Heavy deposits on the entrance side were observed, and some deposits along the tube indicated the presence of a biofilm that may promote microbiologically induced corrosion.

Figure 5. Longitudinal cross-section of (a) tube without defects; (b–e) plugged tube; (f) unplugged tube.

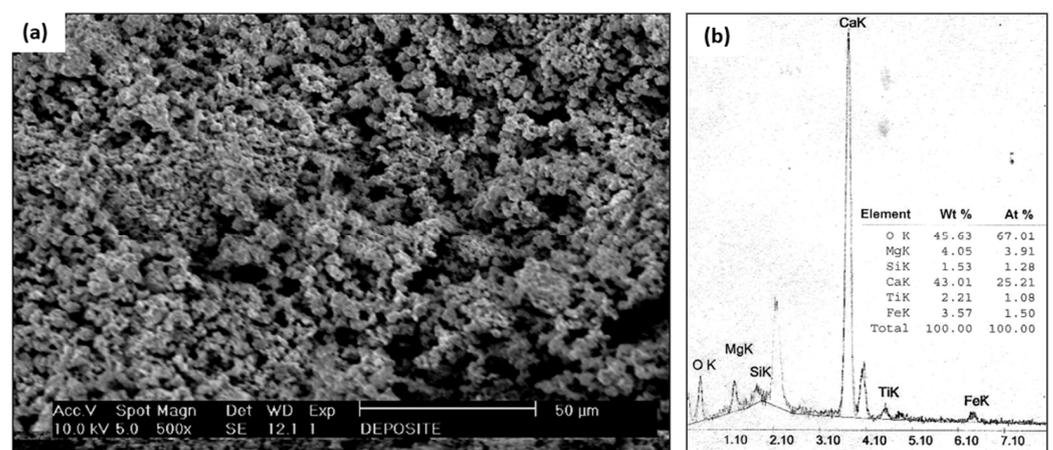
The tube deposit in Figure 3e was examined using SEM and EDS. Figure 6a is the SEM micrograph of the tube scale deposit; the particle size was very fine, indicating that it was formed through a chemical reaction. Figure 6b shows the results from energy dispersive spectrometry of the tube deposit, with a predominance of calcium, magnesium, and oxygen elements. This examination result were further examined using an XRD analysis, as illustrated in Figure 7.

Figure 6. (a) SEM examination of tube scale deposit (b) EDS results of tube scale deposit.

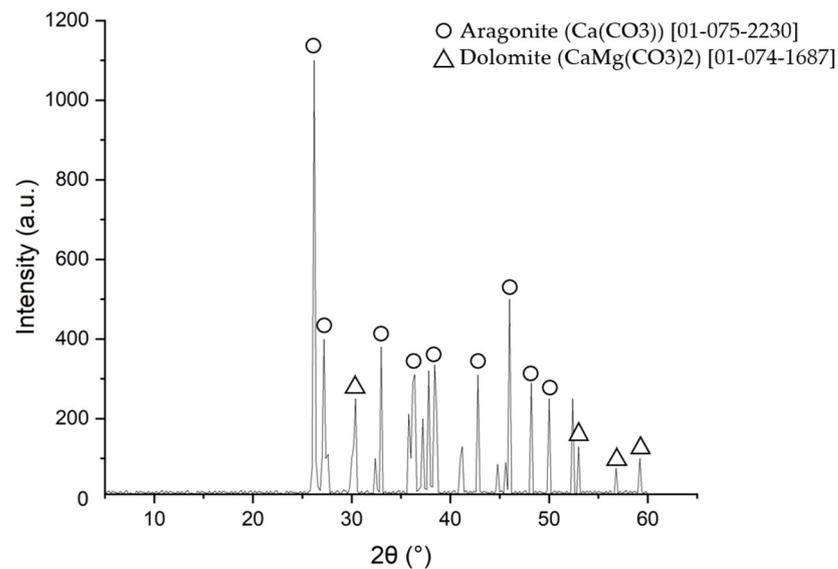
Figure 7. XRD examination of tube scale deposit.

Based on the XRD examination results, the majority of the tube scale was aragonite (CaCO_3) and dolomite ($\text{CaMg}(\text{CO}_3)_2$). The X-ray diffraction results confirmed the energy dispersive spectrometry data, which showed that calcium, magnesium, and oxygen were the main components in the tube deposit. According to the shape of the deposit and its compounds, this scale was formed by microbologically induced calcium carbonate precipitation (MICP) [31–33]. The detailed mechanism of scale formation and the composition of the scale will be discussed further in the discussion section.

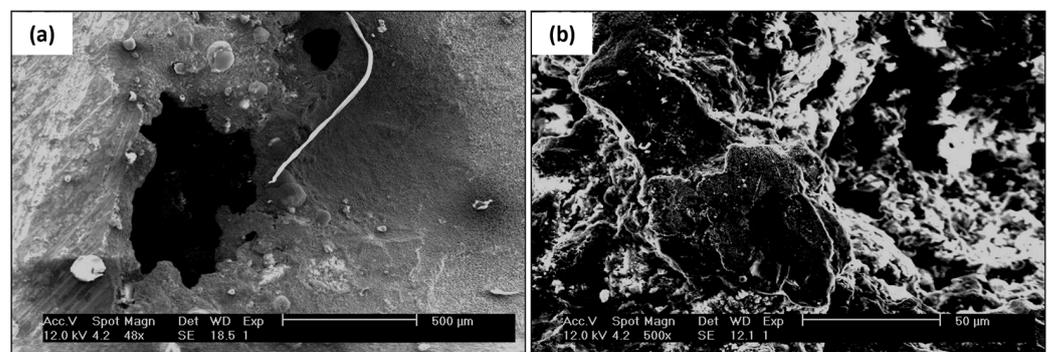
The surface of the tube sheet in Figure 4a,b was cleaned with Clark solution before the examination but the dirt on the surface could not be entirely removed by the Clark solution. The SEM micrograph of the tube sheet's defective surface shown in Figure 8a revealed traces of barnacles. The pitting present indicates the effect of a microbiological attack on the surface; bacterial activity may change the structure and properties of the passivation film on the stainless steel, affecting pitting initiation and growth. Generally, compact microbial biofilms can act as diffusion barriers for reactants such as oxygen, aggressive anions, and cations [34–37]. Figure 8b is the scanning electron macrograph of another defective surface. A detailed examination of the defective surface could not be performed because a permanent deposit covered the surface.

Figure 8. SEM examination of tube sheet (a) pitting appearance (b) defective surface.

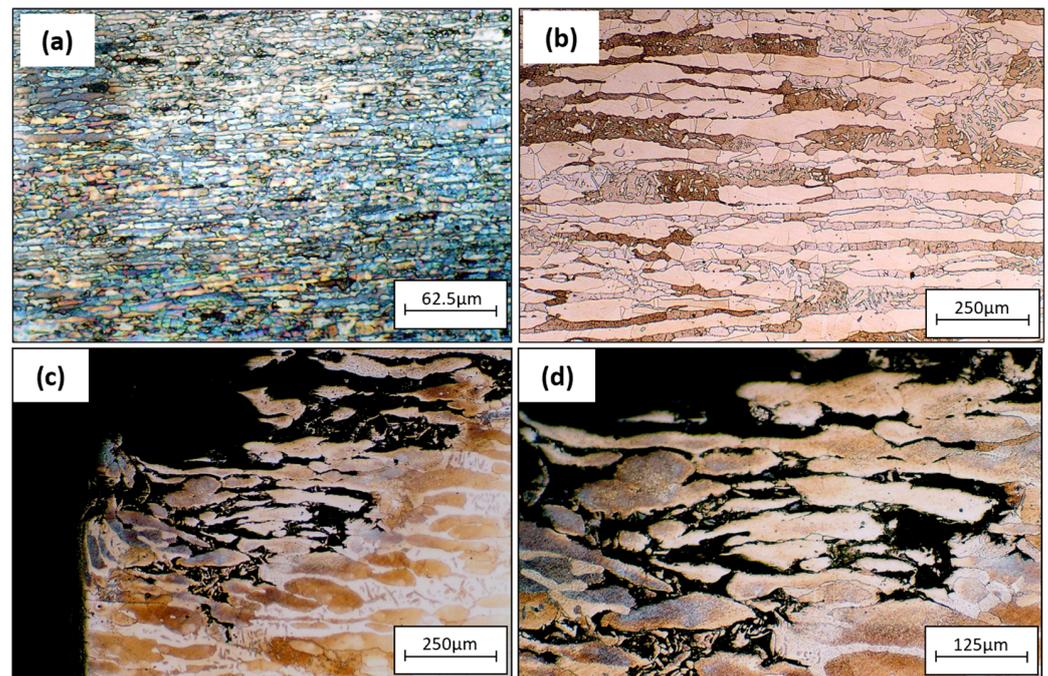
Figure 9a represents the tube base material with no defects, and Figure 9b shows the base material microstructure of the tube sheet. The corroded surface of the tube sheet from Figure 4a was examined using an optical micrograph. Figure 9a,b show that corrosion attacks occurred preferentially along the austenite grains and there was no attack on the ferrite grain. A preferential attack on the austenite grain of the weld metal phenomenon was observed during the crevice corrosion test. According to prior studies, preferential dissolution occurs at all morphologies of austenitic phases: grain boundary (GBA), Widmanstätten (WA), and intragranular (IGA) [38–40]. The corrosion attack on the tube sheet was caused by crevice corrosion between the surface deposit (bacteria product) on the tube sheet surface and the substrate.

Figure 9. Optical micrographs of (a) tube base material without defects, (b) tube sheet base material, (c,d) corroded section of tube sheet 3(a).

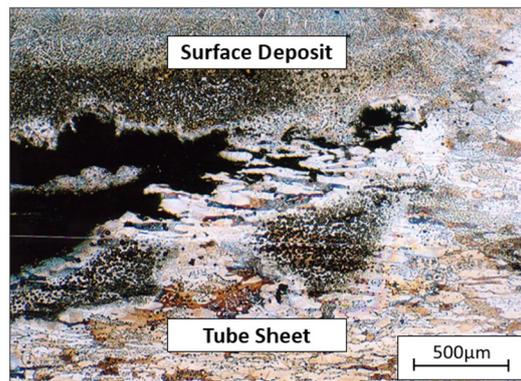
Figure 10 is an optical micrograph of the corroded tube sheet at the other location. The type of attack was different from that of Figure 9. The corrosion attack occurred under a deposit produced by bacteria. Previous fractography data indicated that the corrosion at this site was caused by micro/macro-fouling. However, the corrosion occurred under the gasket; therefore, macro/micro-fouling was formed and attacked the tube sheet surface. According to Figure 10, the corrosion mechanism was crevice corrosion between the substrate and surface deposit that was enhanced by microbiologically induced corrosion (MIC) [39–41].

Figure 10. Optical micrograph of a corroded section of tube sheet 3(b).

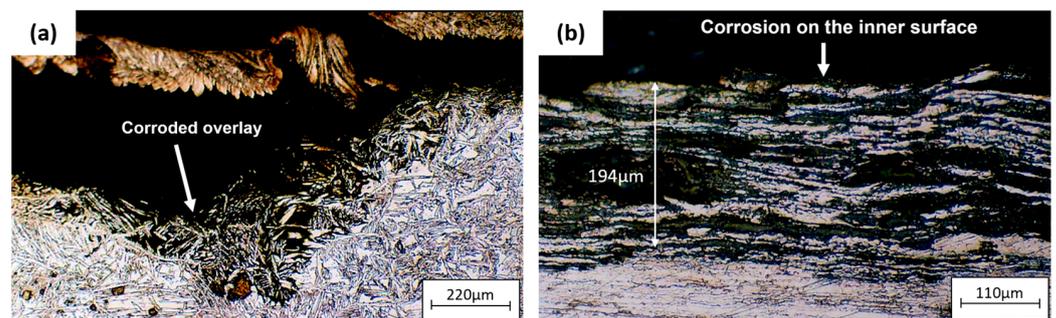
Figure 11 is an optical micrograph of the unplugged tube. Corrosion occurred on the inner surface of the tube, and the austenite grains were attacked by crevice corrosion [39,40]. Corrosion also occurred on the tube sheet overlay.

Figure 11. Optical micrographs of (a) corrosion on tube sheet overlay of the unplugged tube, (b) corrosion on the inner surface of the unplugged tube.

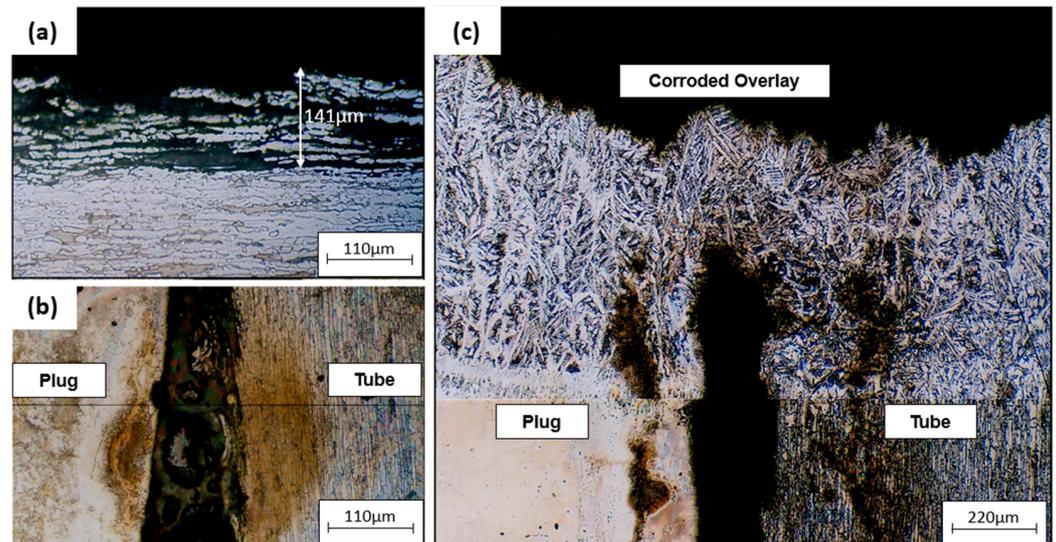
Figure 12 is an optical micrograph of a plugged tube. Figure 12a shows the inner surface of the tube attacked by corrosion, with the depth of the austenite grains attacked being 141 μm. Figure 12b shows the occurrence of corrosion in the crevice between the plug and the tube. The tube-sheet overlay was also attacked by corrosion (Figure 12c).

Figure 12. Optical micrographs of (a) corrosion on the inner surface of the plugged tube, (b) tube and plug corroded interface, (c) corrosion on tube sheet overlay of the plugged tube.

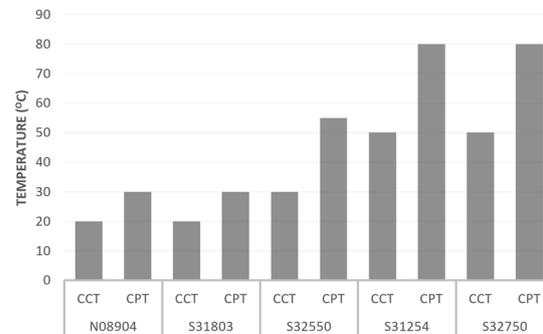
The duplex stainless steel type with the lowest pitting and crevice corrosion resistance is UNS S31803. The critical crevice temperature of UNS S31803 is about 20 °C; above this, crevice corrosion will occur. The severity and rate of crevice corrosion will depend on the crevice's geometry and the seawater quality. Crevice corrosion of the tube-sheet joint is likely to occur under the gasket and between the tube and tube-sheet joint. Crevice corrosion under the gasket is a consequence that cannot be prevented for seawater service unless a better design and better materials are selected. The expanded joint type is not

Figure 13. Critical pitting temperature (CPT) and critical crevice temperature (CCT) of some alloys reproduced from [45].

recommended for tubes and tube sheets used in seawater service, as the possibility of crevice formation is much higher than that of a welded joint. Applying an overlay on the tube–sheet surface is acceptable, but the overlay material should be selected to avoid crevice corrosion. The current overlay was insufficient to prevent crevice corrosion, as some parts were attacked. The surface quality of the overlay should also be considered because a rough surface will create tiny crevices that can harm the surface.
