# Contact Fatigue Failure Analysis of Helical Gears with Non-Entire Tooth Meshing Tests

Received: 20 June 2018; Accepted: 24 August 2018; Published: 4 September 2018

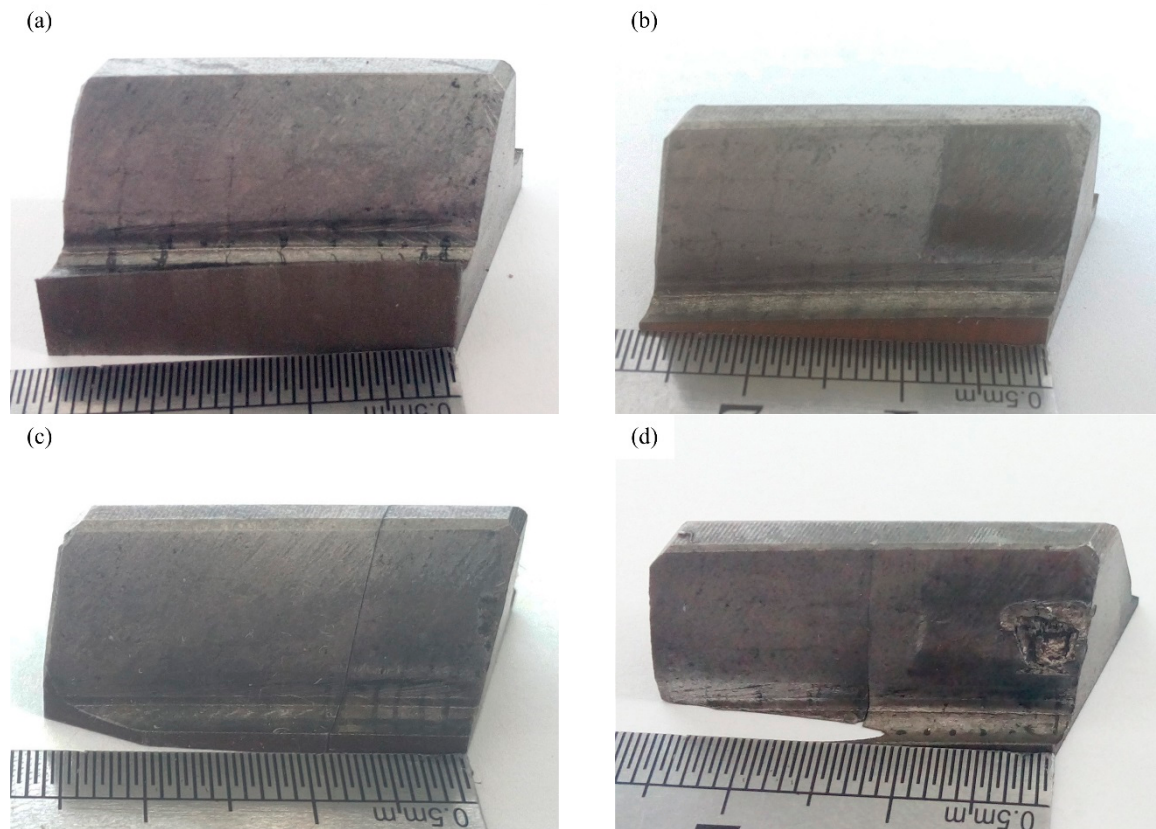
The cut representative teeth are shown in Figure 8, without cyclic loading for gear 1-2 (Figure 8a). Gear 2-2 had no teeth failure (Figure 8b). In the third test group, gear 3-1 did not fail, and gear 3-2 had a  $1.5 \times 4$  mm spalling near the point (V8, H5) close to the pitch circle of the transverse (Figure 8c). No failure occurred on the gear 4-1 tooth flank; there was a large zone of continuous cracking spalling near the transverse of gear 4-2 (Figure 8d). The maximum depth of the spalling was 0.72 mm. This spalling usually had the characteristics of a sharp edge profile and irregular edge shape.

**Figure 8.** Macroscopic morphology of gears' teeth: (a) gear 1-2, (b) gear 2-2, (c) gear 3-2, and (d) gear 4-2.

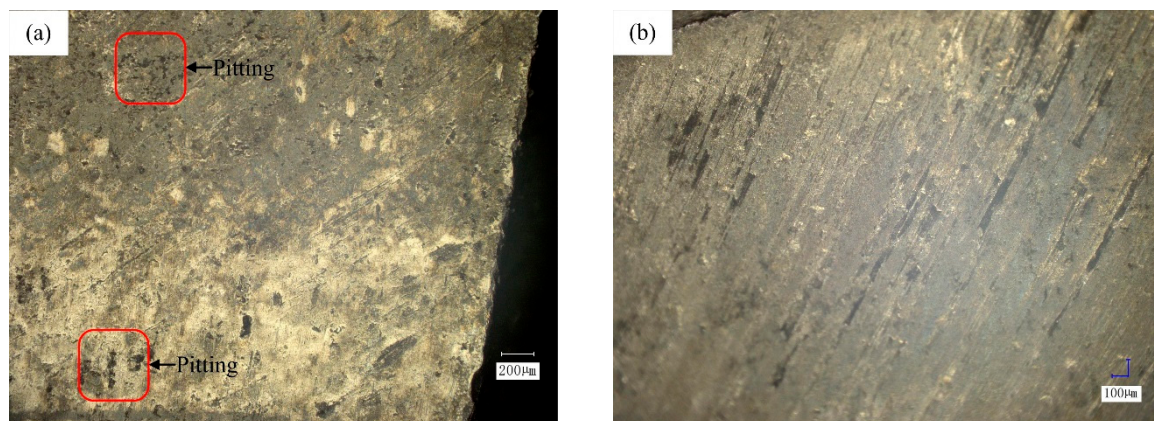
The tooth of gear 2-2 was observed with a digital microscope. Under  $10^6$  cyclic loading, a bright fatigue striation was formed on the lower side of the pitch circle. This indicated that in the early stage of meshing, the effective contact zone of the tooth flank increased with increasing number of cycles, and gear meshing condition was good. It should be noted that a small amount of pitting formed in the fatigue striation zone around point (V7, H6) in this stage (Figure 9a). Diameters of the small pits were less than 50  $\mu\text{m}$ , and pit depths were less than 10  $\mu\text{m}$ . This is related to the intrusion of lubricating oil into surface cracks, and fluid pressure forced cracks to develop into pitting. In Figure 9a, a large amount of small pits were formed in the upper left corner (V7, H4) farther from the pitch circle. The reason for this was that the relative sliding speed of the zone farther from the pitch circle was large, and the friction coefficient was large because of the poor lubricating condition caused by

the large linear velocity. After cyclic alternating loading, tangential instability lodging of the small bulges created during the machining process occurred. Small bulges peeled off after repeated bending. The spalling of small bulges was also clearly observed in the tooth addendum (Figure 9b).

**Figure 9.** Typical morphology of gear 2-2 tooth flank: (a) point (V8, H5) and (b) point (V6, H2).

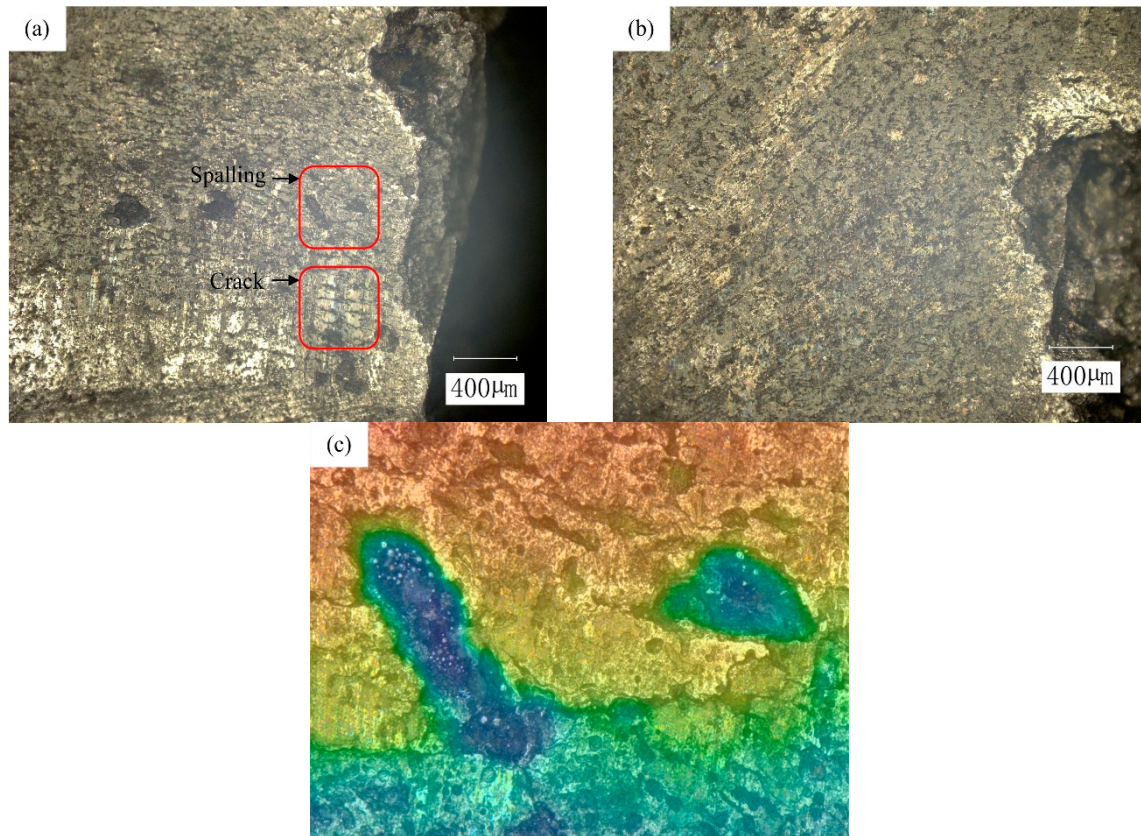
Under  $3.3 \times 10^6$  cyclic loading, the edge of the spalling on the tooth flank of gear 3-2 was observed (Figure 10a), and a large amount of conchoidal shallow spalling with a diameter of less than 0.5 mm and depth of less than 0.2 mm appeared at the zone 0.4–2 mm from the transverse. Using a digital microscope to further observe the spalling 0.6 mm away from the edge of the large spalling at the transverse, we found that there were a large number of aggregated granular objects with a diameter

of 3–6  $\mu\text{m}$  in the spalling pit (Figure 10c). This might have been caused by the mismatch between the plastic formation process and the subsequent heat treatment process. In addition, at the zone 0.3–0.8 mm away from the spalling at the transverse, a large amount of micro-cracks 0.3 mm in length and less than 0.02 mm in depth appeared.

**Figure 10.** Morphology of the zone near spalling on gear 3-2 tooth flank: (a) point (V8, H8), (b) point (V7, H5), and (c) the three-dimensional (3D) morphology of the spalling zone in (a) (the purple represents the deeper zone, and the red represents the shallower zone).

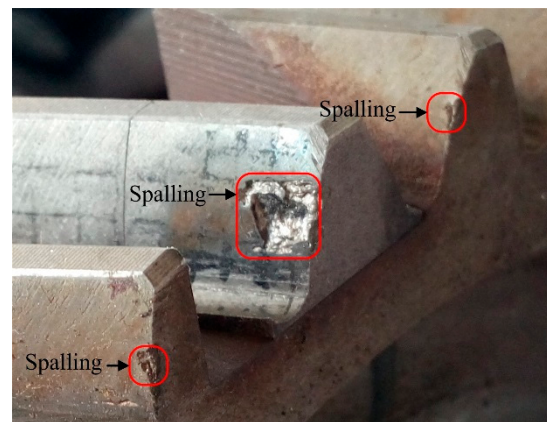
Continuous spillings on the boundary of the tooth meshing zone were observed in the teeth in the vicinity of the cut tooth of gear 4-2 (Figure 11). This further indicated that the spalling began at the pitch point of the transverse, which might have been due to the insufficient bearing capacity of the transverse profile caused by the machining marks on the transverse. Under the effect of variable loading, a number of fatigue crack sources in the circumferential direction formed; the connection of fatigue cracks could cause spalling. Meanwhile, as observed in Figure 8d, the edge of the spalling was sharp and the spalling pit was stepped. This occurred because the carburizing process of the gear increased the brittleness of the material and accelerated the crack propagation. With the increase in the single tooth spalling zone, uneven loading impact on the gear might have been caused. Due to this, the tooth flank spalling gradually occurred near the gear transverse.

**Figure 11.** Macroscopic morphology of gear 4-2.

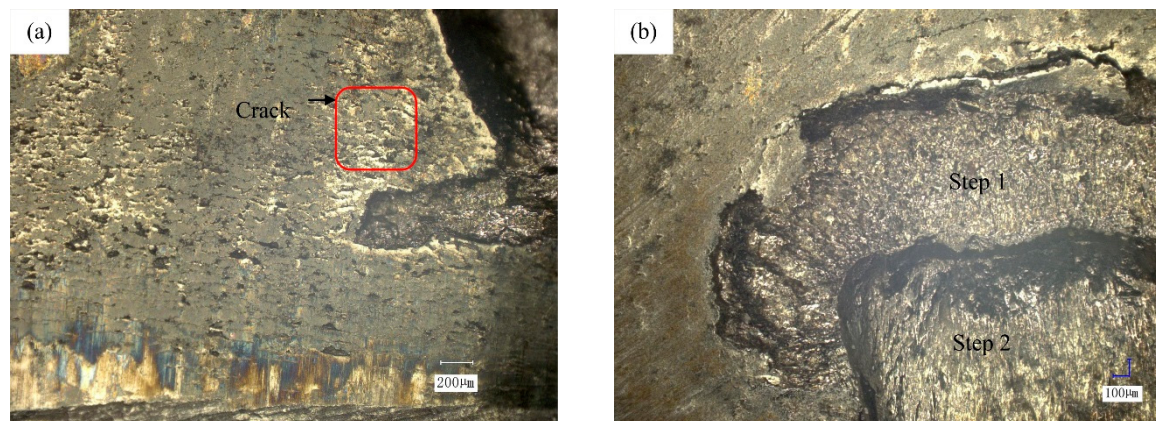
Then, observing the indentation-type spalling boundary near the pitch circle of the cut tooth of gear 4-2, a large number of cracks with lengths of approximately 100–600  $\mu\text{m}$  appeared at a distance of 0.2 mm (V6, H8) from the edge of the shallow spalling (Figure 12a). The zone near point (V5, H5) showed a stepped layer spalling (Figures 8d and 12b). We observed that the surface layer was crushed and separated. The depth of step 1 was about 0.3 mm, and the depth of step 2 was about 0.6 mm. According to Hertz's theory, the failure form belonged to typical spalling caused by the initiation of

cracking in the transition zone of the hardened layer, and multi-layer spalling was caused by continued cyclic loading after failure.

**Figure 12.** Morphology of the zones near the spalling on the gear 4-2 tooth flank: (a) point (V5, H8) and (b) point (V5, H5).

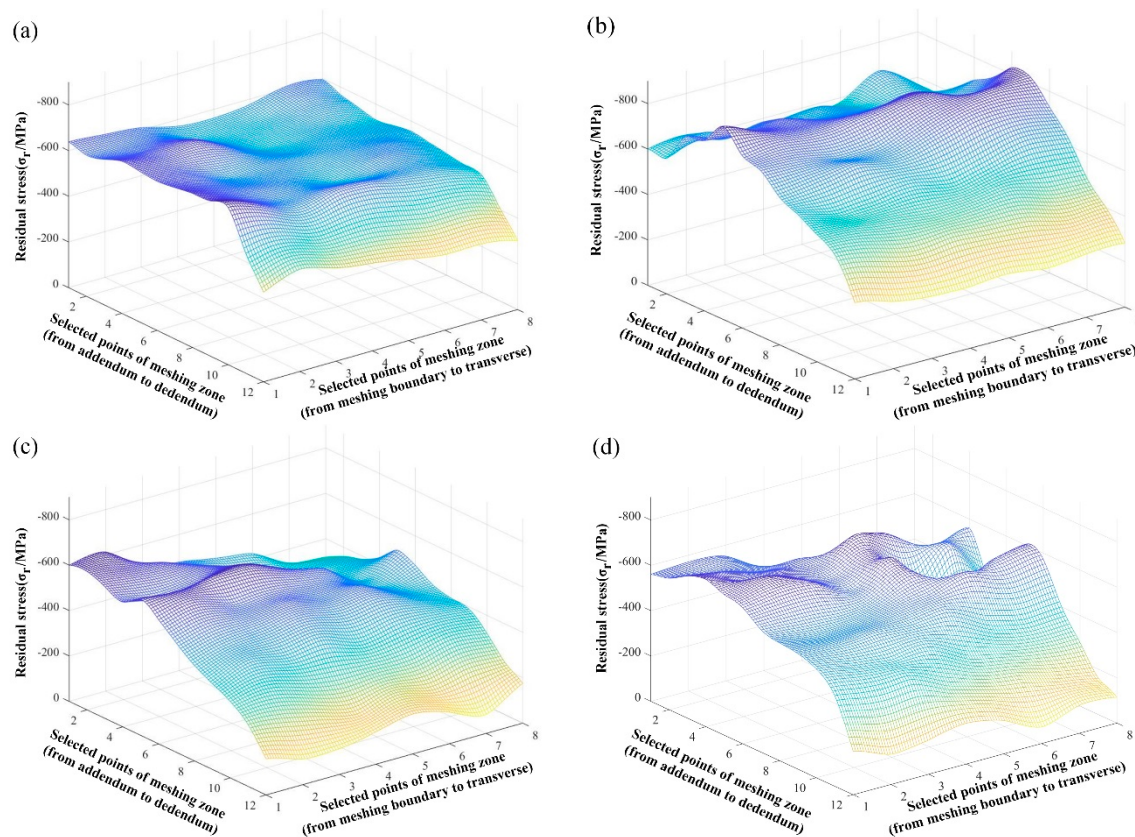
**Figure 13.** Fitting flanks of residual stress value: (a) gear 1-2, (b) gear 2-2, (c) gear 3-2, and (d) gear 4-2.

The tooth flank of gear 2-2 was in a normal wear stage (Figure 8b) after  $10^6$  cyclic loading. In Figure 13b, the residual compressive stress in the meshing zone, except for line H1, was obviously larger than that of the unloaded gear. This occurred because, in the early period of cyclic loading, the tooth flank had micro plastic deformation under the low-cycle alternating circulation contact stress, which then produced cold-work hardening. Also, the contact fatigue strength of the tooth flank further increased and the residual compressive stress improved. The residual compressive stress values at line H5 and line H6 below the pitch circle were obviously higher than those of the other zones of the tooth flank, and the average value was  $-782.0$  MPa. The reason for this was that the contact stress in this zone was larger than the others, and the effect of cold-work hardening was more apparent than the others. Comparing gear 1-2 with gear 2-2, the residual compressive stress at the dedendum line H12 decreased from  $-369.3$  MPa to  $-285.5$  MPa (Figure 13a,b, respectively). This indicates that the superimposed bending fatigue stress surpassed the cyclic yield strength of the material, and residual compressive stress relaxation appeared near the dedendum line H12.

The gear failure mode after  $3.3 \times 10^6$  cyclic loading is shown in Figure 8c. The residual stress fitting flank of the meshing zone is shown in Figure 13c. Comparing the residual stress value of gear 3-2 with those of the other gears, the residual compressive stress values at pitch circle H5 and line H6 were lower than the others. Also, the average residual compressive stress value of pitch circle H5 and line H6 were reduced by 7.6% with respect to gear 1-2, and by 29.0% compared with gear 2-2 (Figure 13a–c). This indicated that the aggregation of the pitting in the zone resulted in residual compressive stress relaxation. In addition, the residual compressive stress value 1 mm away from the edge of the spalling was larger than that farther away from the spalling. The residual compressive stress value of the dedendum of gear 3-2 was lower than that of gear 2-2, and its average residual compressive stress value decreased to  $-138.7$  MPa.

After  $5.0 \times 10^6$  cyclic loading, the residual stress distribution of the meshing zone of gear 4-2 was fitted (Figure 13d). The residual compressive stress of the tooth flank fluctuated in the zone from lines V5 to V8 and from lines H5 to H8. That zone was the spalling on the tooth flank. The average value of the residual compressive stress on the tooth flank outside the spalling zone was lower than that of gear 2-2. The average residual compressive stress value of the dedendum line H12 of gear 4-2 was  $-138.6$  MPa.

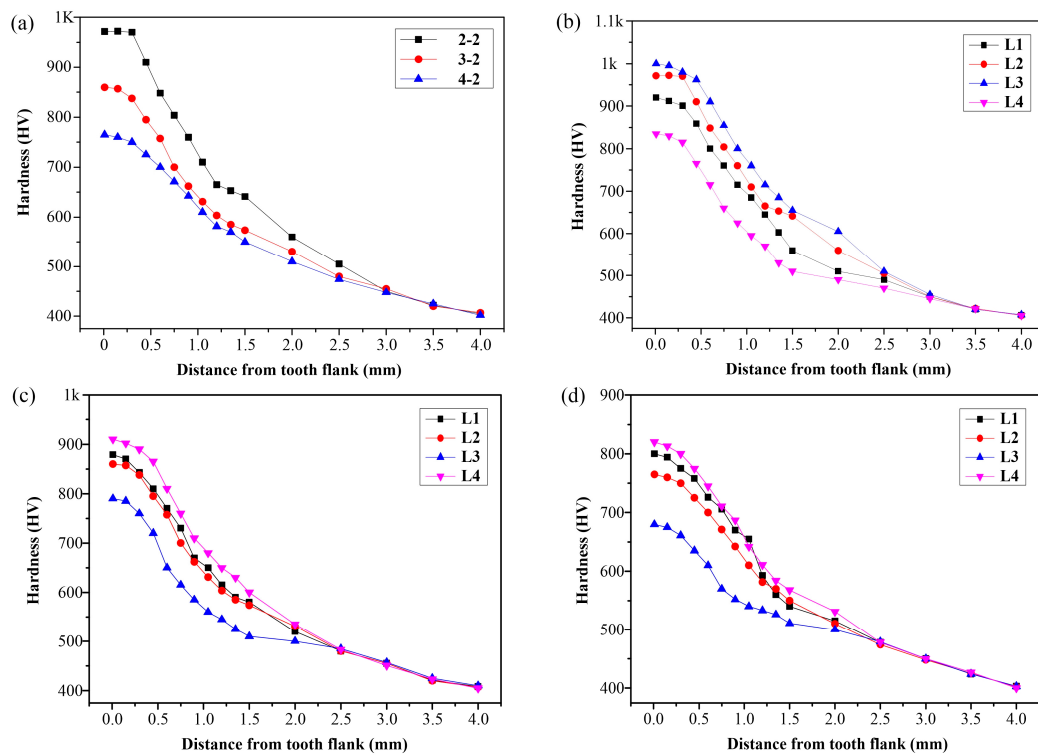
Figure 16a presents the hardness distribution measured along the inner normal direction at point (V2, H5) of gears 2-2, 3-2, and 4-2. Hardness gradually decreased from the tooth flank to the core. Combined with the depth of the carburized layer, the shallow surface layer from the surface to a 0.3-mm depth was analyzed. Below  $10^6$  cycles, hardness was rather constant along the inner normal direction and reached, on average, 970 HV. With the increase in the cycle number, the hardness value of the surface hardened layer increased first and then decreased, and decreased along the inner normal direction. In addition, the hardness value of the hardened layer of the tooth flank increased at  $10^6$  cycles. Comparing the hardness of the tooth flank at lower cycle numbers, the hardness value of the hardened layer of the tooth flank was lower for  $3.3 \times 10^6$  cycles and  $5.0 \times 10^6$  cycles. This indicated that the long-term meshing decreased the hardness of the tooth flank, which would likely accelerate the contact fatigue failure of the gear. Subsequently, the hardness value decreased significantly from a depth of 0.3 mm to 1.2 mm of the carburized layer. From a 1.2-mm depth to the core, the hardness decreased slowly.

In Figure 16b, after  $10^6$  cycles, the hardness values on L3 were higher than those measured on L1, 2, and 4. Since contact stress on line H6 below the pitch circle was highest on the tooth flank, the hardness enhancement was more significant for L3 and the inner normal of intersection (V2, H6) in the early part of the fatigue progress. The hardness value of L2 and the inner normal of the intersection (V2, H5) were the second largest—slightly lower than that of L3. The hardness value of L4 and the inner normal of intersection (V2, H8) were the lowest.

Figure 16b–d were compared to each other. The carburized layer thickness was smaller than 2 mm. At  $10^6$  cycles, L2 showed the overall largest hardness. Hardness variations observed along lines L1 and L3 were consistent with those of line L2. Microstructure analysis (Figures 17 and 18) indicated that structural performance of the gear flank decays for smaller values of hardness.

**Figure 16.** Hardness distributions measured for gear teeth: (a) gear 2-2, 3-2, and 4-2; (b) L1, 2, 3, and 4 of gear 2-2; (c) L1, 2, 3, and 4 of gear 3-2; and (d) L1, 2, 3, and 4 of gear 4-2.

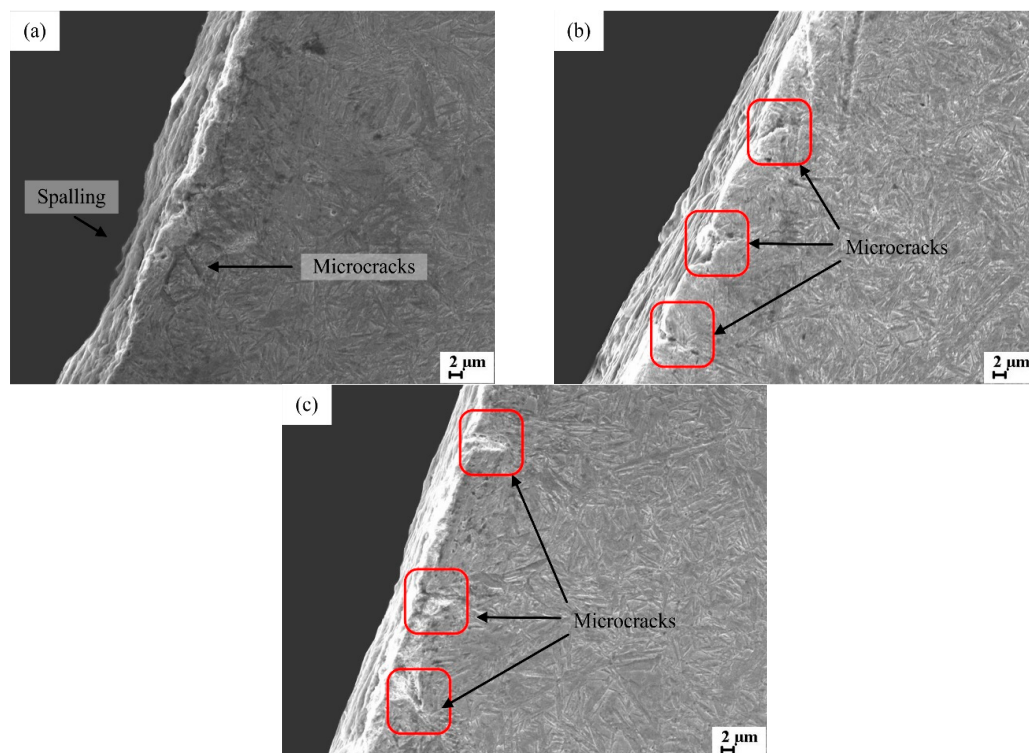
**Figure 17.** Microstructure of the zone near the tooth flank of gear 4-2: (a) pitch point (V2, H5), (b) point (V2, H2), and (c) point (V2, H6).

The microstructure near the pitch circle on the tooth flank of gear 4-2 was observed (Figure 17a), distributing a large amount of acicular martensite and a small amount of retained austenite. A flake is about to peel off at the pitch circle of the tooth flank. The initial crack began to expand inward, which could lead to the appearance of spalling. With the mutual expansion of some parallel micro-cracks on the subsurface layer, and with the contact internal compressive stress surpassing the critical value, due to the anisotropy of the material, tearing from the inside to the outside under the effect of cyclic loading led to this spalling formation. There was a small amount of micro-cracks inside the hardened layer located at point (V2, H2) above the pitch circle. Compared with the microstructure at the pitch circle, acicular martensite content increased (Figure 17b) and martensite content decreased at point (V2, H6) below the pitch circle. Lubricating oil was pressed into the micro-cracks, and a high-pressure chamber was formed, causing the cracks to expand and connect and thus leading to spalling (Figure 17c).

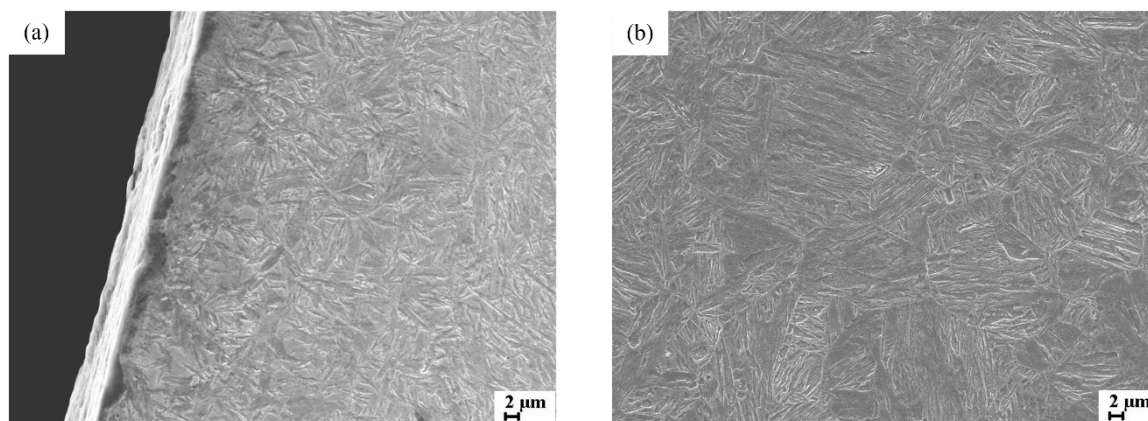
**Figure 18.** Microstructure of the tooth flank and core of gear 1-2: (a) surface and (b) core.

The micro-morphology of the tooth flank near the pitch circle of gear 1-2 was observed (Figure 18a). Compared with gear 4-2, the surface was relatively flat and there were no micro-cracks on the surface, but the content of martensite in the microstructure was the greatest. The core microstructure was composed of lath martensite, retained austenite, and cementite, and the content of martensite was obviously less than that of the tooth flank (Figure 18b). This proves that the carburized layer had a more acicular martensite, thereby increasing the surface hardness, and the surface could withstand greater contact stress. This improved the contact fatigue strength to reduce tooth flank failure.

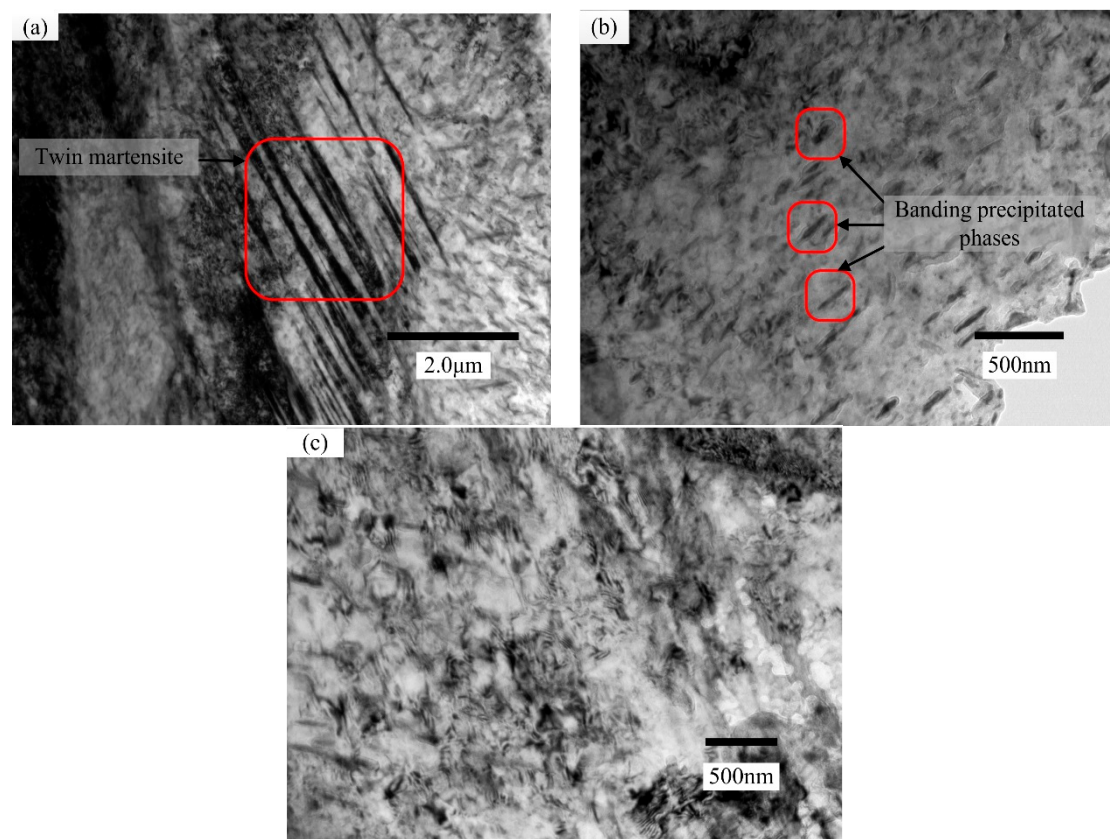
The transmission microstructure near the pitch circle of the tooth meshing zone of gear 2-2 after  $10^6$  cycles loading was observed, and a large amount of twin martensite was distributed inside the microstructure (Figure 19a). The uniform distribution of the banding precipitated phases inside the microstructure, increasing the hardness value of the tooth flank (Figure 19b). In addition, there was a small number of dislocations within the microstructure (Figure 19c).

**Figure 19.** Transmission electron microscopy (TEM) images of pitch point on the tooth flank of gear 2-2: (a) twin martensite, (b) banding precipitated phases, and (c) dislocation.

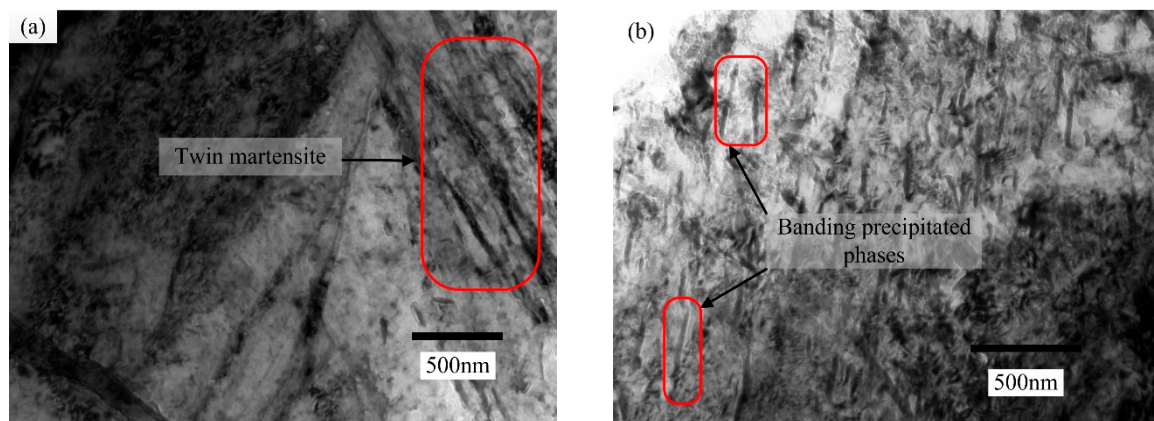
The transmission microstructure near the pitch circle of the tooth flank of gear 4-2 after  $3.3 \times 10^6$  cycles was observed (Figure 20a). Compared with gear 2-2, the content of twin martensite inside the microstructure was lower. The corresponding hardness value of the tooth flank decreased, and the tooth flank of gear 4-2 was prone to fail under cyclic loading. After long-term cyclic loading, the precipitates aggregated and grew (Figure 20b). The discontinuous distribution hindered the grain boundary slip. The dislocation density increased, and the pile-up of dislocation resulted in stress concentration at the grain boundary and the phase boundary, which induced the initiation of fatigue cracks of the tooth flank.

**Figure 20.** TEM images of the pitch point on the tooth flank of gear 4-2: (a) twin martensite and (b) banding precipitated phases and dislocation.
