Use of TLS (LiDAR) for Building Diagnostics with the Example of a Historic Building in Karlino

Abstract: This article presents the use of TLS (LiDAR) measurement for the evaluation of the technical conditions of a historic building. A FARO M70 laser scanner was used in the study. The measurements was taken as an RCP point cloud. The measurement allowed to partially determine the cause of the building damage. The performed measurement allows to propose a precise solution that could be pre-fabricated. The study shows the usefulness of TLS in building diagnostics. Improper measurement could lead to a wrong solution and a certain degree of uncertainty.

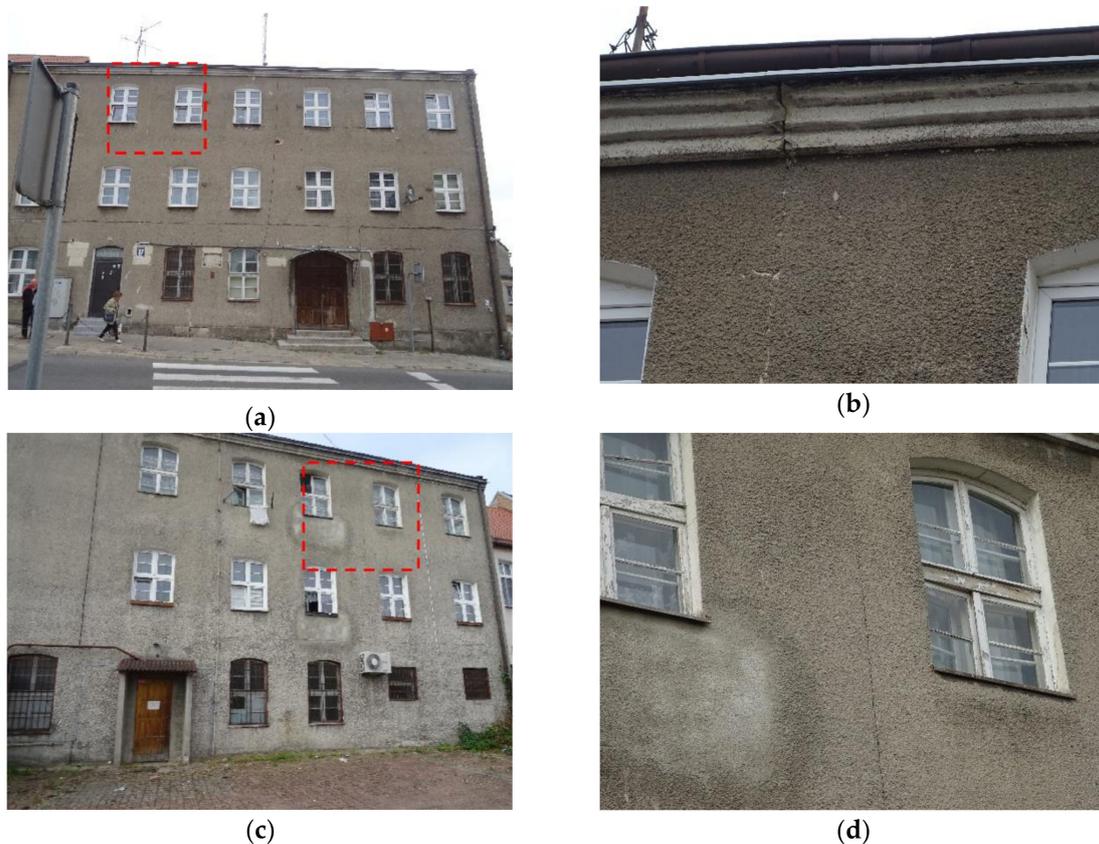
The initial inspection of the building showed only a single vertical crack on the facade (Figure 3). The cause of the crack was, at that time, unknown. Further investigation of the archival photographs (Figure 2) allowed to determine the reasons. The crack was located at the point where the two original tenement houses were connected. The crack in the building was visible from both the courtyard and the front elevation. It can be assumed that the building spontaneously split itself at the location of foundations difference. Apart from the crack, no other significant signs of structural damages were visible on the outside. The structure of the building was not designed to withstand such dilatation.

Figure 3. Damaged facade: (a) front; (b) zoom on crack in the front; (c) back; (d) zoom on the crack in the back.

Incorrectly made connection of building walls (vertical cracks visible from the outside) should be repaired by rebuilding the walls and adding reinforcement $\phi 8$ BSt500S L = 2 m in every second joint. The dimensions of bars should be determined with regard to existing wall fragment.

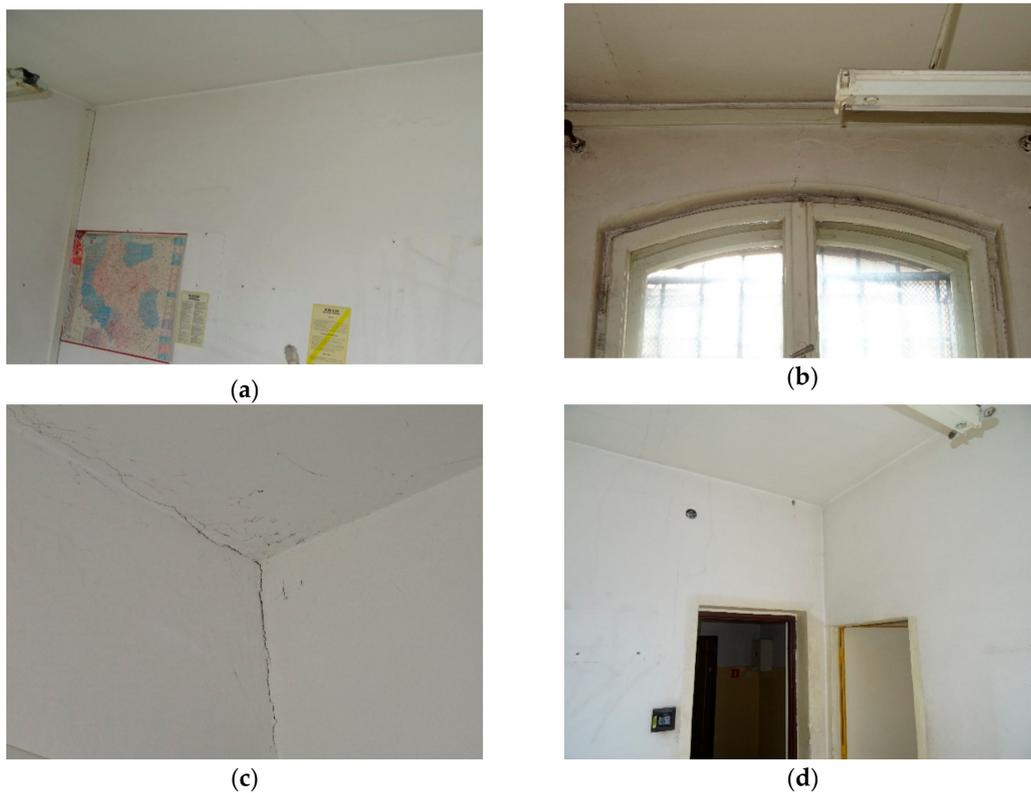
Further visible damage to the structure of the building was identified during internal observations. Numerous plaster cracks were observed on walls and ceilings. Particularly important were significant vertical cracks in the walls and cracks under the ceiling (Figure 4).

Figure 4. Interior damages: (a) wall cracks; (b) damages near the masonry arch lintel; (c) wall corner damages; (d) cracks near the ceiling base.

The load-bearing walls near the location of cracks must be reinforced with additional steel bars $\phi 8$ BSt500S L = 2 m, in every second joint on both sides. It is also possible to consider rebuilding of the cracked fragments.

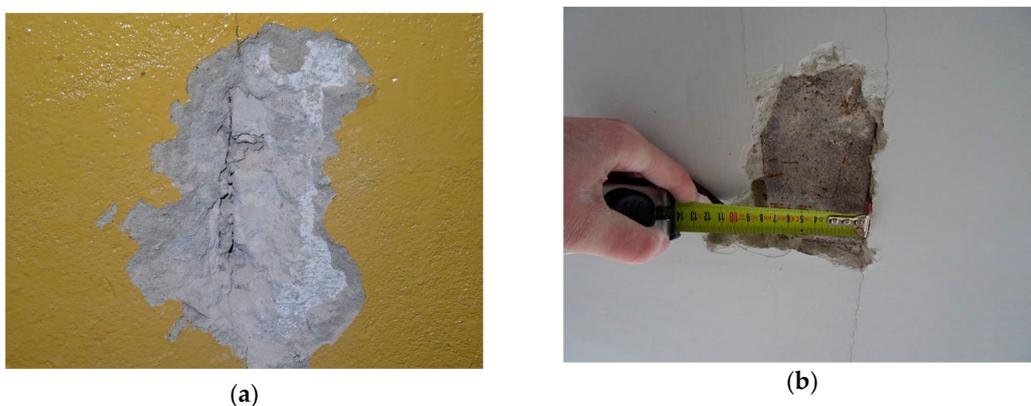
The visible cracks on the plaster required further examination. The plaster was removed, which allowed to determine the state of the construction layer. The action confirmed structural damages. The bricks of a load-bearing walls were damaged—they had been split by the shear force (Figure 5a). The following step focused on the evaluation of the ceiling between the ground and the first floor. The ceiling was identified as a beam and block floor (Figure 5b)—a type based on steel beams with reinforced concrete slabs. Unfortunately, this type of floor has a relatively low load capacity and has rarely been used in residential buildings.

Figure 5. Uncovered main structure elements: (a) vertical crack of the brick wall; (b) measurement of uncovered steel beam.

The beam support on load-bearing walls was also verified. The inspection showed that there was no tie beams in the building; the beams were located directly on the walls. This situation explains the problem of cracks in the walls under the floor beams. It was found that the shear resistance of the wall was exceeded and the steel beams were supported incorrectly. An intermediate plate or reinforced concrete tie beams should have been installed. Incorrect fixing of the floor beams caused vertical cracks on the walls, which began at the floor beams support location. The lack of tie beams is disadvantageous to the entire load-bearing structure as no elements are binding the walls together. The result is a lowered stability of the whole building. In older buildings, the role of tie beams was often played by steel anchors fixed to the wooden beams and supporting walls. The inspection did not confirm existence of any type of strengthening.

It was proposed to reinforce the floors by welding IPE 120 profiles to existing IPE 140 steel beams at the bottom of the residential dwellings. The solution should provide the necessary strength to the structure. If possible, reverse deflection should be imposed on the beams to reduce the deflections in the future. A deflection of about 5–7 mm was assumed as sufficient. The welding of profiles can only be carried out if the entire floor slab on all floors has been stamped beforehand. This is necessary because the steel profiles may yield during welding due to high temperatures. Alternatively, steel channels 20 × 50 mm (50 mm of height) can be welded to the beams to increase the load-bearing capacity. The solution can be applied only if initial profiles are already covered with concrete (preventing loss of stability). This will increase the floor height by 5 cm. At the same time, the filling panel of the beam and block floor should be replaced with lighter material, e.g., mineral wool.

Steel channels should be supported through plates and not directly on the masonry. The solution prevents wall shearing in the future. Concrete cushions in these locations may also be considered.

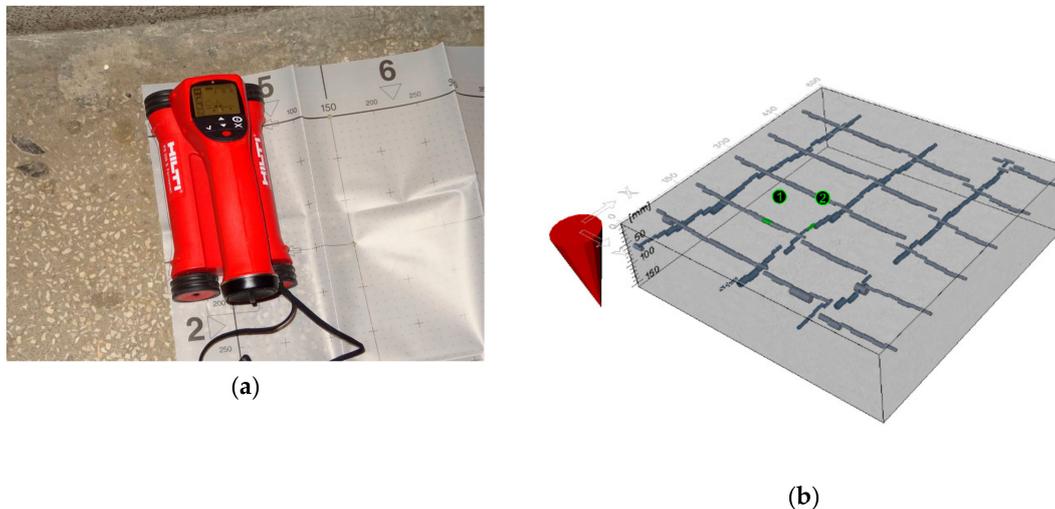
As part of the evaluation, an analysis of the internal staircase was performed. The staircase was located in the part of the building that originally coincided with a smaller tenement house. Diagnostics at this stage were performed using a HILTI PS 200 S (Figure 6) inductive scanner. The evaluation determined the reinforcement as $\phi 10$ with a 10 cm spacing and partition rods of $\phi 6$.

Figure 6. Staircase measurement: (a) during measurement; (b) view of digital model made in HILTI PROFIS Detection.

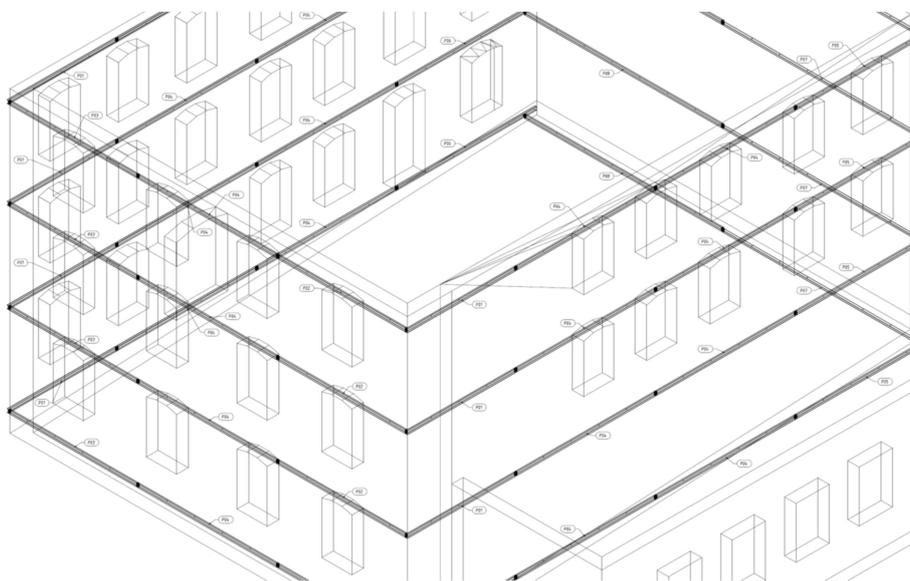
Figure 13. Proposed reinforcement solution for studied building—axonometry.

Due to the lack of tie beams that would stabilize the structure, a steel frame must be made from the outside. The frame should be fixed to the walls with chemical anchors and tensioned with bolts (Figures 13 and 14). Three sides are accessible from the outside while the fourth needs to be reached from inside of the building. Designed reinforcement of steel channels C120 was limited to a L80 × 60 × 7 angle bracket at the location of passing through the dwelling. Tensioning joints with 2 cm range were designed every 5 meters. These joints were also designed at each corner of the building.

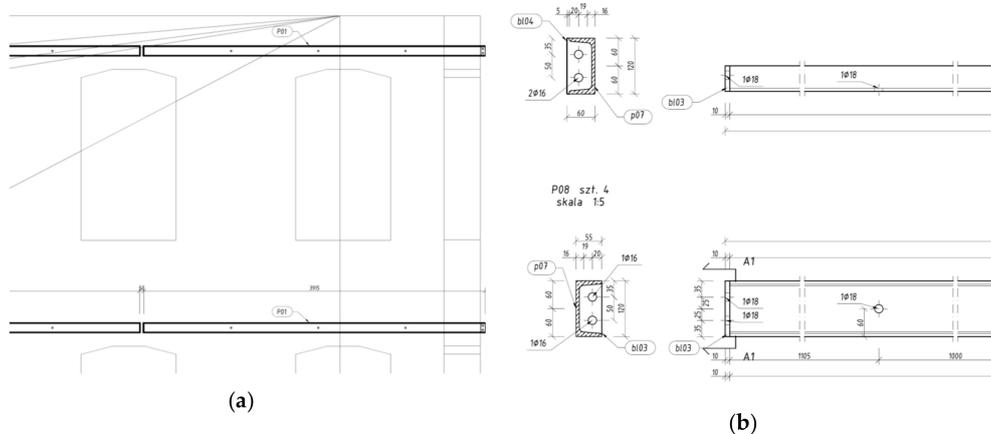
Figure 14. Proposed reinforcement solution for studied building: (a) front; (b) details.
