# Assessment and Rehabilitation of Culturally Protected Prince Rudolf Infantry Barracks in Zagreb after Major Earthquake

This paper presents the procedure of a detailed inspection of a building under cultural heritage protection. The case study building was damaged in the earthquake and needs to be renovated according to new laws in Croatia to ensure the safe and functional future use of the building.

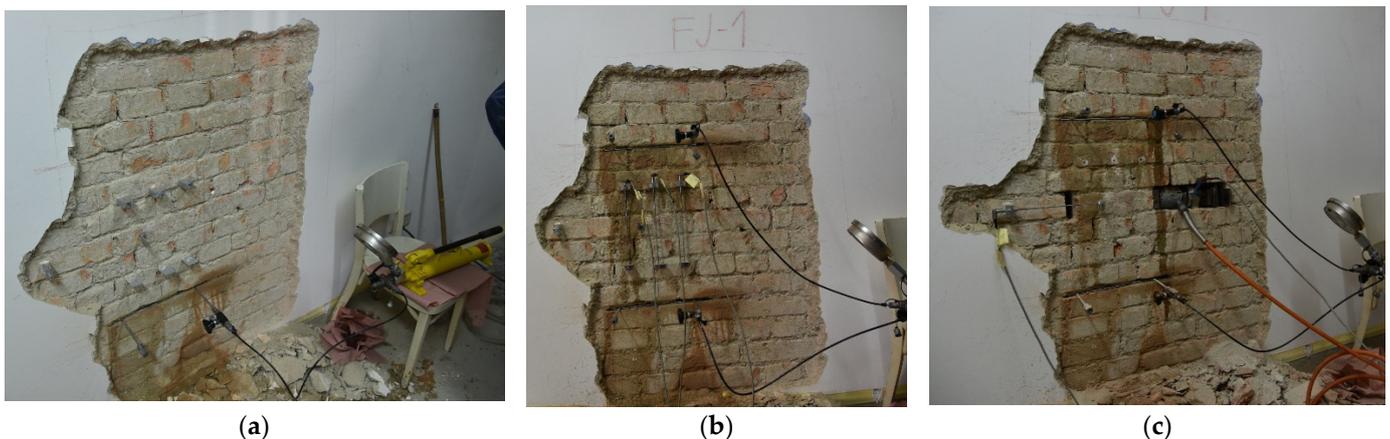
According to the tests (Figure 10), the following values were obtained: compressive stress state in masonry at test location  $\sigma_0 = 0.46 \text{ N/mm}^2$  (used for model calibration regarding weight distribution), modulus of elasticity  $E = 1469.5 \text{ N/mm}^2$  (used for wall stiffness definition), initial shear strength  $f_{v0} = 0.323 \text{ N/mm}^2$  (used for wall shear resistance definition) and coefficient of friction  $\mu = 0.447$ .

**Figure 10.** (a) Connected hydraulic system and flat jack; (b) Determination of stress and deformation dependence of masonry; (c) Testing of shear strength of masonry with control of vertical stress by flat jacks. (photo credit: Luka Lulić).

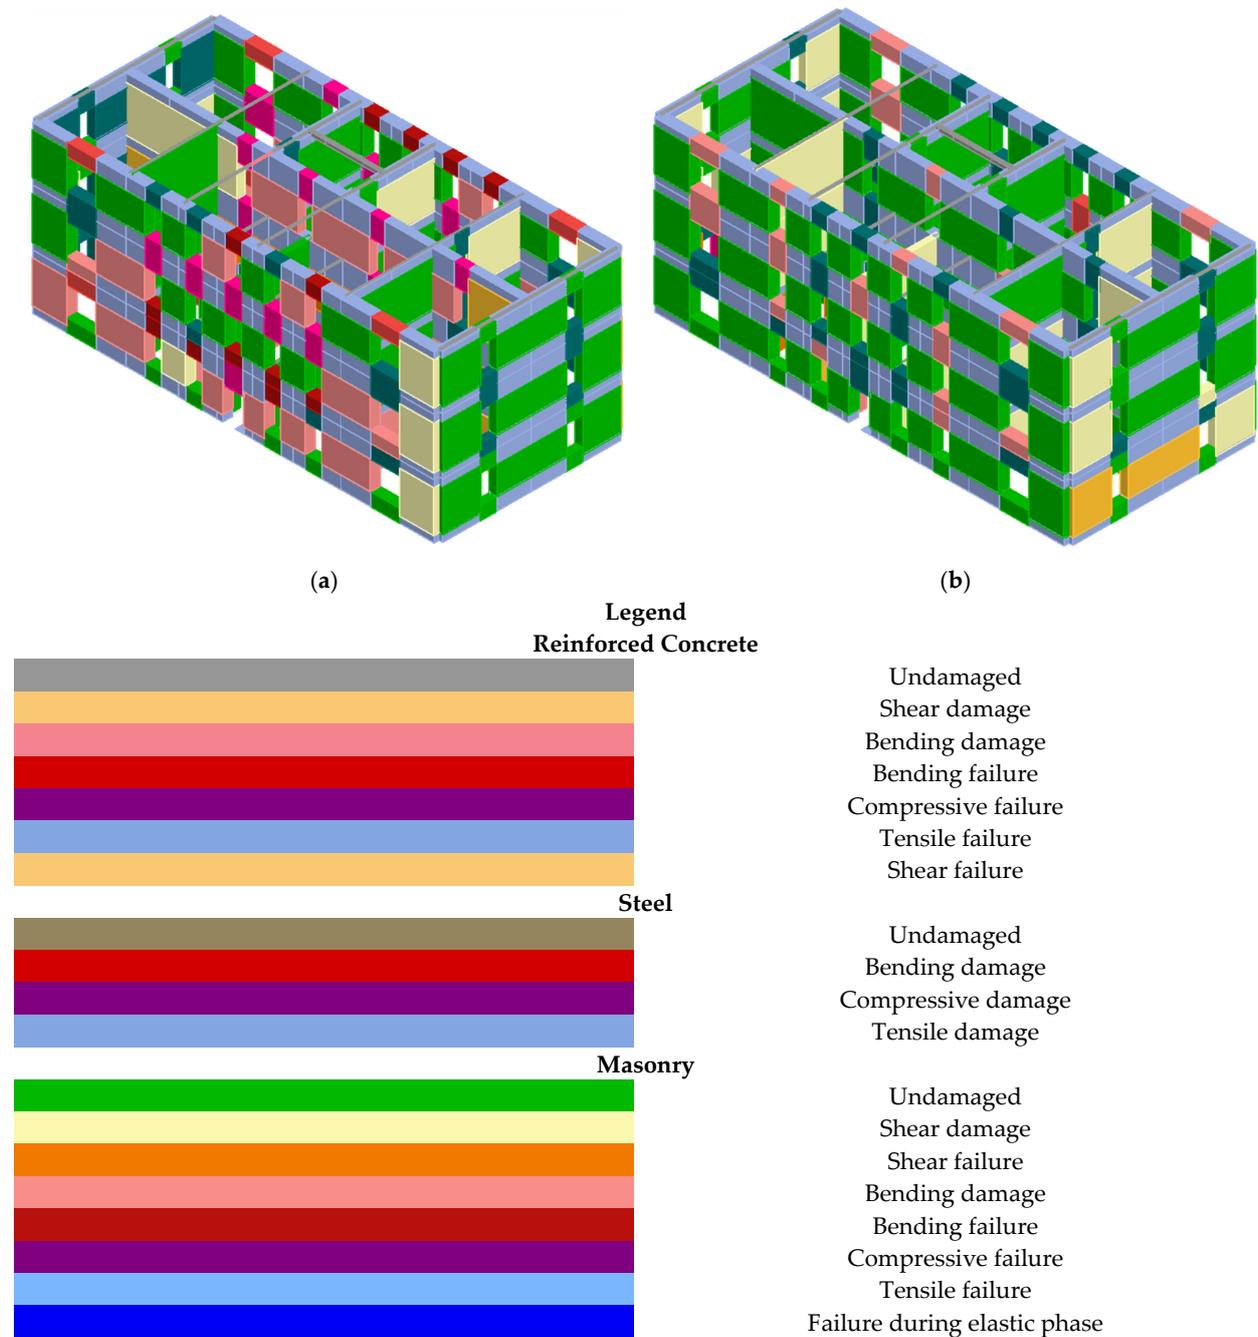
The pushover analysis was performed for all three distributions of lateral load without random eccentricity. Finally, the capacity/demand ratio obtained according to the simplified calculations and the values of the safety indices for critical analyses obtained using the 3Muri software were compared, as shown in Table 5. According to the regulation, the safety index is the ratio of peak ground acceleration for which the structure reaches a certain limit state, i.e., capacity and peak ground acceleration (PGA), i.e., demand. PGA for a return period of 95 years was used, and it has a value of 0.13 g. The limit state of significant damage (SD) was observed.

**Figure 18.** Three-dimensional (3D) model with damage for the near-collapse limit state: (a)  $x$ -direction; (b)  $y$ -direction.

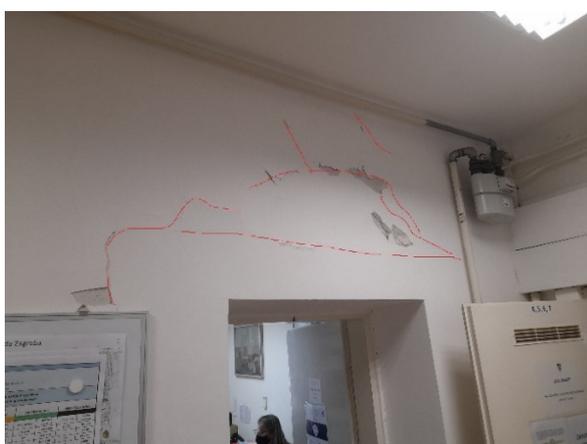
(a) Ground floor damage

Figure 20a shows the actual damage to the right part of the load-bearing wall on the ground floor corresponding to the shear damage. Figure 20b shows the actual damage to the middle part of the load-bearing wall on the first floor, which corresponds to the damage due to bending. Similar damage is detected in height in the building itself, and damage corresponds to the model.
