# Post-Earthquake Assessment and Strengthening of a Cultural-Heritage Residential Masonry Building after the 2020 Zagreb Earthquake

**Citation:** Ademović, N.; Toholj, M.; Radonić, D.; Casarin, F.; Komesar, S.; Ugarković, K. Post-Earthquake Assessment and Strengthening of a Cultural-Heritage Residential Masonry Building after the 2020 Zagreb Earthquake. *Buildings* **2022**, *12*, 2024. <https://doi.org/10.3390/buildings12112024>

### 3. Case Study-Building in the Street Ribnjak

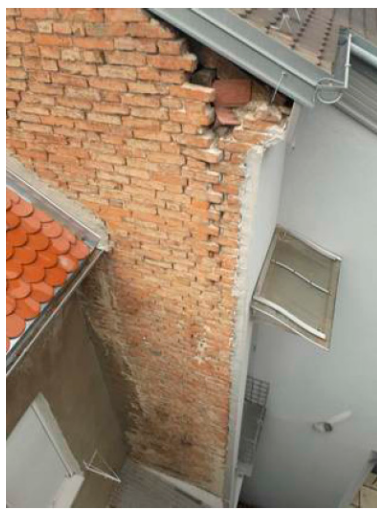
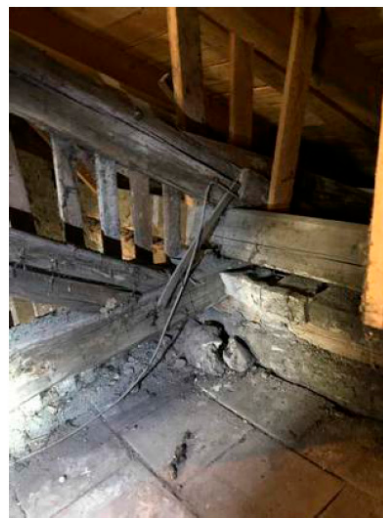
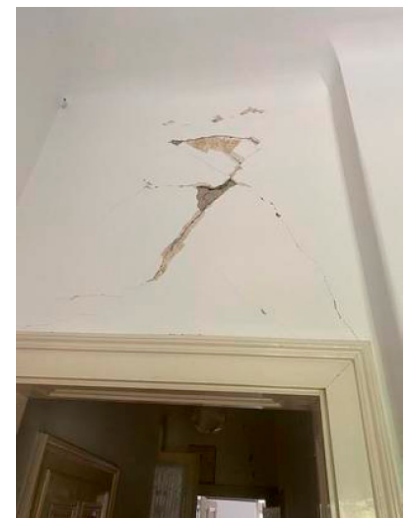
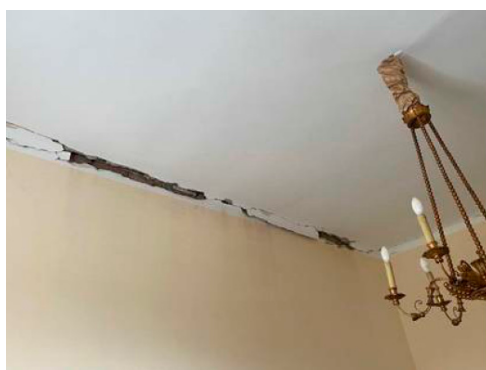
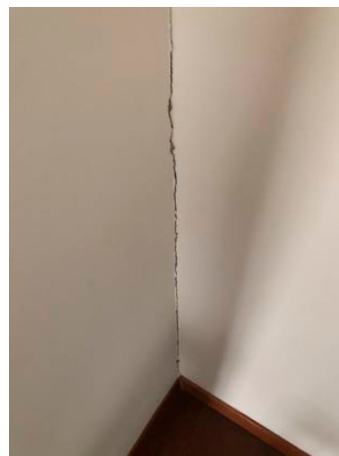
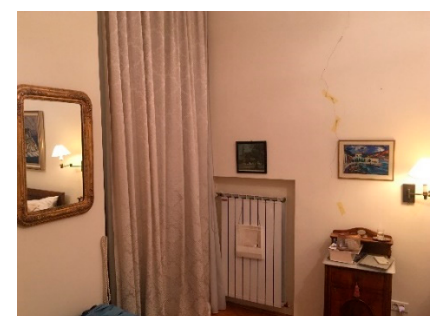
**Figure 7.** (a) Partial collapse of a gable wall; (b) oration of purlin's; (c) damage in the spandrels; (d) cracks at the contact of the ceiling; (e) vertical crack at the contact of two walls; (f) vertical crack along the wall [32]. Reproduced with permission from Projekt na kvadrat d.o.o., 2022.

The interpretation of the crack pattern can be of substantial assistance in understanding the structure's state of damage, its possible causes, and the type of survey to be performed [33]. Cracks were observed on the largest number of lintels, both vertical

and diagonal in one direction and cross (diagonal) cracks (Figure 7c). Moreover, minor diagonal and X-pattern cracks are visible in the walls at the lintels (above the doors) and parapets between the windows on the façade. These are minor cracks that indicate that there has been an exceedance of the shear strength, but since the width of the cracks is small, it enables the transfer of forces through friction. Additionally, vertical cracks were observed on the lintels near the openings. These are mostly minor cracks that are located at the top and bottom of the walls. The appearance of these smaller cracks in most cases is caused by arch action and indicates that the tensile strength has been exceeded. This represents characteristic damage to such structures. Some of the cracks were repaired after the earthquake. In any case, it is necessary to determine the exact width of the cracks and, depending on the degree of damage, the decision will be made regarding an appropriate rehabilitation method (injection of crack or installation of spiral reinforcement bars). The observed horizontal cracks, which were recorded at the bottom and top of the walls between the openings, occur mainly due to stress concentration along the corners of the opening. These are mostly minor cracks that can be rehabilitated with the injection process.

The floors of the ground and first floor of this URM building are made of light and flexible timber so the appearance of cracks in the ceiling structure was expected, as most probably there is no good connection between the floors and the wall and between the walls (Figure 7d,e). This is an additional parameter that makes these structures vulnerable to earthquakes. More severe damage was noted in wooden ceilings, load-bearing walls, and connection between the load-bearing walls and the ceiling. The cracks extend throughout the entire height of the wall at the connection of the two walls Figure 7e and along the height of the wall Figure 7f.

In this case, as the floor is flexible, the loads on the walls are transferred in relation to their surface, and not as per their stiffness as in the case of the structures with rigid floors which exhibit a “box” behavior [21]. The appearance of horizontal cracks located at the level of the floors and the gable wall was also observed. Generally, when it comes to very small movements (which is not the case here) sliding occurs on the surfaces between the wall and the floor structures, and in this case, it is a damage of a minor degree. In case the cracks are followed by dislocations in the value of several mm, it is a serious slip between the floor structure and the wall. In this case, it is necessary to carry out appropriate rehabilitation strengthening of the floor structure, and appropriate connection of the floor and the walls.

If the crack width is relatively small (e.g., less than 10 mm) and the wall thickness is relatively small, cracks that occur may be sealed with injection material. This was selected as a strengthening measure for walls with small cracks. Around the crack, it is necessary to remove the plaster (preferably traditional, not using electric tools, in order to avoid vibrations and their negative impact on the walls), the area around the crack and inside the cracks has to be cleaned, the cracks will be sealed with grouting material, and a new layer of plaster will be applied.

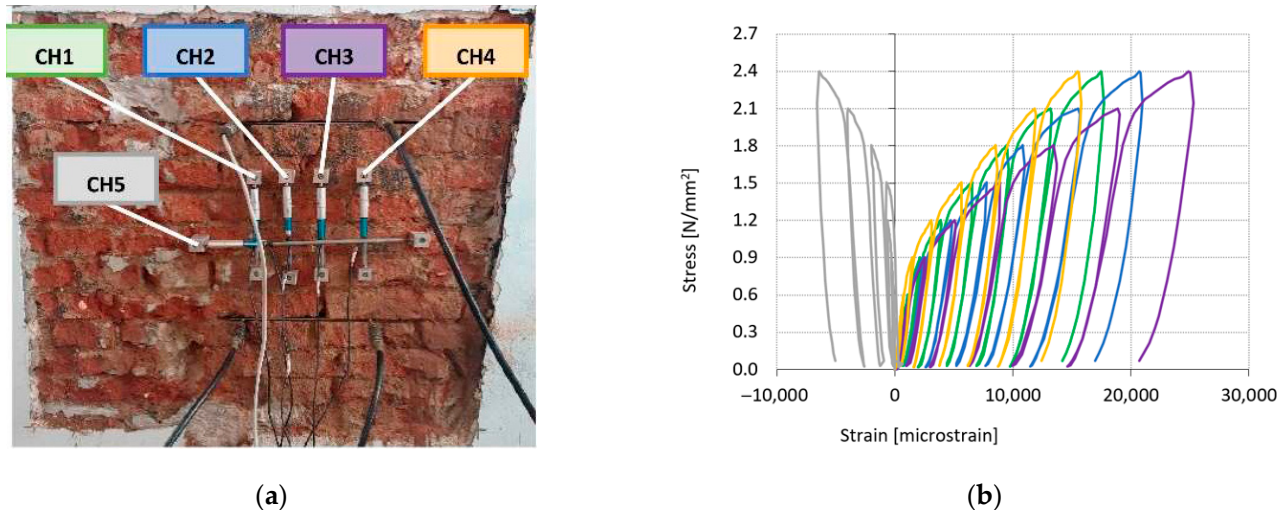
**Figure 8.** (a) 3D Sensors' layout; (b) Stress-strain relationship measured at different sensors.

The tests were made in accordance with the ASTM C1197-14a [38]. The maximum attained stress values were in the range of 2.4 to 2.7 N/mm<sup>2</sup>. Maximum values were limited also for the great deformability encountered in masonry. The modulus of elasticity at the first and second sampling positions were in fact 554 and 470 N/mm<sup>2</sup> at the beginning of the loading paths (between 0.00 and 0.30 N/mm<sup>2</sup>), and tests were carried out almost until material plasticization or strong Young's modulus reduction of masonry. The obtained values are rather low compared to the suggested values found in the literature, and this may be explained by the relatively thick joints and by a very deformable mortar. It has also to be stressed that maximum tests values do not correspond to the material strength, since the tests induced “compaction” in the material (seen in the hardening effect at the end of the second test) and that almost no cracks—indicating masonry crushing—were noticed throughout the tests. This once again emphasizes the importance of on-site testing and the fact that each building represents a case study of its own and has to be separately examined. The values that were selected as input in the numerical modeling were cautiously defined as  $f_m = 2.2$  N/mm<sup>2</sup> for the compressive strength of masonry and the modulus of elasticity  $E = 500$  N/mm<sup>2</sup>.

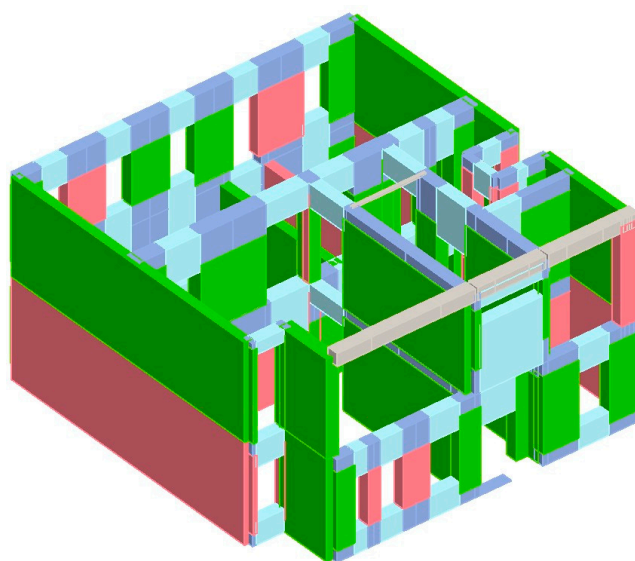
As in any calculations, first of all, static analyses are conducted. Due to very low masonry characteristics, many of the elements had already bending damage and did not possess adequate capacity to take over the gravity loads as indicated in Figure 12. According to the calculation, 32 out of 75 elements did not possess adequate vertical load resistance. This had a direct effect on the seismic capacity of the walls.

**Figure 12.** Damage stated due to static loads.

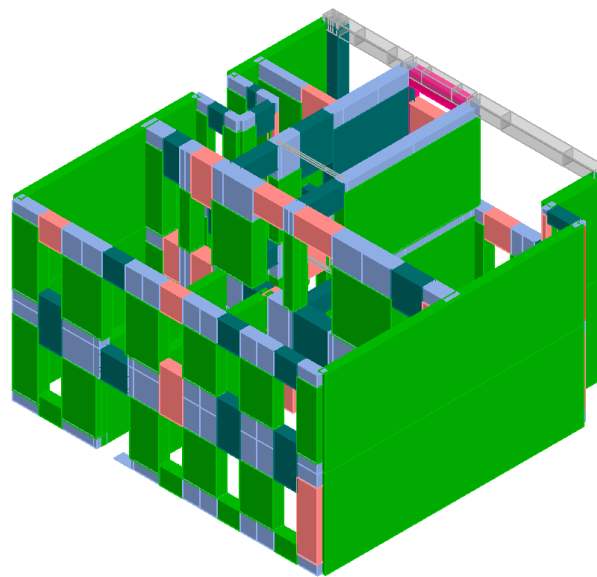
The type of damage at the maximum displacement capacity for X and Y directions is presented in Figures 14 and 15a. The predominant damage in the walls is caused by bending (pink). A rather similar situation is observed in the Y direction; however, additionally, one of the walls experienced shear failures (orange color) and bending failure (red color) (Figure 15b). The bending damage above the windows in the lintels is clearly observed on the façade wall (Figure 15c) and the visible cracks on the walls due to bending have been presented in Figure 7f.

**Figure 14.** Damage at maximum displacement capacity for pushover in the X direction.

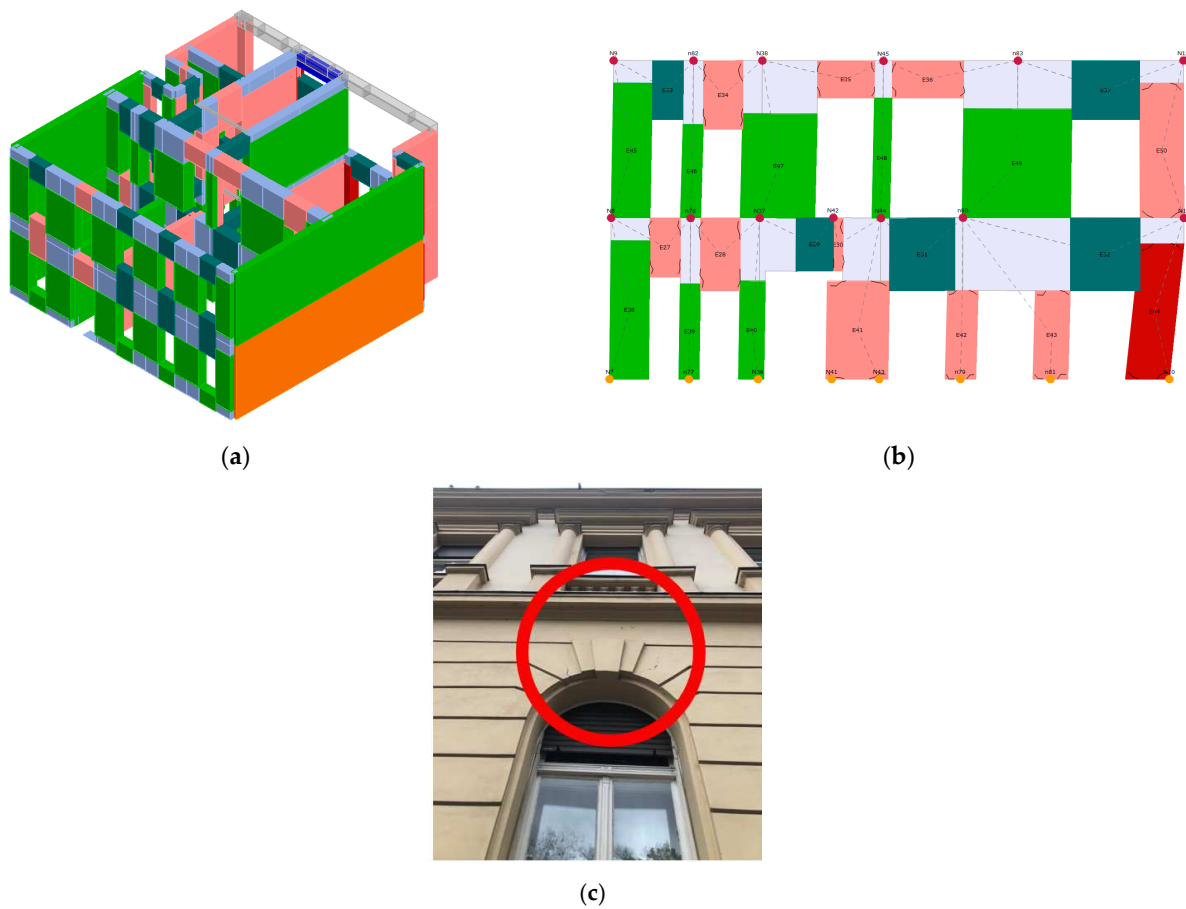
**Figure 15.** Damage at maximum displacement capacity for pushover in the Y direction; (a) shear failure of the wall; (b) bending failure of the wall; (c) bending damage above the windows in the lintels.

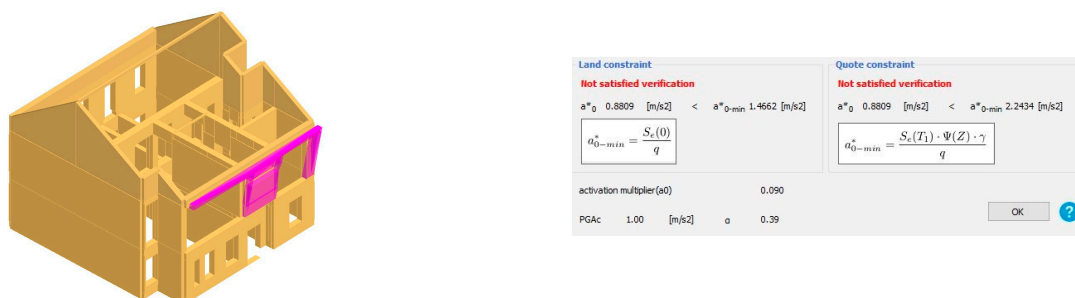
Besides checking the global in-plane behavior of masonry structures, it is as well necessary to check the out-of-plane behavior which is basically the first mode of failure in traditional URM structures, especially the ones with flexible diaphragms. The timber floors are usually not well connected to the walls and the connection of the walls is not constructed in a proper way, not providing a “box” behavior of the structure and leading to out-of-plane failures. As expected, the façade wall looking at the courtyard did not pass the out-of-plane verification (Figure 16). The failure mode is consistent with the 1st eigenfrequency mode.

**Figure 16.** Local mechanism out-of-plane failure of the façade wall.
