Earth to Earth: Patterns of Environmental Decay Affecting Modern *Pisé* Walls

Dirk H. R. Spennemann

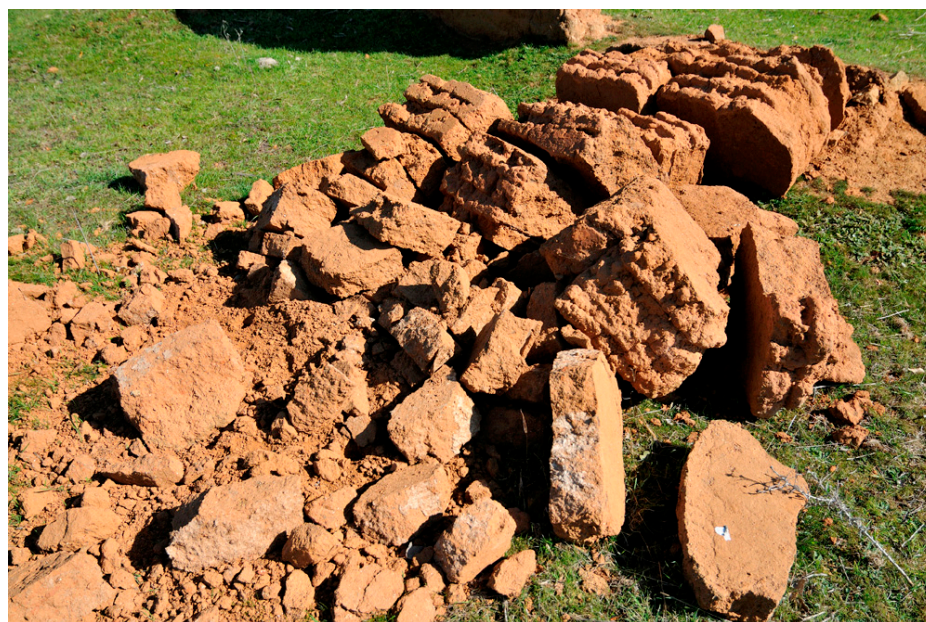
Figure 2. The collapsed southeastern block as seen from the southeast on 30 September 2015. Note the clean breaks and lack of bonding between the compaction layers. Reprinted from Ref. [9].

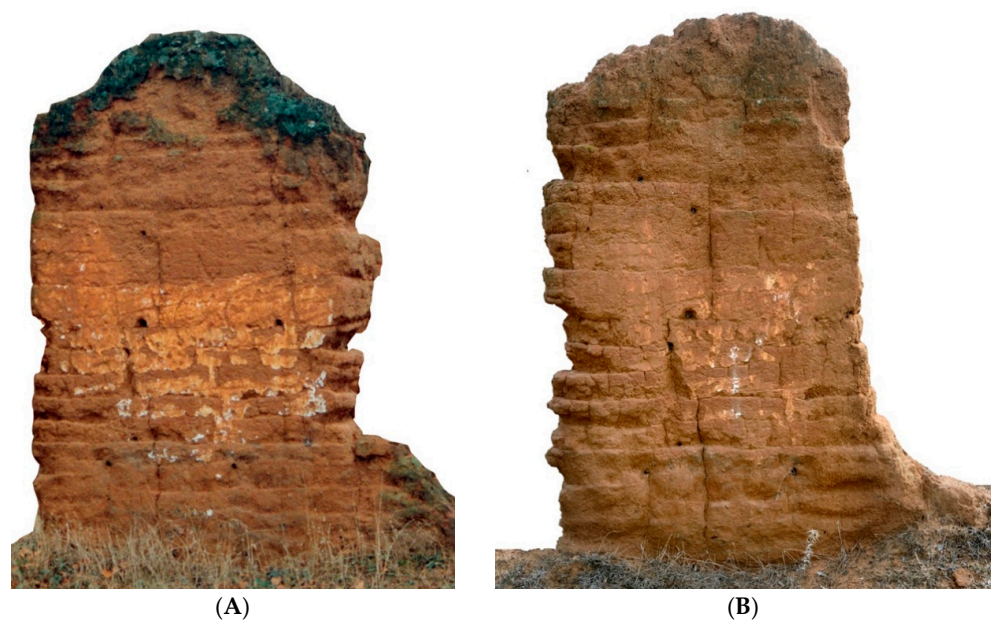
Figure 4. The southern face of the southeastern wall block at Jugiong (NSW). (A) Appearance on 15 February 1993; (B) appearance on 2 April 2015. Reprinted from Ref. [9].

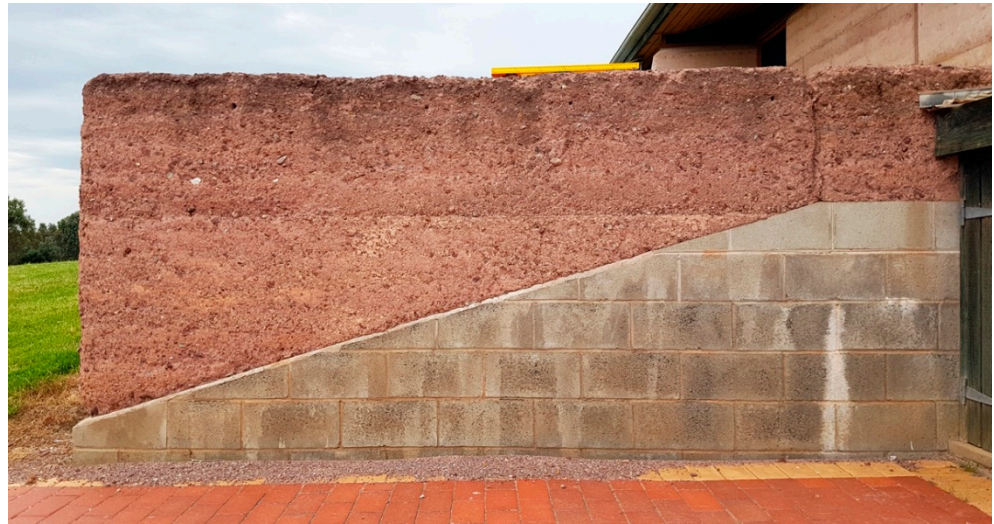
Figure 8. Wall 1 seen from the west. Note the accumulation of eroded debris at the base of the wall.

The decay documented here has occurred in an incremental fashion but seems to have accelerated in the past few years (pers. obs). The decay of some of the walls is very obvious, with the loss of surface finish on most of the wall areas, the loss of fabric in some sections of the wall, and the concomitant accumulation of the gravelly component of the mix at the base of the wall (Figure 8).

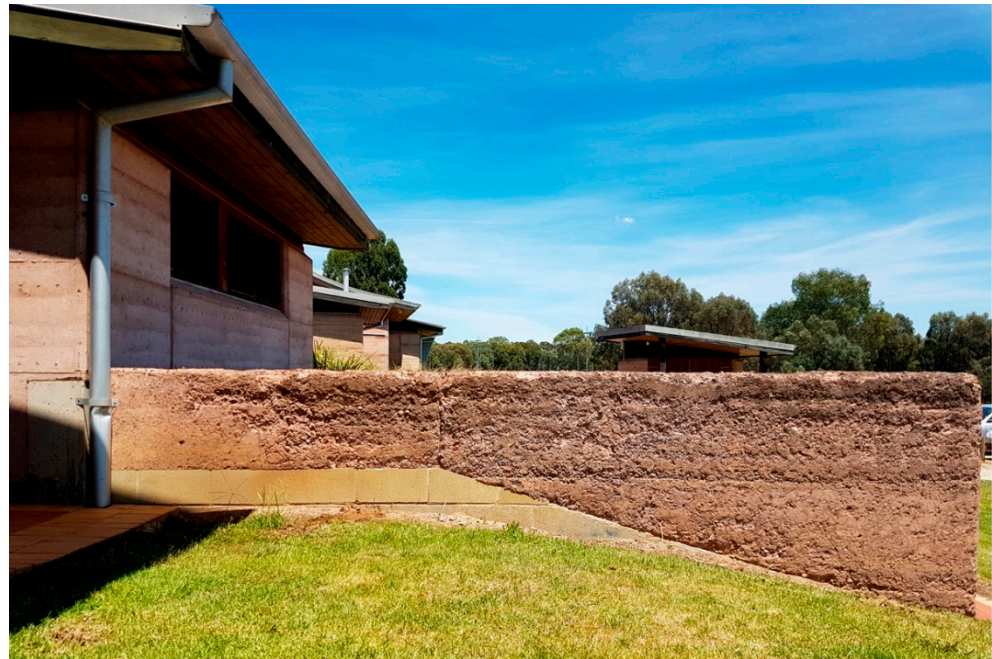
Figure 10. Wing wall 3 seen from the east. Note the linear decay at left, indicating different layers of compaction.

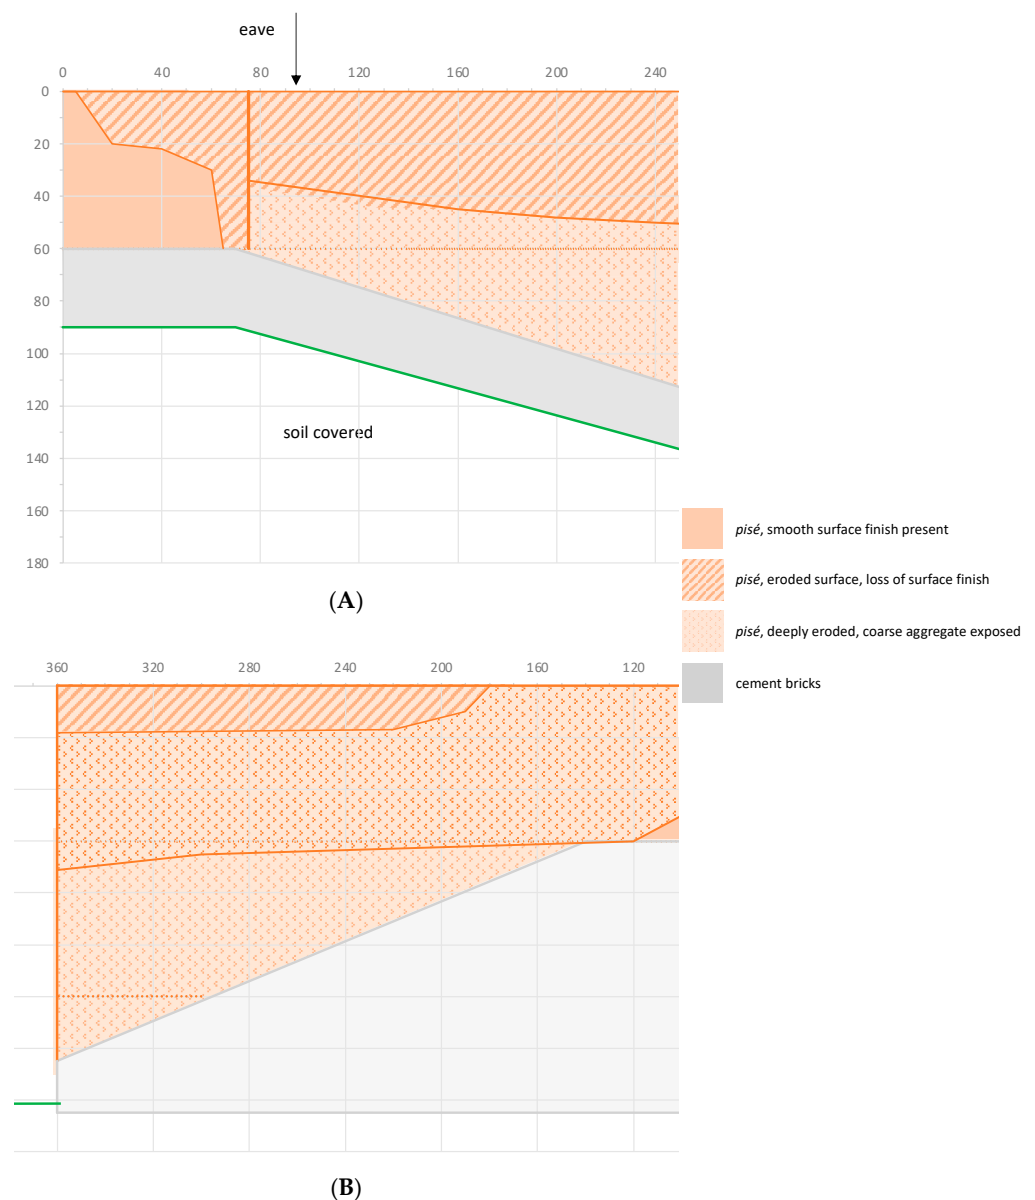
The eastern face of wall 1 (Figure 13A) is the one that has been studied in the most detail. It comprises a small section under the eaves, with a clear boundary of the form section and a larger section ending at 3.60 m from the wall of the building. While the small section was executed as one piece, the larger section shows three horizontal lines indicating the form board levels (Figure 12). The top half of the second wall segment exhibits extensive and largely uniform surface decay, exposing the coarse aggregate. The wall section closest to the northern wall of building 762 exhibits a small patch of original surface finish, located under and protected by the eave. All the measurements obtained relative to the laser beam (see methodology) were recalculated relative to the base value provided by this original surface.

Figure 13. Schematic representation of the observed decay of wall 1: (A) eastern face; (B) western face.

Macroscopic observations of the surface on the eastern face of wall 1 show five states (Figure 13A), which, at different heights and to different degrees, are manifested on the surfaces of all the other walls (Figures 13 and 15–19):

- (i). An original surface with a rougher texture and some loss of detail compared to the surfaces of the control walls that are roofed and protected from the environment.
- (ii). Surfaces that show pitting and general loss of finish, resulting in a coarse-textured surface revealing the nature of the aggregate. The top of the wall is eroding and loses definition, exposing the aggregate.
- (iii). Below-surface separation of the external skin from the core, resulting in bulging of the exterior and noticeable ‘drumminess’.
- (iv). Surfaces where the original skin has spalled off, resulting in a very uneven and very coarse textured fabric, exposing the aggregate. The top of the wall has become rounded.
- (v). Continued deep erosion.

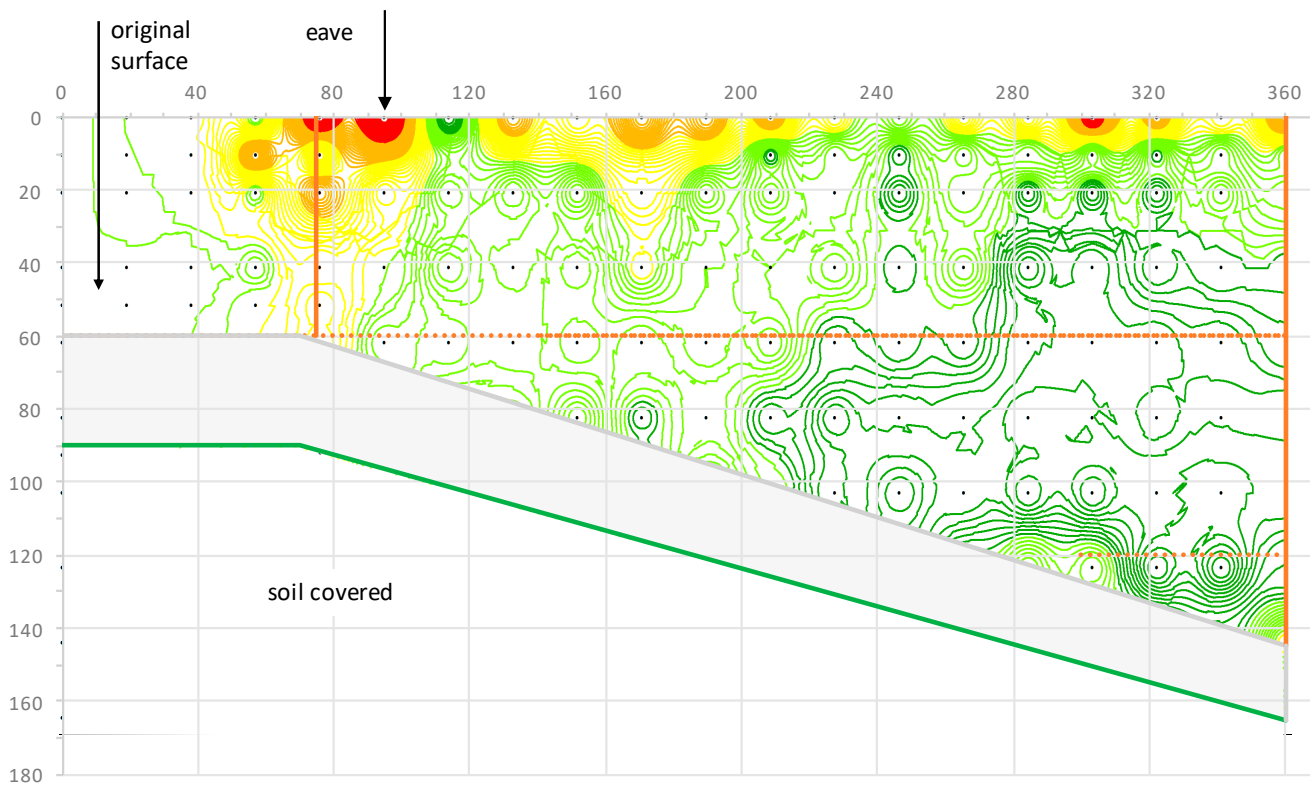
Figure 14. Observed decay on the eastern face of wall 1. Contour intervals 2 mm. Contours (relative to the patch of original surface): dark green 11–22; green 0–10; yellow –13––1; orange –29––14; red –50––30.

Wholly unexpected, however, was the fact that the majority of the lower sections of the unprotected wall seemed to be protruding from the baseline (as defined by the section under the eave). In particular, the lower section of the wall towards the northern end appeared to be much thicker than the rest. The contours clearly show a bulging wall surface (Figure 14). Gentle impact testing (with the blunt end of a broad marker pen) showed that the surface was ‘drummy,’ indicating a large-scale separation of the surface layer from the wall substrate. This indicates eventual structural failure and cleaving of the wall surface. The extent of the bulging suggests that the fissure between the core of the wall and the surface layer is considerable.

In the case of the eastern face of wall 1, these four states only partially correlate with the observed contours (Figure 14). The major bulging occurs in the area that shows pitting and general loss of finish, but no spalling. Some of the area returned a hollow sound when knocked, indicating a separation of the external surface from the core. Tapping the surface at the upper margins of that zone led to spalling.

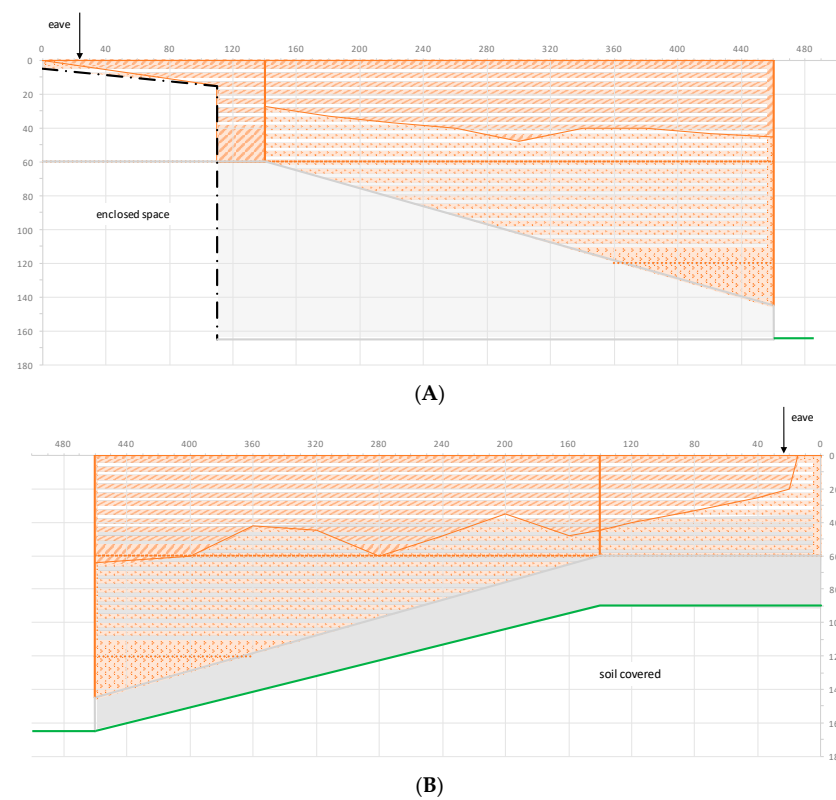
Figure 15. Schematic representation of the observed decay of wall 2: (A) eastern face; (B) western face. For the legend, see Figure 13.

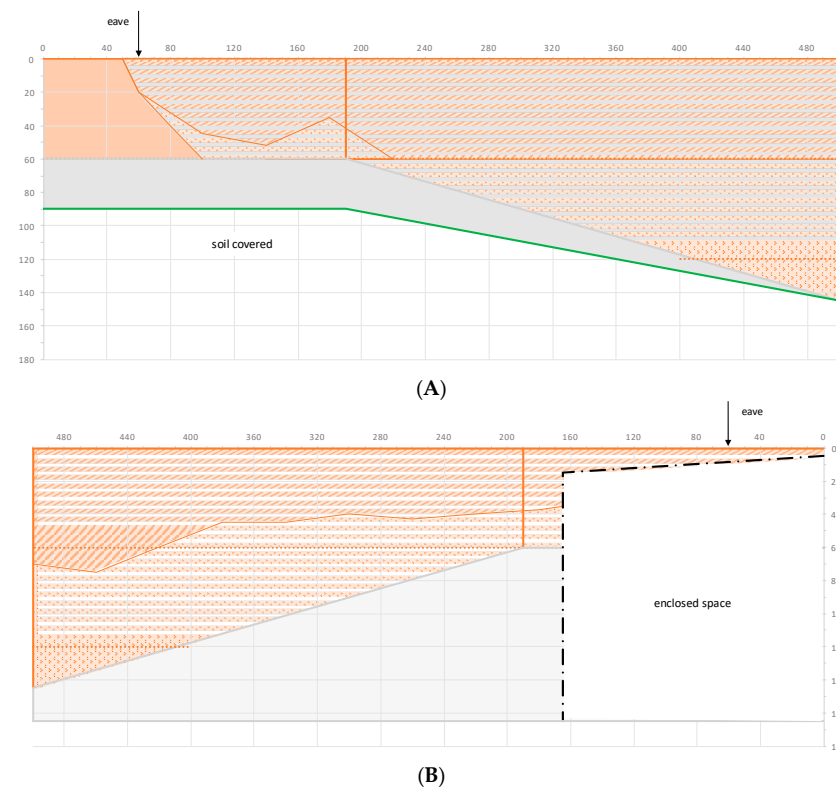
Figure 16. Schematic representation of the observed decay of wall 3: (A) eastern face; (B) western face. For the legend, see Figure 13.

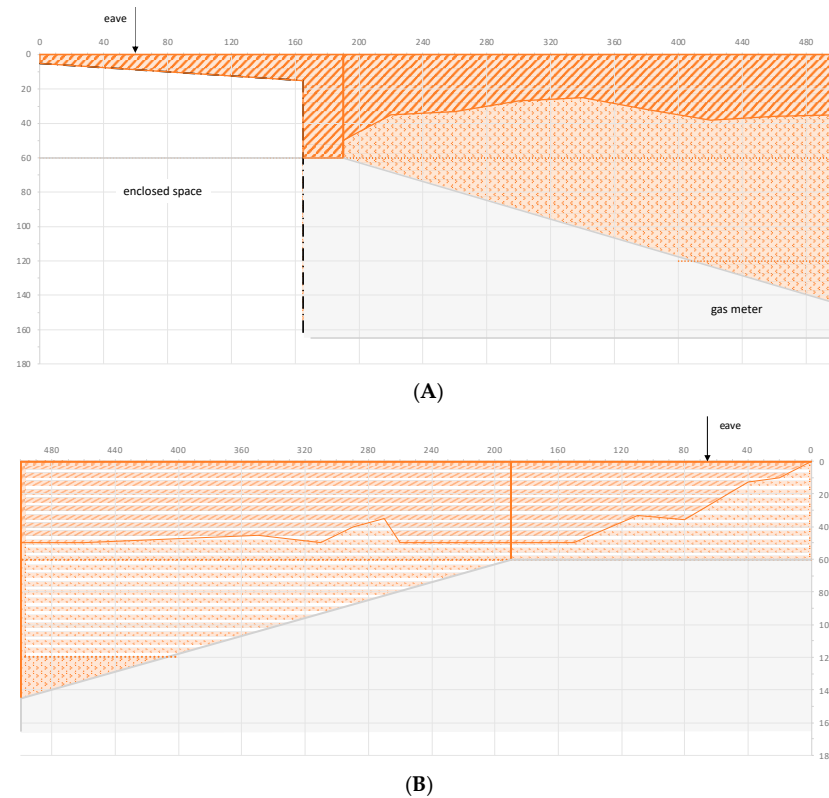
Figure 17. Schematic representation of the observed decay of wall 4: (A) eastern face; (B) western face. For the legend, see Figure 13.

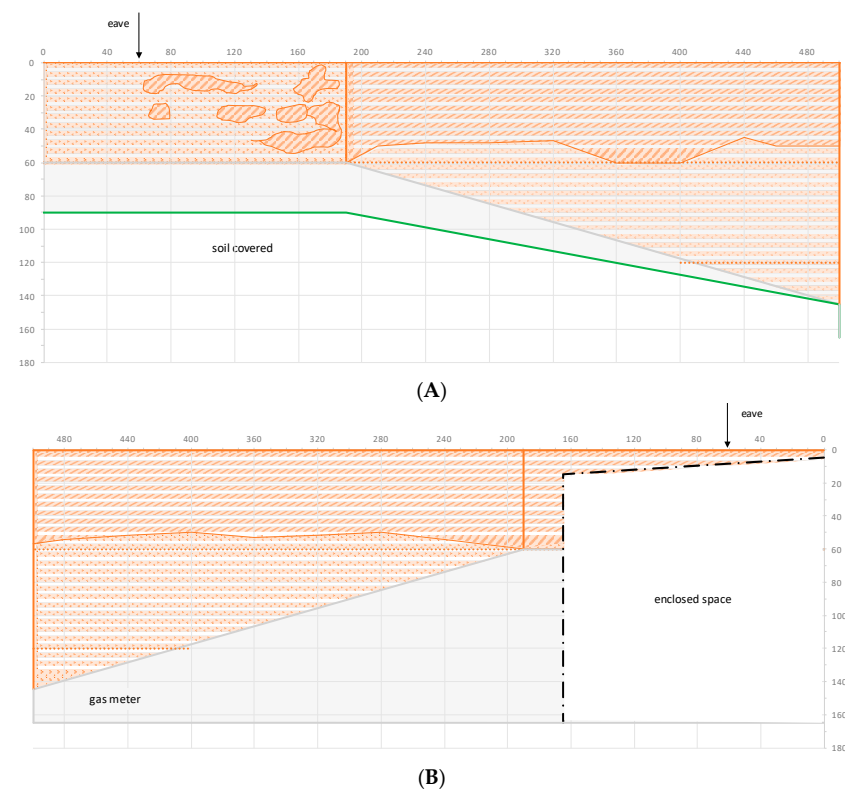
Figure 18. Schematic representation of the observed decay of wall 5: (A) eastern face; (B) western face. For the legend, see Figure 13.

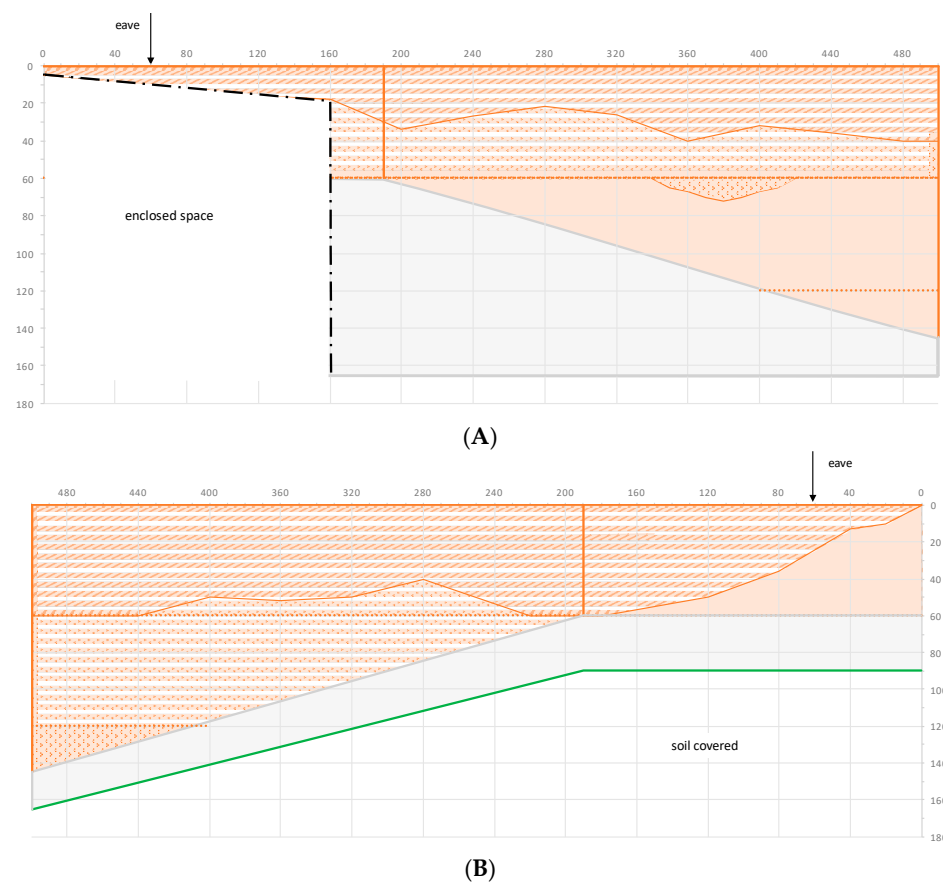
Figure 19. Schematic representation of the observed decay of wall 6: (A) eastern face; (B) western face. For the legend, see Figure 13.

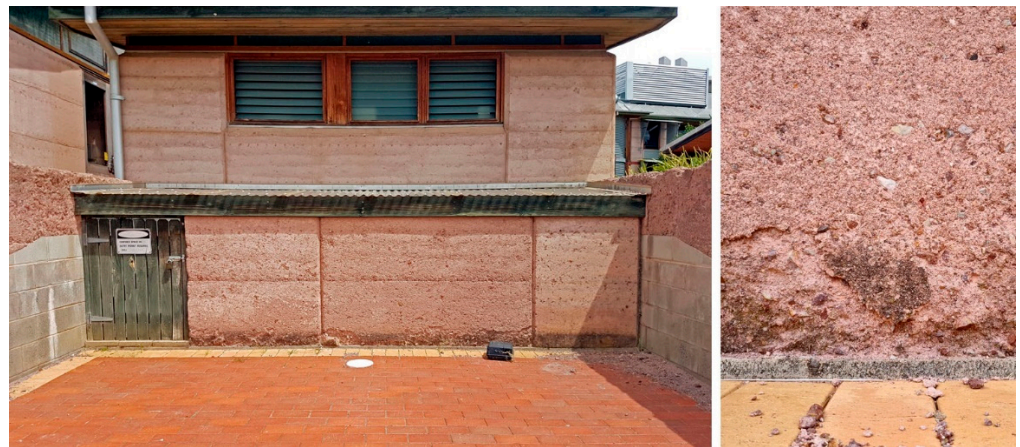
Figure 20. Paved space between wing walls 3 (left) and 4 (right) of Building 762. Note the decay at the base of the wall of the composting chamber.

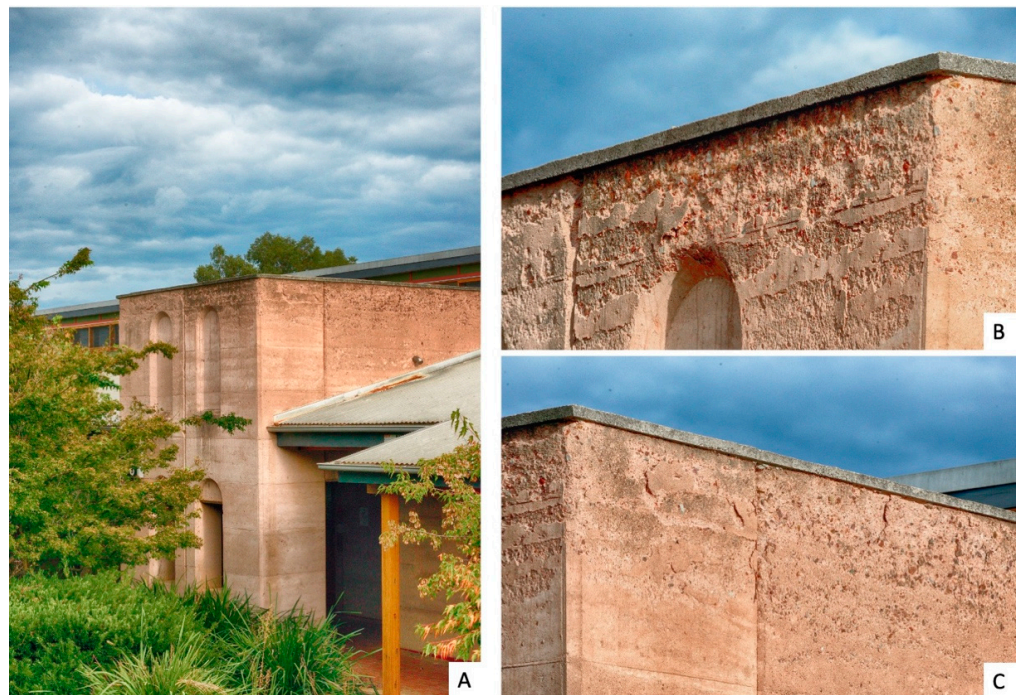
The effects of merely capping the walls instead of roofing with an eave can be studied at the entrances to buildings 761 and 762. These show raised parapets as architectural features (Figure 21A). These walls are capped with concrete pavers but have no eaves and only 20 mm-wide protective overhangs. Consequently, the rainfall runs off the flat capping onto the wall and then straight down the front façade (and presumably also the back), causing slight but broadscale erosion of the surface of the *pisé* wall (Figure 21B). The fact that the tops of the walls are flat contributes to the problem, as a similarly capped, but sloping, feature wall of the network facility (Bldg 754) does not show this level of decay. The walls of the single-storey buildings, 760–762, that are protected by overhanging eaves do not exhibit any obvious decay and only exhibit a broadscale micro-erosion. This manifests itself in a loss of the shine on the otherwise smooth surface.

Figure 21. Parapet over the entrance to building 761, seen from southeast: (A) the portico; (B) decay below the capping, southern façade; (C) decay below the capping, eastern façade.
