# On-Site Risk Assessment Methodology of Historic Timber Structures: The Case Study of Santa Cruz Church

To carry out this study, we have taken advantage of the course of repair work on the roofs of the Santa Cruz Parish Church in Ecija, a town in Andalusia (Spain) (location (WGS84): 37.543, −5.080).

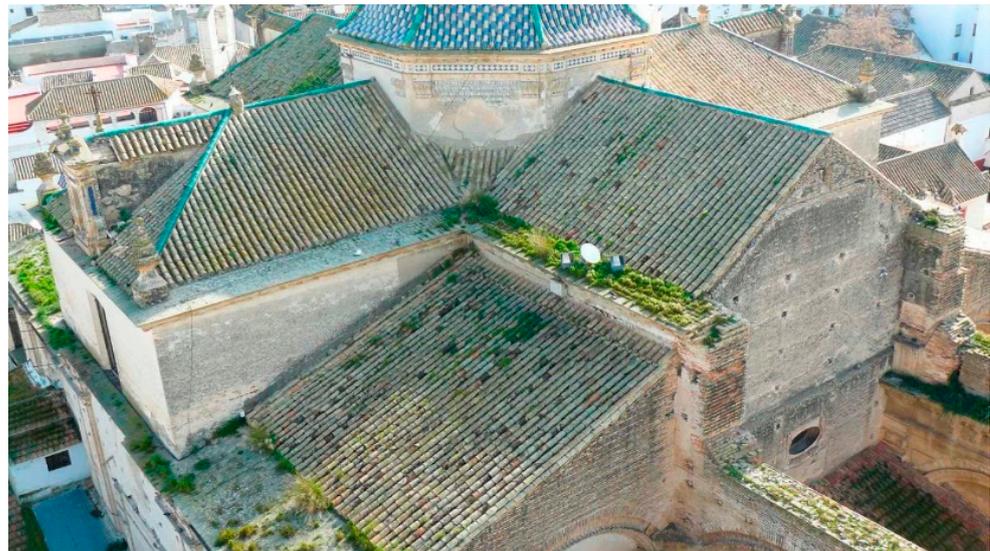
**Figure 5.** Previous state of the roofs at the beginning of the repairs works due to the absence of maintenance access.

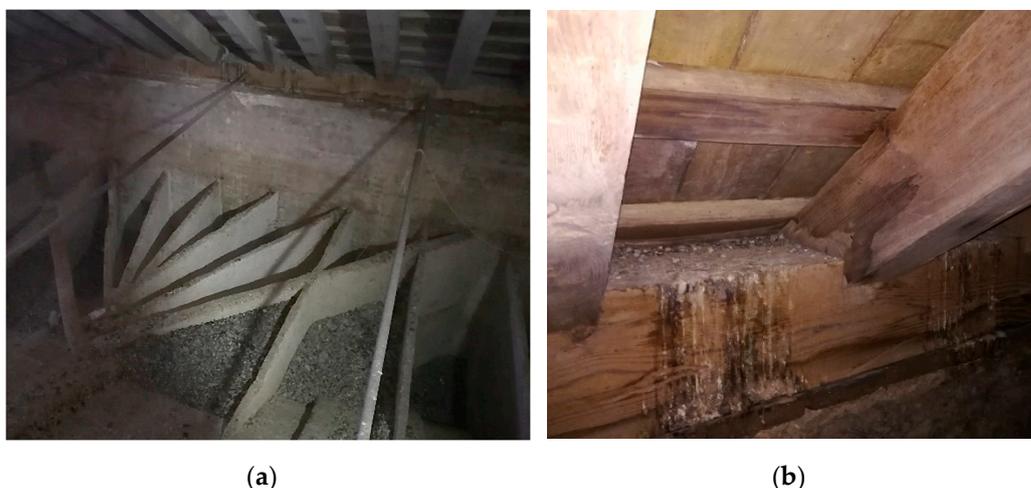
The EV4 sector structure had a lot of dirt, especially due to biological remains (pigeon guano, insects, and dead animals) (Figure 12a). The dirt, although widespread, accumulated in large deposits on the sides of the vault, in the gaps between the bracing partitions, and on the wall plates. The timber beams were covered with a patina of dirt that had accumulated over time. However, unlike other sections, no serious signs of deterioration were observed, and significant deformations were not observed, including broken or collapsed elements. There were certain areas: ridge beam points, some joint of the rafters with the ridge beam or with the wall plates (Figure 12b), and some wall plate sections, which presented active areas of moisture damage. Thus, almost 50% of the joints between rafters and wall plates seem to be affected by moisture, but with a nonuniform distribution. Only two pieces were affected by biological attacks, with actual nonactive termite signs. In addition, two small areas with signs of brown rot were found. Despite all this, the structure presented at first sight an acceptable condition, without risk to its integrity signs. The results of this first inspection are represented in Figure 13.

**Figure 12.** (a) Appearance of the structure: dirt and pigeon guano were found in large quantities; (b) joint between the rafter and wall plate with pigeon guano, moisture, and colouration changes.

A statistical sampling was carried out through incisions with a manual punch. Penetrations of about 3–5 mm were obtained in most of the apparently healthy areas, while, in the areas that presented humidity damage or colour changes, penetrations of up to 17 mm were obtained.

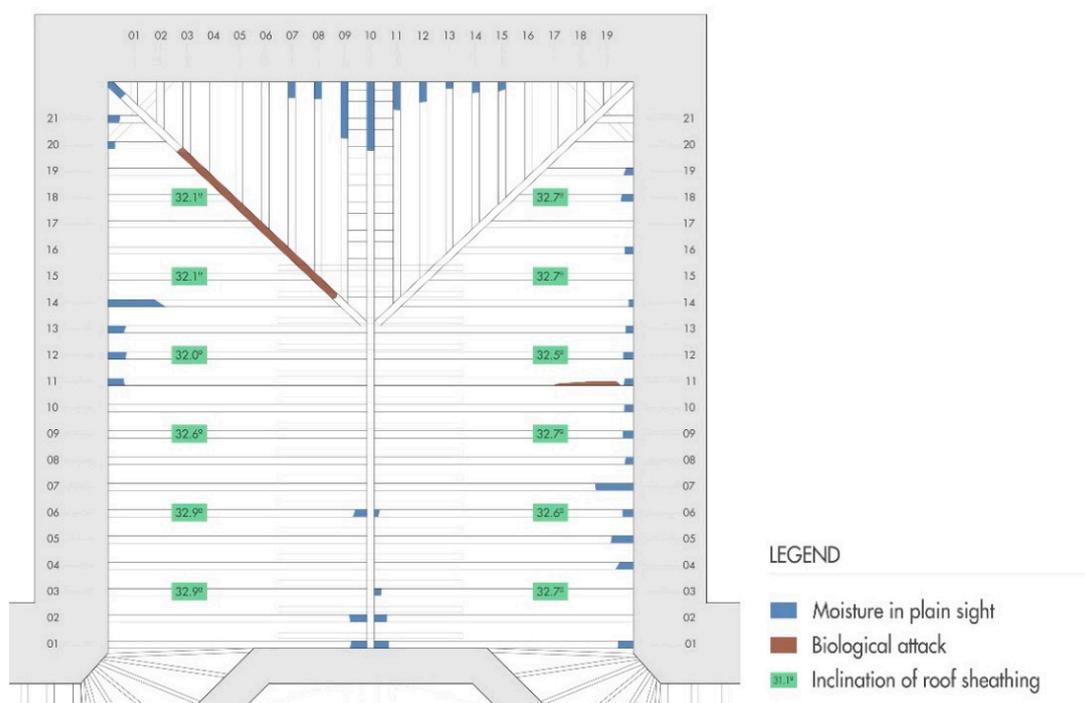
**Figure 13.** Results of deformation measurements and organoleptic inspection.

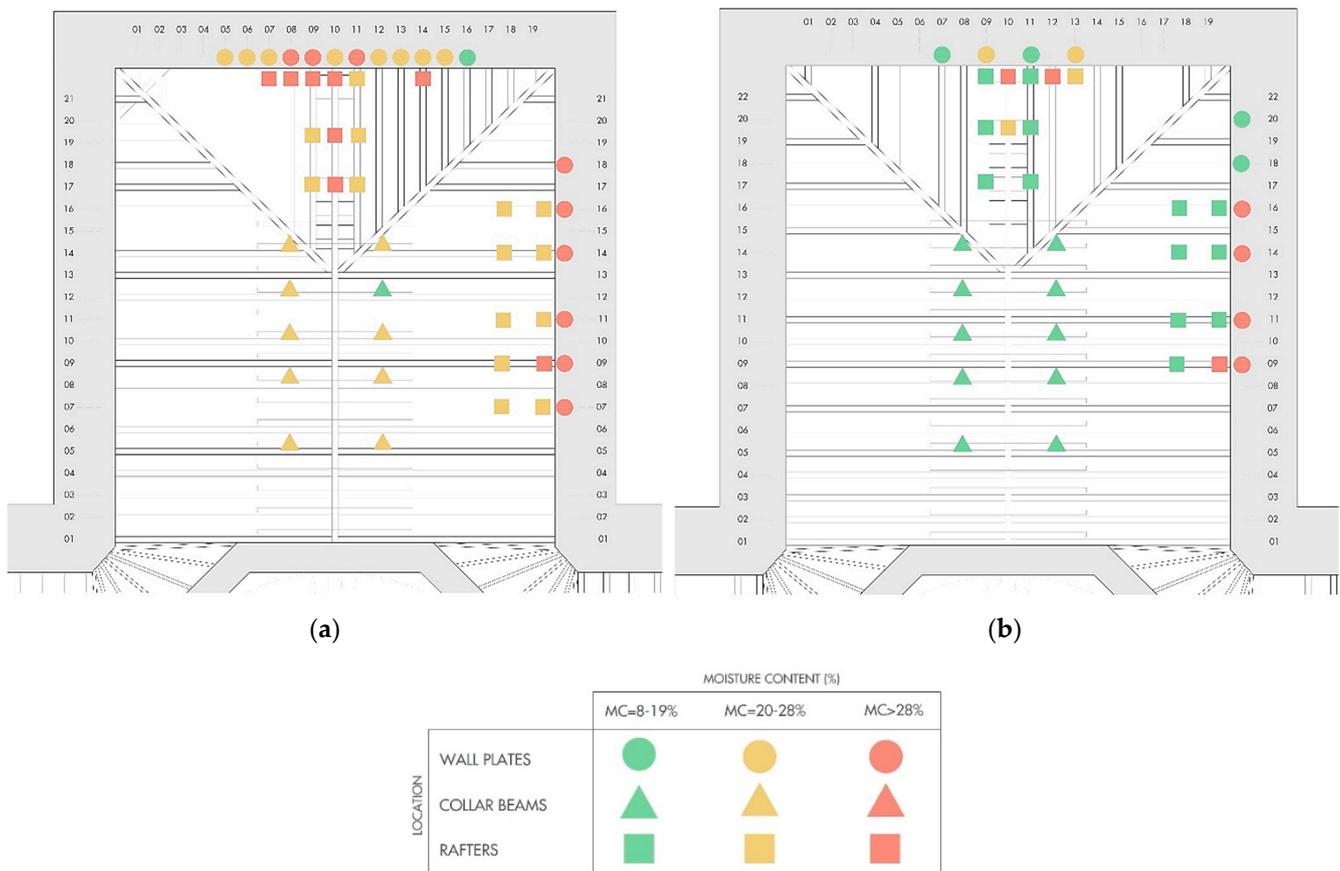
**Figure 14.** Results of the moisture content of the wood by electrical resistance tests: (a) rainy day measurement results; (b) sunny day measurement results.

During the first day, usually all measurements were above 20% MC. The collar beams, which are the most ventilated pieces, had values of between 19% and 24%. The wall plates were the pieces with the highest MC values, and they are, in many cases, above the saturation point (MC > 28%). In any case, most of the structural frame was in danger of attacks from degrading agents. During the second day, an average MC around 17% was obtained in the collar beams and 18% in the rafters. However, the wall plates continued to present numerous areas where the MC was above the saturation point not only in those that are visually wet.

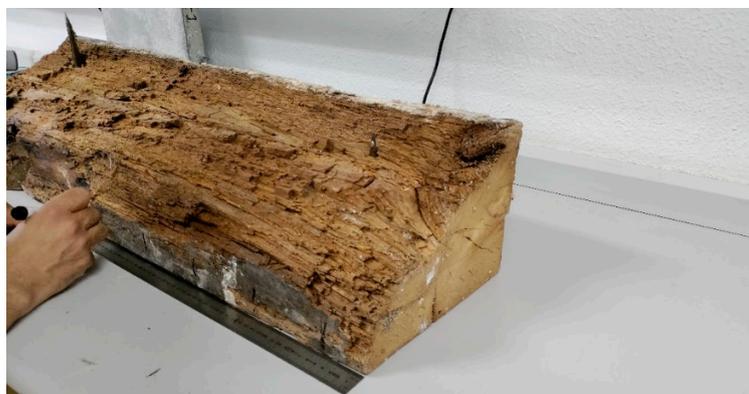
Furthermore, by conducting the resistography test, it was known that at least some of the walls were deteriorated inside. Some perforations carried out in other areas and by the openings of small prospectations executed in the repair works confirmed the suspicions. Indeed, the wall plates were, as indicated by resistography, decayed by rot inside. Between 40 and 60% of their effective real section had been lost (Figure 15).

**Figure 15.** Rot sample: decay condition in the extracted timber section. Almost 50% of the wood section is damaged.

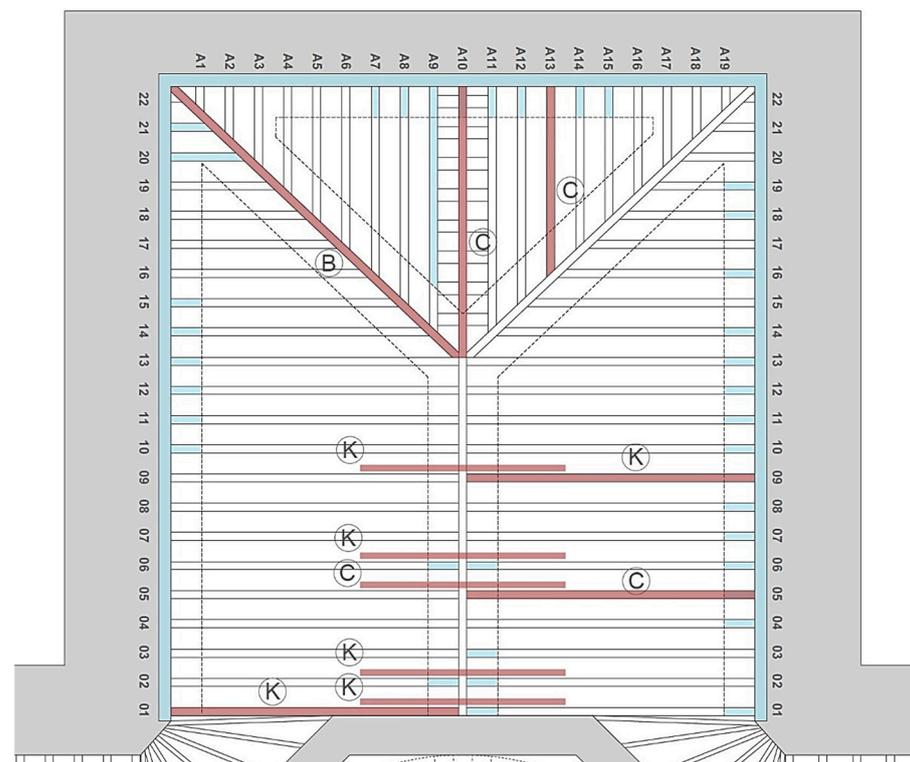
**Figure 16.** Visual classification results and areas with high MC. The rejected elements are shown in red; at the circles, we have the reason. C = Checks; K = Knots; B = Biological attack. Sections of pieces with high moisture levels are shown in blue.

Of a total of 79 pieces, 11 were rejected, which represented 14% of the total. Among all rejections, more than half were due to the presence of knots (54.5%) (Figure 17a), while checks were 36.4% (Figure 17b) and biological alteration was only 9.1%. It should also be noted that 33% of total of the collar beams were rejected according to these standards. This, together with the general analysis carried out for the classification, shows that pieces of worse quality were used in the execution of these timber frame elements in the original construction.

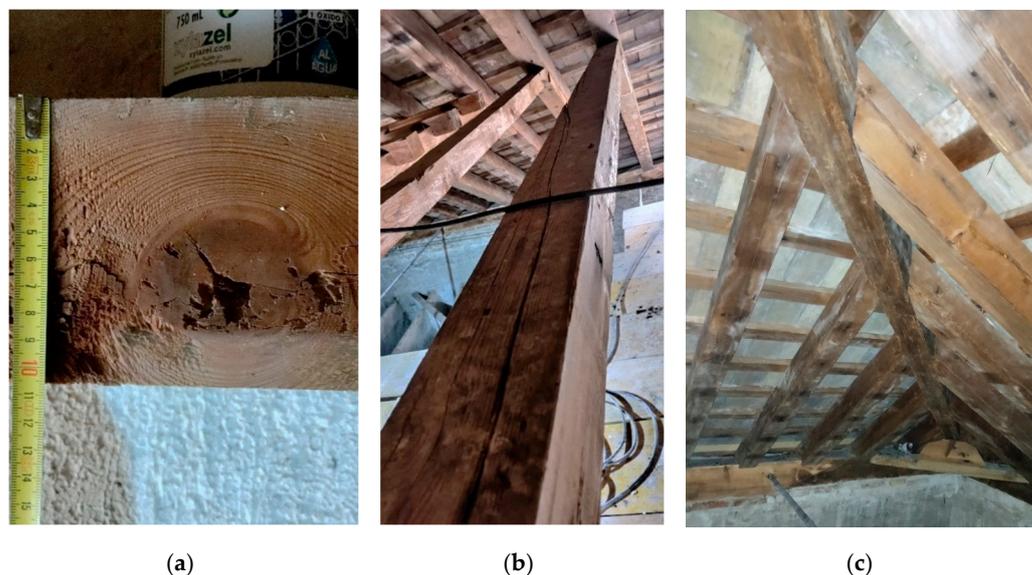
it is not logical to reject pieces, as it is proven that they are structurally working [26]. In this case, the particularity was more remarkable because one of the rejected pieces was a main ridge rafter (Figure 17c) that collects the joints of numerous rafters reaching the ridge beam and configuring one of the main lines of the structural frame, which shows its good behaviour as a bearing piece to consider.

**Figure 17.** Defects causing pieces to be rejected: (a) knot; (b) timber check; (c) one of the main pieces, which is supposedly rejected by CTE standard parameters.

That is why these pieces have been assigned with the lowest of the Resistance Class contemplated in the CTE: C-14. In this manner, they are considered in the transmission of force, but with a lower resistance than the optimal parts according to the quality parameters.

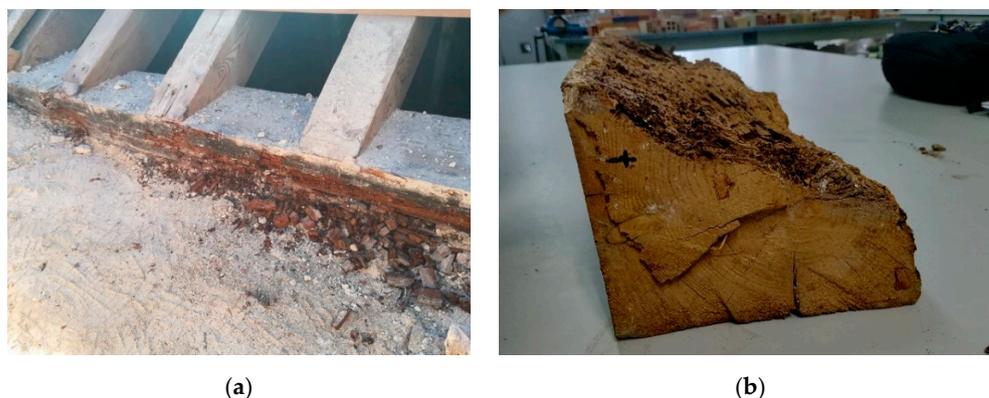
- Wall plates, saturation of still healthy wood fibre: The remaining wood that has not rotted has a high MC above the saturation point (MC > 28%) Again, according to [24], saturated timber has lost up to 40% of its mechanical properties compared to one with a standard MC level. To simulate this reduction, the wall plates had already been applied by the C-14 Resistant Class (which makes a 30% reduction) and the effective section reduced by an additional 10% (on the section already reduced by half because of rotting). In this manner, simplifying to a square shape, the final dimensions of the wall plates have been configured with 15 × 13.4 cm.

**Figure 19.** State of the wall plates: (a) the hidden face is completely decayed due to rot; (b) a section of the piece is extracted and analysed.

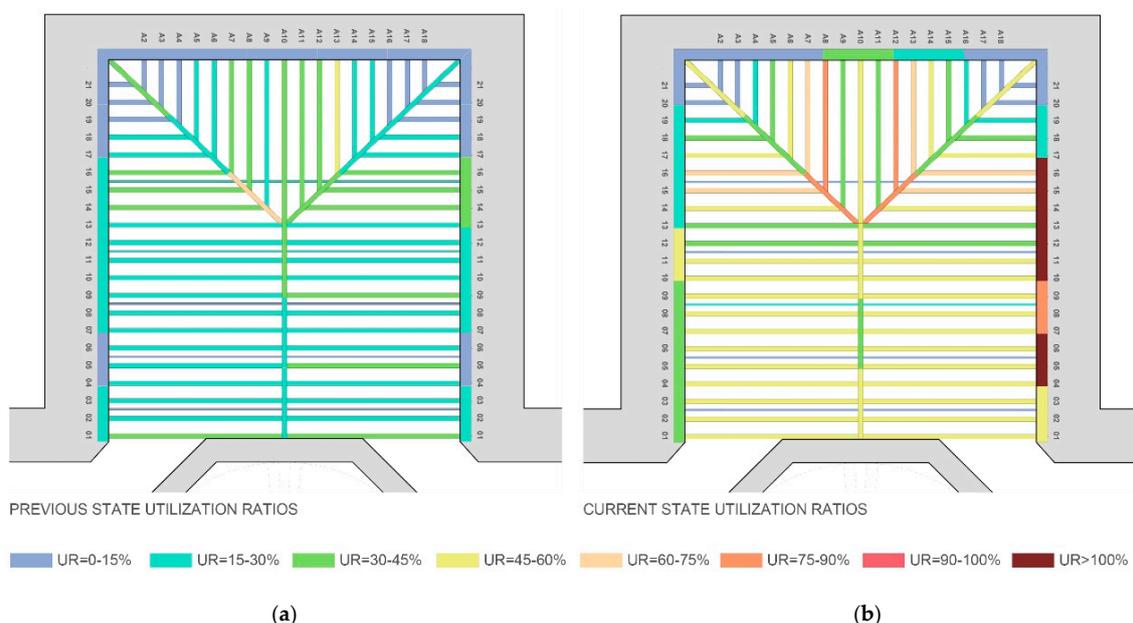
**Figure 21.** (a) Comparison of URs of the previous and (b) of the current state UR.

On the other hand, considering the current status, a higher UR was obtained. Most of the rafter beams reach 45–60% UR, while some specific pieces near the mean node at the ridge beam reach a 75–90% UR, almost wasting the structural timber section. Moreover, some sections of the wall plates, in the convergence with rafters and tie beams, have reached a UR higher than 100%. Therefore, their sections are overloaded, even, one point has a 130% of UR. This would mean that theoretically the timber element cannot withstand the tensions that reach it. Thus, the section would begin to crush, leaving everything contained by the massiveness of the wall (Figure 22a).

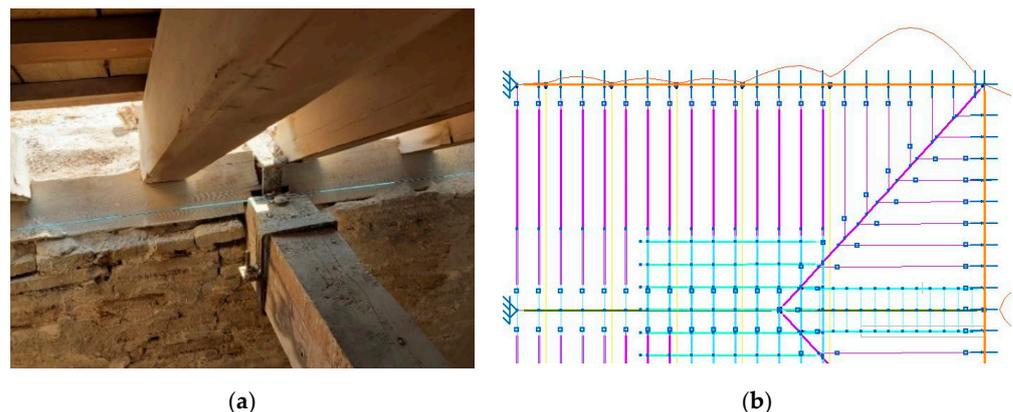
**Figure 22.** (a) Wall plate break due to rot. Piece found at the EP4 sector before the repair works; (b) displacements of the studied wall plate (orange line) in the freedom movement simulation (without the wall link).
