Mind-Mapping Assessment of Reuse Potential of Glulam: An Experimental Study

Abstract: The goal of this work is to suggest a method for assessing the state of salvaged glued laminated timber and deciding whether it is appropriate for reuse. After conducting a thorough analysis of the wood pathology, a decision tree mind map was created. This was followed by the application of this methodology to evaluate a salvaged glulam frame obtained from a demolition site. To ensure the reliability of this approach, laboratory-based ex situ tests were carried out. A working protocol was established for obtaining a sample of the salvaged timber, and its characteristics were identified by examining the species, density, type of adhesive and its shear resistance, as well as the mechanical properties in the bending of both single and double laminates of timber. The results concluded that the glulam under investigation can be reused. The results revealed that the wood was spruce, with a density of $420 \pm 45 \text{ kg/m}^3$ under dry conditions. The glue used was melamine-urea-formaldehyde with a shear strength of $7.37 \pm 1.79 \text{ MPa}$, which is below the standard threshold. The results of th

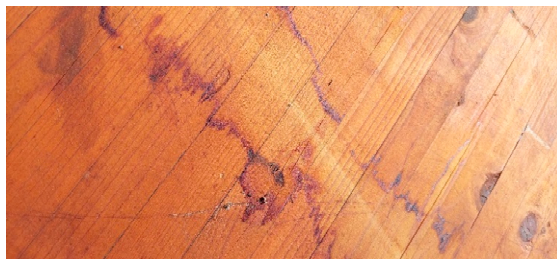
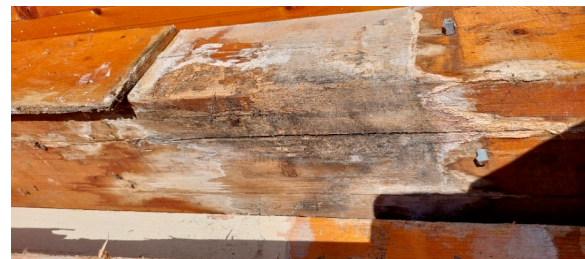
Lot Number	Designation	Number of Pieces	Observations	Mind Map Results
1	External portals	6	Five visually sound glulam beams with some greyish water infiltration stains–discolouration (Figure 10a) One beam with a mouldy zone (Figure 10b) No major cracks No major delamination No insect holes	5 beams → SD1+SC1+SI1 → reusable; 1 beam → SC1+SD2+SI1 → reusable if adhesive mechanical properties are verified.
2	Internal portals	4	Visually sound glulam beams No major cracks No major delamination No insect holes	4 beams → SD1+SC1+SI1 → reusable
3	Internal portals	4	No significant discolouration Visually sound glulam beams No major cracks No major delamination No insect holes No significant discolouration	4 beams → SD1+SC1+SI1 → reusable
4	External portals	7	Visually sound glulam beams with some greyish water infiltration stains No major cracks No major delamination No insect holes	7 beams → SD1+SC1+SI1 → reusable

Figure 10. On-site visual observations: (a) surface water infiltration; (b) severe infiltration.

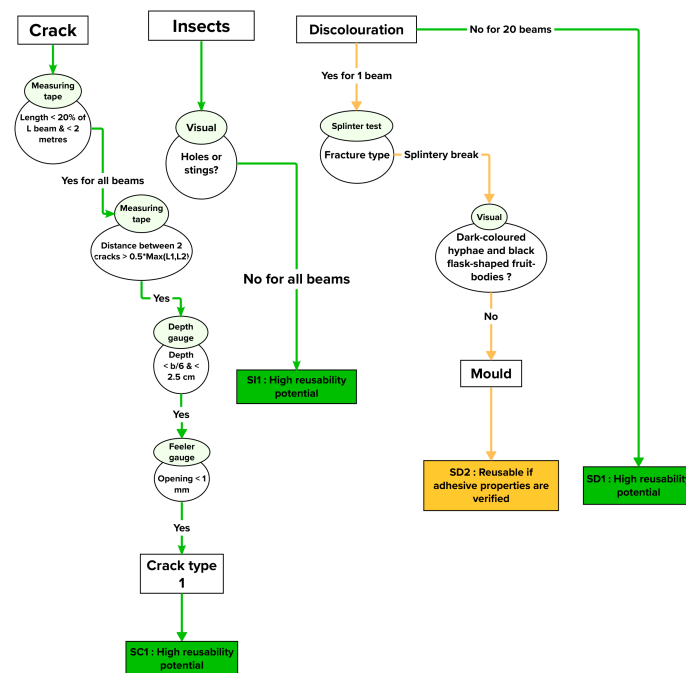
Figure 11. Mind map approach application on glulam batch.

Figure 11 shows the conclusions drawn from the mind maps and the conditions for reusing these glulam beams. Generally, the results show that none of the beams contained either type 2 or type 3 cracks or laminations leading to an SC1 reuse scenario. For the insects, no anomaly was observed, which means that the concluded scenario is SI1. However, for the discolouration part, it was found that, for 20 beams, only some traces of surface water infiltration (Figure 10a) were noted, and they can be considered as SD1. The traces were easily removable via cleaning. One exception contained significant stains of water infiltration and had a grey mouldy section, as shown Figure 10b. The splinter test showed that penetration was not easy, the fracture of the wood seemed splintered, and the stains were more surficial, which means it is an SD2 scenario. Also, delamination can be seen on the stained area but not on other locations. According to the mass plan provided by the owners, the mould might be linked to the presence of a heating system nearby or some water infiltration from the roof.

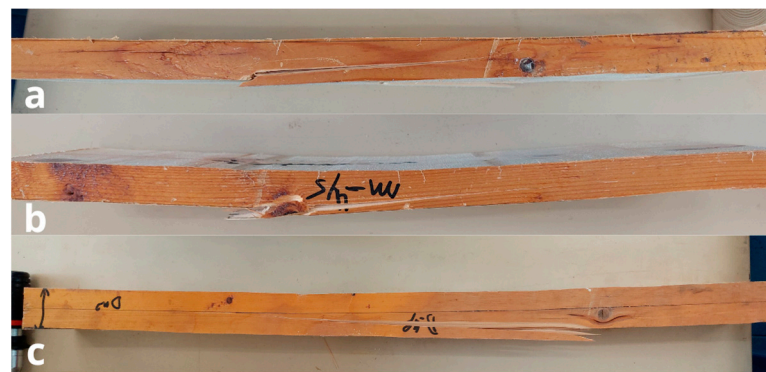
This transverse breakage in Figure 17a may be attributed to tension parallel to the grain in the lower portion of the laminate, which initiates the fracture at a point offset from the middle of the laminate. The origin of the defects or a combination of all these factors may also contribute to this type of failure.

Figure 17. Tested specimens: (a) wood failure type of single laminates; (b) knot presence in a tested 1.3.3 specimen of SS 1.3; (c) knot presence in a tested double laminate.
