# Repair of Old Timber Log House Using Cavity Filling with Compatible Natural Materials

**Abstract:** The paper describes a method of structural repair to damaged elements of protected timber houses. Emphasis is laid on minimum intervention in the valuable material that needs to be preserved to the maximum possible extent, especially without larger interventions in the visible parts. The designs will find application in situations where it is not possible or appropriate to use common building methods, and it is necessary to carefully fill out or substitute bio-damaged parts of structural elements. The material for the production of fillings of structural elements corresponds to the originally used wood species; in the case of contact with the ground, oak is the choice due to its durability. Small caverns are filled with earth-based mortar with lime, casein, and chopped wheat straw. Such mortar mixtures were subjected to laboratory tests, which have shown that earth-based mortar (E) and earth mortar with lime putty modification (EL) have very similar physical, mechanical, and hygric properties. The properties significantly changed when curd cheese/casein was added to fresh mortar (

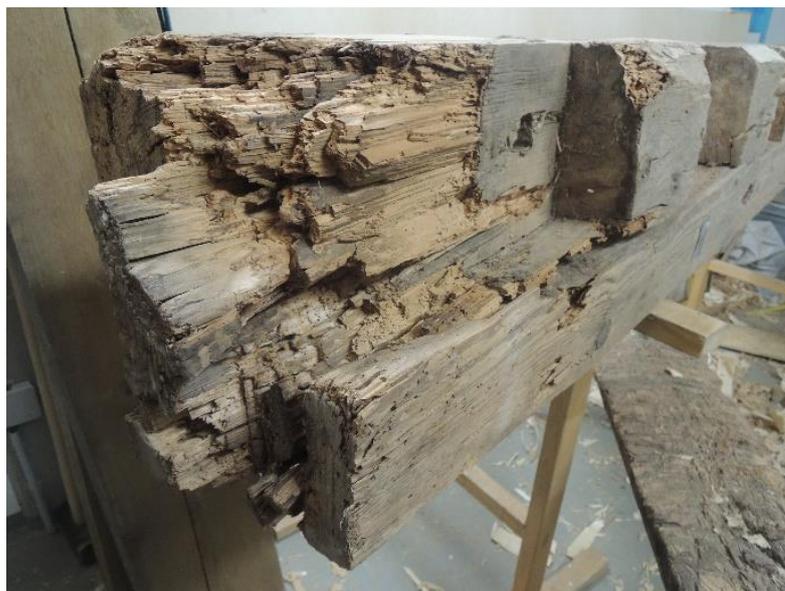
Access to the barn from the south was allowed through an elevated entrance with a double-hung pivoting door. On the other side, there was only a simple ledge door used to take care of animals. The barn interior was divided into three parts: the central place used for beating corn was adjoined by smaller parts, separated by continuous thresholds. Furthermore, there was a wooden second floor, held by purlins sitting on wooden pillars (fastened with tapes). One of the pillars damaged at the bottom was chosen as the third beam for the case study presented here (Figure 2).

**Figure 2.** Damage to beam (III) at the bottom.

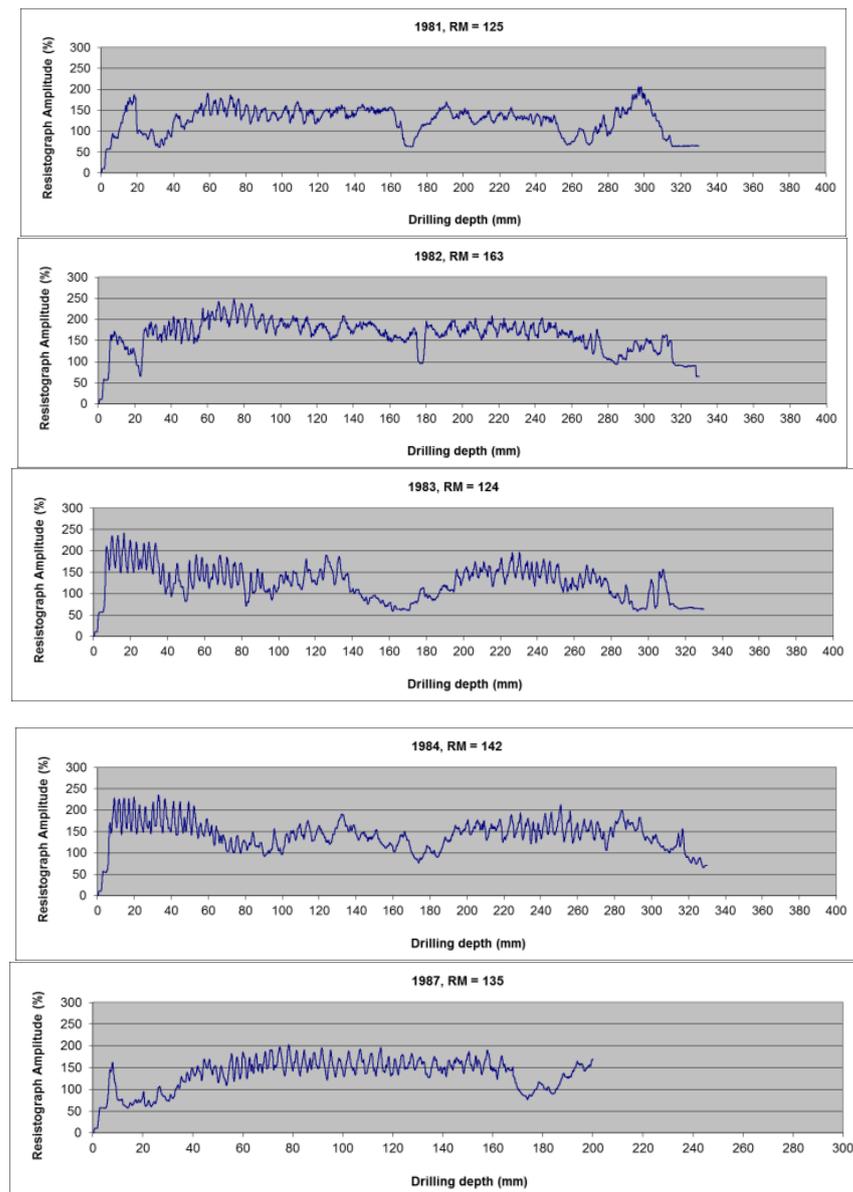
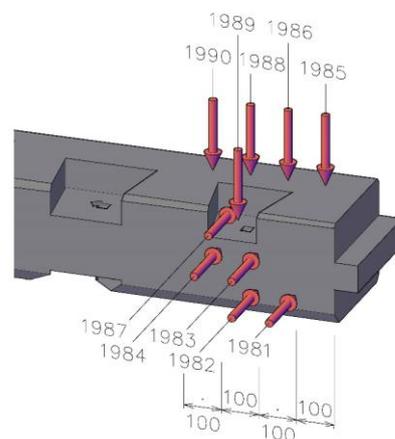
The detailed examination of selected elements of the polygonal barn for the purposes of the case study was performed using resistance drilling, which is based on measuring the resistance to penetration of a small drill bit through the material examined. The device used, Rinntech Resistograph 4453-S, provides data about the internal state of the element. Due to the minimal damage to the material, this is a semi-destructive method of testing the condition of timber structures [34]. The resistance drill Resistograph measures the energy required to maintain a constant speed of the drill when drilling through the material. Resistograph measures the energy required to maintain a constant speed of the drill when drilling through the material (see Figure 3). The peaks in the graph correspond to higher energy, i.e., higher resistance and higher density, while lower points are associated with lower energy, i.e., lower resistance and lower density [10]. Figure 3 shows the graphic records from the individual measurement points. The extent of the damage was determined by measuring perpendicular to the longitudinal axis of the beams. Each measuring point was recorded in the scheme of the element estimated (Figure 4). Based on resistance characteristics (RM), calculated from the area under the curve and the drilling depth, the extent of the rot was determined.

**Figure 3.** Graphic records from the individual points of measurement by Resistograph, beam (III), measured parallel to the orientation of the pin at the bottom of the beam.

**Figure 4.** Marking of the points measured by Resistograph, beam (III).

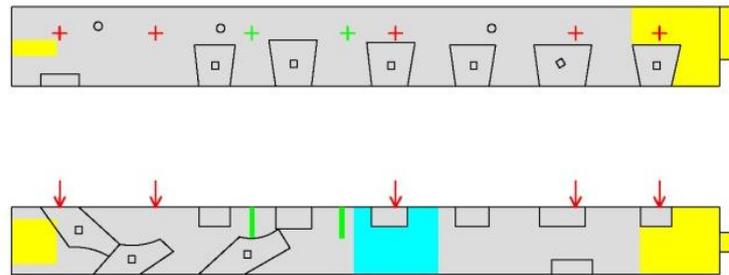
Before the repair, the damaged spot was also thoroughly visually mapped, photographed, and captured in a drawing (Figure 5). Natural defects (knots and drying checks) played an essential role when designing the repair. Although knots can play a different role when in different places in the beam and under different load conditions, here the role of knots was positive; by contrast, checks had a negative effect. For example, a ring of knots in the beam ends ensured integrity near the rotting (Figure 6), since only shear loading can be expected here. Additionally, the knot between the mortises of the double-sided dovetails also provided integrity (Figure 6). The checks in the centre of the element restricted the possible preservation of a large part of the profile and the damaged portion had to be removed up to the check (Figure 6).

**Figure 5.** A scheme of the rot extent, beam (III), (yellow—replacement, blue—reduced wood density without the need for repair, grey—standard wood density without the need of repair). Arrow and + marking points measured with Resistograph.

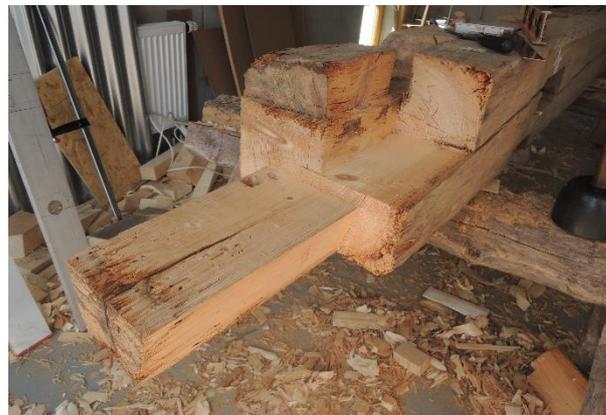
**Figure 6.** Gradual removal of the damaged wood at the beam bottom (after cleaning).

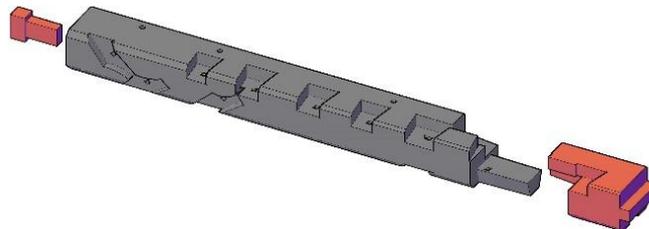
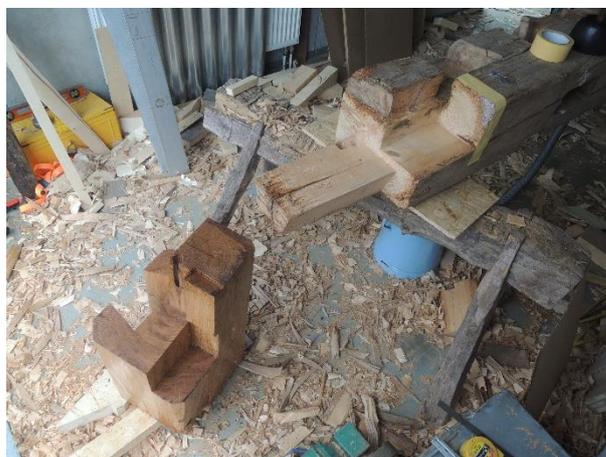
**Figure 7.** A 3D model beam (III) drawing of the structural repair of the damaged beam.

**Figure 8.** The new part before being inserted by a ledge joint.

Inserting a new part by a ledge joint became the central idea of inserting a new short piece of wood into the damaged bottom (Figures 7 and 8). On the other hand, a check was made use of when the ledge was secured by a wedge (Figure 9). The top surface of the pillar laid down (Figure 9) shows the sensitive connection of the inserted new part in the place of the drying check. The gentle structural solution was repeated in the place of a double-sided dovetail lap joint (Figure 10), which provides an overlap and, thus, a visually more pleasant view.

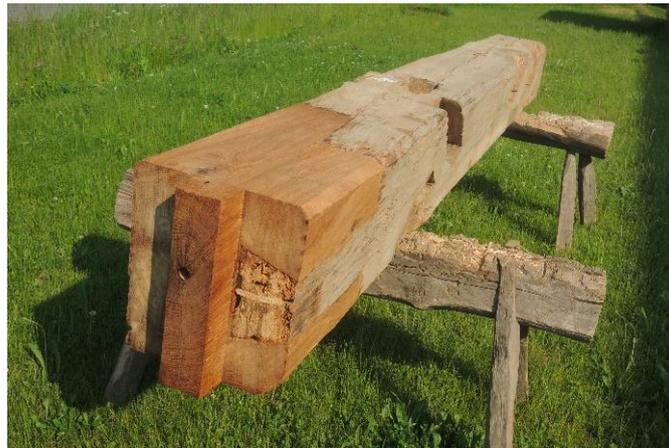
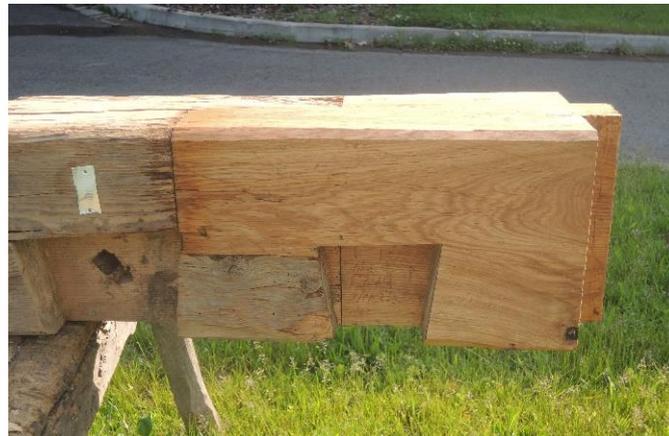
**Figure 9.** The bottom of the damaged beam (III) after the repair, including the ledge joint secured by a wedge placed in the drying check.

**Figure 10.** The bottom of the damaged beam (III) after the repair.

The material was selected so that the tree rings corresponded with the orientation of the tree rings of the repaired beam. The material was naturally dried before use to a moisture content of less than 20%, thereby eliminating shape and dimensional deformations, which are undesirable after installation. In the case of the lower damaged part of the column, oak was chosen as a repair material due to its better resistance to increased moisture stress in the sill part and due to better homogeneity, which was needed for this very short and highly shaped insert. The same material was used to repair the belfry of the White Tower in Hradec Králové [35]. The total time to repair the beam was 30 h of work.

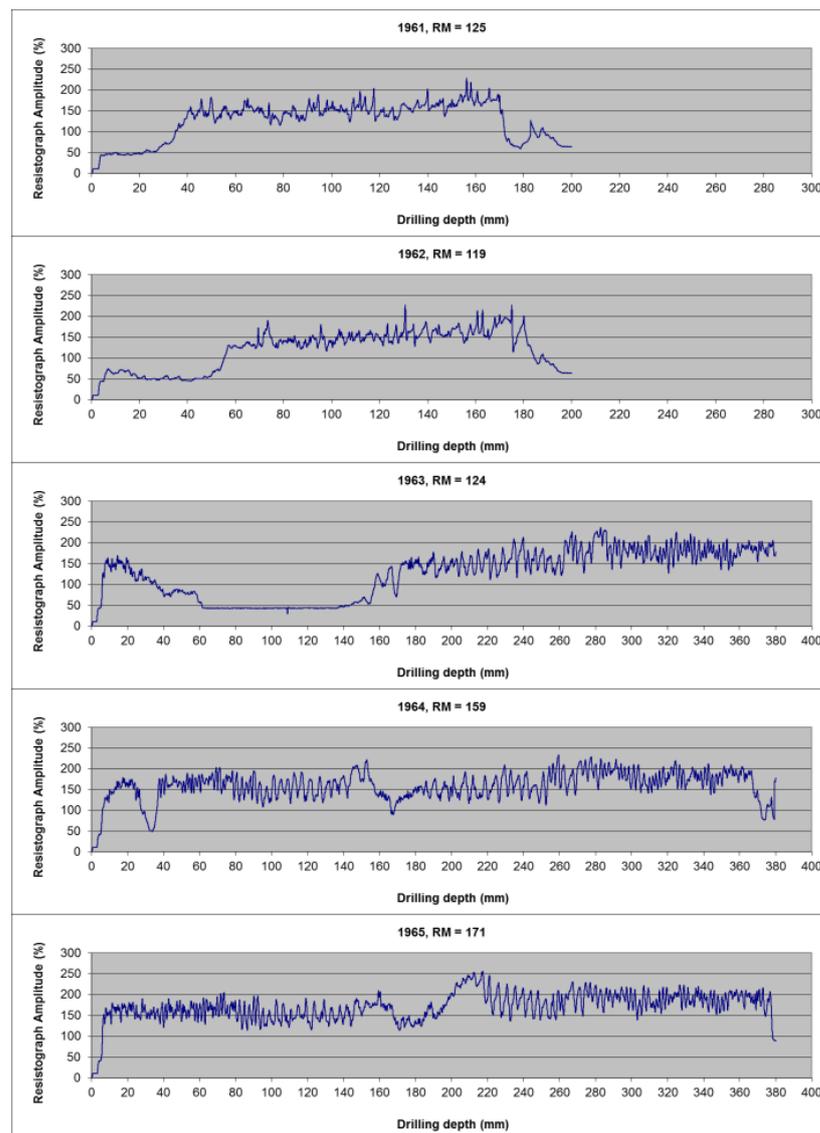
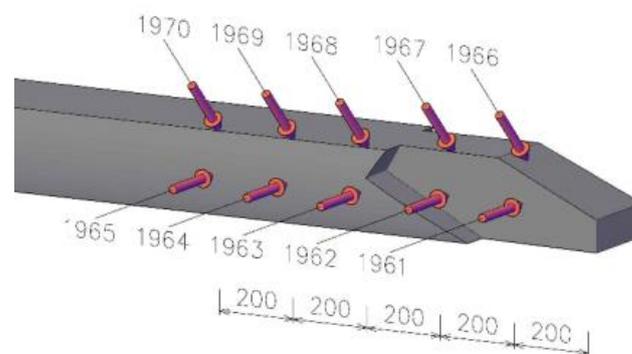
Another design of structural repair focused on beam (H2), i.e., a part of the polygonal wall damaged by central rot in the location of a dovetail joint. The main objective was to change the damaged element as little as possible and, if possible, not to interfere with the front (visible) surface of the beam. As in the previous case, a detailed examination was performed using resistance drilling. Figure 11 shows the graphic records from the individual measurement points. The extent of the damage was determined by measuring perpendicular to the longitudinal axis of the beams. Each measuring point was recorded in the scheme of the element estimated (Figure 12). Based on resistance characteristics (RM) calculated from the area under the curve and the drilling depth, the extent of the rot was determined.

**Figure 11.** Graphic records from the individual points of measurement by Resistograph, beam (H2), measured parallel to the orientation of the pin at the bottom of the beam.

**Figure 12.** Marking of the points measured by Resistograph, beam (H2).

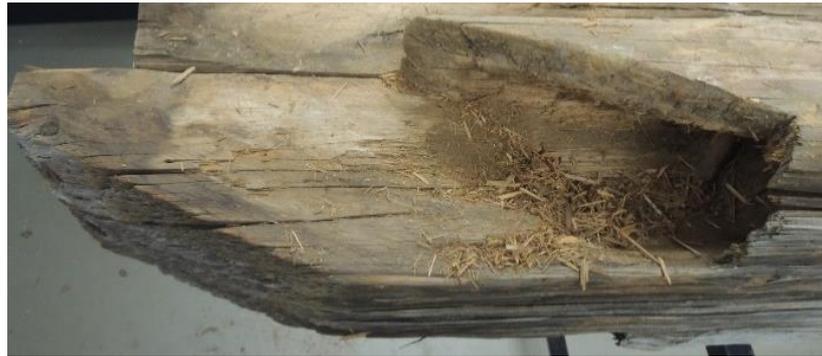
Before the repair, the damaged spot was also thoroughly visually mapped, photographed (Figure 13), and captured in a drawing (Figure 14). Natural defects (knots and drying checks) played an essential role when designing the repair. The role of knots was

**Figure 13.** Damage to the beam (H2) in the location of the dovetail joint.

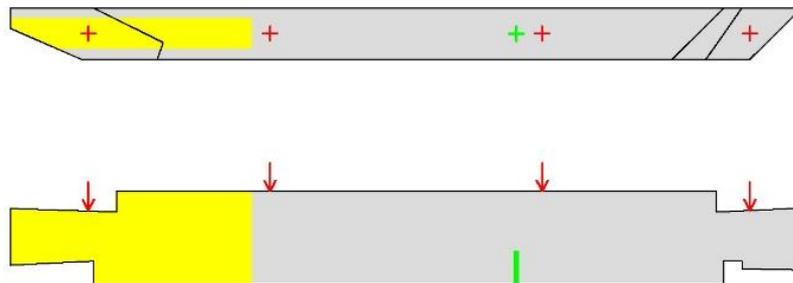
**Figure 14.** A scheme of the extent of rot, beam (H2) (yellow—replacement, grey—standard wood density without need of repair). Arrow and + marking points measured with Resistograph.

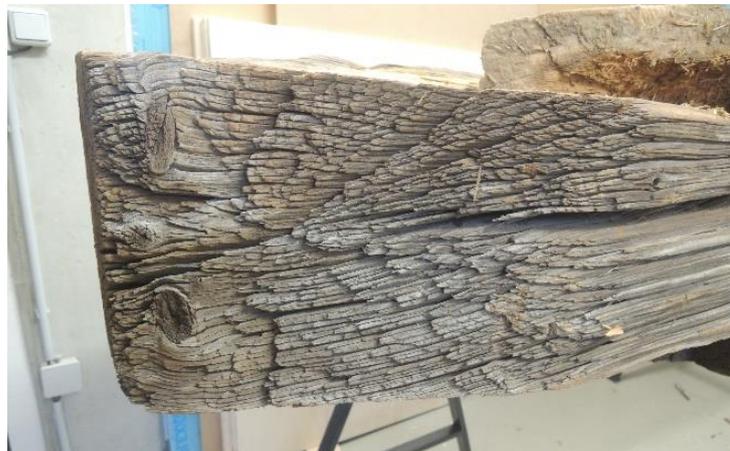
positive; by contrast, checks had a negative effect. A knot in the sloping end ensured integrity near the rotting, between two drying checks (Figure 15). Due to the checks converging towards the element centre, the sloping beam end could not be preserved in its entire profile, and the damaged section between the checks also had to be removed. This partially breached the request for no interference with the external surfaces of the element repaired. In case of surface damage, the beam end integrity was ensured by a knot on the opposite side of the joint. The knot in the hole in the central part of the beam served as a reinforcing element; therefore, it was fully preserved (Figure 16).

**Figure 15.** Detail of the damaged beam end before the repair, the end integrity ensured by the knot near the drying check.

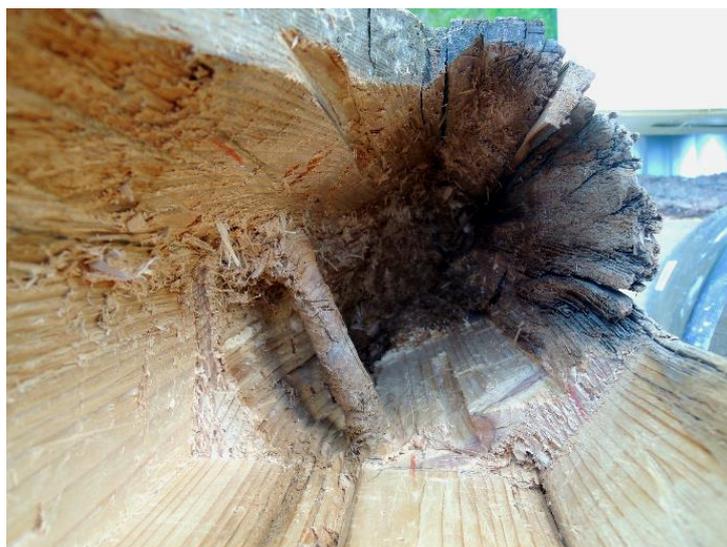
**Figure 16.** Detail of the cleaned hole in the central part of the beam, including the grooves for the rear insert.

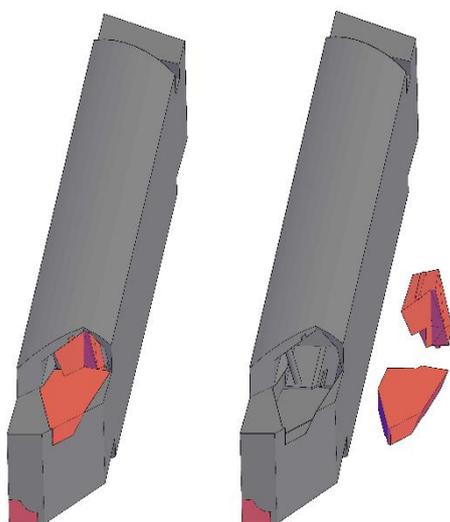
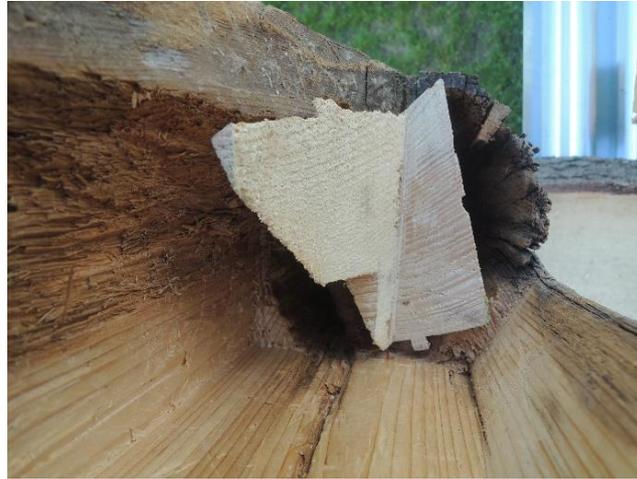
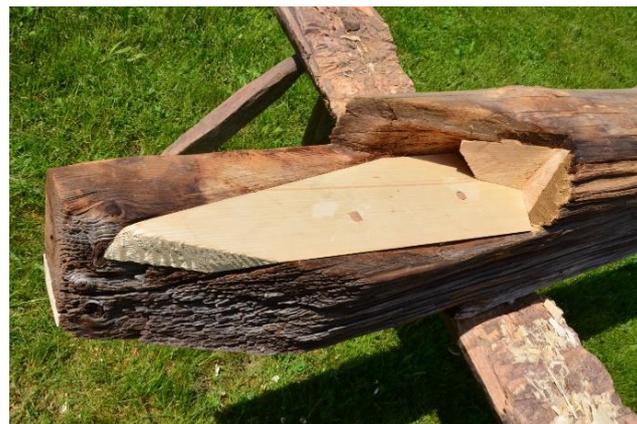
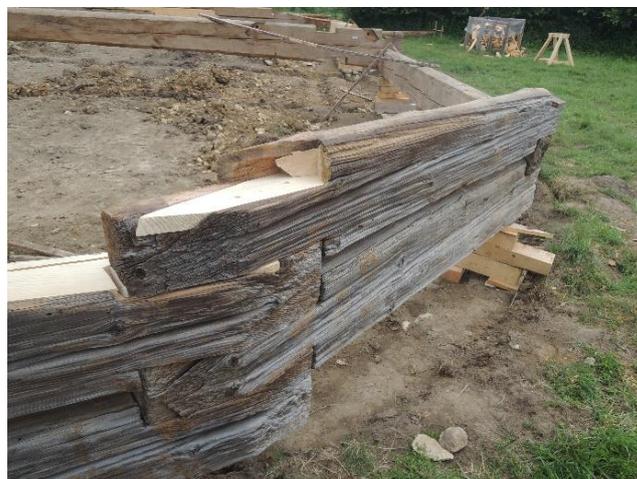
**Figure 17.** A 3D model beam (H2) drawing of the structural repair of the damaged beam.

**Figure 18.** The rear insert fixed in the grooves.

**Figure 19.** Dovetail joint of the damaged timber beam (H2) after the repair.

**Figure 20.** The repaired beam put back to its original place in the barn timber wall.

The insert filling the surface of the dovetail joint was shaped exactly by the longitudinal and transversal surfaces formed by the removal of the rot from the damaged part of the beam (Figure 17). The insert was fixed by oak pins. The rear insert was inserted into the prepared grooves providing fixed position of the insert in the cleaned hole and thus stabilization of the thin superficial preserved part of the beam (Figure 18). Figure 19 shows the entire view of the repaired dovetail joint of the damaged beam, with inserts respecting the drying check, i.e., the area of the dovetail joint. Figure 20 shows the repaired beam back in its position in the timber wall of the barn, manifesting the visually gentle structural solution.

The material for the production of the inserts was selected so that the tree rings correspond with the orientation of the tree rings of the repaired beam (Figure 19). The material for the inserts was naturally dried before use to a moisture content of less than 20%, thereby eliminating shape and dimensional deformations, which are undesirable after installation. The material for the structural repair was the originally used spruce of strength class C20. The rotten-out space around the rear insert (Figure 18) was left without structural repair. Before the insert was put in place, the rotten space was spread with clay mortar with

addition of lime, curd cheese, and chopped wheat straw (Figure 19). The preparation and properties of the clay mortar are described in detail in Section 6. The total time to repair the beam was 27 h of work.

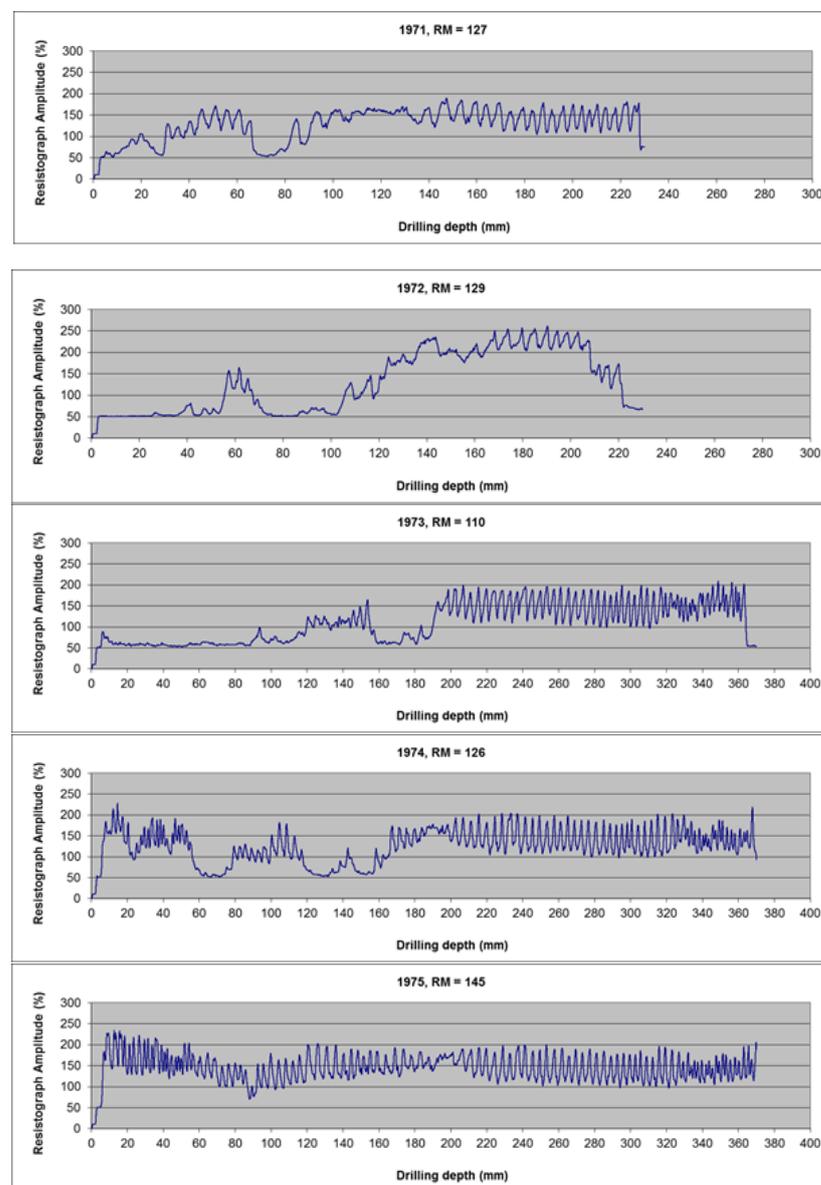
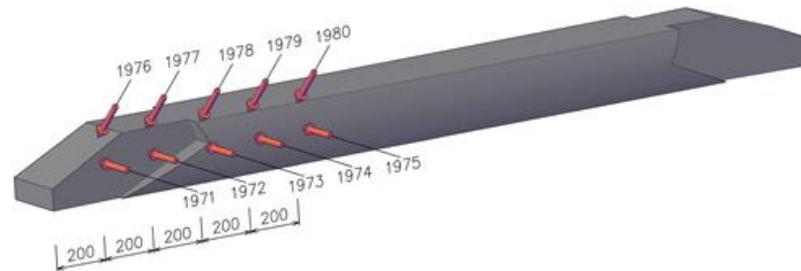
The third design of structural repair to be presented focused on beam (I2), i.e., a part of the polygonal wall damaged by central rot in the location of a dovetail joint. Again, the main objective was to change the damaged element as little as possible and, if possible, not to interfere with the front (visible) surface of the beam. With regard to the extent of the damage, this request seemed almost unrealistic, and in the common repair of a monument, such an element would be replaced in its entire profile. As in the previous case, a detailed examination was performed using resistance drilling. Figure 21 shows the graphic records from the individual measurement points. The extent of the damage was determined by measuring perpendicular to the longitudinal axis of the beams. Each measuring point was recorded in the scheme of the element estimated (Figure 22). Based on resistance characteristics (RM), calculated from the area under the curve and the drilling depth, the extent of the rot was determined.

**Figure 21.** Graphic records from the individual measurement points using the Resistograph drill, beam (I2), measured vertically in the centre of the element.

**Figure 22.** Marking of the points measured by Resistograph, beam (I2).

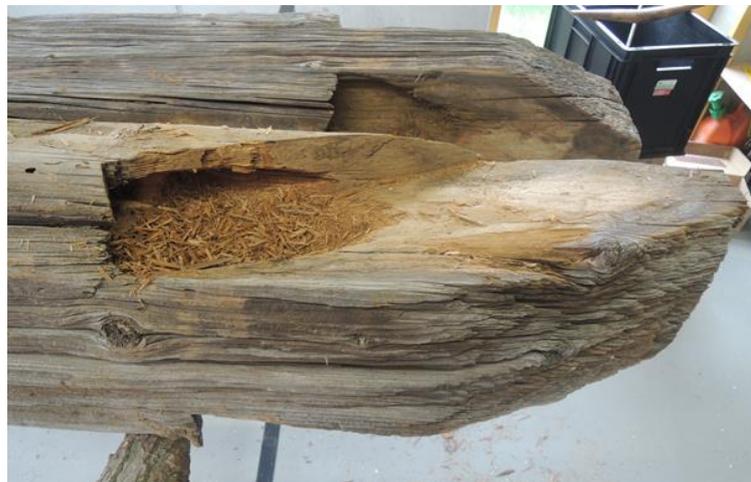
Before the repair, the damaged spot was thoroughly visually mapped (Figure 23) and captured in the drawing (Figure 24). The role of knots was positive; by contrast, checks had a negative effect. The knot in the joint end ensured integrity near the rotting (Figures 23 and 25). Due to the checks converging towards the element centre, the sloping beam end could not be preserved in its entire profile, and the damaged section between the checks also had to be removed. However, the new wood addition to the beam was of a minimum extent (Figure 26). The space where a new part had to be inserted was enclosed in two ends (Figure 27), which could be partially sawed, and the remaining end plane had to be formed by gradual chiseling. Figure 28 documents the gradual formation of the bed for insert with several levels. The insert had to be fitted into the precisely defined longitudinal space (Figure 29), which made the formation significantly more complicated as no additional modifications were possible.

**Figure 23.** Damage to the beam (I2) in the location of the dovetail joint.

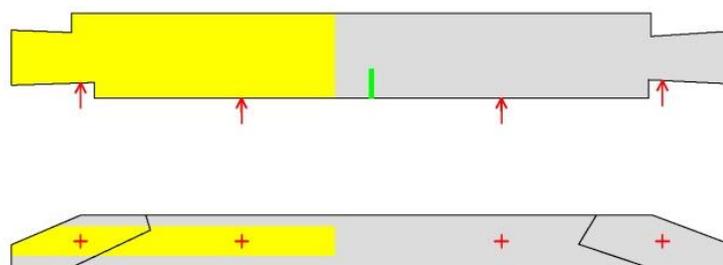
**Figure 24.** A scheme of the extent of the rot, beam (I2) (yellow—replacement, grey—standard wood density without the need of repair). Arrow and + marking points measured with Resistograph.

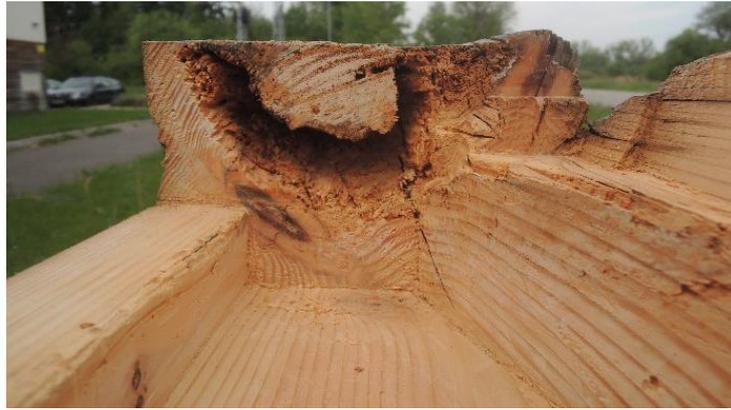
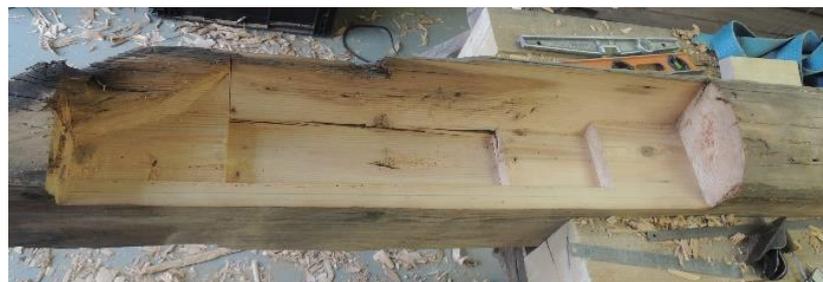
**Figure 25.** Detail of a hole left in the end of the damaged beam after the cleaning.

**Figure 27.** Finally cleaned part of the damaged beam.

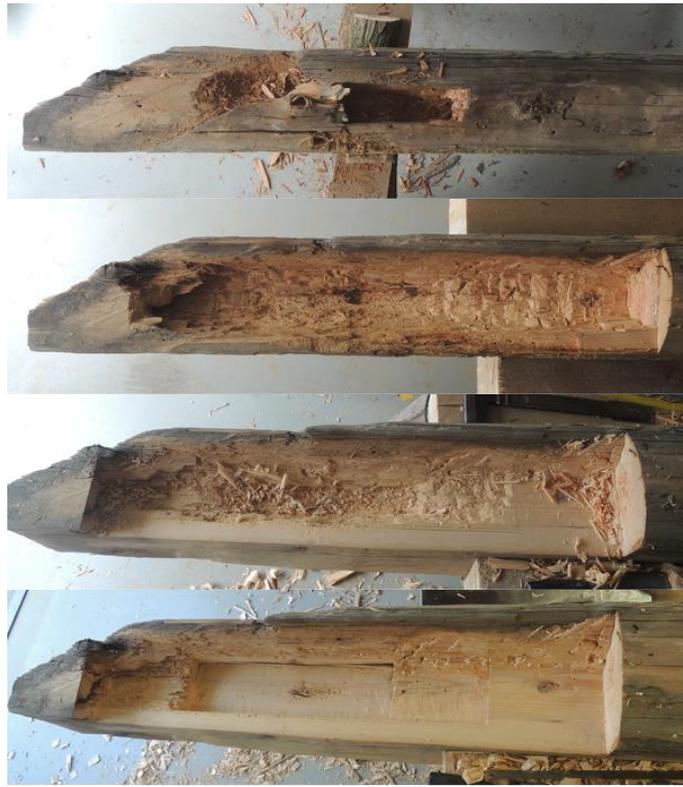
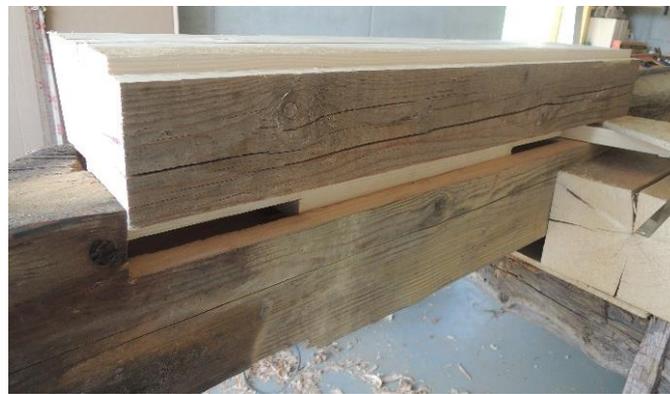
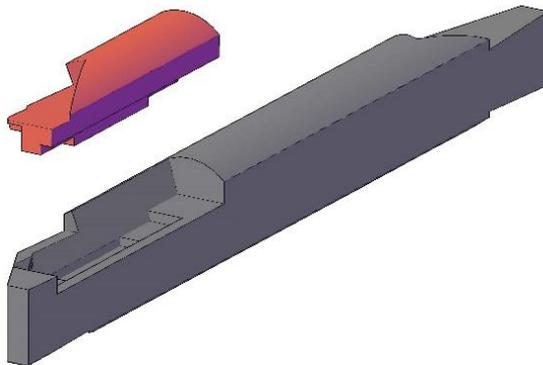
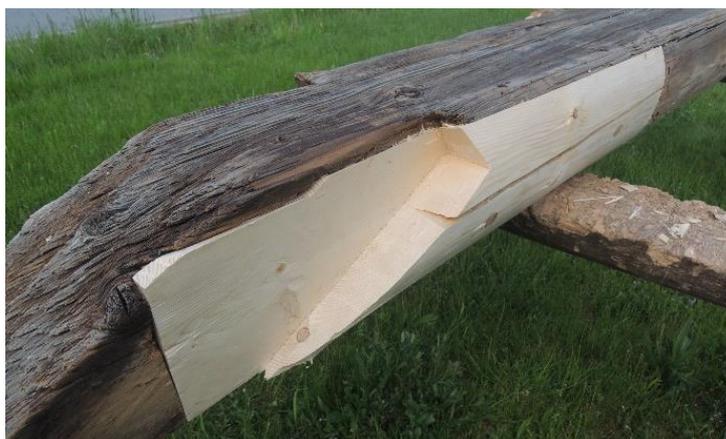
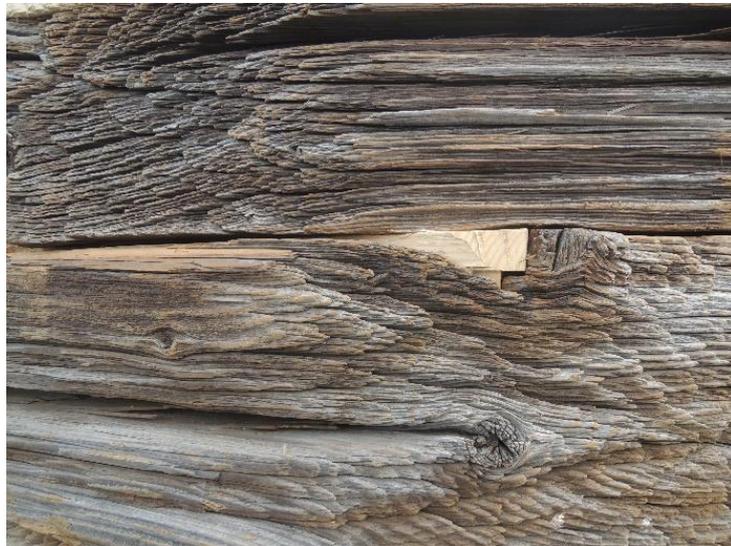
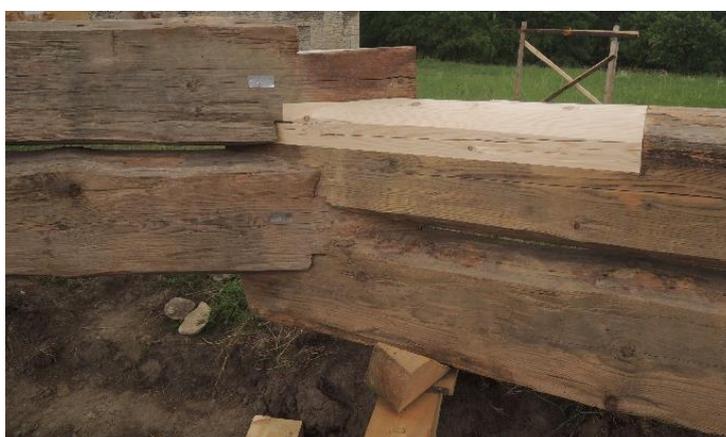
**Figure 26.** The repaired beam put back to its original place in the barn timber wall (outside view).

Figure 28. The gradual formation of the bed for the insert copying the damage area.

Figure 29. Formation of the insert and the gradual fitting.

Figure 30. A 3D model beam (I2) drawing of the structural repair of the damaged beam.

**Figure 31.** Dovetail joint of the damaged timber beam (I2) after the repair.

**Figure 32.** The repaired beam put back to its original place in the barn timber wall (inside view).

The insert filling the surface of the dovetail joint was shaped exactly by the longitudinal and transversal surfaces formed by the removal of the rot from the damaged part of the beam (Figure 30). The insert was fixed by oak pins. The following figures show the entire view of the repaired dovetail joint, finished with the insert fitted (Figure 31), the repaired beam put back in its place in the barn timber wall (Figure 32), including the detail of the outside view of the timber wall (Figure 32), manifesting the very sensitive structural solution.

The material for the production of the insert was selected so that the tree rings correspond with the orientation of the tree rings of the repaired beam (Figure 31). The material for the insert was naturally dried before use to a moisture content of less than 20%, thereby eliminating shape and dimensional deformations, which are undesirable after installation. The material for the structural repair was the originally used spruce of strength class C20. The rotten out space around the back of the insert (Figure 25) was left without structural repair. Before the insert was put in place, the rotten space was spread with clay mortar with the addition of lime, casein, and chopped wheat straw. The total time to repair the beam was 40 h of work.
