Architectural Characteristics and Determination Seismic Risk Priorities of Traditional Masonry Structures: A Case Study for Bitlis (Eastern Türkiye)

Citation: Arkan, E.; Işık, E.; Harirchian, E.; Topçubaşı, M.; Avcil, F. Architectural Characteristics and Determination Seismic Risk Priorities of Traditional Masonry Structures: A Case Study for Bitlis (Eastern Türkiye). *Buildings* **2023**, *13*, 1042. <https://doi.org/10.3390/buildings13041042>

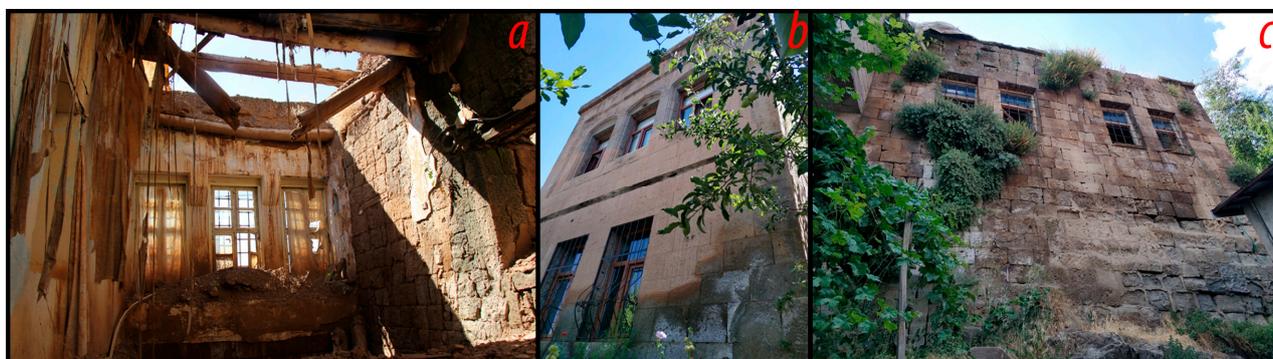
Bitlis City, in addition to being the province with the most snowfall in Türkiye, is located in a geography where temperature differences are high [42,43]. Snowfall generally starts in the first week of November and continues until the middle of the spring season. In the last week of April, the precipitation leaves its place to the melting process of the accumulated snow. The fact that the precipitation period is so long during the year increases the risk period in Bitlis [44]. Due to these reasons, various types of damage occur in Bitlis houses. In addition, various damages have occurred due to other environmental factors such as rupture and wear, depending on time. In these structures, which do not receive any engineering services, additional damages are observed due to precipitation, since no water isolation is applied to the ground. Water alone or together with other environmental factors negatively affects the mechanical properties of the building blocks and accelerates the degradation. It is known that due to temperature differences and frost events, some of the structures cause disintegration and rupture. Moisture-induced deterioration is observed in the sections of the stone texture that come into contact with water. The freeze–thaw cycle, which is effective in cold periods, is one of the most significant factors in the deterioration of structural materials, especially in Bitlis City, where the winter season is long. Depending on the seasons dominated by the dry climate, lichen formations attract attention. Lichen formations can have negative effects on the appearance and characteristics of the natural structure over time. There are calcifications in some of the structures examined due to excessive precipitation. It is observed that there are wear and mass losses in the wall joints. In addition, one of the common features of Bitlis stone is color change and discoloration with the impacts of natural conditions over time. Discoloration was observed in nearly all the examined structures. Since the soil properties are good in the examined structures, it has been observed that there is almost no ground consolidation over time.

In general, soil roofs are preferred in Bitlis masonry houses, which cause significant damage due to excessive snowfall. In some cases, depending on the degree of damage, structures become unusable over time. Damage to the structures due to roof leaks or collapses and the premature end of their useful life cause the homeowners to leave the buildings. Due to the official process for the repairs, it is not repaired and the house is in ruins over time. It is not possible to regain the houses that started to disappear over time because they are not used and maintained. Some images of the damage observed in the examined structures are shown in Figure 4.

Figure 4. Some of the observed damages to the structures: (a) Collapsed roof, (b) Moisture and lichen formation, (c) Surface loss, color change, vegetation.

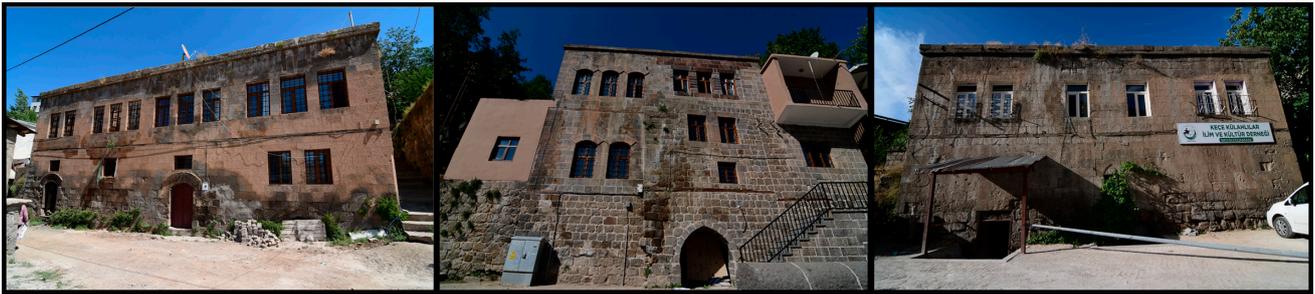
Figure 17. Some examined masonry structures.
