Reflections from the 2019 Durrës Earthquakes: An Earthquake Engineering Evaluation for Masonry Typologies

Abstract: Two earthquakes struck the NW region of Albanian territory on 21 September 2019 ($M_w = 5.6$) and on 26 November 2019 ($M_w = 6.4$). The epicenters of the seismic activity were located offshore NW Durrës, one of Albania's most populated cities, located 30 km from the capital Tirana. Various aftershocks followed subsequently. While there were no reported injuries, a number of buildings sustained significant damage near the epicenter following the initial event. Subsequently, during the second event, there was loss of life and extensive damage to civilian structures, resulting in multiple collapses. This study focuses on the earthquake damages observed in residential and public buildings in the earthquake-affected region. The earthquakes predominantly affected low-rise masonry buildings, while the newly constructed RC structures built according to the latest seismic rules were almost unaffected. The commonly encountered building typologies in the region, together with photos showing the amount of destruction are presented here. As observed by the authors during the rec

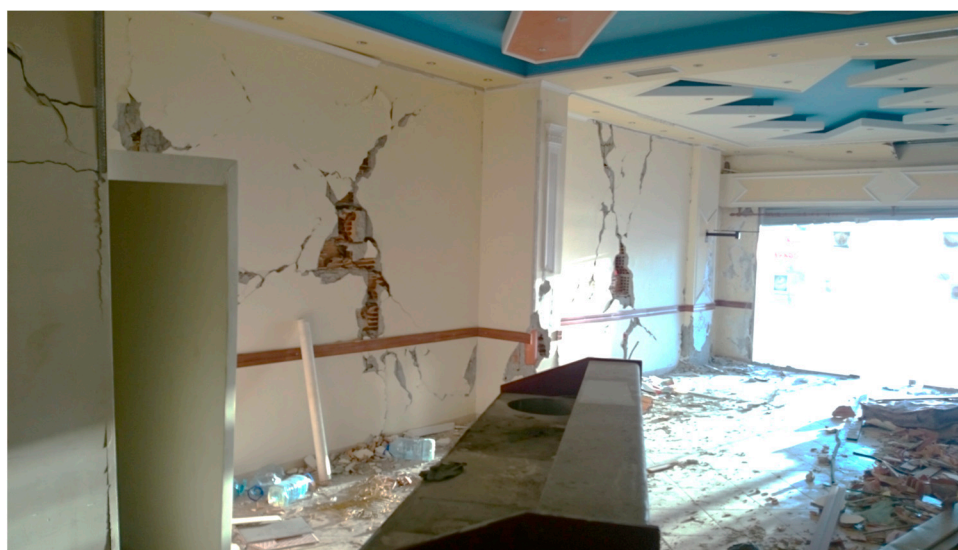
Figure 4. Infill wall damage in an RC building due to out-of-plane bending and shear failure.

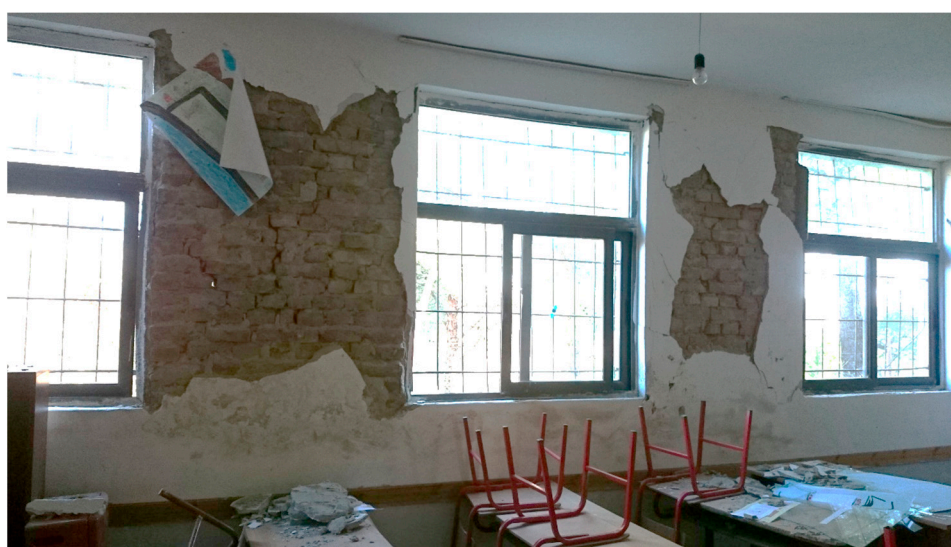
Figure 5 illustrates an instance of in-plane shear failure observed in a poorly confined masonry wall at a primary school in Durrës. The cracking observed in the masonry exhibits a characteristic diagonal shear crack pattern that follows a zigzag path.

Figure 5. In-plane shear failure of inadequately confined masonry wall due to windows opening.

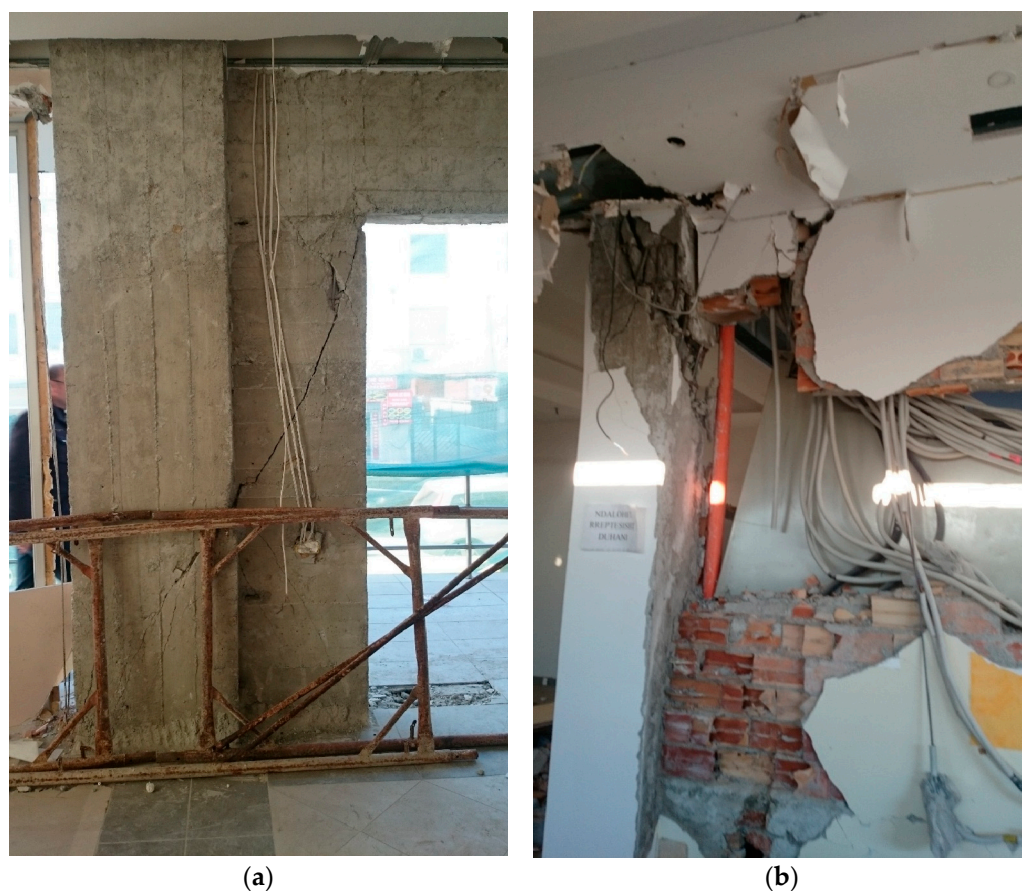
Although a significant part of RC buildings experienced merely non-structural damage, there were instances of severe damage, as shown in Figures 6 and 7. The severe damage to RC buildings was primarily concentrated on soft-story ground floors. These buildings were predominantly designed and constructed before 2000. Due to the absence of shear reinforcement and reduced stiffness resulting from open ground floors, shear failures occurred in columns and beam-to-column joints. The lack of adequate shear reinforcement and the structural characteristics of open ground floors contributed to such failure patterns.

Figure 6. Shear failure of columns on RC buildings in Durrës. (a) Typical shear failure of columns; (b) Buckling of rebars in plastic hinge regions of columns due to insufficient transverse reinforcement.

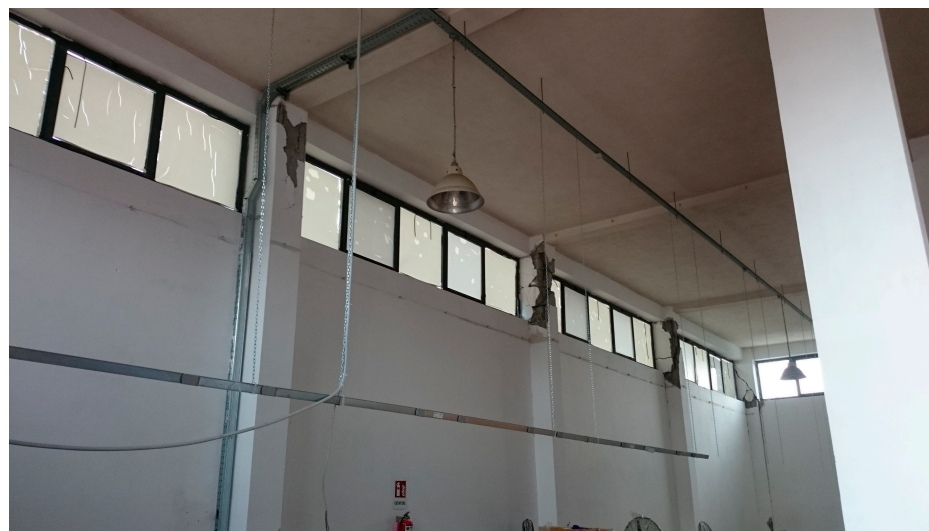
Figure 7. Short column failures due to bad window openings.

Insufficient horizontal reinforcement, such as stirrups, led to the buckling of longitudinal rebars in the columns (as shown in Figure 7). While the strong beams remained relatively unaffected, severe damage and the formation of plastic hinges were observed at the top of the columns. This highlights the importance of proper horizontal reinforcement to ensure the structural integrity and performance of columns during seismic events.

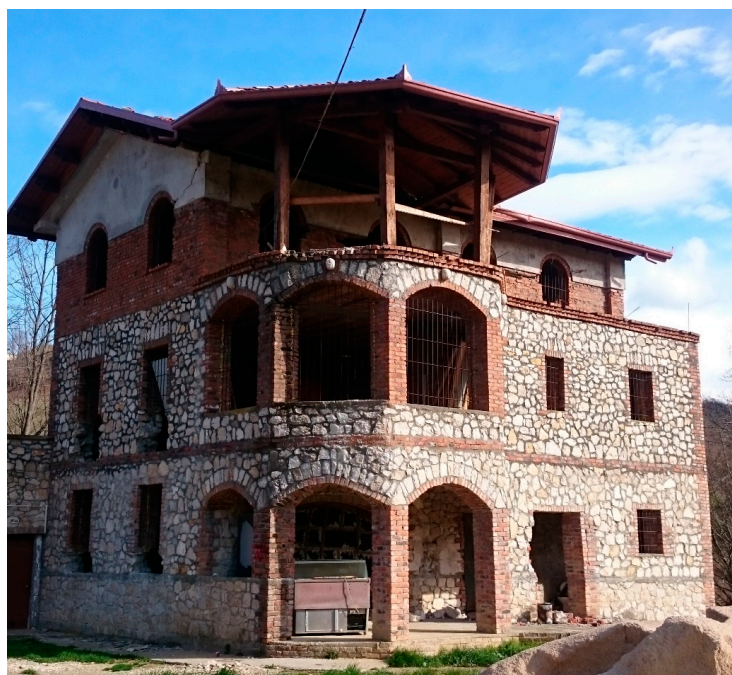
Residential masonry buildings in the country have experienced significant damage (Figure 10). The extent of damage fluctuates between different buildings as well as across

Figure 10. Masonry dwelling with large openings and wooden lintels above openings in Vore. The 1st and 2nd floors are constructed of stone brick while the 3rd story is built of clay bricks.

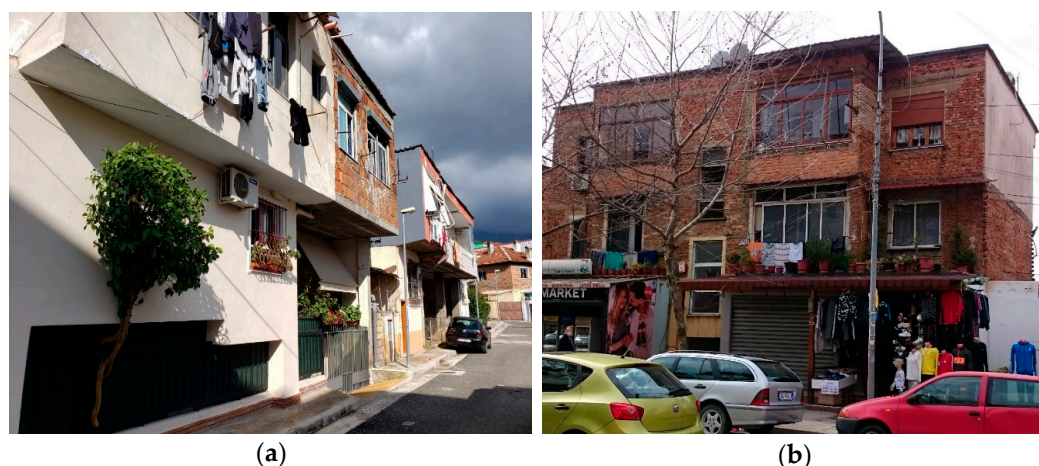
The survey identified several significant deficiencies in these buildings, primarily related to unauthorized interventions and modifications carried out by owners without proper engineering consultation. These interventions included closure and creation of new openings, the use of unique types of masonry for repairs, and the addition of extra stories [28]. Examples of these irregularities are shown in Figure 11a,b. Such alterations, combined with a lack of preservation, degradation of material properties over time [29], and changes in load paths [30,31], can contribute to damage and deterioration, ultimately increasing the structures' seismic vulnerability throughout their lifespan.

Figure 11. Intervention examples on URM buildings: (a) expanded overhangs as balconies and use of different construction materials; (b) Interventions done after its construction on the ground floor (New openings).

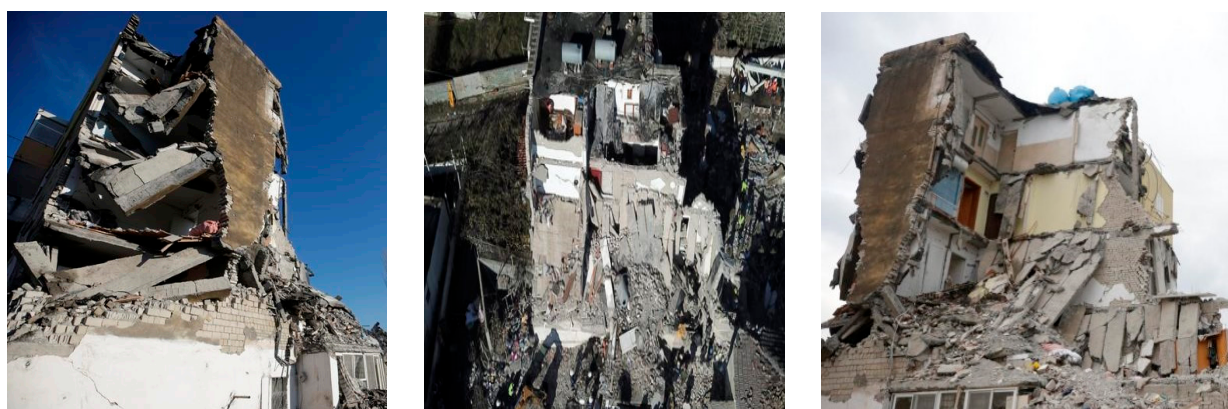
Although buildings constructed with fired bricks and reinforced concrete (RC) slabs generally demonstrated good performance, there were reported instances of structural failures in Thumanë town. In Thumanë town, three unreinforced masonry (URM) buildings, comprising one 3-story and two 5-story structures, constructed with solid silicate bricks and hollow core prefabricated concrete slabs, experienced collapse, as depicted in Figure 12. The structural failure of these buildings was ascribed to the insufficient mechanical attributes of the silicate bricks and the lack of proper connections between the prefabricated concrete slabs and the load-bearing walls. These deficiencies led to overturning failures, ultimately resulting in the structural collapse of the buildings.

Figure 12. Collapsed building in Thumanë (1- added story before the collapse).

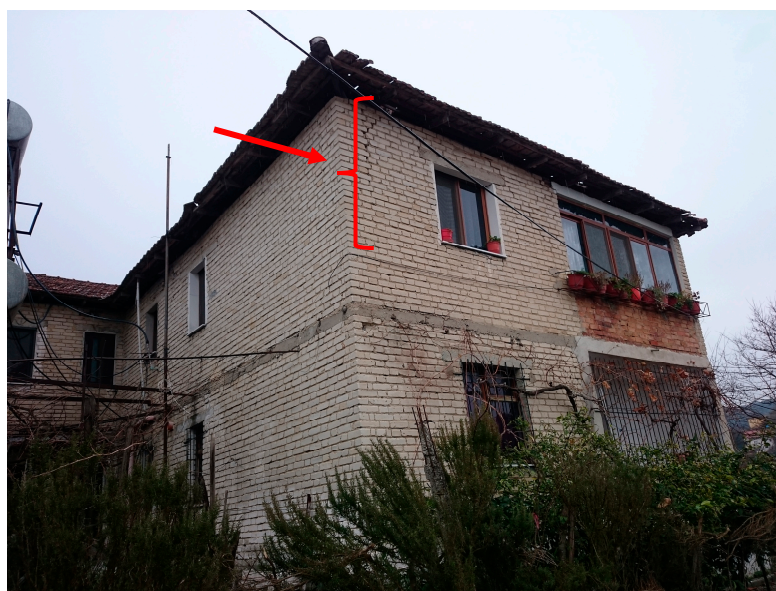
The lack of essential structural elements further contributed to the vulnerability of buildings in the country [32]. Most buildings did not have a ring beam below the roof, which is an important element for distributing seismic forces and providing stability to the structure. Furthermore, the lack of rigid in-plane diaphragms at the floor and roof levels further compromised the overall structural integrity of the buildings. Figure 13 depicts buildings with loosely connected walls and the absence of a sturdy top floor or reinforced concrete (RC) ring beam. The weak connection between the walls and the roof, coupled with the poor quality of stone arrangement and weak mortar, significantly heightened the risk of collapse during the earthquake.

Figure 13. Separation of walls because of improper connection between the roof and the underlying masonry and flexible top floor.

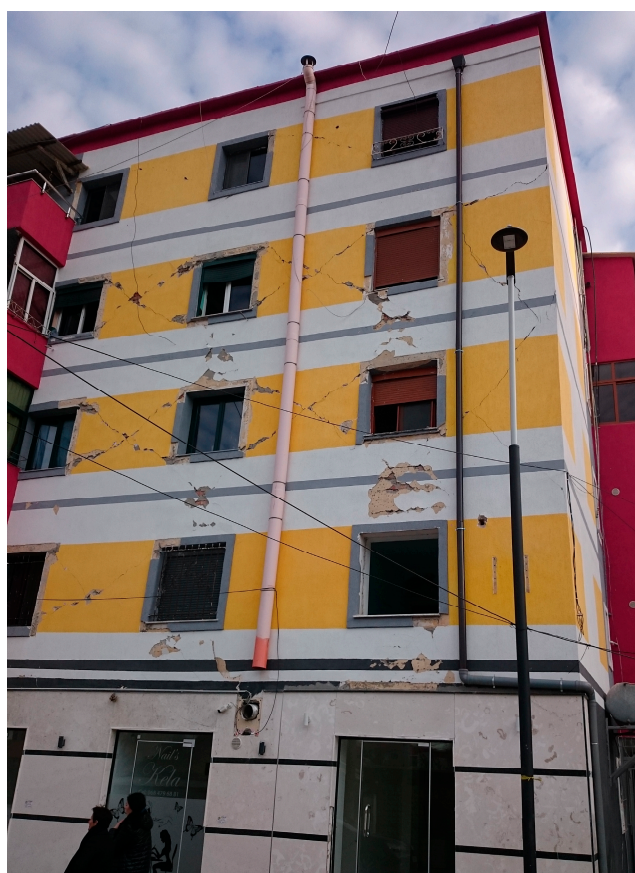
A significant number of masonry buildings in the region displayed damage to walls in the form of double-diagonal shear (X) cracking. This type of cracking is a typical vulnerability observed in unreinforced masonry walls subjected to shear forces. When a complete diagonal shear crack develops during an earthquake, the triangular sections created by the cross-diagonal crack become unstable and pose a risk of collapse, particularly when subjected to subsequent aftershocks.

Figure 14 provides typical patterns of diagonal shear failures observed in load-bearing walls as a result of the earthquake in Albania. These cracks highlight the vulnerability of unreinforced masonry walls to shear forces and emphasize the need for appropriate seismic design and reinforcement measures to improve their resistance to such failures.

Figure 14. Shear cracks stemming from diagonal tension in residential masonry buildings in Albania.

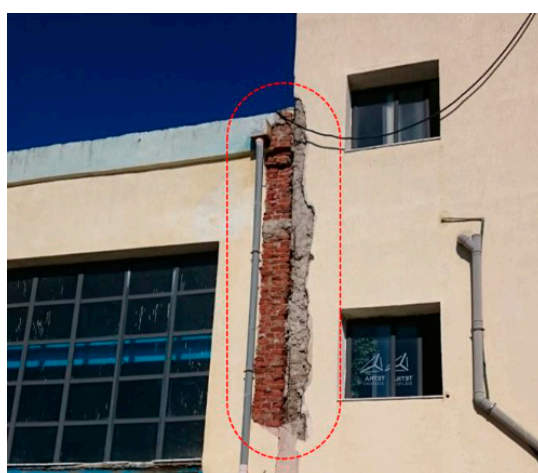
Figure 15 depicts an example of pounding, which refers to the collision or impact between adjacent buildings during an earthquake. In this case, the reinforced concrete (RC) building slab is seen to have penetrated the masonry wall of the adjacent building at the corner where the wall meets the roof.

Figure 15. Pounding failure b/w adjacent masonry and RC buildings.

Pounding can occur when there is insufficient separation distance between buildings or when the buildings have different dynamic characteristics during the earthquake. As a result of pounding, significant damage can be inflicted on the structures involved, as seen in the image. The impact of the RC building slab on the masonry wall at the wall-to-roof connection caused damage to both the slab and the masonry. This type of interaction

This earthquake led to minor damages in several buildings attributed to pounding, a phenomenon stemming from inadequately sized or absent seismic gaps, alongside variations in story heights. The structure depicted in Figure 15 encountered damage from pounding, primarily resulting from its proximity to an adjacent masonry building and an inadequate seismic gap.

between different building materials can lead to structural failures, compromise the stability of the affected buildings, and increase the overall damage caused by the earthquake. To mitigate the risk of pounding, it is important to consider appropriate separation distances between buildings, incorporate appropriate structural details to accommodate differential movements, and employ suitable design measures to ensure the integrity of the building envelope during seismic events.

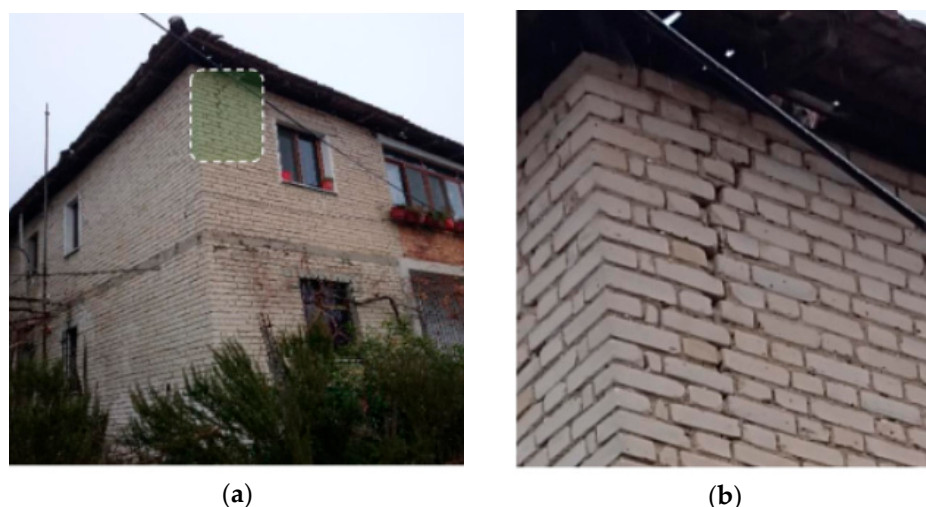
Figure 16a,b showcase significant vertical cracks and gaps that have developed and spread along the height of the intersections of bearing walls. This particular type of damage can be attributed to the absence of horizontal diaphragms. Horizontal diaphragms are structural components that provide rigidity and distribute forces within a building. Without these diaphragms, the building's ability to withstand and distribute seismic forces is compromised, leading to the formation of such vertical cracks and gaps.

The lack of proper connections between the load-bearing walls at the intersections and between the load-bearing walls and the roof leads to compromised structural stability. Consequently, the walls act individually along the in-plane and out-of-plane directions during the earthquake, as indicated by the absence of diagonal shear cracks. The vertical cracks and gaps indicate significant distress and compromised load-bearing capacity in the masonry walls. This type of damage can lead to instability, reduced structural strength, and potential collapse if the load-bearing capacity is further compromised. To enhance the seismic performance of masonry buildings, it is crucial to incorporate effective horizontal diaphragms that can distribute forces and provide structural continuity. Proper design and construction of connections between bearing

Figure 16. Vertical cracks on corners of the building indicates the lack of rigid diaphragm action of the roof and floor systems. (a) Loosely connected walls; (b) Absence of a sturdy toop roof or lack of RC ring beam.

walls and diaphragms are essential to ensure the effective transfer of forces and maintain the structural stability of the building during earthquakes.

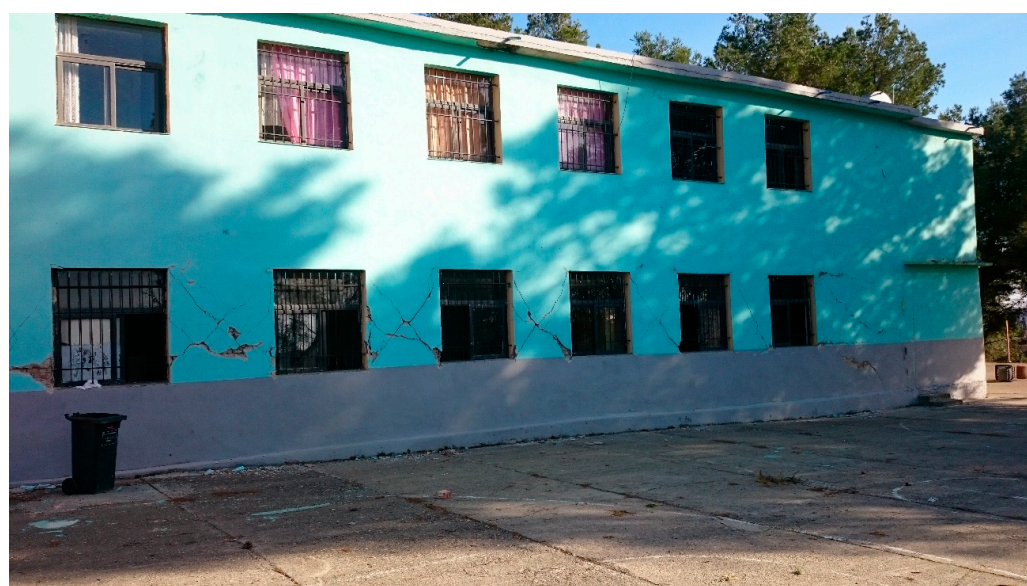
Figure 17 depicts the extent of damage in a school building located in the NW Durrës. Fortunately, all students and teachers were unharmed, as the collapse of some local masonry walls did not result in casualties since the earthquake hit in the early morning. The damage in the school building includes localized out-of-plane failures of the load-bearing walls and diagonal shear cracks between the window openings on the ground floor (Figure 18).

Figure 17. The extent of damage on a school building.

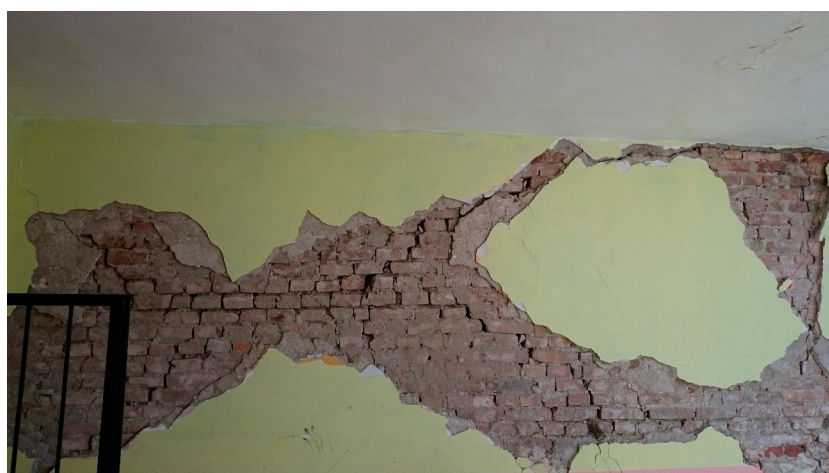
Figure 18. Showing shear cracks and in-plane failure of the masonry walls.

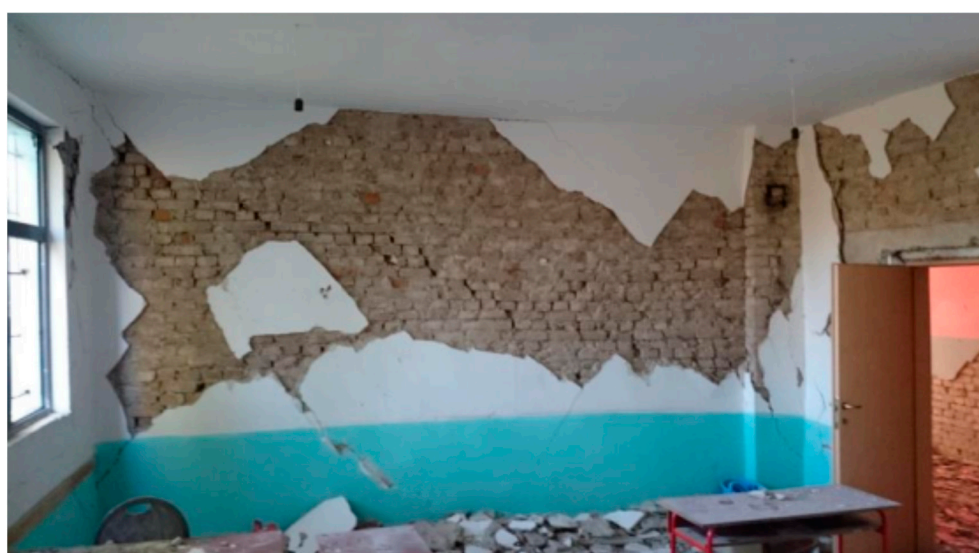
Significantly, the school's front facade experienced more damage than the backside. This discrepancy can be attributed to the higher concentration of openings at the front, where the classrooms were situated, in contrast to the back side, which primarily consisted of a corridor leading to the classrooms. Upon inspection inside the building, prominent diagonal shear failures were observed in the masonry walls, along with the separation of coating materials from the walls and the toppling of furniture and equipment (Figure 19). The overall structural condition of the building was deemed unsuitable, leading to its demolition a few weeks after the initial strong earthquake. These observations highlight the vulnerability of masonry school buildings in Albania and emphasize the importance of implementing proper seismic design and retrofitting measures to ensure the safety of students and staff during earthquakes.

Figure 19. Damage pattern observed on load-bearing wall of the masonry school building.
