Preliminary Geospatial and In Situ Reconnaissance of the 8 September 2023 Moroccan Atlas Earthquake Damage

Abstract: This research investigates the post-earthquake performances of structures in four rural villages in the Moroccan Atlas, emphasizing common construction system characteristics and design flaws that render buildings susceptible to seismic events. Village selection was based on a prior multispectral satellite-image study, proving effective for planning high-impact, post-earthquake field campaigns. The significance of this research resides in on-site data collection, facilitating the physical assessment of earthquake-induced damage and identification of inherent vulnerabilities in construction systems. The constructions in the study area exhibited structural design deficiencies, inadequate construction techniques, and urban modifiers, leading to damage extensively documented in the literature, as well as less-documented unique damage. Predominant seismic-design shortcomings in the study area included subpar material quality, insufficient earthquake-resistant design, and unskilled labor. In situ data were complemented by a global geospatial approach using differential sy

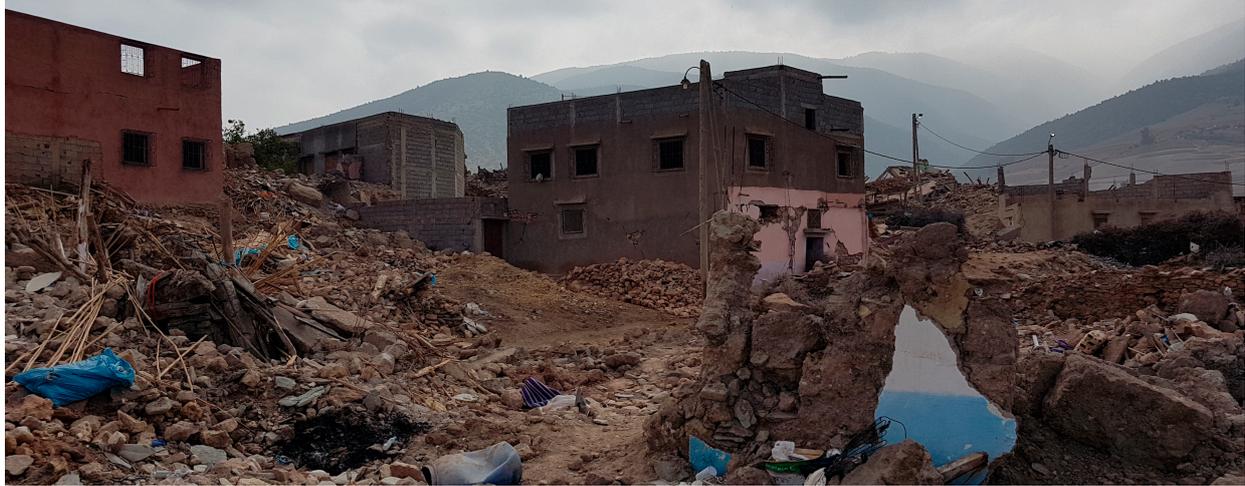
In accordance with the EMS manual [31], the structures in Tafeghaghte, primarily composed of stone masonry with non-anchored one-way wooden floorings, are categorized as Class A vulnerability. Most of these buildings had collapsed (grade 5), whereas confined masonry constructions suffered less damage (grade 2 to 4), suggesting an intensity of approximately IX in this area (Figure 7). In contrast, in the analyzed area of Talat N'Yaaqoub there were numerous constructions with confined masonry walls made of concrete blocks with beam and block floorings, classified as Class C vulnerability [31]. A less-vulnerable construction system recommended by Moroccan seismic regulations and other guidelines

Figure 7. Evaluation of damage along a street in Tafeghaghte subsequent to the 8 September 2023 earthquake. Stone masonry structures have predominantly collapsed, while confined masonry systems or confined mixed systems mostly display damage ranging from grade 2 to 4 [31].

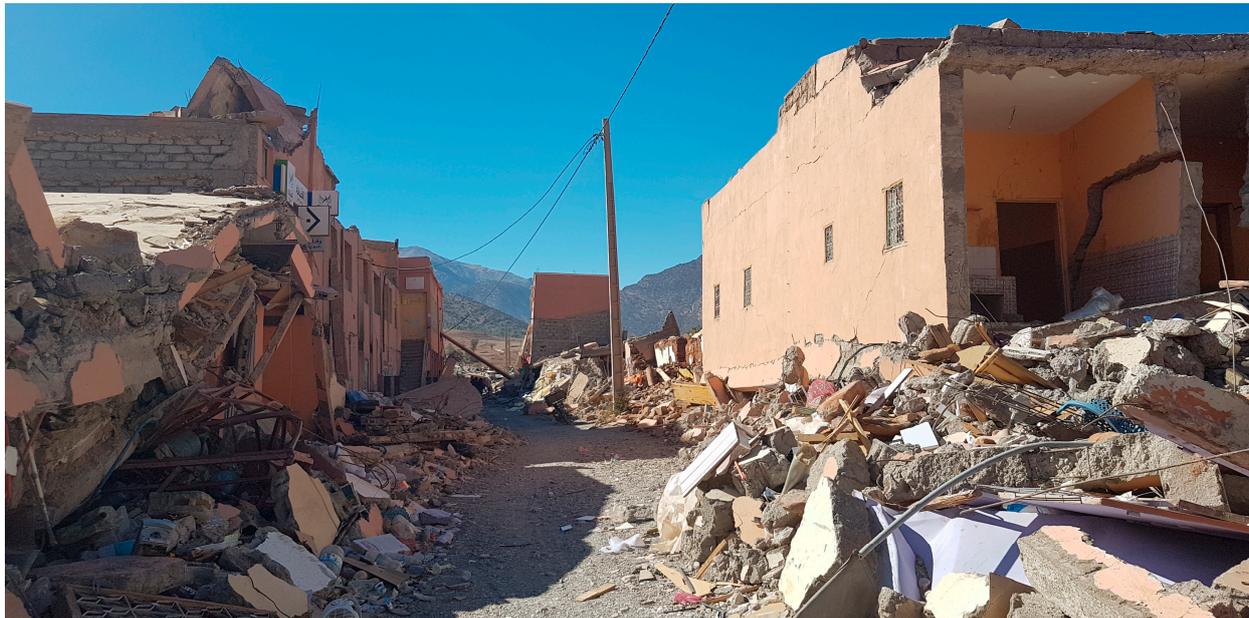
in regions with high seismic-threat [13,32] suffered damage ranging from Grade 3 to 5 in many buildings. The macroseismic intensity in this zone is estimated to fall within Grade X, according to the damage observed to the constructions (Figure 8).

Figure 8. Assessment of damage in a street of Talat N'Yaaqoub following the 8 September 2023 earthquake. Confined masonry structures exhibit extensive destruction, with buildings suffering grade 3 or higher damage, and numerous collapses recorded at grade 5 [31].

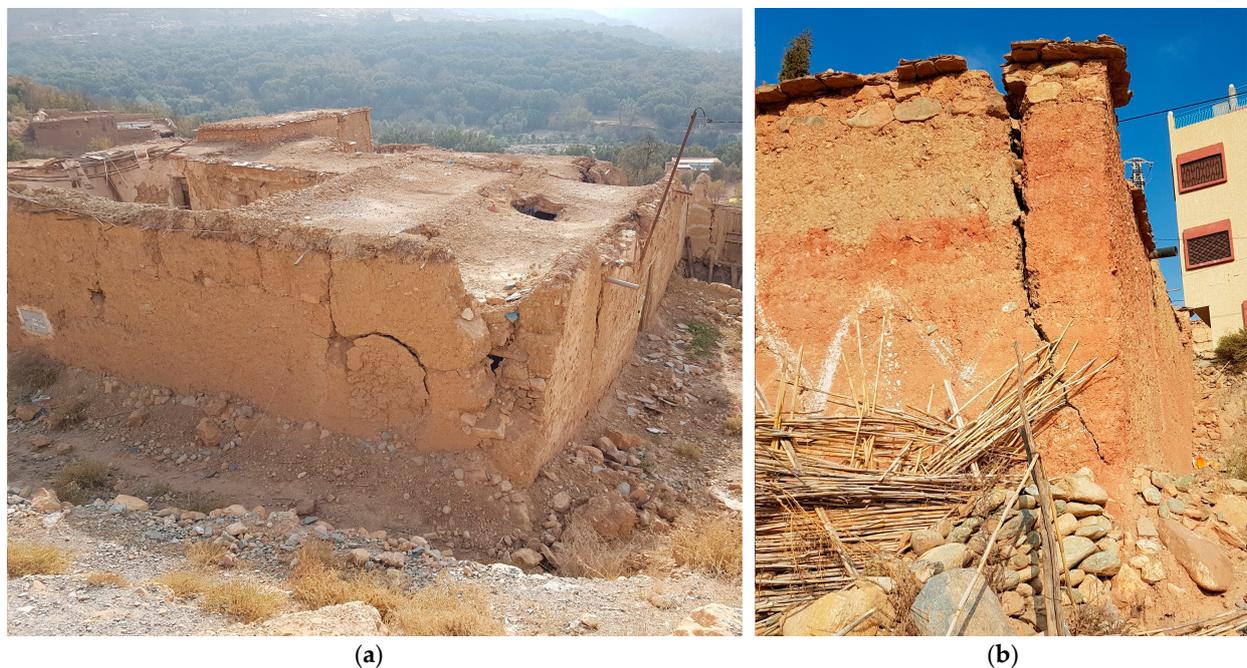
Figure 10. Out-of-plane failure of an exterior wall on a rammed-earth building with a floor constructed from wood, straw, and mud. These images highlight insufficient connectivity observed between the perpendicular walls and the floor diaphragms. Image (a) displays damage to the corner and a portion of the parapet and image (b) illustrates an out-of-plane failure of a wall. The buildings were situated in the central area of Adassil.

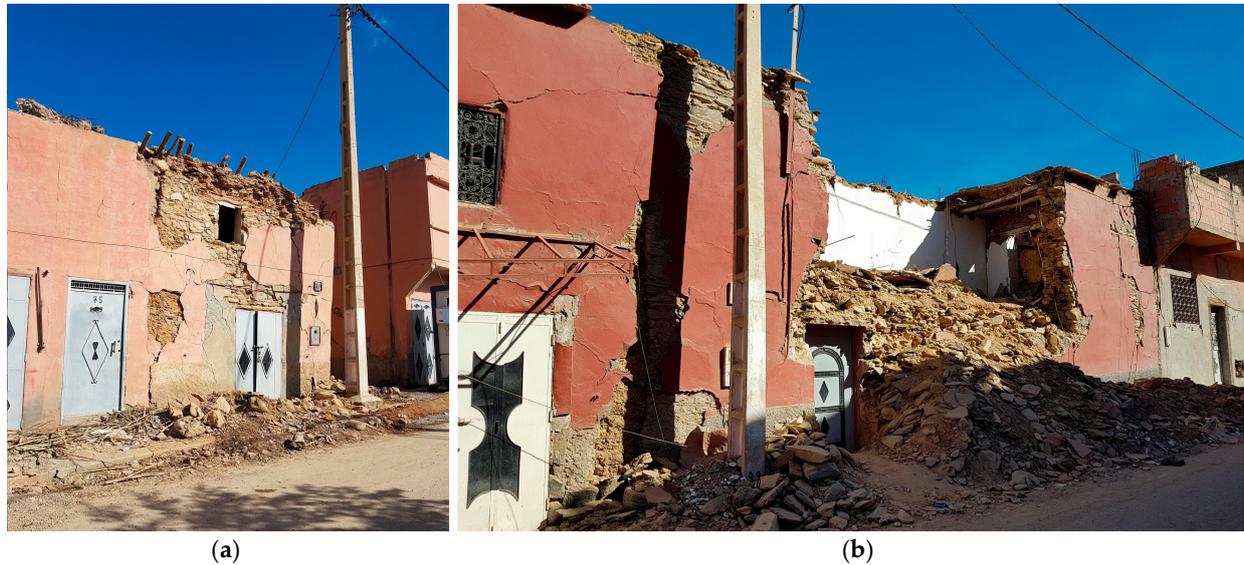
Figure 11. Impact of the 8 September 2023 earthquake on a stone masonry building with wooden log slab in Amizmiz. Image (a) illustrates the inward collapse of the roof, attributed to inadequate support, leading to the subsequent collapse of the upper part of the wall. Image (b) shows the crumbling of the walls.

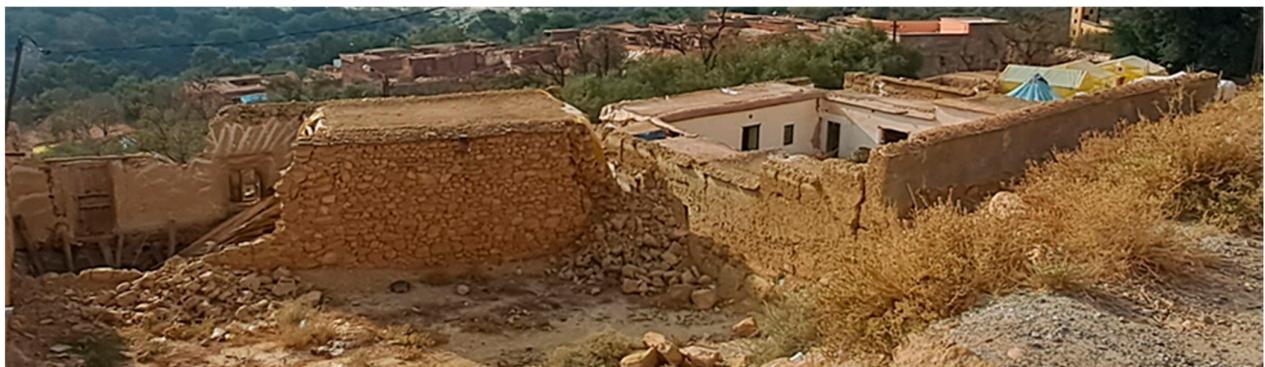
Figure 12. Impact of the 8 September 2023 earthquake on a traditional building in Adassil with a floor made of wood, straw, and mud. The observed damage includes the disintegration of sections of the stone masonry walls of the house and failure characterized by perpendicular bending at the corners of the rammed-earth dwelling.

The most prevalent failure mode identified in traditional structures was the partial or complete overturning of walls out-of-plane, as depicted in Figure 12. This failure pattern is commonly associated with inadequate connections between perpendicular walls or floors [35,36]. In stone masonry, such failure is frequently witnessed in instances of wall collapse caused by weak mud mortar, inadequately integrated multi-leaf stone wall construction, and insufficiently supported floors [37].

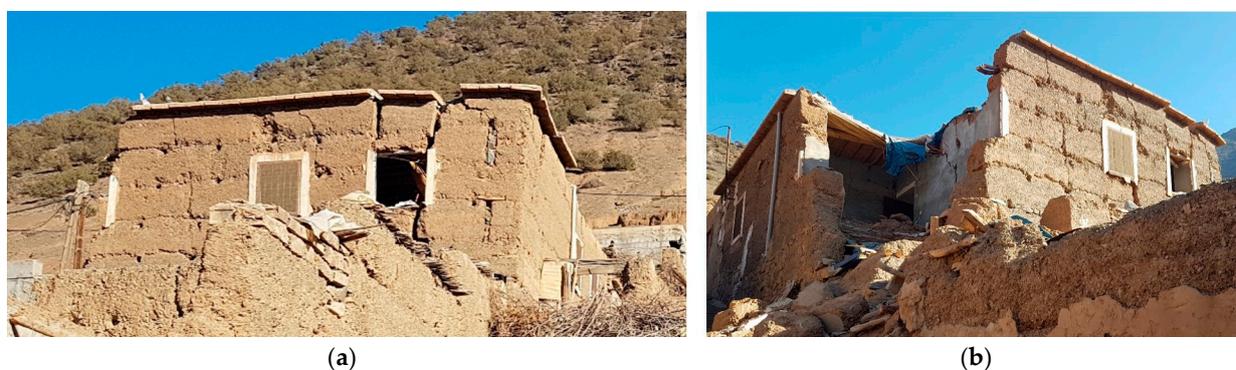
Figure 13. Damage assessment of a traditional rammed-earth building depicting various stages of damage. The corner failure is exacerbated by the presence of window openings. (a) Partial corner failure, (b) Total corner failure.

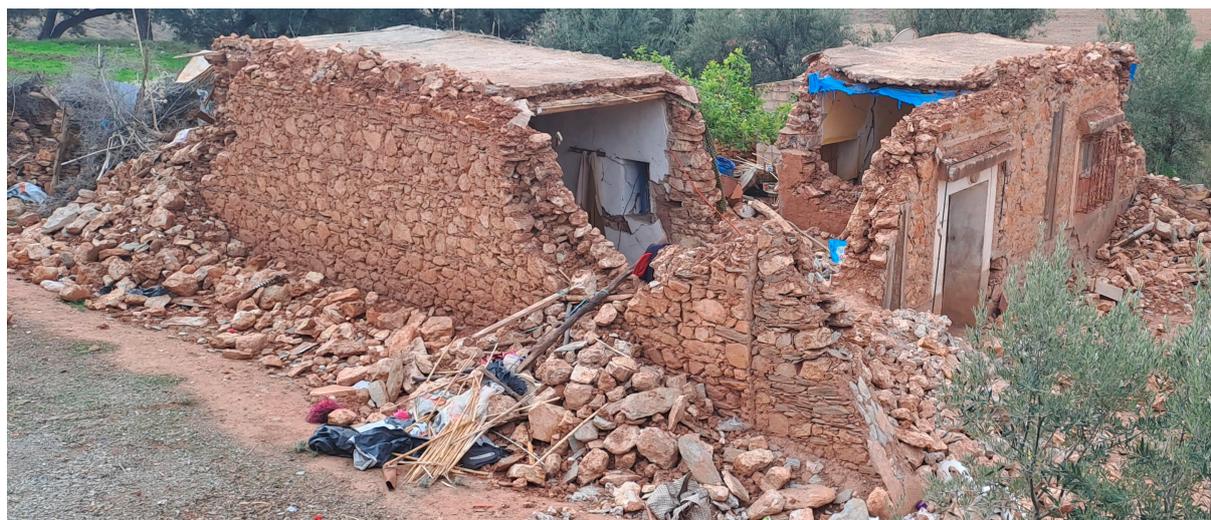
Figure 14. Damage observed in an L-shaped masonry residential structure. The damage at the corner is evident, attributed to concentration of stress in this specific area. Residential dwelling in the vicinity of Tafeghaghate.

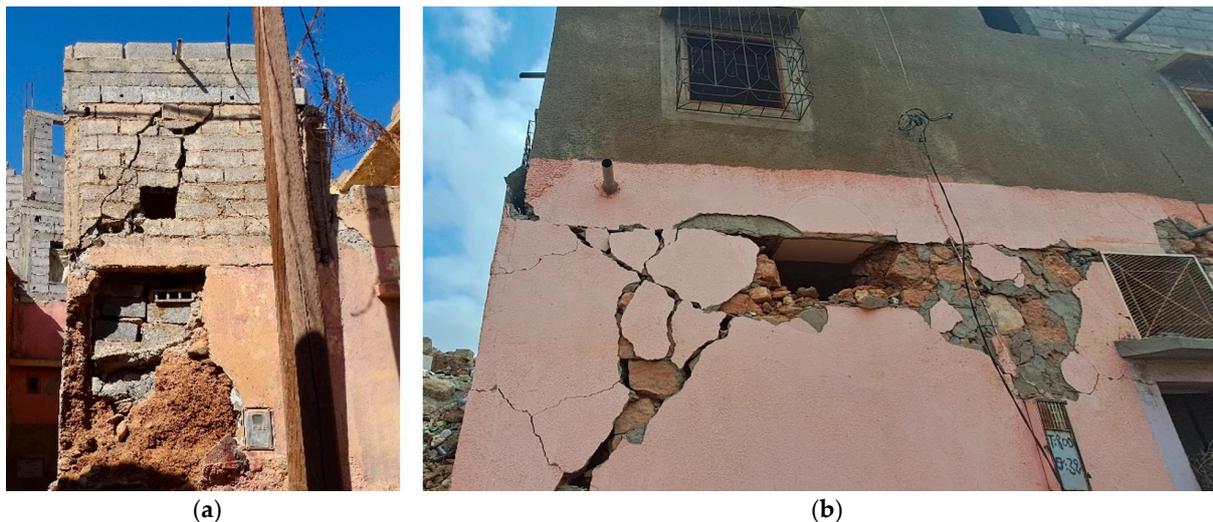
Figure 15. Traditional ground-floor buildings with upper floors constructed using reinforced masonry. Image (a) shows evident inadequate connections between traditional and modern construction elements. Image (b) illustrates the lack of connection, combined with varying stiffness among the floors, resulting in the manifestation of horizontal cracks. Location: Amizmiz and Tafeghaghat.

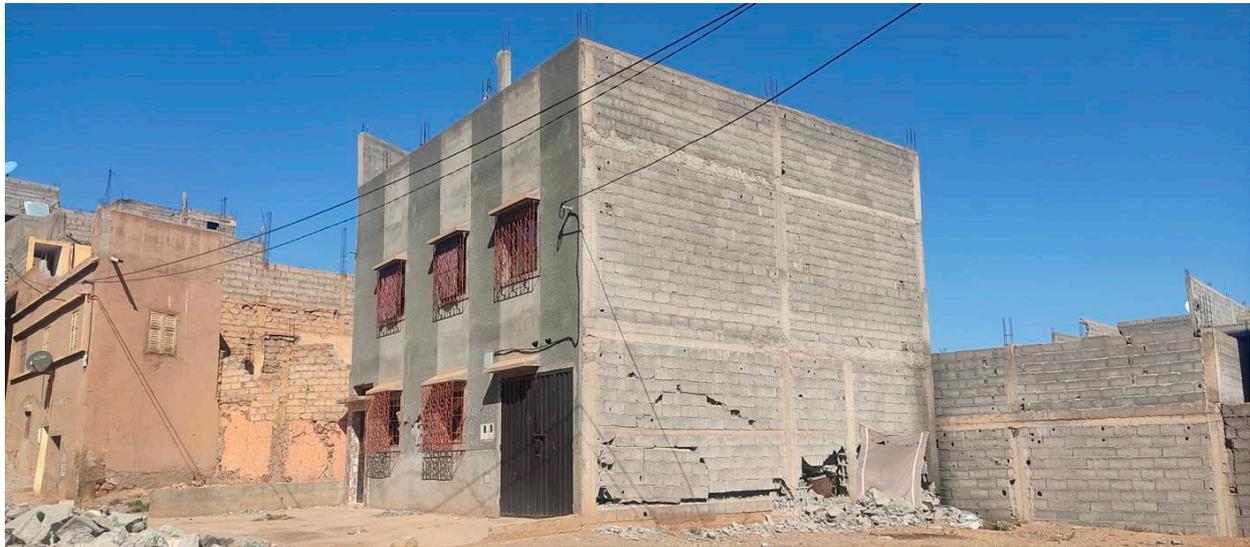
Figure 16. Several buildings with starter bars at the top of columns to facilitate the anchorage of RC elements of future upper stories (Amizmiz).

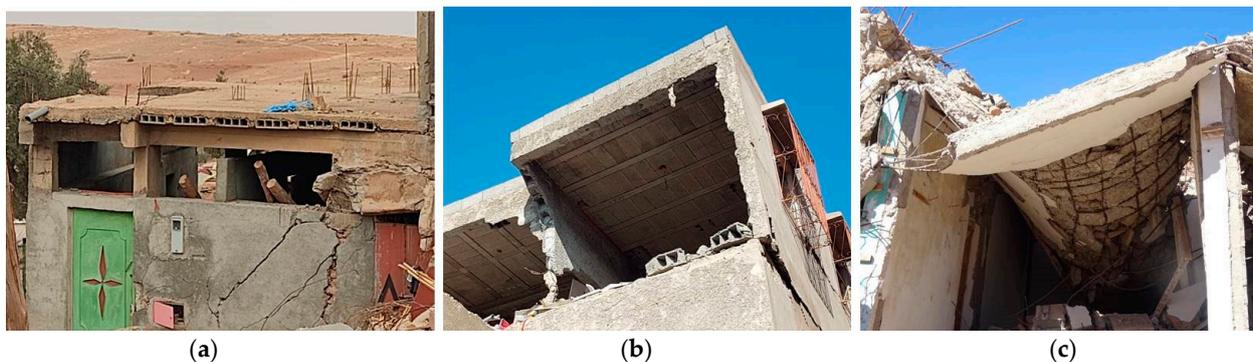
Figure 17. Several buildings with starter bars at the top of columns to facilitate the anchorage of RC elements of future upper stories. (a) Tafeghaghte, (b) Amizmiz, (c) Talat N'Yaquod.

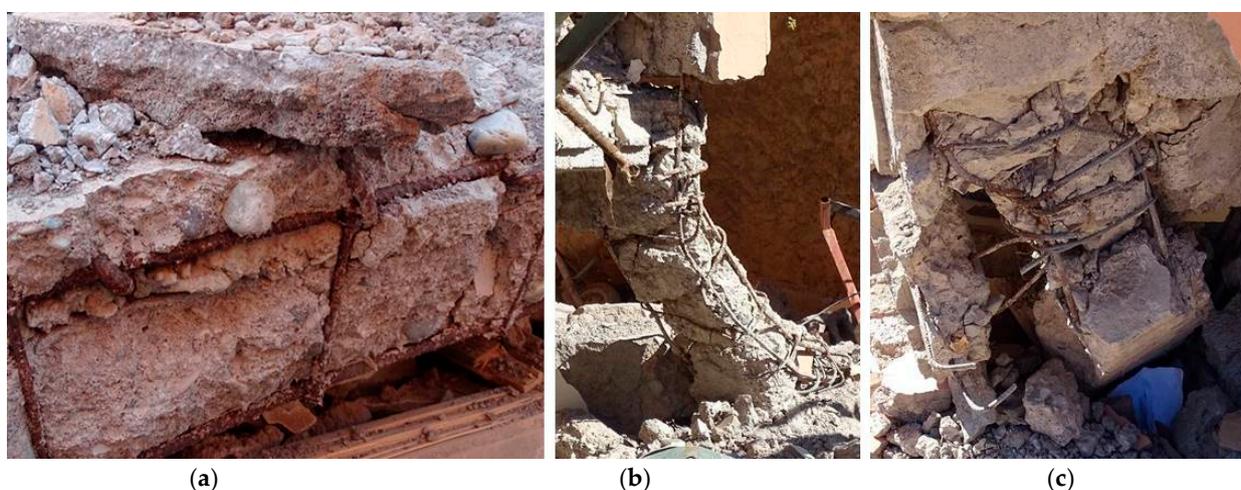
Figure 18. Low-quality reinforced concrete due to visible porosity and cavity/holes, discontinuous granulometry, and the employment of large rounded aggregates in structural elements pertaining to different buildings (Talat N'Yaquod) (a–c).

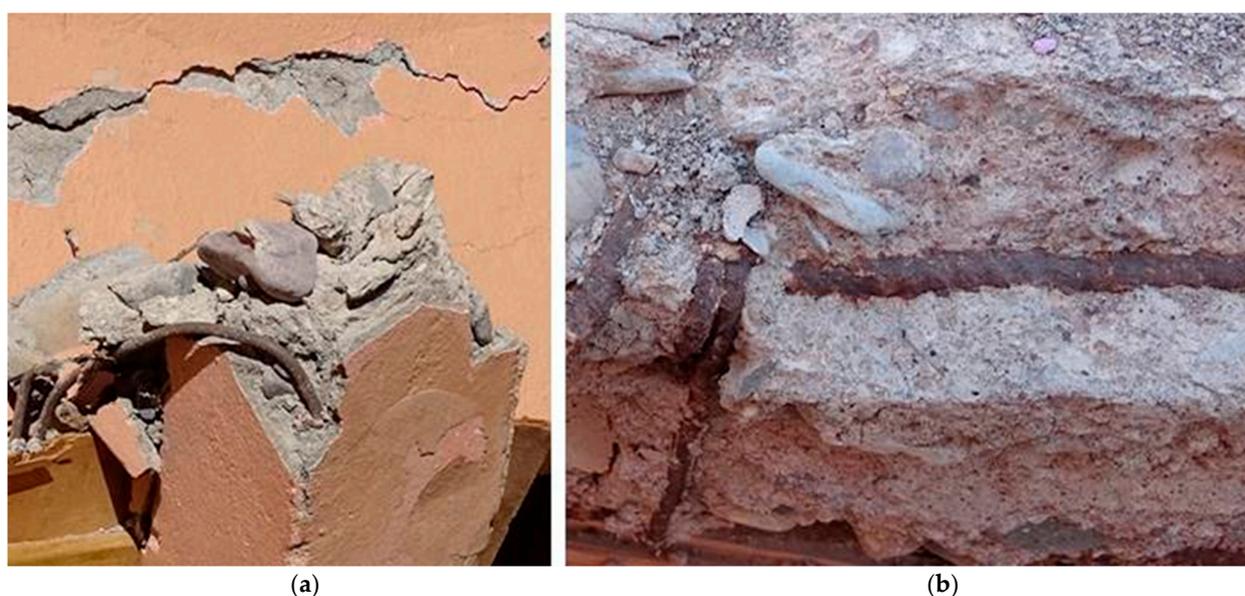
Figure 19. Deficiencies in steel bar reinforcement in concrete elements: (a) smooth bars; (b) presence of corrosion and minimal transversal ribs in longitudinal reinforcement (Talat N'Yaquod).

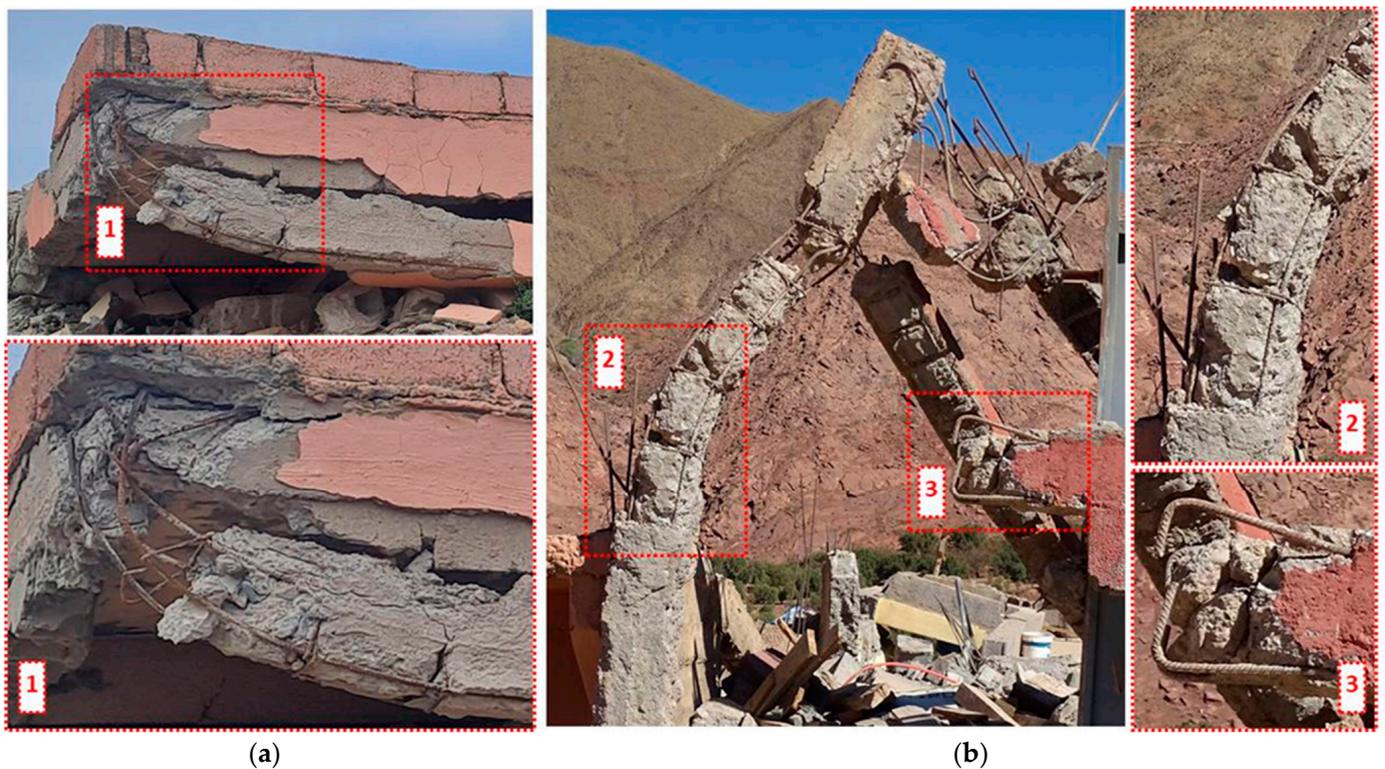
Furthermore, the dimensions of the transversal sections of the columns and the steel stirrups were identified as being insufficient for both confined-masonry and RC frame constructions, given the damage observed, such as fragile failure (Figure 20). Additionally, the abovementioned dimensions were below those established in the RPS 2000 version 2011, which in turn are below those established in the EC8 and ACI-318 codes. Specifically, the steel stirrups were not only insufficient in number and sometimes inexistent, but also excessively distanced (Figure 20, details 1 and 2), in several cases exceeding 25 cm. In addition, widespread use of stirrups with hooks at 90° at their ends and reduced development length was detected, resulting in these elements opening more easily under the earthquake load. In this regard, reference regulations for RC with special requirements for seismic zones, such as ACI 318 [42], state that the hooks should have an angle of 135° and that the minimum length should be six times the diameter of the bar and longer than 75 mm (Figure 20, detail 1). Similarly, it was observed that overlapping of the longitudinal steel bar reinforcements was frequently carried out in areas of greatest demand, for example, near the beam–column joints. Moreover, it was found that the development length of the longitudinal steel reinforcement was insufficient at the junction of beams with end columns (Figure 20, detail 3).

Figure 20. Deficiencies in RC elements that lead to low-ductility sections and fragile failure. Details 1 and 2: fragile failure in the support at the floor–support–system joint due to low-quality concrete, excessive distance between steel stirrups at a critical point, and non-earthquake-proof hooks ($<135^\circ$ or length less than 6ϕ or 75 mm) in the joint. Detail 3: short development length and deficient anchoring of steel for longitudinal reinforcement of the beam where it connects with the column. (a) Amizmiz; (b) Talat N'Yaquod.

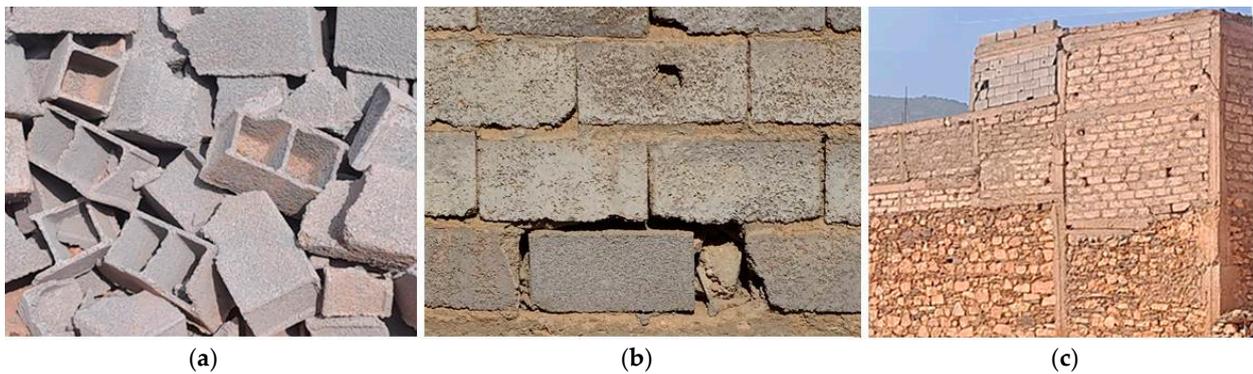
Figure 21. (a) Cement–mortar blocks (Tafeghaghte). (b) Bed joints (Amizmiz). (c) Different types of masonry of highly dissimilar quality in the same wall (Tafeghaghte).

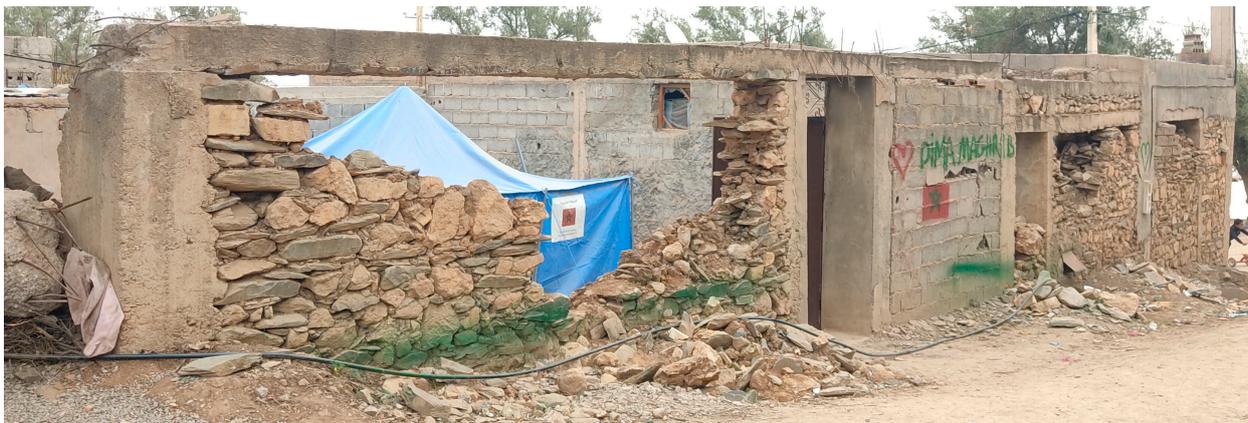
Figure 22. Comparison of damage for different infill materials in the same wall (Tafeghaghte).

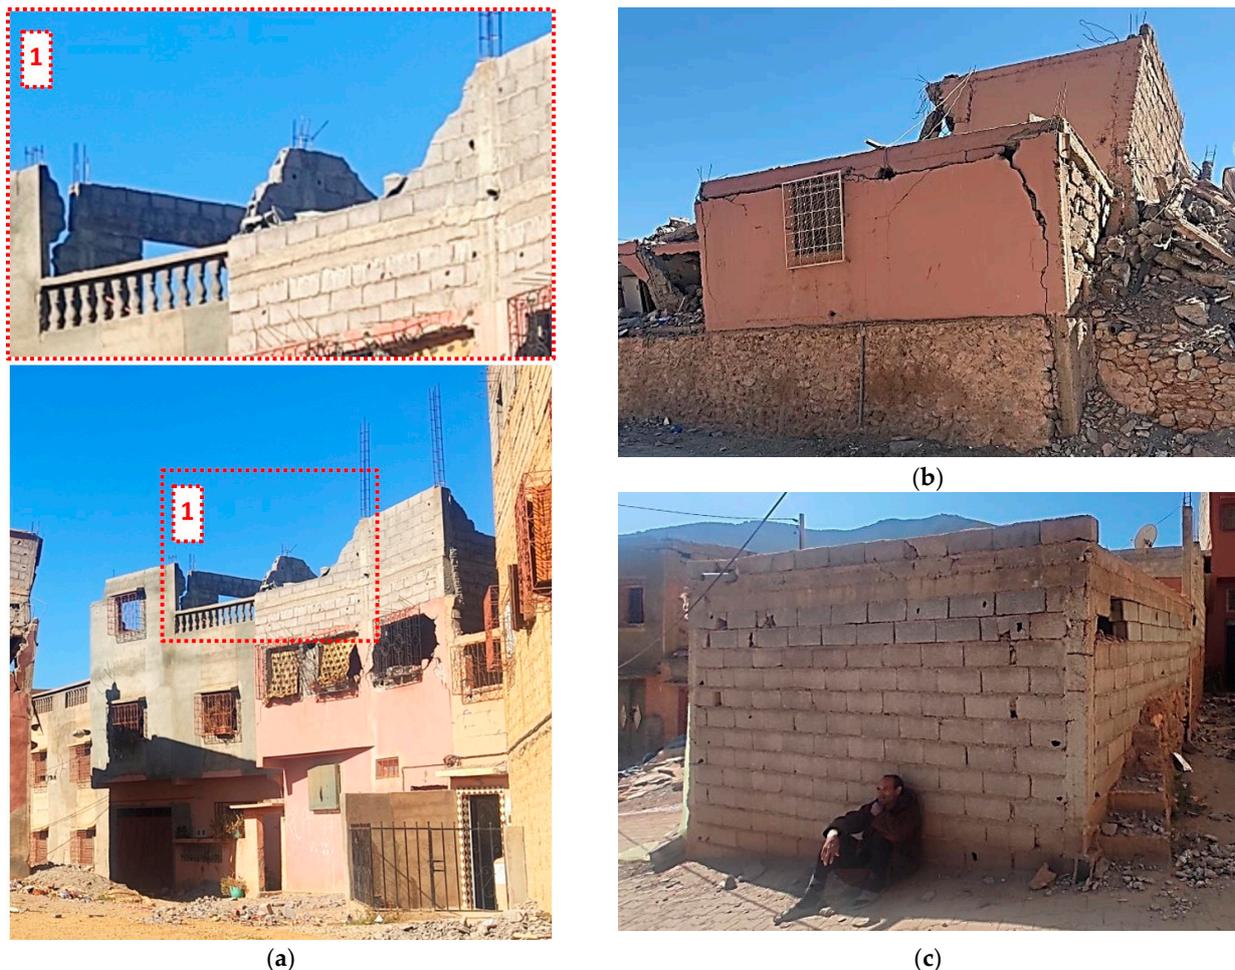
Similarly, low-quality connections between vertical elements and low-quality materials were identified as factors causing out-of-plane failure of walls (Figure 23). Mention should be given to cases of some buildings combining RC frames and masonry walls presenting out-of-plane failure of infill walls. This occurred either due to inefficient connection (Figure 23c) or inadequate sequencing during the execution of the different components: reinforced concrete beams and columns were erected before the block walls, leading to poorer structural behavior than would be the case in a confined masonry structure with the same quantity of materials (Figure 23c). Moreover, some buildings presented confining beams and columns which were poorly bounded to extremely low-shear-strength hollow concrete blocks, which failed during the seismic event (Figure 23a).

Figure 23. Out-of-plane failures: (a) a confined masonry load-bearing wall and parapet wall because of the low-quality materials employed (Amizmiz). (b) Failure of a masonry wall with RC beams and columns due to the low shear strength of the masonry employed (Amizmiz). (c) Out-of-plane failure of a masonry wall with RC beams and columns due to inappropriate order of execution of components (Amizmiz). The structure does not behave as a confined masonry structure.

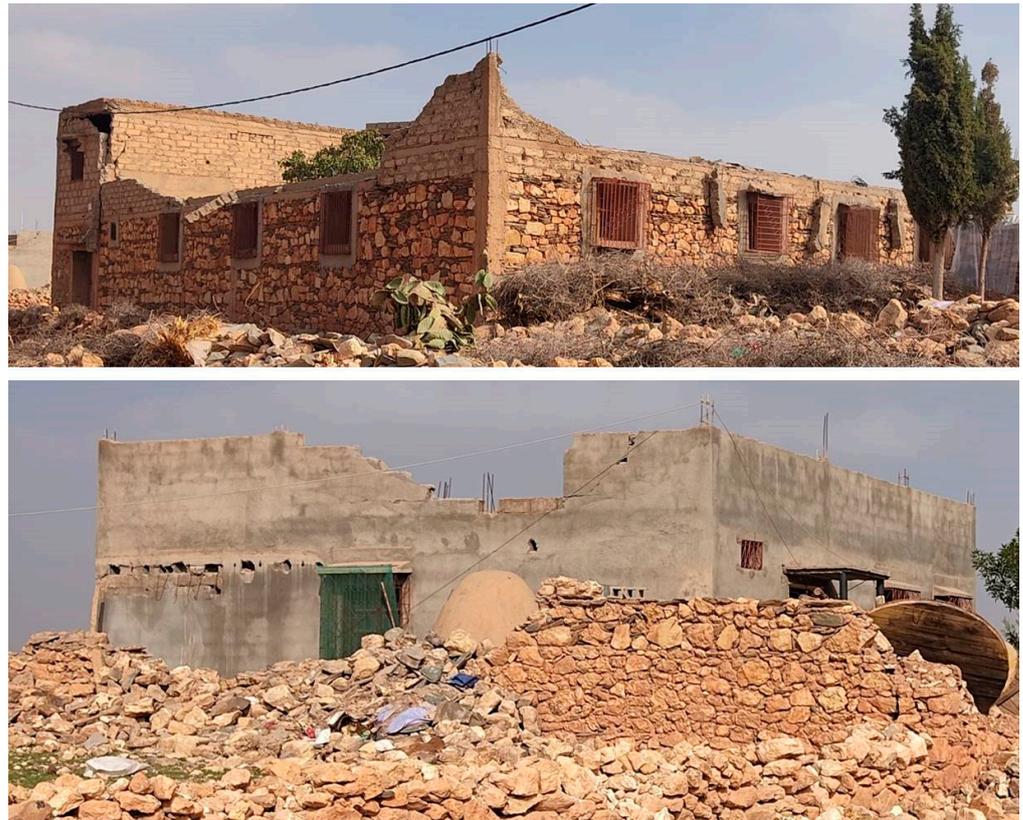
Figure 24. Out-of-plane failure of confined masonry parapet walls in two buildings with different structural wall material (Tafeghaghte) (both).

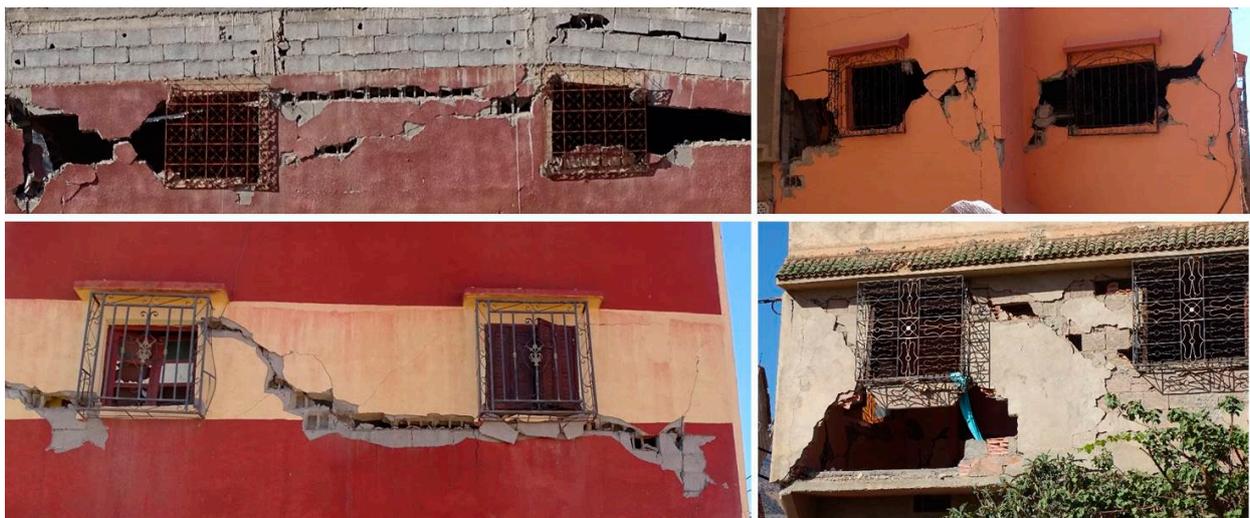
Finally, a key aspect of these structures that should not be ignored is the scarcity of confining elements found. Most buildings presented a lack of RC elements that confined the masonry in the door and window openings (Figure 25). This absence facilitated the openings acting as weak point determinant for the damage in the resistant walls.

Figure 25. Damage mainly due to the absence of reinforced-concrete confining elements in door and window openings (Amizmiz) (all).

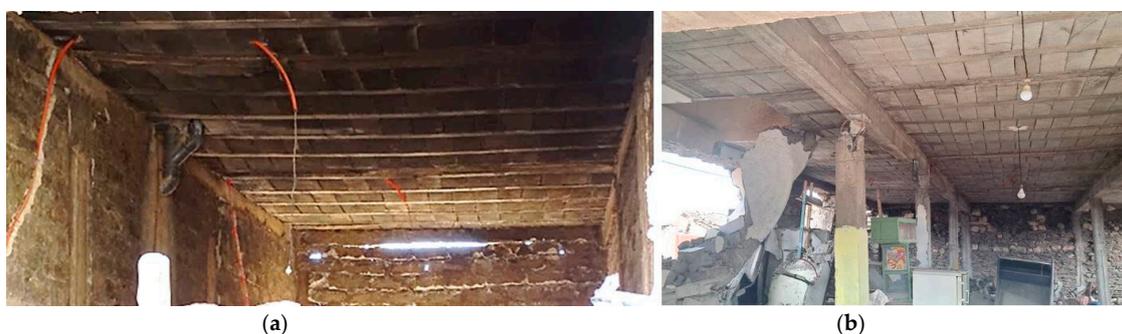
Figure 26. Buildings presenting a structural system which provides seismic resistance and stiffness mainly in only one of the two orthogonal directions. (a) Amizmiz; (b) Tafeghaghte.

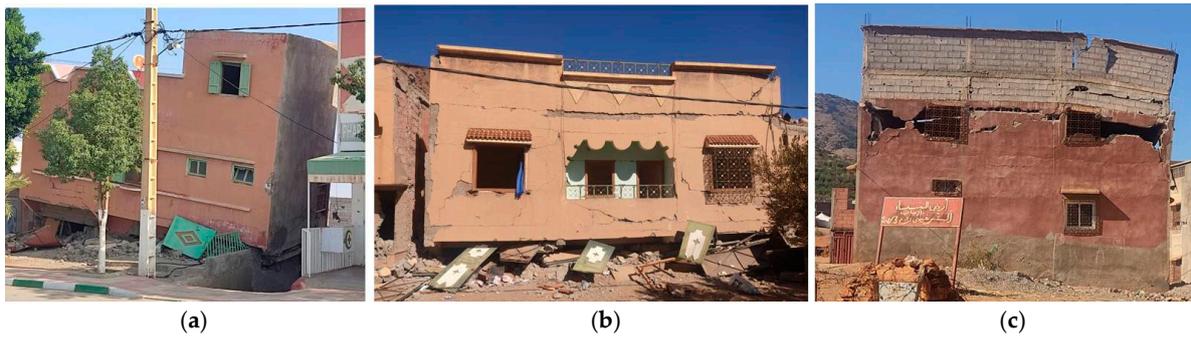
Figure 27. (a) Building in which the minor presence of shear-resistance walls on the ground floor resulted in a weak ground-story overturning failure (Amizmiz). (b) Building in which the excessive number of doors on the ground floor, which is characteristic of commercial buildings in the same road, causes a weak ground-story overturning failure (Talat N'Yaaqoud). (c) Building with major damage mainly concentrated in the intermediate story, due to window openings (Amizmiz).

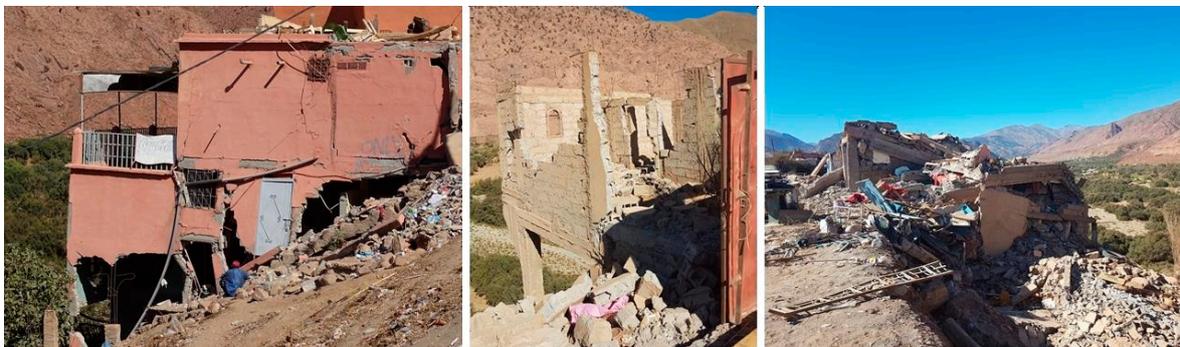
Figure 28. Buildings located on slopes and presenting very different column lengths (Talat N'Yaaqoud).

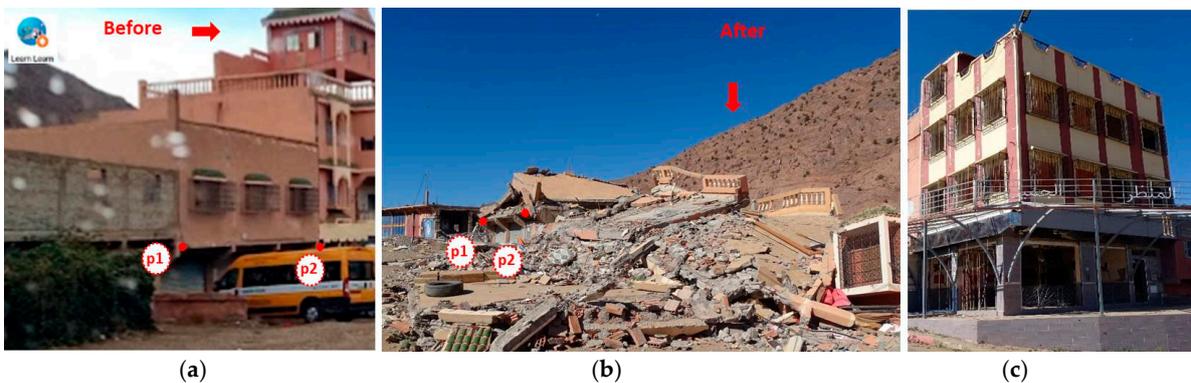
Figure 29. (a,b): state of a building before and after the earthquake (red dots). The building exhibited a high number of irregularities in height and plan, such as differences in stiffness and strength and balconies. p1 and p2 are inserted as reference points (Talat N'Yaaqoud). (Source photo before the earthquake: Google Maps, <https://www.google.es/maps/place/Talat+N%E2%80%99Yaaqoub,+Marruecos>, accessed on 18 January 2024). (c) Building with a marked height irregularity between the ground floor and the rest, along with columns displaced from the same vertical line. Possible torsional effects due to the presence of a much more rigid, blank dividing wall and the three very open façades facing the street (Amizmiz).

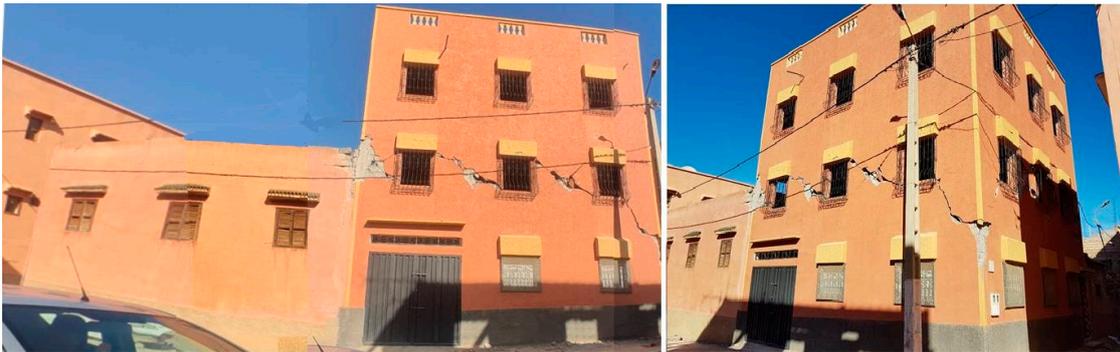
Figure 30. Building on a corner where a lower, more rigid adjacent construction has caused very noticeable pounding effects (Amizmiz).

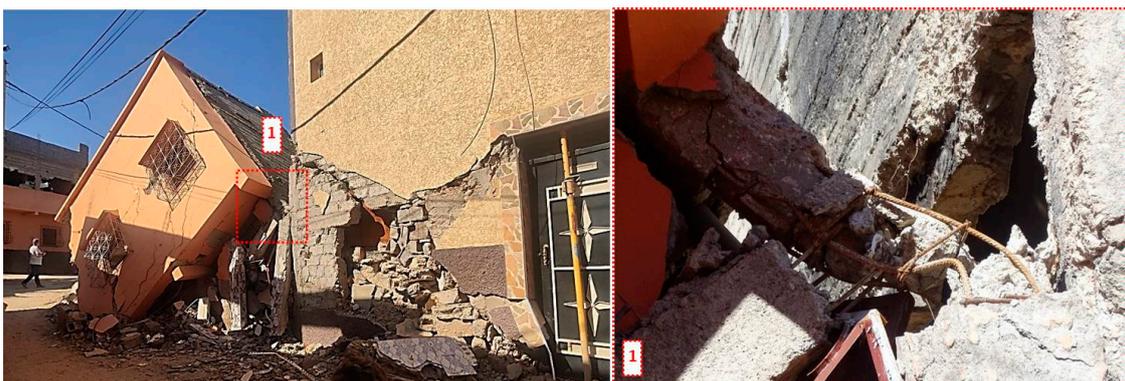
Figure 31. Building located on a corner, collapsed and overturned, presenting a possible weak-story deficiency and pounding effects from the adjacent building. Detail 1. Low resistance of the concrete and areas of low-longitudinal-reinforcement steel in the beam and the column. Short length of development and anchoring of steel for longitudinal reinforcement of the beam where it connects with the column. Absence in the beam of the recommended first closed confinement stirrup located no more than 50 mm from the face of the support element (ACI-318). Excessive distance between transversal reinforcement in a critical point of the column and absence of seismic hooks at the ends of the column stirrups (Amizmiz).
