Seismic Damage Characteristics and Mitigation Strategies in Southern Sichuan Basin, China

Zonghang He, Hongmei Guo *, Ying Zhang, Zhen Zhao, Bingxin Shi, Can Zhang and Yuping Yang

Sichuan Earthquake Agency, Chengdu 610041, China; zonghang@scdzj.gov.cn (Z.H.)

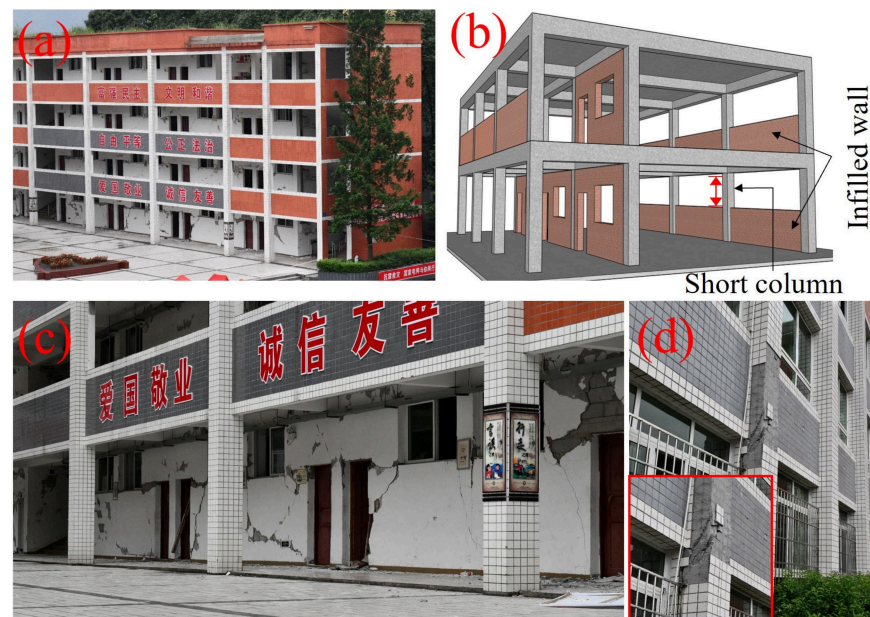
Because the maximum earthquake magnitude in the southern Sichuan region did not exceed Ms 6.0, strong ground shaking was observed only locally in small areas. Consequently, the number of collected cases of beam-column joint damage was limited, and the overall seismic damage was relatively mild. However, in school buildings, a particular frame structure with a distinctive layout exhibited significant damage to its columns. The typical feature of such buildings lies in the arrangement of the main frame and infill walls (Figure 6a,b). Along the short-axis direction of the structure, the column lines are often asymmetrically arranged over two spans: one span is relatively large and functions as a classroom, while the other span is smaller and serves as a corridor. In the corridor area, the ground floor is usually free of enclosing walls, creating a relatively open space. In contrast, the upper floors are equipped with walls approximately 1.2 m high, which also serve as railings. On the sides of the classrooms, conventional-height infill walls are provided, with openings incorporated for doors and windows. This asymmetric arrangement of infill walls leads to significant differences in the constraint conditions of columns at various locations, which in turn results in markedly different actual stress states. As a consequence, the frame columns at the front remain undamaged, while the infill walls suffer extensive damage (Figure 6c). Conversely, the walls at the rear remain intact, but shear diagonal cracks appear in the frame columns (Figure 6d). The mechanical behavior of columns in different positions within this structural configuration has been extensively investigated in recent years [27–29]. Both shaking table experiments and in situ monitoring of existing buildings have shown that under seismic action, shear forces are highly concentrated in columns constrained by infill walls. The shear forces experienced by these columns can reach three to five times those of columns without infill wall constraints. Regarding mechanical performance, columns without infill wall constraints exhibit lower load-bearing capacity but demonstrate greater deformation ability and ductility; conversely, columns constrained by infill walls possess higher stiffness and load-bearing capacity, while their deformation capacity and ductility are relatively limited. It is noteworthy that when constrained columns are damaged, the structure has often already begun to deteriorate and may even be at risk of collapse. At this stage, unconstrained components typically have not reached their ultimate displacement, and their actual ductility may be lower than that of the constrained columns. This phenomenon indicates that unreasonable structural layouts and internal force distributions prevent effective collaborative action among components, thereby restricting the full utilization of material properties. In summary, even under moderate-intensity earthquakes, irregularities in structural configuration can remain a critical factor affecting seismic performance. Therefore, buildings of this structural type should receive careful consideration. Measures such as the installation of dampers are recommended to improve the structural stress response and adjust the internal force distribution, thereby preventing structural damage and protecting the safety of students and staff.

Figure 6. Construction forms and damage characteristics of a typical frame structure. (a) Overall exterior view of the building. (b) Schematic layout of internal longitudinal beams, columns, and walls. (c) Infill wall damage on the front elevation. (d) Column shear failure on the rear elevation.

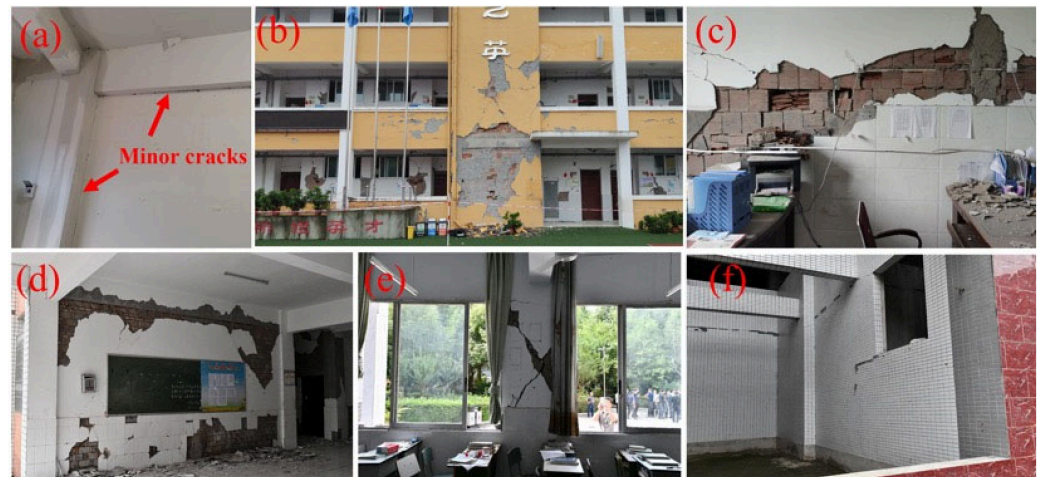
In frame structures, the failure of infill walls is often more common than that of beam-column joints. When the seismic intensity is low, cracks tend to form at the junctions between infill walls and the frame beams and columns (Figure 7a). These interfaces typically rely solely on mortar for connection, which has a low bond strength and is prone to separation under structural deformation. Additionally, infill walls often exhibit diagonal cracks or form intersecting fine cracks due to repeated seismic actions (Figure 7b). As non-load-bearing components, most infill walls are constructed with hollow bricks to control construction costs. These materials are brittle and weak, making them prone to crushing during strong seismic motions. Once a porous brick wall cracks, its stiffness rapidly decreases, leading to poor deformation capacity. Initial cracks tend to expand quickly, resulting in a higher risk of wall instability or even collapse (Figure 7c). In contrast, solid brick infill walls, with higher compressive and shear strengths, exhibit better overall integrity and can more effectively resist seismic forces, resulting in relatively less severe damage (Figure 7d). However, the stronger overall integrity of solid brick walls may have an adverse effect: their restraining effect on the frame beams limits beam deformation, obstructing the formation of the strong column-weak beam mechanism, potentially causing brittle shear failure of the frame columns. Another common issue is the improper design of door and window openings, leading to short-column effects around the openings, which can result in shear failure during an earthquake (Figure 7e). Compared to frame structures, the seismic damage in high-rise shear wall structures is generally less severe, with fewer instances of damage. Fine cracks may form at the junctions between the infill walls and beams or columns, but the walls typically do not suffer severe damage, usually only showing the detachment of exterior finishes such as tiles (Figure 7f).

Figure 7. Failure modes of infill walls. (a) Minor cracks at wall-frame interface. (b) Internal cracks in infill wall. (c) Damage of infill wall with porous shale bricks. (d) Damage of infill wall with solid bricks. (e) Short column failure. (f) Cracks at wall-frame interface in shear wall structure.

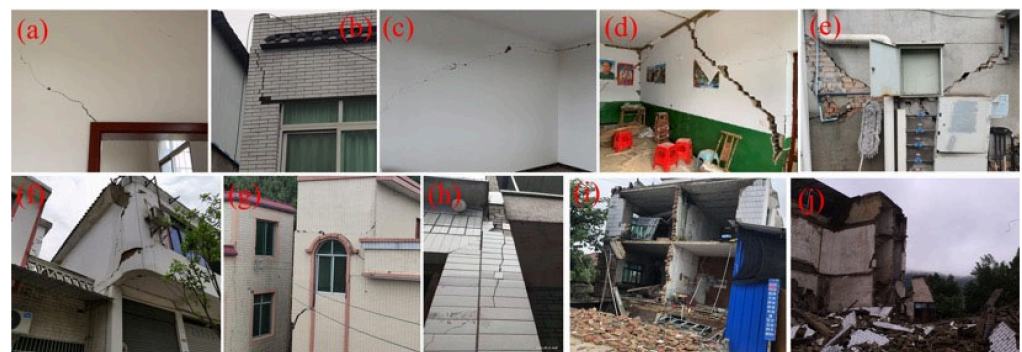
As critical components of masonry structures, walls bear all vertical and horizontal loads. Under seismic forces, the failure modes of these walls are complex and varied, often exhibiting the most severe damage. In areas with larger openings, such as doors and windows, sudden changes in cross-section and stiffness discontinuities tend to create significant stress concentrations, leading to diagonal cracks (Figure 8a,b). These cracks are common even in low-intensity seismic zones, such as those with a seismic intensity of VI. The damage to the main load-bearing walls is progressive: in the initial stages, it typically manifests as slight diagonal cracks on the interior wall surfaces (Figure 8c). As the seismic forces persist, these cracks rapidly expand, eventually traversing the entire wall (Figure 8d). When seismic intensity is high, crack widths increase significantly, causing a dramatic reduction in the wall's load-bearing capacity and ultimately leading to a complete loss of its structural function. Moreover, under repeated seismic actions, the walls often develop intersecting diagonal cracks (Figure 8e). The formation mechanisms of unidirectional diagonal cracks and bidirectional intersecting cracks are closely related to the seismic event's progression. Typically, unidirectional diagonal cracks appear when the wall first

experiences seismic forces, compromising its overall integrity. If subsequent seismic forces are not strong, or if the wall damage is so severe that it can no longer transfer loads, bidirectional intersecting cracks may not develop further. The corners of buildings are also highly susceptible to seismic damage due to stress concentration (Figure 8f). If irregular structures, such as protruding attics, are present at the corners, the damage in these areas is exacerbated by whip-lash or torsional effects (Figure 8g). In urban areas, due to limited space, it is common for two buildings to be constructed closely together with differing floor heights. This height discrepancy can lead to relative displacement or collisions during an earthquake, further aggravating wall cracking (Figure 8h). Additionally, in rural self-built buildings, the lack of proper regulation often results in weak wall connections or insufficient mortar strength. These deficiencies further undermine the structural integrity, making the walls more prone to localized collapse during seismic events (Figure 8i). In cases of extremely strong seismic forces, this can even lead to the structure's complete collapse (Figure 8j).

Figure 8. Failure modes of load-bearing walls. (a) Diagonal cracks at door opening. (b) Diagonal cracks at window opening. (c) Minor diagonal cracks. (d) Severe diagonal cracks. (e) Cross cracks; (f) Corner cracks. (g) Attic cracks. (h) Collision cracks. (i) Collapse of front longitudinal wall. (j) Complete collapse.

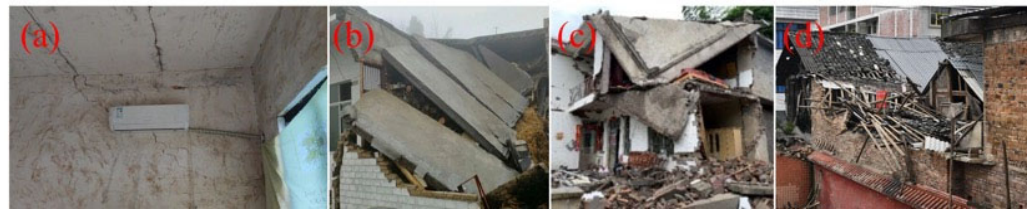
The floor or roof of masonry structures is primarily constructed using reinforced concrete precast panels and cast-in-place slabs. However, precast panels are more susceptible to damage during earthquakes due to unreliable connections between panels and inherent deficiencies in their overall integrity. Typical seismic damage manifests as longitudinal cracks along the joints between panels (Figure 9a). When the displacement between the panels becomes excessive, the precast panels may even detach from the wall support and fall (Figure 9b). In contrast, cast-in-place slabs, which have superior overall integrity, exhibit significantly better seismic performance. Even if damaged due to the collapse of the supporting walls, they generally only experience localized bending or cracking, rather than completely disintegrating as with precast panels (Figure 9c). This allows them to maintain some degree of structural integrity. In addition to the aforementioned roof types, wooden truss roofs are also relatively common. These roofs typically feature a pitched design, with the trusses directly resting on the walls, and lack effective anchorage connections. This non-rigid connection makes it difficult for the roof and walls to work together cohesively, and the walls' compressive stability is insufficient. The lateral stiffness of these walls is much lower than that of concrete-roofed buildings, resulting in poorer overall structural integrity. In general, the displacement at the top floor during an earthquake is the greatest, and due to the absence of reliable connections in wooden roofs, misalignment and detachment are more likely to occur, potentially leading to catastrophic loss of structural integrity in severe cases (Figure 9d).

Figure 9. Typical seismic damage to floors and roofs. (a) Cracking in precast floor slabs. (b) Collapse of precast floor slabs. (c) Local collapse of cast-in-place floor slabs. (d) Collapse of wooden roof truss.

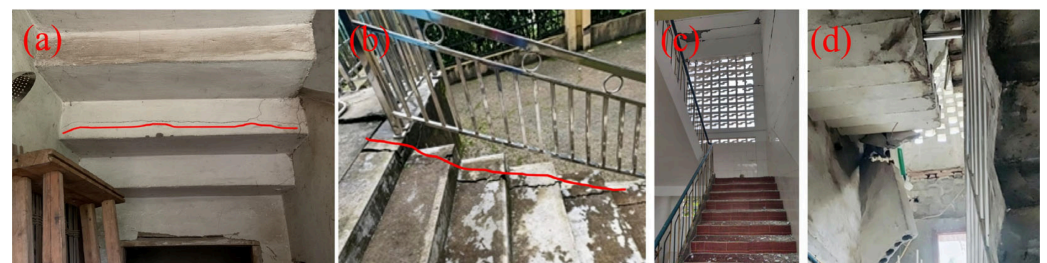
The staircase, as a vertical connection passage within a building, is typically not considered a primary load-bearing component during the design phase. However, under seismic forces, the staircase may actually assume a lateral support function. In masonry structures, staircases are generally embedded within the walls, and their failure modes are primarily characterized by transverse or longitudinal force-induced damage. Figure 10 illustrates a range of typical failure modes of staircases. In the structural system, the staircase serves as a continuous opening within the floor slab, which significantly weakens the horizontal stiffness of that region, creating a vulnerable structural layer. The large lateral forces generated by an earthquake, during transmission, are forced to reroute and redistribute due to the presence of the opening, ultimately concentrating around the walls adjacent to the staircase. Furthermore, the embedded stair segments work in tandem with the walls, functioning as a rigid lever to transfer the forces borne by the staircase to the walls, which can cause severe damage due to overloading. In cases of strong seismic action, some staircases may fracture under repeated tensile and compressive forces or, due to platform displacement, may collapse completely.

Figure 10. Typical seismic damage to staircases. (a) Transverse cracks on stair flight. (b) Longitudinal cracks on stair flight. (c) Wall damage in staircase. (d) Stair flight collapse.

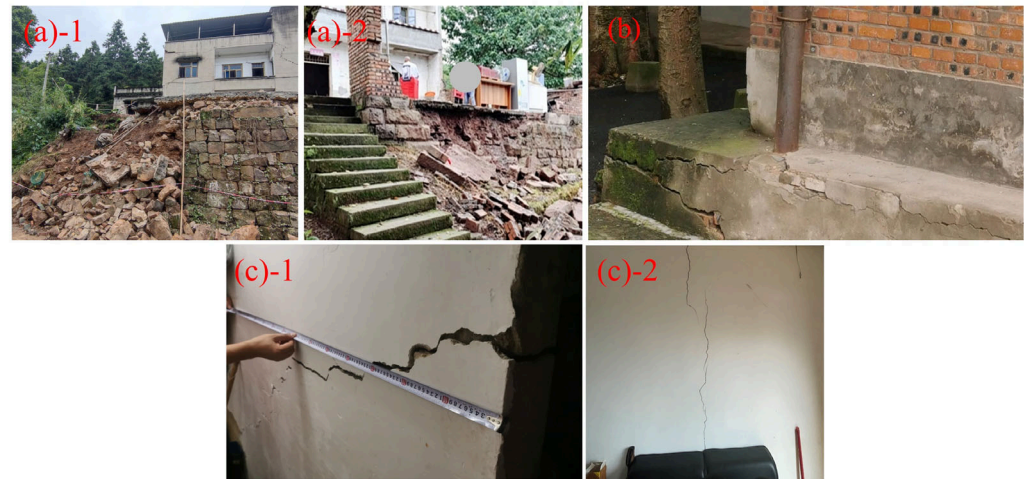
The southern Sichuan region is characterized by hilly terrain with significant topographical variations. Before constructing buildings, the site typically requires excavation and leveling. To create a flat foundation, a common practice is to build retaining walls along the edges of the leveled area using stone blocks or bricks. However, due to construction irregularities, two typical issues often arise during this process: first, the site leveling is often insufficient, resulting in inadequate compaction of the foundation soil; second, the stone blocks used for the retaining structures are typically laid without proper bonding or interlocking measures, relying instead on dry-stacking or simple piling methods. Under seismic forces, these rudimentary retaining walls are unable to resist the lateral pressure from the soil behind them due to insufficient friction between the blocks and poor overall integrity. As a result, they partially collapse. Furthermore, because the foundation soil is not sufficiently compacted, uneven settlement is likely to occur under the combined effects of vibration and rainwater infiltration, leading to potential site instability. Currently, such damage is primarily observed at the edges of the courtyards in front of buildings

(Figure 11(a)-1,(a)-2). Although these issues do not pose an immediate threat to the buildings' structural safety, they pose potential risks to future use. Additionally, seismic activity may cause uneven settlement of the foundation, resulting in additional internal forces within the building's upper structure (Figure 11b). When the tensile strength of the masonry walls is insufficient to resist the resulting tensile stresses, diagonal or vertical cracks may form in local sections of the walls (Figure 11(c)-1,(c)-2). This phenomenon highlights that in seismic assessments of hilly areas, the stability of the site and the reliability of the retaining structures should receive equal attention alongside the assessment of the building itself.

Figure 11. Seismic damage to foundations and substructures. (a)-1, (a)-2 Damage to foundation maintenance structure. (b) Foundation damage. (c)-1, (c)-2 Wall cracks caused by uneven settlement of the foundation.

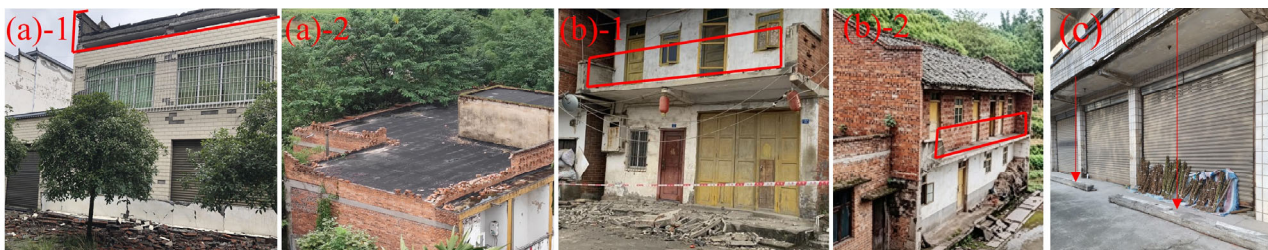
In masonry structures, the failure of auxiliary components typically manifests as damage to the parapet walls and corridor railings, as shown in Figure 12. These two types of seismic damage are frequently observed in southern Sichuan, and their failure mechanisms and causes are highly similar. On the one hand, a lack of reliable connections between the walls and the main structure compromises structural integrity. On the other hand, the relatively loose construction of the walls themselves results in poor overall stability, making them highly prone to collapse under the horizontal forces induced by an earthquake. Such failures not only severely affect the safety of the structure but also expose critical issues in the design and construction quality control of connection systems. Particularly concerning is the fact that the collapse of these walls often occurs at the building's exit, a critical area for outdoor evacuation and emergency exit, which significantly increases the risk of injury and fatalities.

Figure 12. Accessory components damage. (a)-1, (a)-2 Parapet wall collapse. (b)-1, (b)-2 Railing collapse. (c) Walkway precast slab falling.

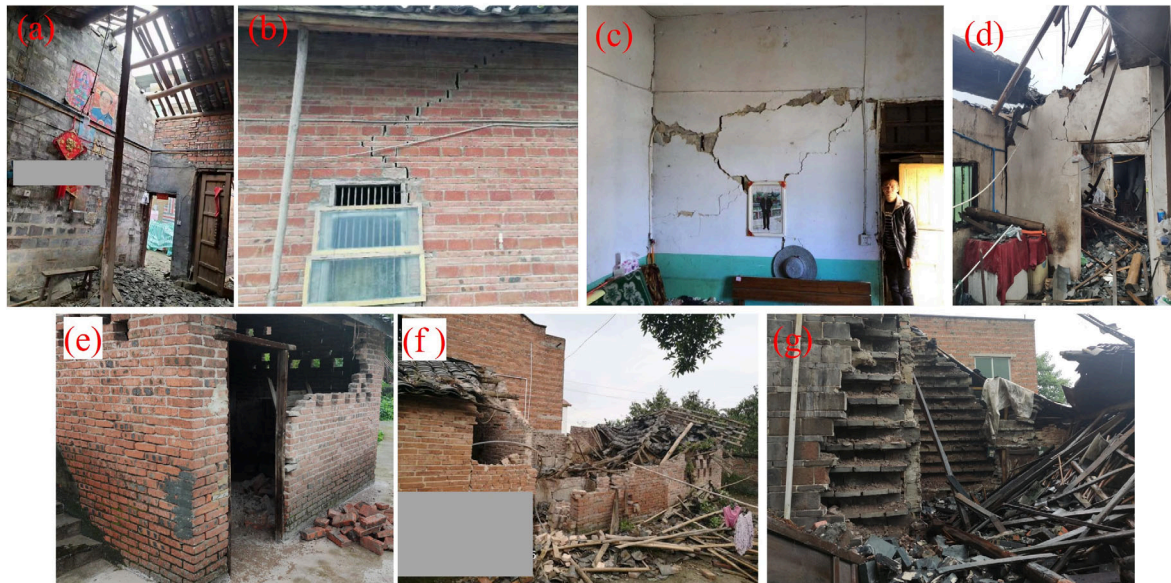
Brick-wood structures are highly vulnerable to damage under seismic forces, with the primary failure mechanisms observed in the roof system, load-bearing walls, and overall structural integrity. The roof trusses in these buildings typically consist of a pitched wooden framework, with tiles secured solely by friction and lacking effective fastening mechanisms. Consequently, even in low-intensity seismic zones, roof deformations and inertial forces can readily cause large-scale tile displacement, resulting in both property damage and potential risks to the safety of evacuees (Figure 13a). The load-bearing brick walls serve as the sole components resisting lateral forces; however, many of these buildings were constructed in earlier periods, using bricks with low tensile and shear strength, while low-strength mortars, such as lime-mixed mud, were commonly employed. As a result, the brick exhibits poor tensile and shear performance, with failure modes typically appearing as stepped cracks along mortar joints (Figure 13b). Under seismic loading, diagonal or horizontal shear cracks frequently develop in walls, particularly in areas of stress concentration around door and window openings (Figure 13b,c). Furthermore, a lack of reliable connections between the walls and timber trusses is prevalent. During an earthquake, significant relative displacement between the brick walls and timber trusses can easily cause the trusses to slide off the walls (Figure 13d). In addition, these buildings are generally single-story, with wall thicknesses often limited to 120 mm, resulting in a severe deficiency in lateral stiffness and stability. Under intense vibrations, localized wall collapses (Figure 13e), such as crushing at door and window openings, can trigger a chain reaction of failures, ultimately compromising the overall integrity of the building (Figure 13f). Additionally, some early buildings used hollow-core walls to reduce material costs (Figure 13g), which substantially weakened the effective load-bearing cross-section. The weak mortar bond between the bricks also facilitates relative sliding, significantly reducing the seismic load-bearing capacity and overall integrity of these walls. Therefore, hollow-core walls are highly susceptible to rapid and severe damage or collapse during seismic events.

Figure 13. Typical seismic damage to brick-timber structures. (a) Slipped roof tiles. (b) Stepped cracking. (c) Failure of load-bearing wall. (d) Collapse of wooden roof. (e) Local spalling of wall. (f) Complete collapse of building. (g) Failure of cavity wall.

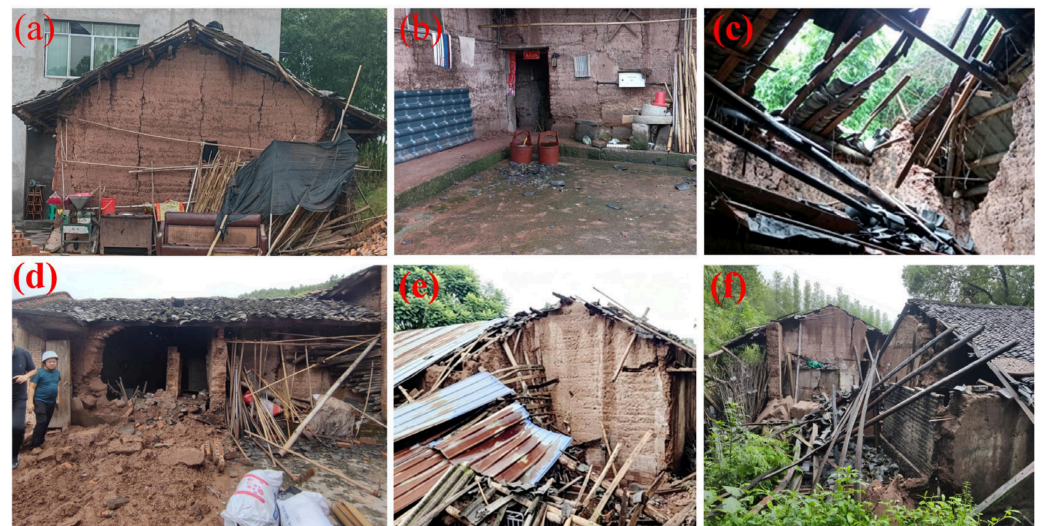
Despite the distinct differences in building materials between rammed earth structures and brick-wood structures, their relatively simple load-bearing systems result in similar overall stress behavior. Consequently, the seismic damage characteristics of both structure types exhibit certain similarities. Rammed earth structures, predominantly constructed in earlier periods, with origins dating back to around the 1960s, exhibit significant material aging. As a result, many pre-existing cracks are evident before seismic events (Figure 14a). Under seismic forces, these existing cracks are prone to further extension and widening,

thereby exacerbating the overall structural damage. Similar to brick-wood structures, rammed earth buildings also commonly experience tile displacement in low-intensity seismic zones (Figure 14b). Furthermore, the timber frames in these structures often suffer from material decay, joint loosening, and other related issues due to their age, significantly compromising their load-bearing capacity and seismic resilience. During seismic events, the timber frames are susceptible to localized fractures or even complete collapse (Figure 14c). As the intensity of seismic motion increases, the walls often experience localized or widespread collapse (Figure 14d), leading to the loss of lateral support for the timber frame, ultimately resulting in severe structural damage or complete collapse of the entire structure (Figure 14e,f).

Figure 14. Typical seismic damage to earthen structures. (a) Widening of pre-existing cracks. (b) Slipped roof tiles. (c) Failure of wooden roof truss. (d) Local collapse of wall. (e) Complete collapse. (f) Complete collapse.

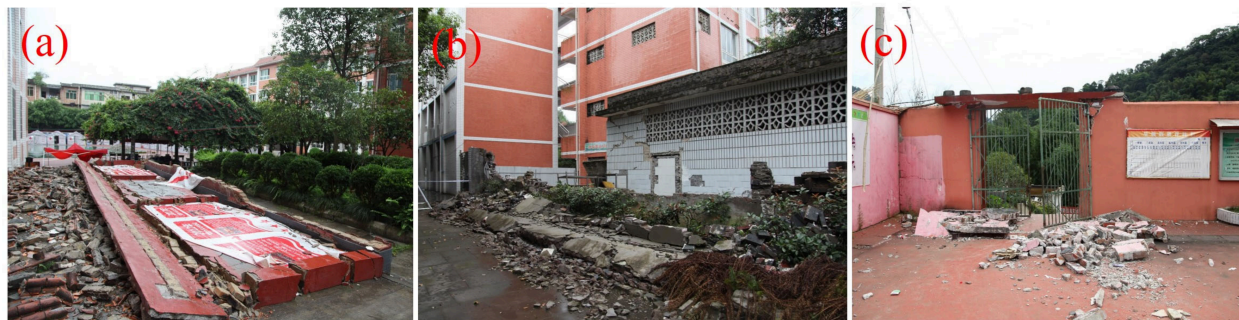
In seismic disasters, isolated non-structural components or auxiliary facilities, in addition to buildings, bear a significantly high risk of collapse. Common examples include display walls, fences, and billboards, as shown in Figure 15. Due to their typically auxiliary functions, these components often receive insufficient attention in structural design, resulting in weak connections to the foundation that lack the necessary anchorage and ties. From a structural mechanics perspective, such walls typically exhibit a tall, narrow, and flat geometry, which results in insufficient out-of-plane stiffness. When the direction of seismic motion is perpendicular to the plane of the wall, the inertial forces can induce substantial oscillatory vibrations of the wall around its base. Should the seismic forces exceed the wall's overturning resistance, there is a high likelihood of out-of-plane instability, ultimately leading to total overturning or fracture collapse.

Figure 15. Typical independent structural seismic damage. (a) School display wall collapse. (b) Perimeter wall collapse. (c) Plaque collapse on a wall.

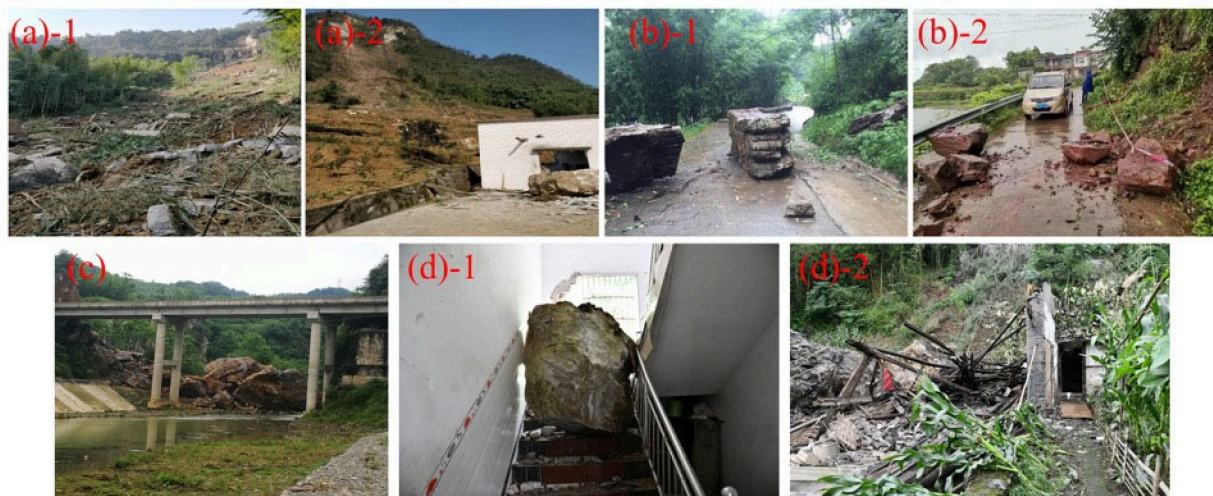
The landforms in southern Sichuan are characterized by complexity and diversity, primarily comprising basins, hills, mountains, and karst landscapes. This forms a typical geomorphological pattern that transitions from the southern edge of the Sichuan Basin to the Yunnan-Guizhou Plateau. The southern portion of the region features distinctive karst topography, where underground caves and fissures are extensively developed. In some areas, the surface cover is relatively thin, contributing to a fragile overall geological environment [30,31]. In such a geological context, the aftermath of an earthquake is often accompanied by geological disasters such as landslides and collapses, particularly in hilly terrain, where landslides and slope failures along roadways are common. Because the slope's geological structure is loose and the degree of weathering is high, the surface geomaterials are prone to instability under seismic shaking, which can trigger rock dislodgement or even rockfalls. Although large-scale landslides have yet to occur, frequent occurrences of smaller to medium-sized landslides and collapses have had severe impacts on road traffic, leading not only to roadblocks, but also potentially causing further damage to pavements, subgrades, and protective infrastructure (Figure 16(a)-1,(a)-2,(b)-1,(b)-2). Additionally, fallen rock debris entering waterways can obstruct channels, alter hydrological pathways, exacerbate bank erosion, and even compromise the integrity of bridge piers on river-crossing structures, thereby jeopardizing the overall safety of these bridges (Figure 16c). It is particularly noteworthy that some residential areas in this region are situated on mountainous and hilly slopes. Landslides and rockfalls threaten not only roads and bridges, but also residences, causing significant structural damage and potentially resulting in casualties (Figure 16(d)-1,(d)-2). Therefore, during post-earthquake assessments and reconstruction efforts, it is crucial to prioritize the geological stability of hilly

Figure 16. Seismic geohazards. (a)-1, (a)-2 Landslide. (b)-1, (b)-2 Road blocked by falling rocks. (c) River channel blocked by a landslide mass. (d)-1, (d)-2 Building destroyed by falling rocks.

and low mountainous areas. There is a need to enhance the identification and monitoring of potential landslide and collapse risk points and implement appropriate engineering protective measures and ecological slope stabilization techniques to improve the region's comprehensive disaster prevention capabilities.

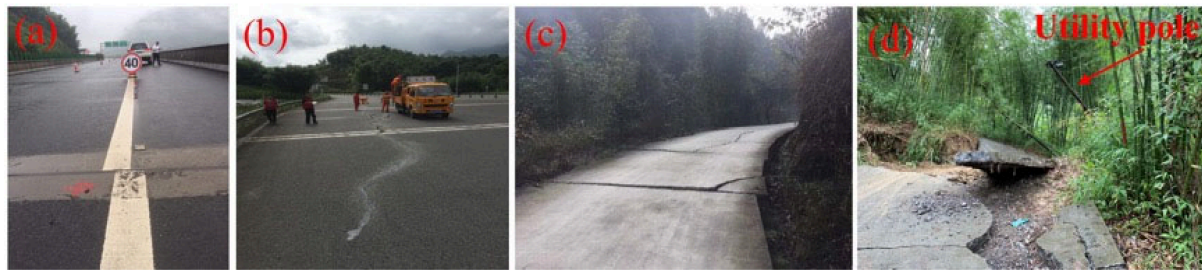
Lifeline engineering primarily refers to essential infrastructure systems that support the normal functioning of urban areas, including power and water supply systems and communication networks. Damage to these systems not only disrupts their operations, but may also trigger a cascade of effects, resulting in significant socioeconomic losses [32]. In the context of relatively low-magnitude earthquakes, lifeline structures typically do not experience severe damage from ground shaking alone, except when geological hazards cause large-scale road disruptions. Overall, the extent of seismic damage to lifeline infrastructure remains limited. The observed types of damage can be generally categorized into several key forms. One commonly observed form of damage is the misalignment of bridge expansion joints (Figure 17a). This occurs because expansion joints are designed with a degree of movement capability, and simply supported beam bridges primarily rely on bearings to transfer loads without being strongly restrained in the horizontal direction. As a result, they are prone to swaying during seismic events, which induces displacement responses and leads to misalignment and uneven driving surfaces at the expansion joints. Cracking of highway subgrade surface layers is another typical manifestation of seismic damage (Figure 17b,c), particularly evident on rural roads. This can be attributed to the fact that rural roads often utilize cement concrete only for the surface layer, which functions as a rigid pavement. The underlying subgrade is frequently inadequately compacted, lacking sufficient structural stability. Under repeated seismic loading, the coordination between the subgrade and the surface layer is poor, making the system vulnerable to longitudinal or transverse cracking. Damage to power infrastructure, such as utility poles, has also been observed, typically in the form of tilting or even toppling (Figure 17d). These failures are usually small in scale and are largely attributed to inertial forces generated by seismic ground motion. However, post-earthquake field investigations indicate that the proportion of utility pole failures caused solely by seismic forces is relatively low. Most damage is instead induced by secondary geological hazards such as landslides and rockfalls, which impact and undermine the foundations of pole towers.

Figure 17. Earthquake damage to roads and power lines. (a) Bridge displacement. (b) Cracks in urban asphalt pavement. (c) Cracks in rural concrete pavement. (d) Damage to roads and power transmission lines.
