# What Changed in Post-Earthquake Reinforced Concrete Damage in Türkiye? A Comparative Study from 1992 (Erzincan) to 2023 (Malatya)

This study presents a damage-based comparative assessment of reinforced concrete buildings affected by the 1992 Erzincan earthquake (Mw 6.8) and the 2023 Kahramanmaraş earthquake sequence (Pazarcık, Mw 7.7; Elbistan, Mw 7.6), two destructive earthquake events in Türkiye separated by nearly three decades. A distinctive contribution of the study is the presentation of original color photographs from the 1992 Erzincan earthquake, systematically documented and comparatively evaluated for the first time and directly compared with post-earthquake field observations from Malatya following the 2023 earthquake sequence. To complement the field-based evidence, representative strong ground motion records from both earthquake events were processed and compared using standard seismic intensity and spectral response parameters. The spectral evaluation indicates that the 1992 Erzincan ground motion and the 2023 Elbistan-related motion recorded in Malatya imposed comparable seismic demands relevant to typical reinforced concrete buildings, thereby providing a rationa

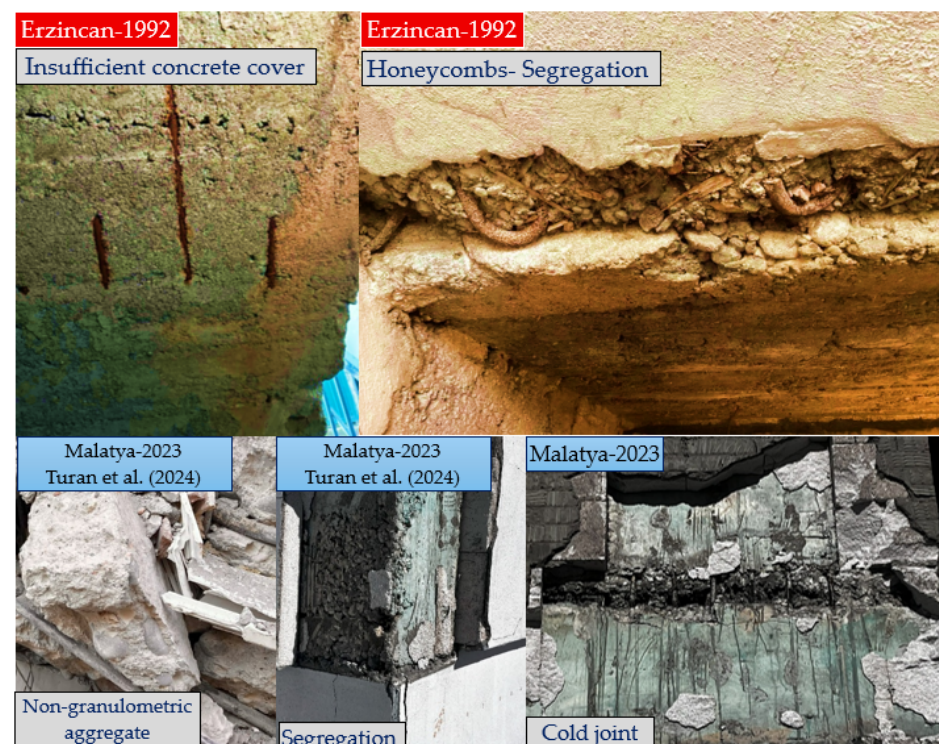
Even though nearly 30 years have passed since the 1992 Erzincan earthquake, similar concrete material property/quality deficiencies were still observed in the buildings examined in Malatya Province after the 6 February 2023 Kahramanmaraş earthquakes. In particular, cold joints were identified in buildings aged 5–10 years, while the use of aggregates with inappropriate gradation was detected in structures that were 25–30 years old. The generally appropriate/homogeneous aggregate gradation observed in 5–10-year-old buildings indicates that ready-mixed concrete was used instead of hand-mixed concrete and that the production process was more controlled. However, due to construction-related issues encountered during on-site applications, adverse conditions such as segregation and cold joints were still observed. Figure 5 illustrates the concrete defects observed in damaged buildings in Erzincan and Malatya provinces.

**Figure 5.** Examples of concrete quality deficiencies observed in reinforced concrete buildings after the 1992 Erzincan and 2023 Malatya earthquakes. The observed deficiencies include insufficient concrete cover, honeycombing/segregation, non-granulometric aggregate use, segregation, and cold joints. The Malatya-2023 images are adapted from field observations reported in Turan et al. (2024) [43], with additional visual documentation and perspective differences introduced for comparative illustration purposes.

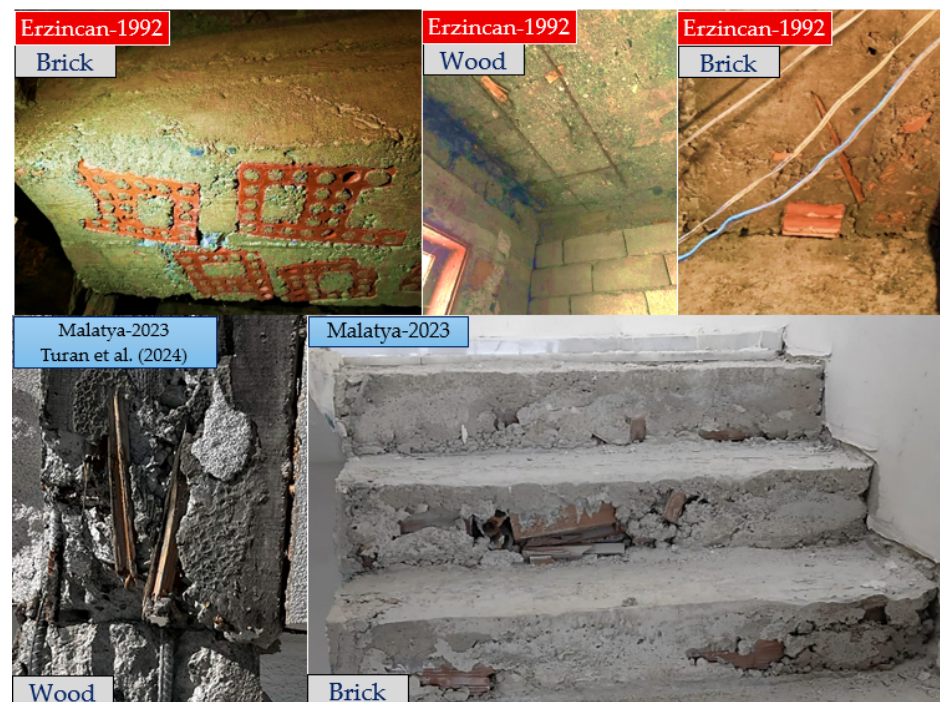
**Figure 6.** Examples of foreign materials embedded in concrete observed in reinforced concrete buildings following the 1992 Erzincan and 2023 Malatya earthquakes, including brick and wood inclusions. The Malatya-2023 case is based on field observations reported in Turan et al. (2024) [43], with additional visual representation for comparative documentation purposes.

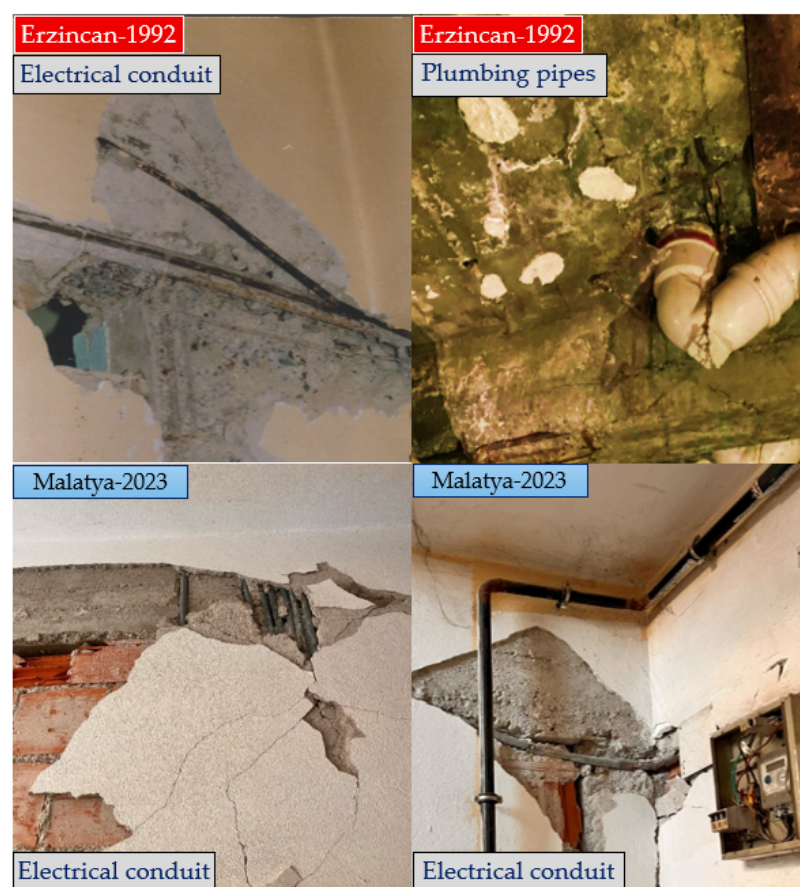
In addition, a further issue compromising the cross-sectional integrity of reinforced concrete members arises from user faults, particularly the passing of utility plumbing pipes through structural elements such as columns and beams. Both Malatya and Erzincan provinces observed these user-related mistakes. Some examples of this are given in Figure 7.

**Figure 7.** User-related construction mistakes involving electrical conduits and water pipes embedded in reinforced concrete members observed in the 1992 Erzincan and 2023 Malatya earthquakes.

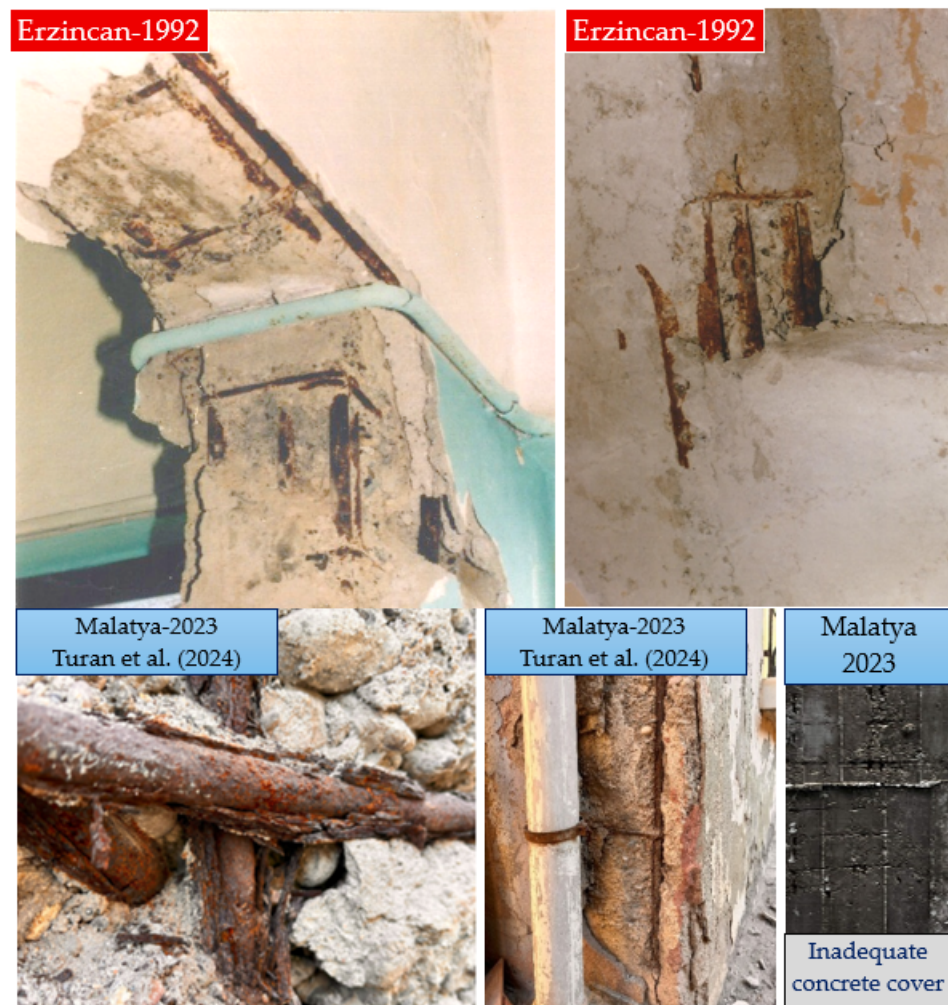
These observations indicate that corrosion-related deterioration and insufficient concrete cover remain critical factors contributing to reduced confinement, bond deterioration, and premature damage development in reinforced concrete members subjected to seismic loading.

**Figure 8.** Examples of corrosion-induced deterioration and inadequate concrete cover observed in reinforced concrete members following the 1992 Erzincan and 2023 Malatya earthquakes. The Malatya-2023 case is based on field observations reported in Turan et al. (2024) [43], with additional visual representation for comparative documentation purposes.

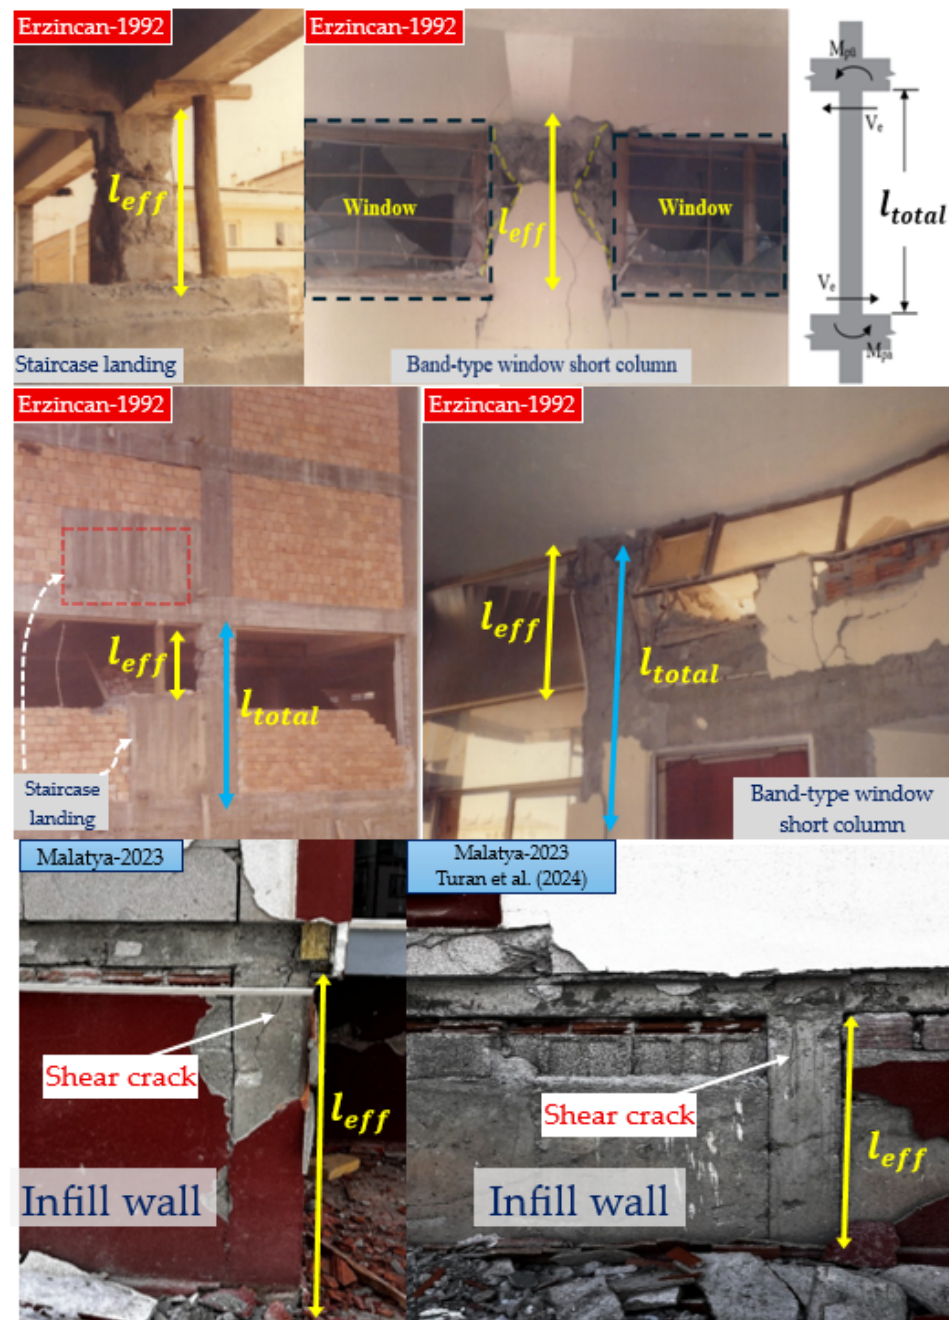
As in many earthquakes in Türkiye, previous post-earthquake investigations have consistently reported shear damage in short columns during the 1992 Erzincan and 2023 Kahramanmaraş earthquakes (Figure 10). The short column failures observed in Erzincan province were attributed to the shortening of column effective lengths due to reinforced concrete walls constructed for various purposes within infill walls, window openings on the ground floors, and shear walls on staircase landing [52]. Another researcher reported that significant damage occurred during earthquakes due to short column formation in buildings where windows extended along the entire facade between columns [53]. In Malatya province, short column failures were commonly identified due to infill walls [43].

**Figure 10.** Examples of short-column damage mechanisms observed after the 1992 Erzincan and 2023 Malatya earthquakes. The notation  $l_{eff}$  represents the effective column height constrained by infill walls, window openings, or staircase elements, whereas  $l_{total}$  denotes the total clear height of the column. The reduction in  $l_{eff}$  relative to  $l_{total}$  increases shear demand and promotes short-column behaviour. The Malatya-2023 case is based on field observations reported in Turan et al. (2024) [43], with additional visual representation for comparative documentation purposes.

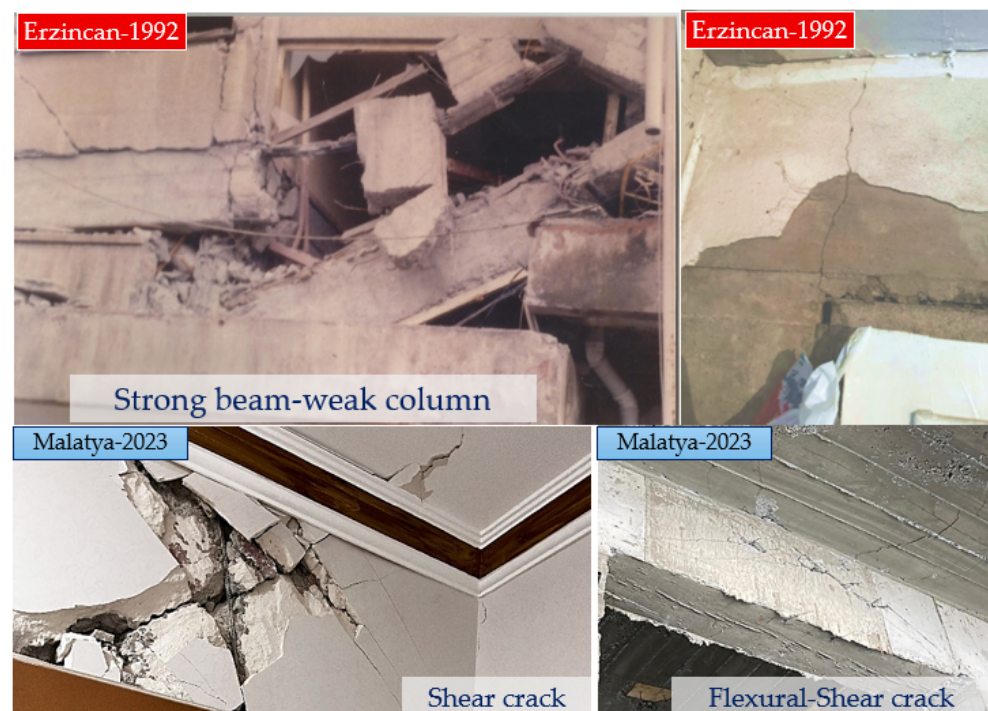
the strong-column/weak-beam principle and ductility-oriented detailing had not yet become established. In practice, beam-over strength-induced column weakness, preventing plastic hinges from forming safely at beam ends and shifting the load-carrying demand to columns and joints. Consequently, column shear failures were prevalent in many buildings, while beams exhibited limited flexural cracking; reinforcement pullout due to lap splices falling within the hinge region; flexure–shear interactive diagonal cracking and end-region crushing associated with sparsely spaced stirrups with 90° hooks; and spalling of cover concrete (Figure 11—Erzincan 1992). In addition, low concrete quality and insufficient transverse reinforcement reduced the shear capacity of the beams and promoted brittleness instead of the expected ductile hinging. Although the strong-column/weak-beam principle has been largely adopted in design in recent years, beam damage was widespread in Malatya during the 2023 Kahramanmaraş earthquakes. Thus, these damage patterns indicate that construction practice, detailing quality, and field implementation deficiencies may significantly alter the intended seismic behavior of reinforced concrete frame systems. The main factors are thought to include insufficient transverse reinforcement and lack of 135° hooks; lap splices placed near joints and inadequate anchorage; workmanship and inspection deficiencies; the short-beam effect induced by infill walls shortening clear spans; bond weaknesses hidden beneath finishes; and, in some buildings, diaphragm discontinuities. Moreover, the repeated loading imposed by the earthquake sequence exacerbated capacity loss at beam ends that had been damaged in the first event, ultimately producing a damage pattern characterized by diagonal shear cracks, end-region crushing, and spalling of cover concrete (Figure 11—Malatya 2023).

**Figure 11.** Examples of flexural–shear interaction, diagonal cracking, and beam-end damage observed in reinforced concrete beams following the 1992 Erzincan and 2023 Malatya earthquakes.

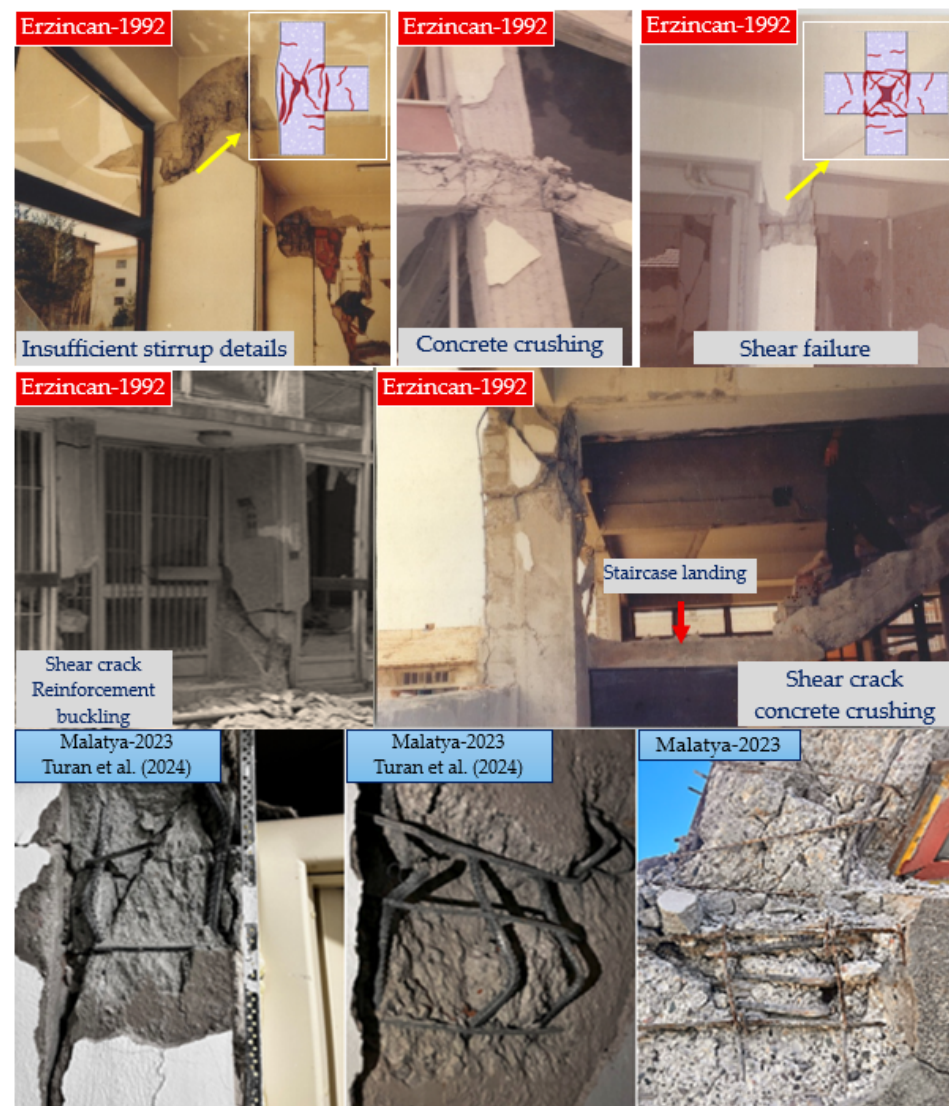
Figure 13 shows the damage patterns at the column–beam joints for the provinces of Erzincan-1992 and Malatya-2023. The damage patterns observed in Erzincan result from factors including inadequate reinforcement detailing, as well as poor-quality reinforcement and concrete, which are discussed in the materials section. While similar causes are believed to be responsible for this type of damage in Malatya, the devastating impact of the earthquake is also taken into account. The observed joint damage patterns indicate that inadequate confinement reinforcement, insufficient anchorage detailing, and low concrete quality continue to promote brittle shear-dominated behavior in beam–column connections subjected to seismic loading.

**Figure 13.** Column–beam joint damage and shear failure patterns observed in reinforced concrete buildings following the 1992 Erzincan and 2023 Malatya earthquakes, including insufficient stirrup detailing, concrete crushing, shear cracking, and reinforcement buckling. The Malatya-2023 observations are based on field data reported in Turan et al. (2024) [43].

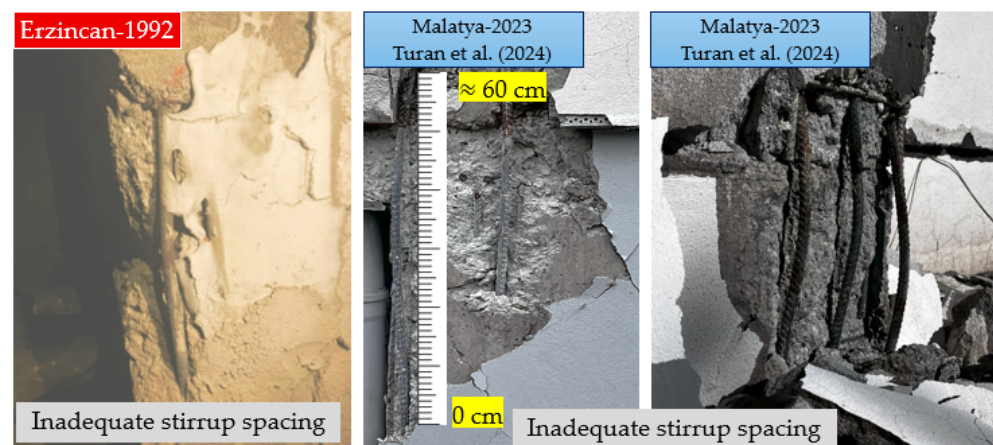
Several experimental studies have been conducted to investigate the impact of confinement on structural performance. The primary objective of these studies was to increase the flexural capacity of columns, which are vertical load-carrying elements, and to observe the formation of hinge mechanisms at the column ends. It was emphasized that significant reductions in the shear capacity of RC columns were observed when subjected to cyclic reversible loading [58]. Some researchers have also conducted studies to simulate the damage caused by stirrup corrosion in earthquakes [59]. Damage observed in structural elements in past earthquakes has revealed the importance of stirrup reinforcement detailing in limiting shear damage in buildings, thus ensuring ductile behavior. In structures examined after the 1992 Erzincan earthquake, it was noted that stirrup spacing in the buildings was between 50 and 70 cm, which was not in accordance with the design [60]. Similarly, another researcher noted that the stirrup diameter and spacing did not comply with either the earthquake code or TS500 [40]. Stirrup spacing in column elements was reported to be 30–40 cm [38]. Figure 14 shows the improper stirrup spacing observed in Erzincan 1992 and Malatya 2023. This common mistake is the main cause of shear damage in RC structures.

**Figure 14.** Examples of insufficient transverse reinforcement detailing and inadequate stirrup spacing observed in reinforced concrete members following the 1992 Erzincan and 2023 Malatya earthquakes. The Malatya-2023 case is based on field observations reported in Turan et al. (2024) [43], with additional visual representation for comparative documentation purposes.

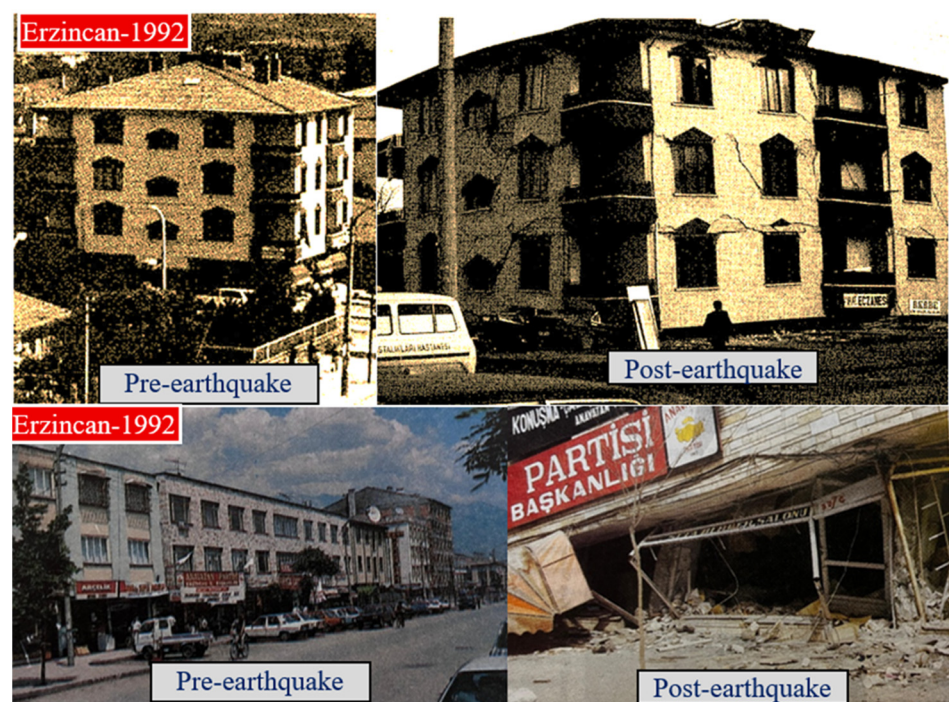
Researchers reported that the majority of the collapse damage in the 1992 Erzincan Earthquake occurred in the form of a “bottom-up” collapse, progressing from the bottom up. The primary cause of this damage mechanism was attributed to the formation of soft stories on the ground floors. Under seismic loading, plastic hinges are expected to form primarily at the ends of ground-floor columns in buildings exhibiting soft-story irregularities. It is known that the rotations caused by these hinges would cause greater displacements than the more rigid upper floors [61]. In studies conducted in Erzincan province, soft story damage was reported in buildings with commercial units on the ground floors of the city’s main streets [9]. For example, Figure 15 shows the condition of a ground floor and three-story reinforced concrete building damaged in the 1992 Erzincan Earthquake. The first striking feature of the building, as mentioned above, is that the ground floor was designed for commercial use with a lower infill wall density compared to the upper floors [62,63]. Although infill walls are generally treated as non-structural elements in conventional design approaches, their contribution to lateral stiffness significantly alters the seismic response distribution within reinforced concrete frame systems [64–66]. Considering this, the ground-floor layout, which creates a difference in stiffness between floors, has caused damage to the building’s vertical load-carrying elements and fractures and collapses in the infill walls on the upper floors.

**Figure 15.** Examples of soft-story collapse mechanisms observed in reinforced concrete buildings in Erzincan Province before and after the 1992 earthquake.

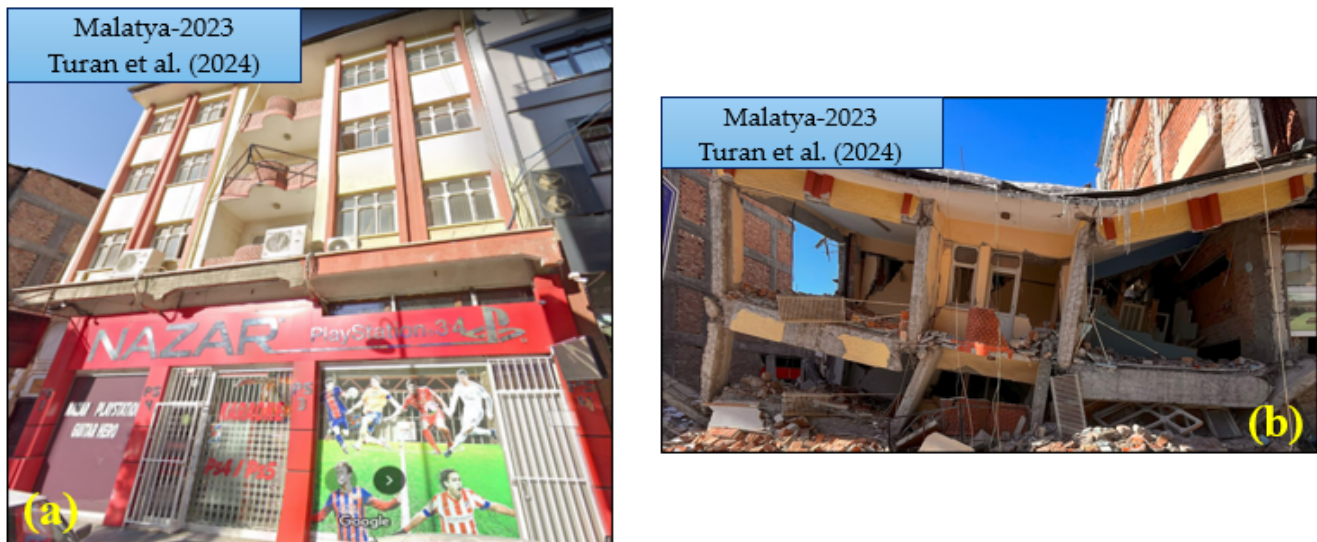
The recurrence of soft-story collapse mechanisms in both the 1992 Erzincan and 2023 Malatya earthquakes demonstrates that commercial ground-floor usage, stiffness discontinuities, and infill-wall irregularities continue to generate critical seismic vulnerabilities despite substantial improvements in Turkish seismic design codes.

**Figure 16.** (a) Pre-earthquake and (b) post-earthquake views of a reinforced concrete building in Malatya Province exhibiting severe soft-story collapse behavior following the 2023 Kahramanmaraş earthquake sequence. The Malatya-2023 case is based on field observations reported in Turan et al. (2024) [43], with additional visual representation for comparative documentation purposes.

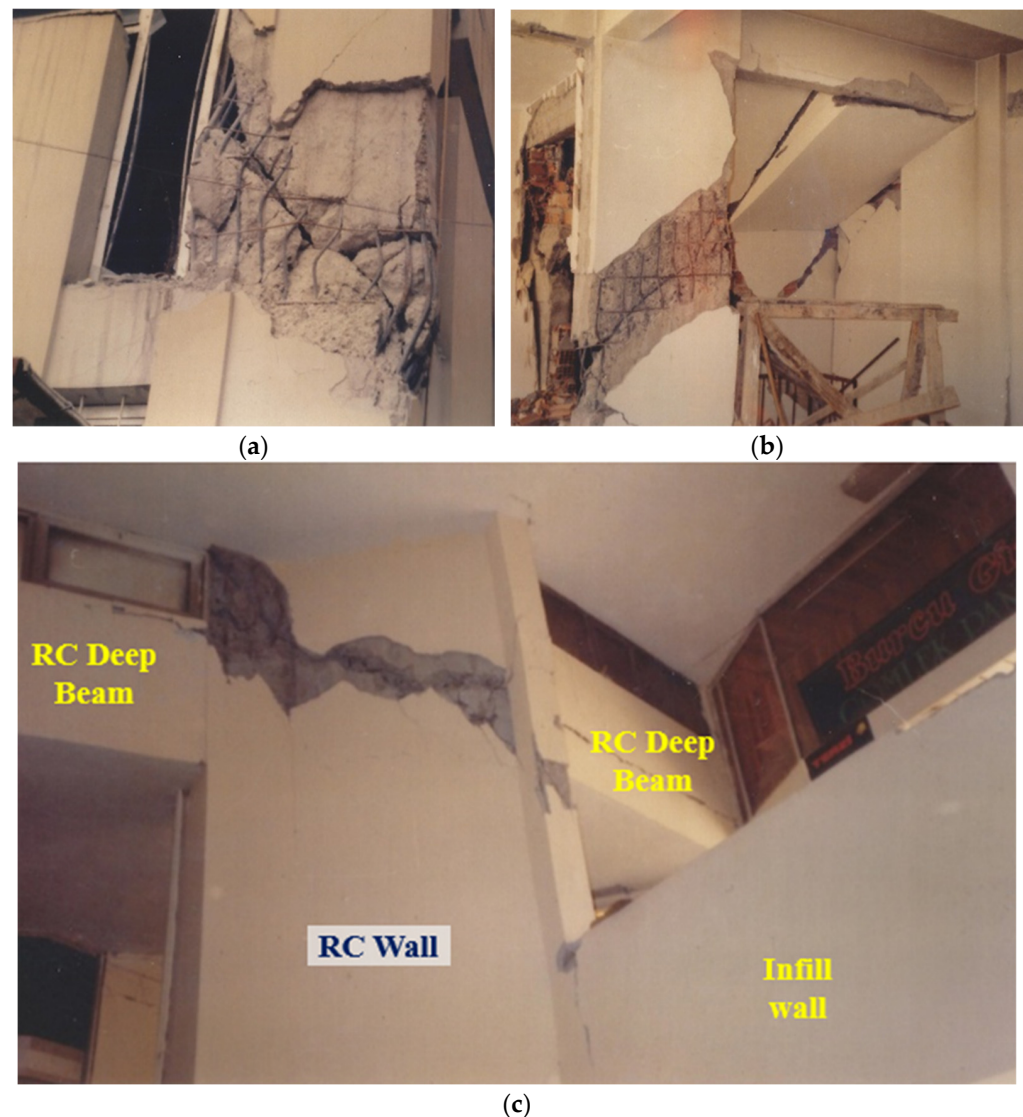
Although structural shear walls are intended to enhance lateral stiffness and seismic resistance, inadequate confinement detailing and local stiffness irregularities may still result in brittle damage mechanisms under strong earthquake loading. Shear walls are load-bearing elements that, thanks to their geometric properties (aspect ratio) and high moments of inertia under seismic loads, attempt to limit the drift of the structure by carrying a significant portion of the lateral loads. Regulations provide various definitions for shear walls. For example, the 1975 regulation specified a ratio of the longest side to the thickness of the building as 5, while the 1998 and 2007 regulations defined this ratio as 7, and the 2018 regulation defined it as 6 or greater. Structural shear walls were rarely used in reinforced concrete buildings in Erzincan Province during the investigated period. As shown in Figure 17, damage to shear walls can be attributed entirely to the material and design deficiencies outlined in Sections 4.1–4.4 (i.e., insufficient winding reinforcement, inadequate diameter of the winding reinforcement, and insufficient concrete compressive strength). A special case presented for Erzincan province in Figure 17a is the situation where the short beam in the shear wall causes shear damage by shortening the effective length of the shear wall. Concrete crushing/concrete cover separate in the confinement zones, as well as the buckling of longitudinal bars in unconfined beam–column joints, were also observed, as illustrated in Figure 17.

**Figure 17.** Examples of shear wall damage observed in reinforced concrete buildings in Erzincan Province following the 1992 earthquake: (a) shear cracking associated with short-beam effects, (b) diagonal shear cracking near RC beam–wall intersections, and (c) local crushing and cracking damage in RC deep beam–shear wall regions interacting with infill walls.

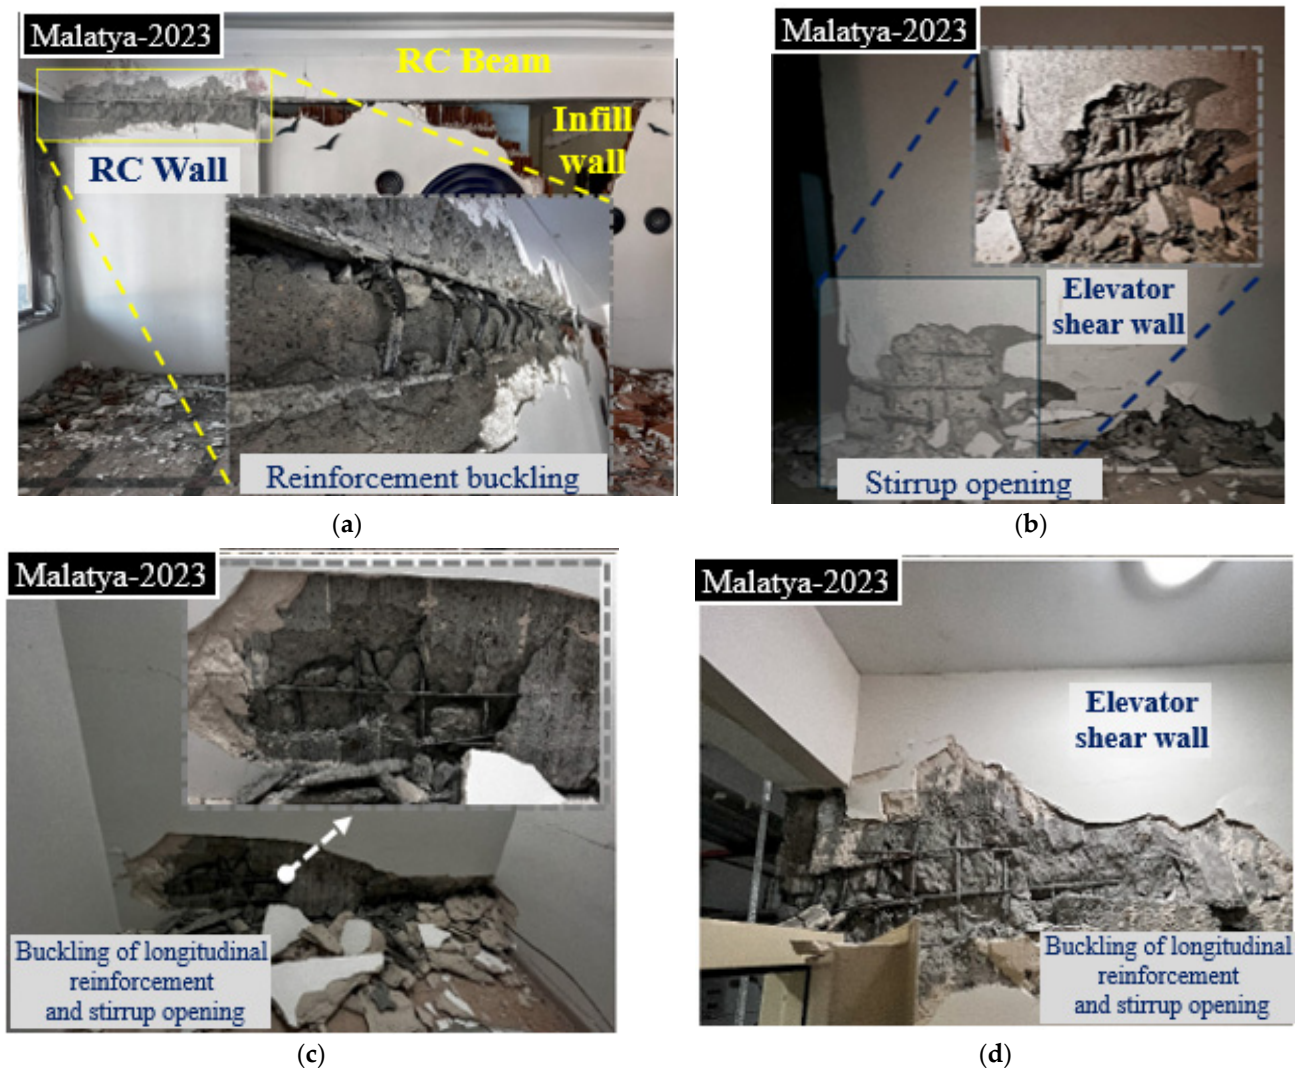
The observed shear wall damage mechanisms demonstrate that inadequate confinement detailing, high axial-load demand, and local reinforcement deficiencies may significantly reduce the expected ductile seismic performance of reinforced concrete wall systems despite modern code provisions.

**Figure 18.** Examples of damages observed in reinforced concrete shear walls in Malatya Province following the 2023 earthquake; (a) reinforcement buckling; (b) stirrup opening; (c) concrete crushing; (d) elevator-core wall damage.

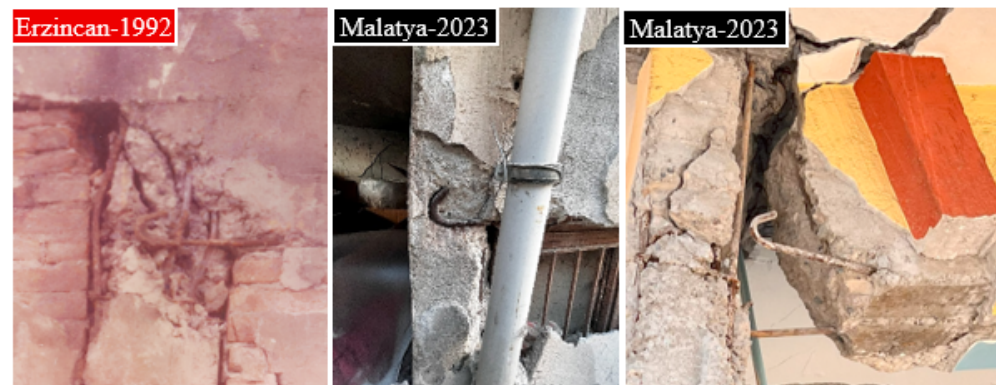
promoted concrete cover separation and bond deterioration around the reinforcement ends. Similar damage to this type has also been observed in older structures in Malatya province.

**Figure 19.** Examples of inadequate hook detailing and insufficient anchorage observed in reinforced concrete members following the 1992 Erzincan and 2023 Malatya earthquakes.

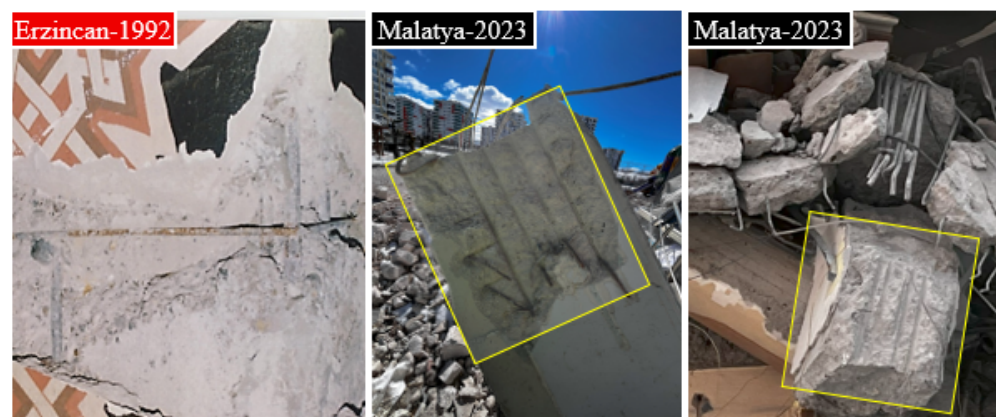
Bond-related deficiencies were more frequently observed in older reinforced concrete members [68] constructed with plain reinforcement bars, inadequate concrete cover, and poor material quality in both Erzincan and Malatya provinces (Figure 20).

**Figure 20.** Examples of bond deterioration and pullout-related damage of longitudinal reinforcement observed in reinforced concrete members after the Erzincan and Malatya earthquakes. The yellow boxes indicate regions of bond degradation and reinforcement pull-out failure.

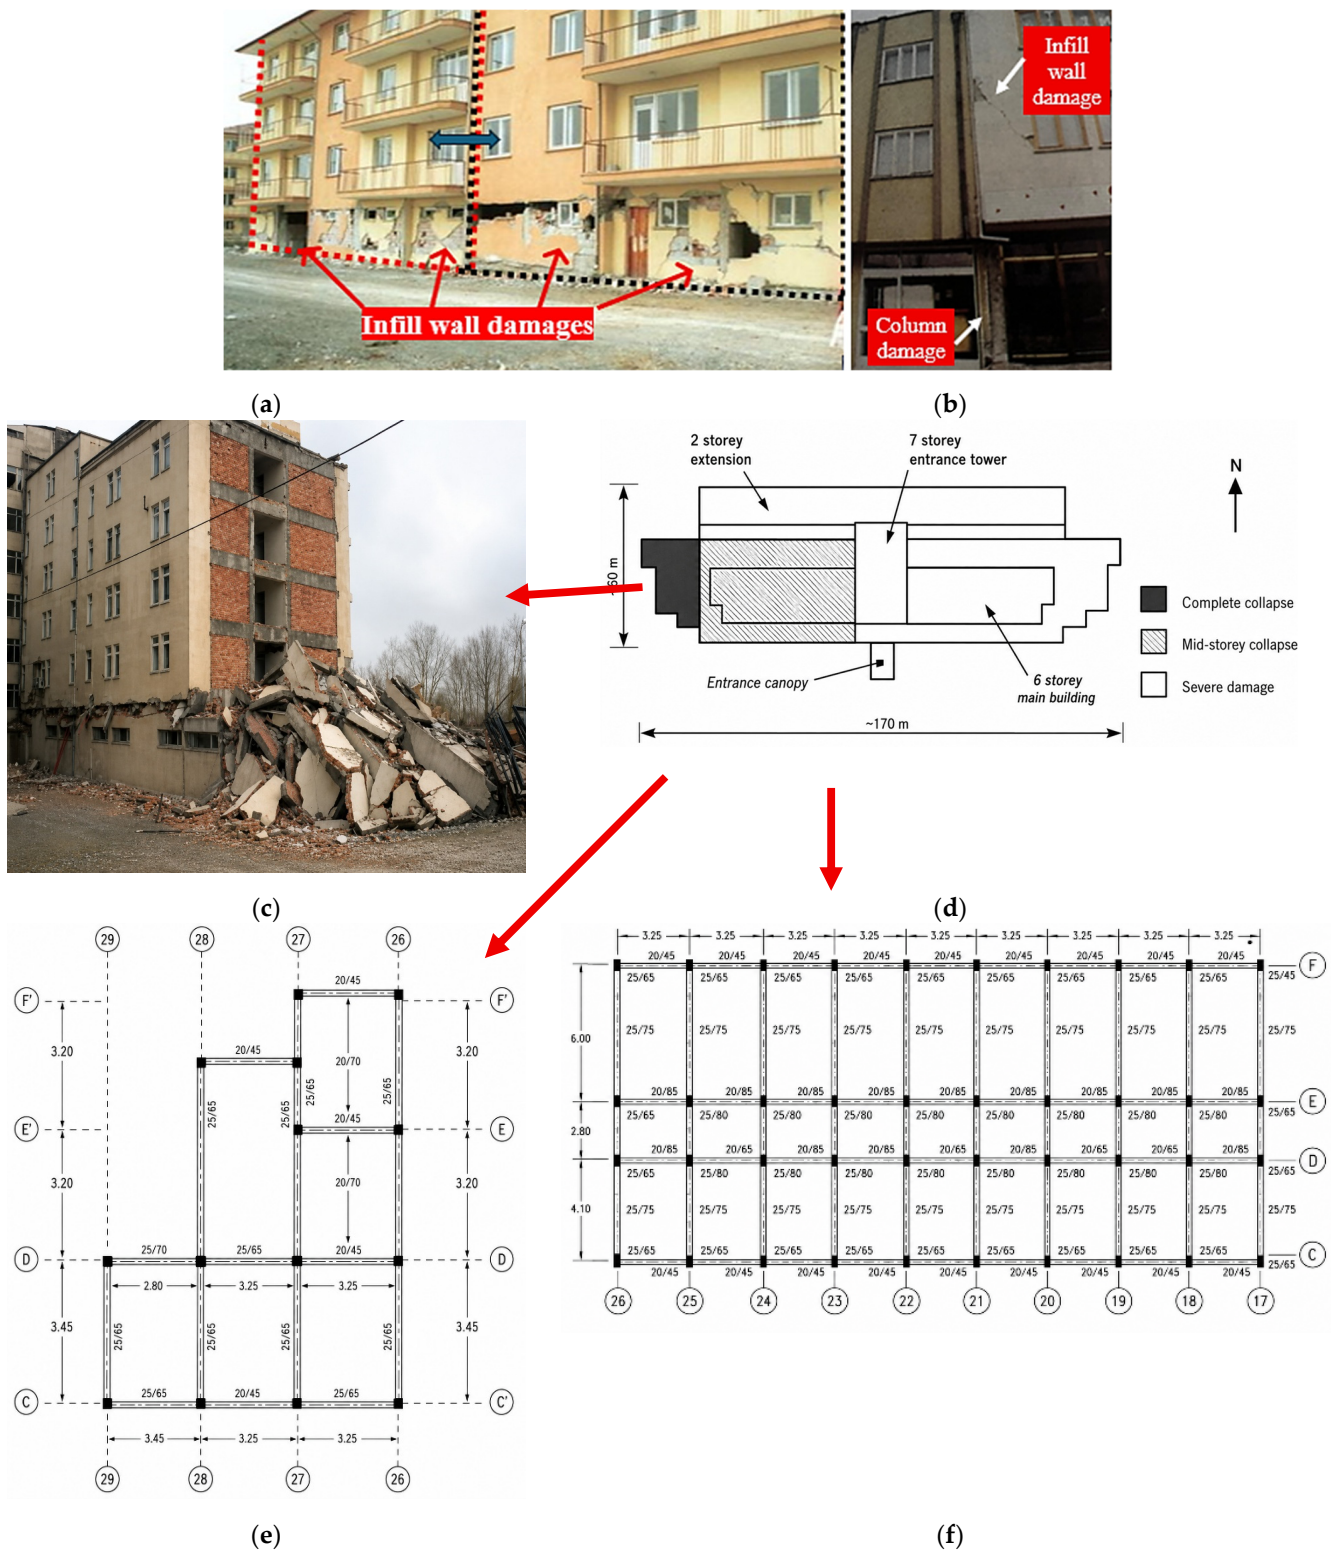
The recurrence of pounding-related damage in both Erzincan and Malatya demonstrates that dense urbanization patterns, insufficient seismic separation distances, and architectural irregularities continue to generate significant seismic vulnerabilities despite the evolution of Turkish seismic design codes.

**Figure 21.** Examples of pounding-related damage observed in Erzincan Province: (a) infill-wall pounding damage; (b) column pounding damage; (c) partial collapse associated with building pounding; (d) schematic representation of the observed collapse mechanism; (e) structural layout of the investigated building; and (f) floor plan of the building associated with the observed pounding damage. The numbers and letters shown in the structural layouts represent gridline identifiers, while the dashed box indicates the investigated or highlighted structural region.

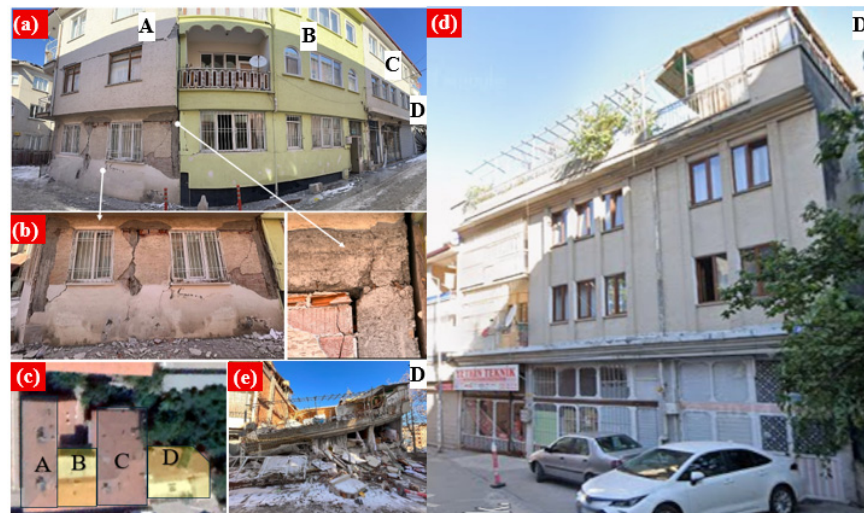
**Figure 22.** Post-earthquake damage assessment of adjacent reinforced concrete buildings (A–D) in Malatya Province following the 2023 Kahramanmaraş earthquake sequence: (a) overall view of the investigated buildings and observed damage patterns; (b) infill wall cracking, plaster spalling, and façade damage in Building A; (c) aerial view illustrating the layout and relative positions of Buildings A–D; (d) general façade view of Building D; and (e) partial-to-total story collapse and extensive structural damage recorded in Building D.

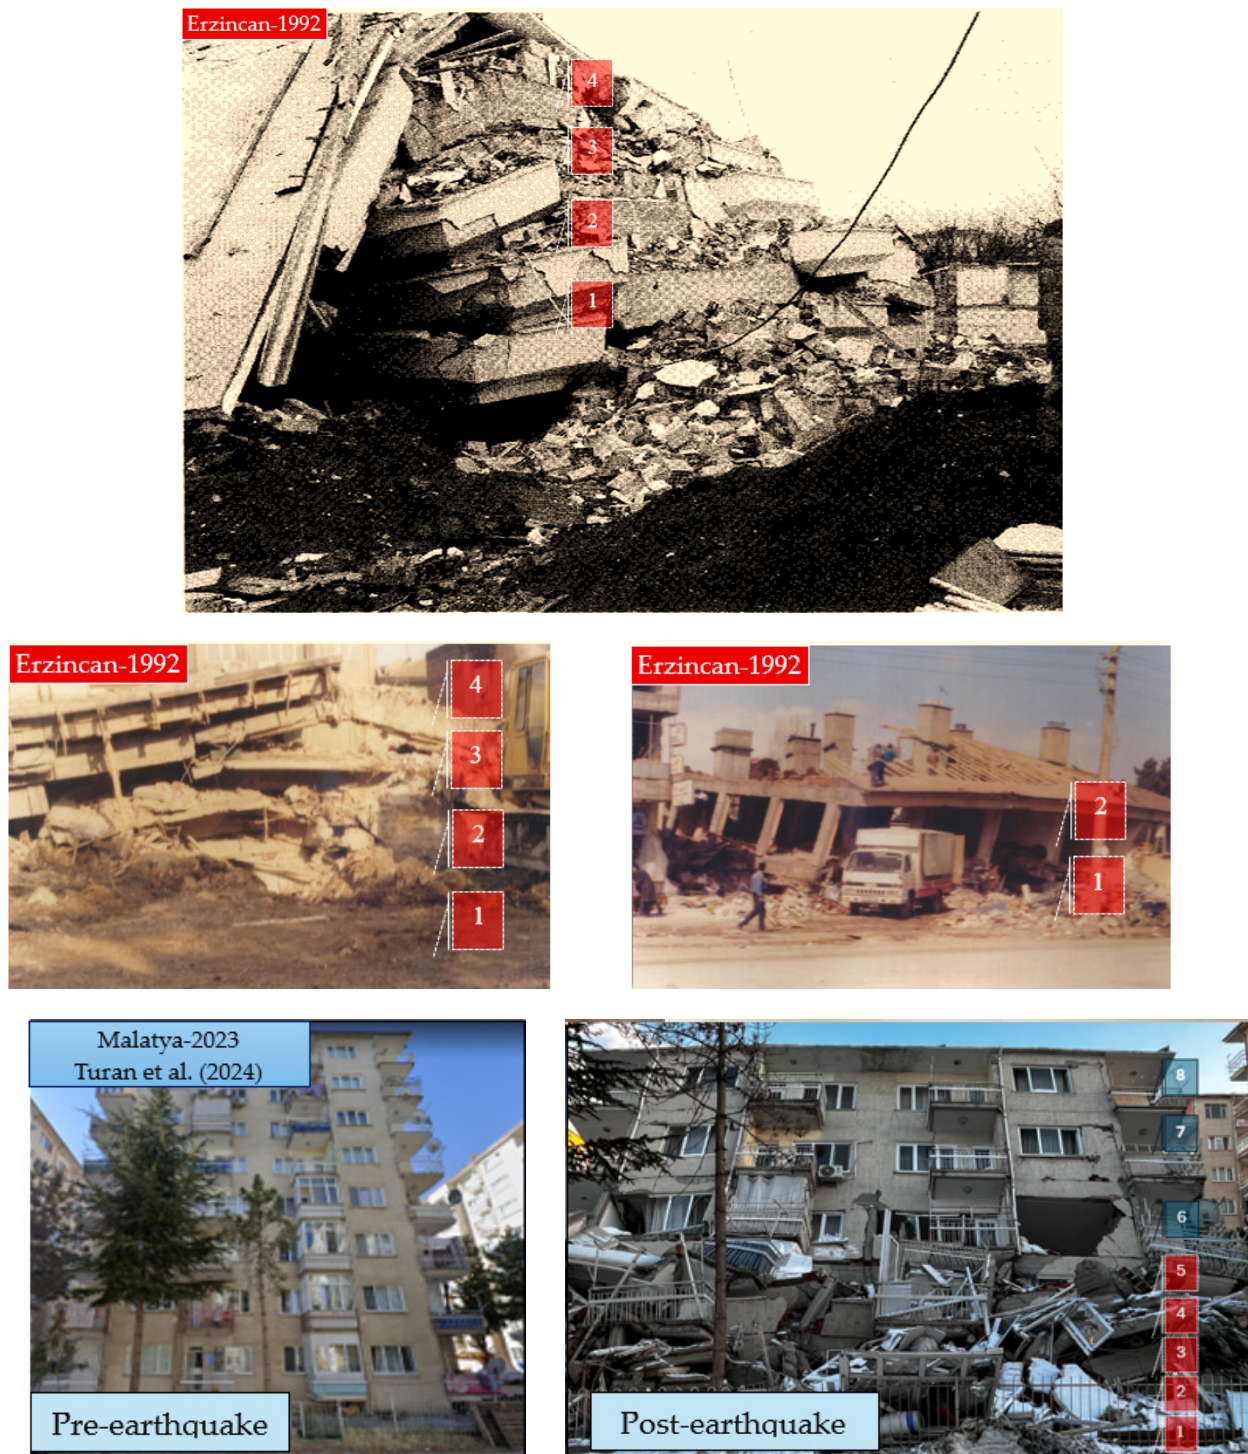
**Figure 24.** Examples of progressive collapse observed in multi-story reinforced concrete buildings in Erzincan (1992) and Malatya (2023): the sequential failure of lower-story columns led to upper-story collapse, highlighting weak-story mechanisms and stiffness irregularities. Numbered annotations indicate the sequence of failure across stories. The Malatya-2023 case is based on field observations reported in Turan et al. (2024) [43], with additional visual representation for comparative documentation purposes.

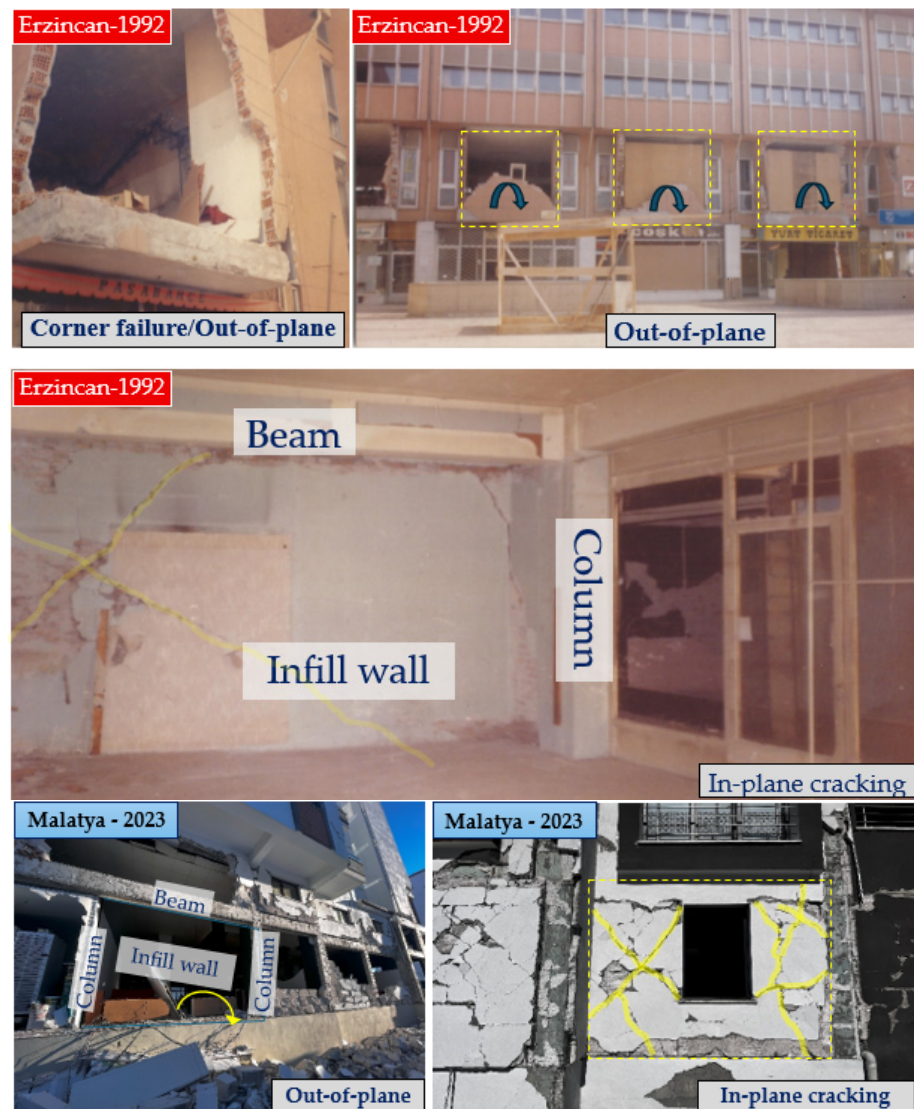
The recurring infill-wall damage patterns observed in both Erzincan and Malatya demonstrate that infill walls continue to significantly influence the seismic response of reinforced concrete buildings, particularly when stiffness discontinuities, inadequate detailing, and unintended frame–wall interaction are not properly considered in design and construction practice.

**Figure 26.** In-plane cracking, corner failure, and out-of-plane collapse mechanisms observed in infill walls of reinforced concrete buildings following the Erzincan (1992) and Malatya (2023) earthquakes.

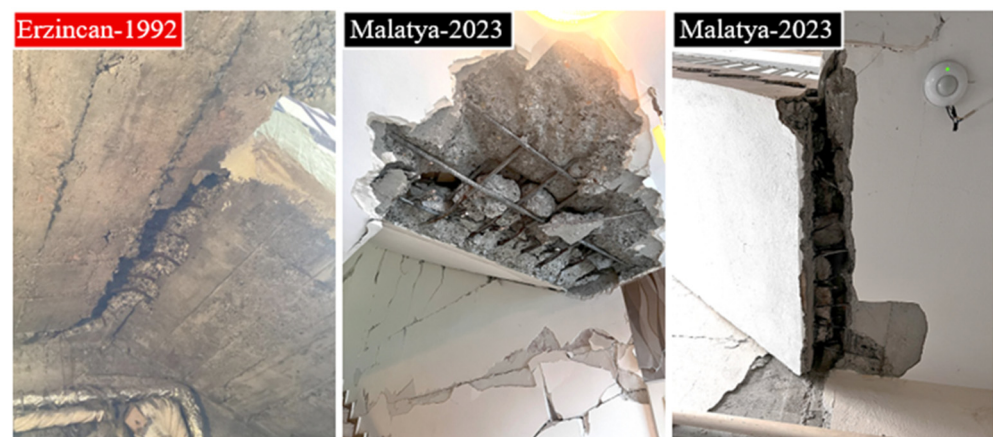
**Figure 28.** Examples of cracking and local crushing damage observed in reinforced concrete staircase landing regions following the Erzincan (1992) and Malatya (2023) earthquakes.
