# The Partial Collapse of the South Road Axis Viaduct in Brasilia—A Forensic Investigation

## Abstract

The partial collapse of the South Road Axis Viaduct in 2018 generated widespread concern about the safety of similar critical bridges and viaducts built during the same historical period in Brasilia. Since many of these structures were designed with analogous structural systems, a thorough post-incident investigation was conducted to understand the failure mechanisms involved. The viaduct collapse remains insufficiently examined in the available technical literature. The present work offers a detailed forensic investigation of the partial collapse of the asset, clarifying the key structural elements and governing mechanics that triggered the sudden failure. This study combined the collection of historical documentation, in situ debris investigation, geometrical and mechanical characterization, manual and numerical calculations, and the determination of structural performance. The results revealed that the viaduct had hidden vulnerabilities (such as a lack of structural redundancy and insufficient reinforcing steel) and significant material degradation and that it was operating u

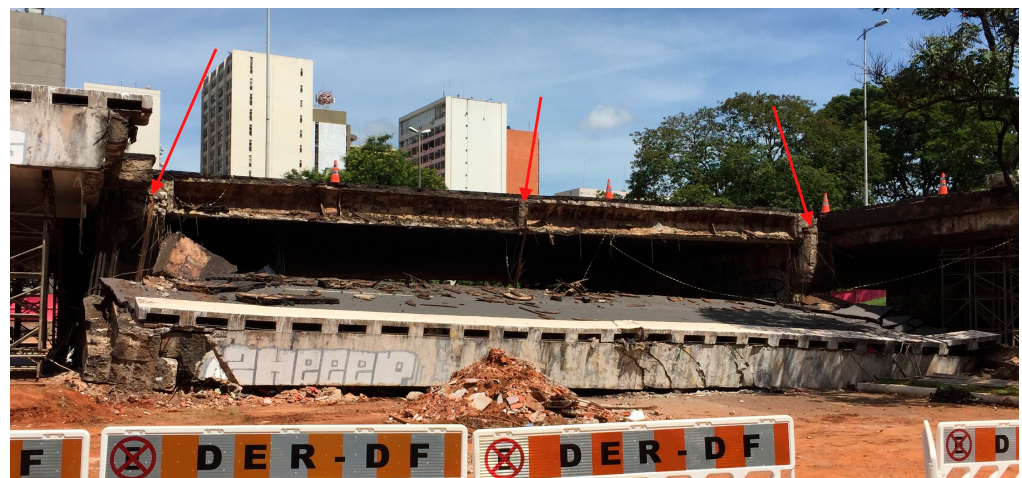
The sudden partial collapse of the South Road Axis Viaduct at the Galeria dos Estados (Figure 1) revealed structural vulnerabilities that could have been common to similar critical structures built during the same period of Brasília's construction. This alarmed the authorities and the population, even more so after the temporary obstruction of one of the main arterial roads in the Federal District.

**Figure 1.** Section of the viaduct at Galeria dos Estados after the partial collapse in 2018, with indication of fracture of the main elements.

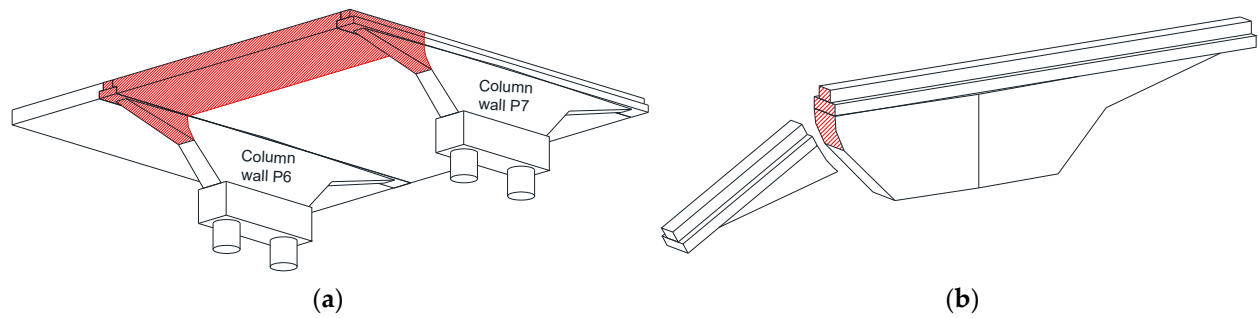
Local assessment of the debris and site scene revealed that the failure mechanism started with the shear failure of column wall P7 (indicated by the smooth "clear" section in Figures 6 and 7b) at the beginning of the extension of the element, where there is a transition from the delta shape to the column cantilever extension.

**Figure 5.** (a) View of the deck section that collapsed (in red); (b) indication of the plane of failure of column wall P7 at the beginning of the cantilever extension (in red).

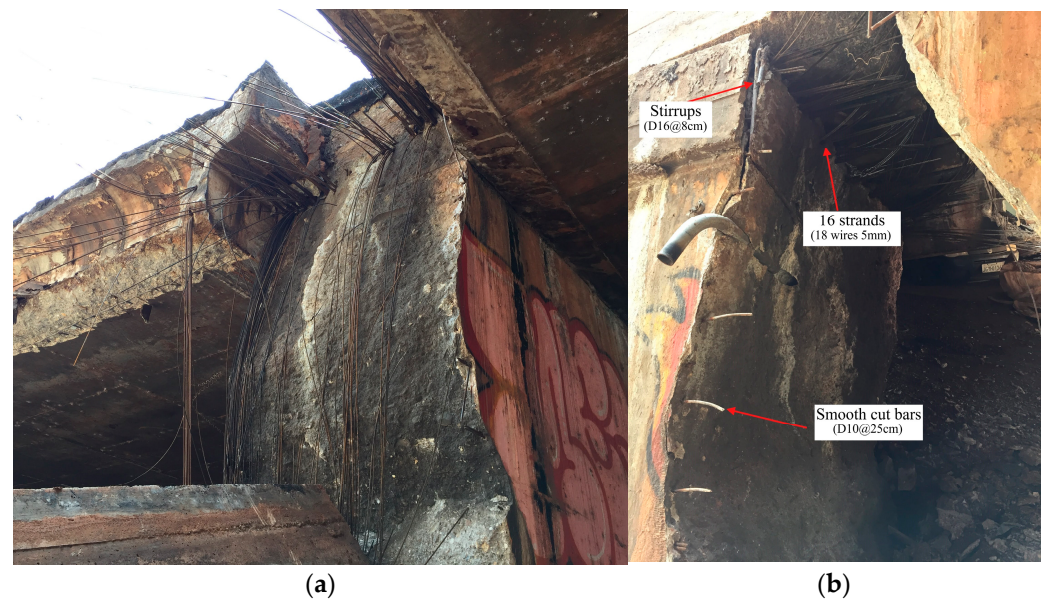
**Figure 6.** Investigation of the debris: (a) close-up view of column wall P7, indicating the smooth section, cut strands, and water infiltration; (b) fallen column-wall extension after collapse, indicating the small-diameter smooth bars and the stirrups only at the top of the prestressed cross-beam.

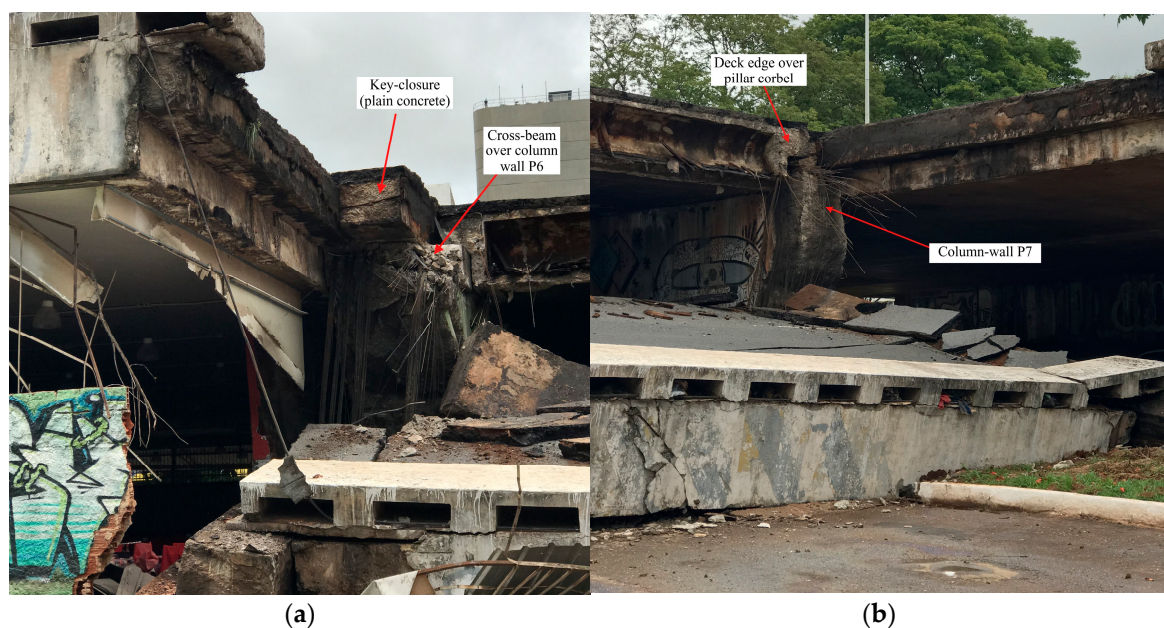
**Figure 7.** Investigation of the debris: (a) column wall P6 fracture; (b) column wall P7 fracture.

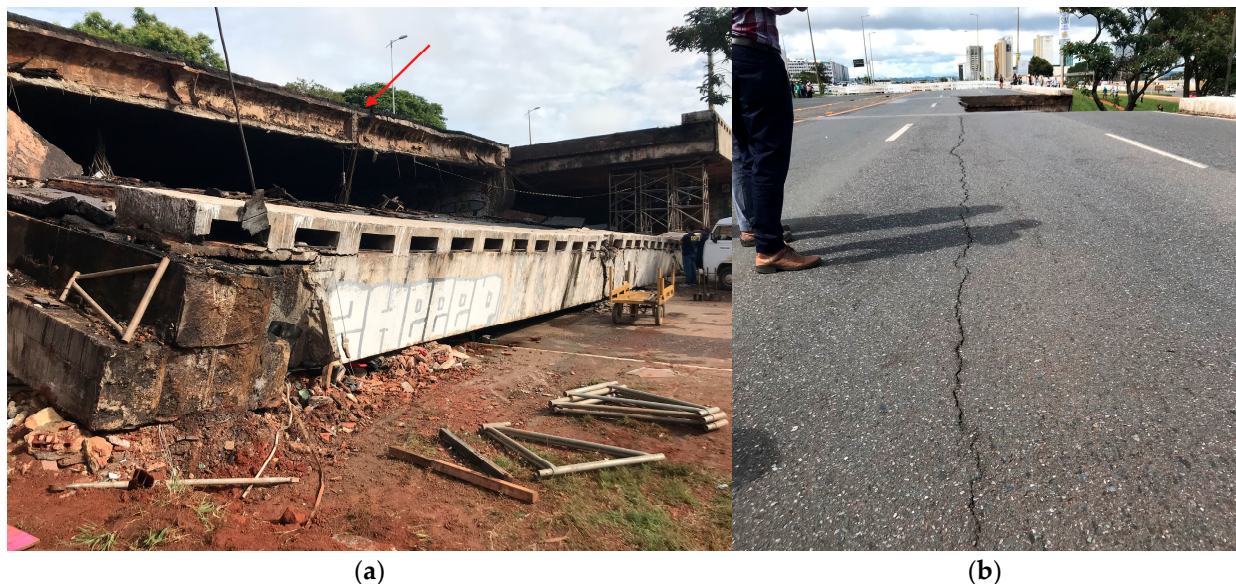
Once the column-wall extension at P7 collapsed, the right support of the concrete hollow deck began to move downward due to the loss of equilibrium. This movement pulled the other end of the deck, which was connected to the top of column wall P6 by the plain concrete key closure and the deck prestressing anchorage. The movement of this massive section generated immense kinetic energy, which was partially absorbed by the cross-beam of column wall P6 (which presented the same chronic deficiency as column wall P7). This created a large, unbalanced lateral force that exhausted the remaining capacity of the cross-beam at column wall P6, fracturing it by pullout and shear, spalling the concrete, and damaging adjacent members (as seen in the destroyed surface in Figure 7a). The last component of the concrete hollow deck was its prestressed transverse beam, which was unable to support all the remaining loads from the system. This last element also failed under shear, creating a smooth surface evident on site, as shown in Figure 8a (highlighted by the center arrow). Additionally, a large longitudinal crack was present across the road lane in all deck sections adjacent to the partially collapsed deck, indicating that endemic problems were not exclusive to this region. This crack is shown in Figure 8b.

**Figure 8.** Investigation of the debris: (a) section of the deck that collapsed, highlighting the transverse beam that failed under shear (indicated by the red arrow); (b) large longitudinal asphalt crack across the deck next to the fallen section between column walls P5 and P6.

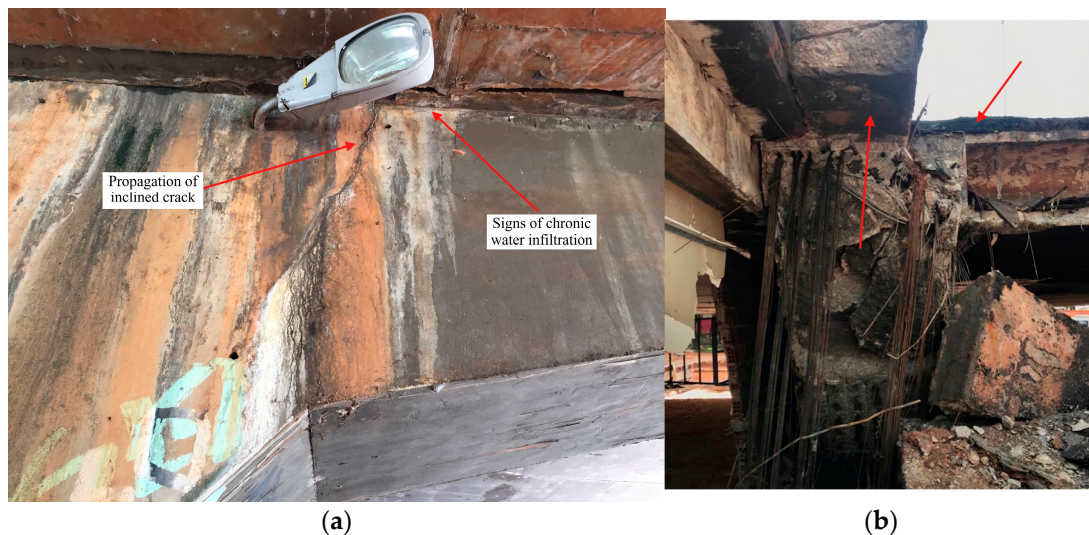
Additionally, engineering teams were unable to assess the structure across the viaduct because a restaurant had been located underneath the viaduct, where infill partition walls and ducts obstructed the view of the pillars. Once these elements were removed or demolished, engineers were able to detect several problems, including severe cracking and chronic water infiltration, in all column walls. These problems are indicated in Figure 9.

**Figure 9.** Investigation of the debris: (a) column wall P7 (on the end that did not collapse), indicating the propagation of the inclined crack and water infiltration (which was common to all columns); (b) underside view of the prismatic key-closure element over the fallen column-wall extension P6, where signs of chronic water infiltration were detected (in the locations pointed by the red arrows).

site investigations revealed a large individual crack (Figure 9a) rather than well-distributed cracks, this evidence supports the previous comments.

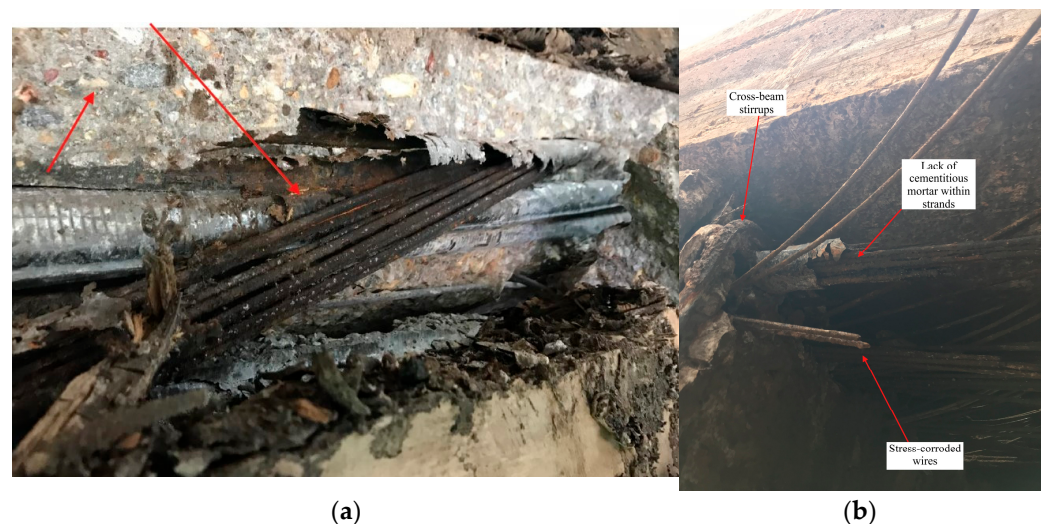
Engineers were also able to evaluate the quality of the materials employed during the construction of the viaduct. They detected a lack of cementitious mortar (grout) in several strands of prestressing cables, as per Figure 10a. Additionally, the concrete was composed of rounded river gravel aggregate rather than conventional limestone coarse aggregate. This evidence can be seen in Figure 10b.

**Figure 10.** Investigation of the debris: (a) concrete made with rounded river gravel aggregate and absence of grout in strands (indicated by arrows); (b) absence of grout mortar within the prestressing strands and stress-corroded steel wires.

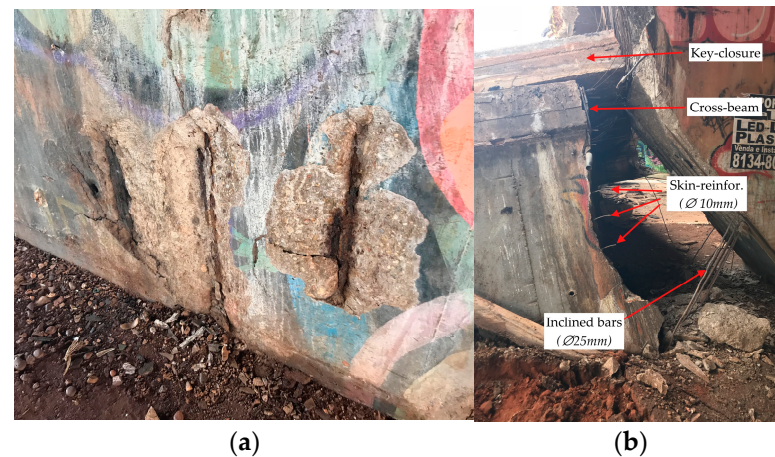
In addition, degradation at the base of the column wall was identified by extensive corrosion of the column rebars, along with concrete spalling and cracking of the nominal cover, as seen in Figure 11a. This region is usually targeted by homeless people, with unsanitary conditions exposing the concrete to aggressive chemical agents. Lastly, at the base of the column wall, inclined bars from the extension faces had peeled out during the collapse of the extension as they resisted the partial collapse through dowel action. This is shown in Figure 11b.

**Figure 11.** Investigation of debris: (a) severe corrosion of column rebars near ground level; (b) fallen section, indicating cut rebars and inclined column bars that had peeled out.
