Analysis of Daylight Control in a Chateau Interior

Abstract: Assessment of daylighting in the residential hall of a historical chateau is presented. The evaluation is based on both the daylight measurement and simulations. Illuminance levels in the interior were controlled in accordance with requirements for light exposition of light sensitive materials. Valuable paintings and claddings as well as wallpapers and furniture upholstery in the hall are extremely light sensitive and they need to be protected from light damage. The daylight measurements and simulations give an overview of daylight conditions in the annual profile for clear sky conditions and for different levels of window shadings.

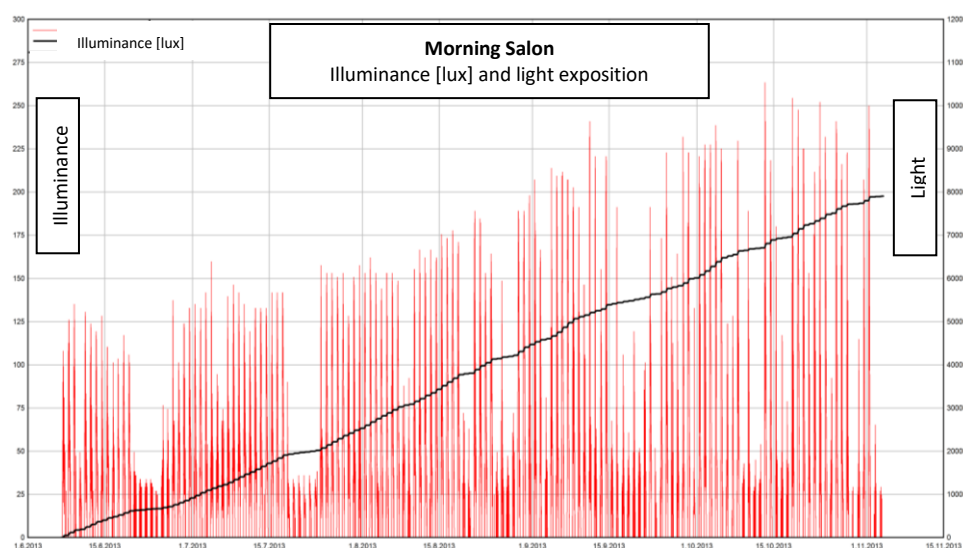
Illuminance data processing brought important information. Light exposure monitoring in October 2013 showed extremely high light exposition of about 80,000 luxhours [24] (Figure 12).

Figure 12. Graph from the data from light measurement in the Morning Salon—illuminance [lux] and light exposition [luxhours] monitoring interval from July to October 2013 [24].

Reasonable explanation of such high values seems to be negligent solar shading activation by the staff. This was confirmed by a test using Light Check light dosimeters, and after a 90-min time exposition very high values were found at the window jambs. High light exposition might be very negative for light-sensitive materials and cause serious and irreversible change and deterioration of quality of the materials such as paintings or upholstery. This finding has led to demands for detailed study of the daylight level in the Morning Salon under different conditions in the annual profile assessment.

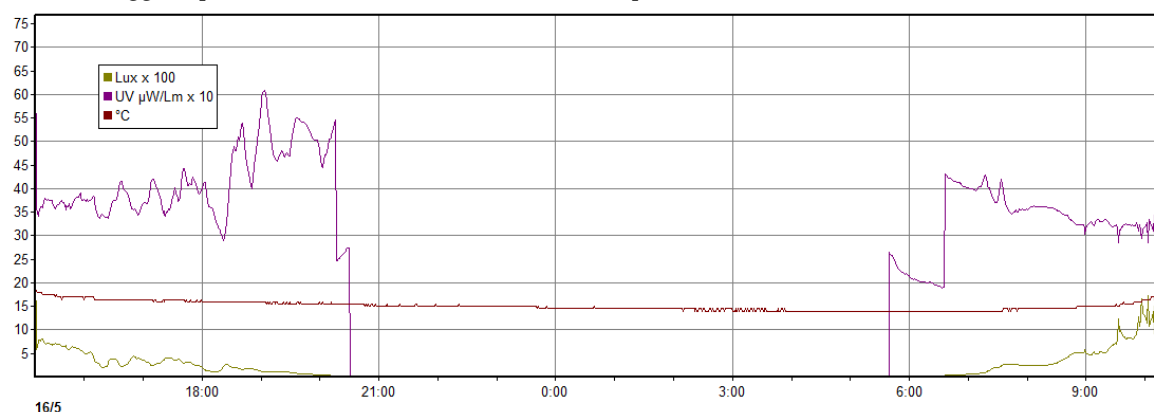
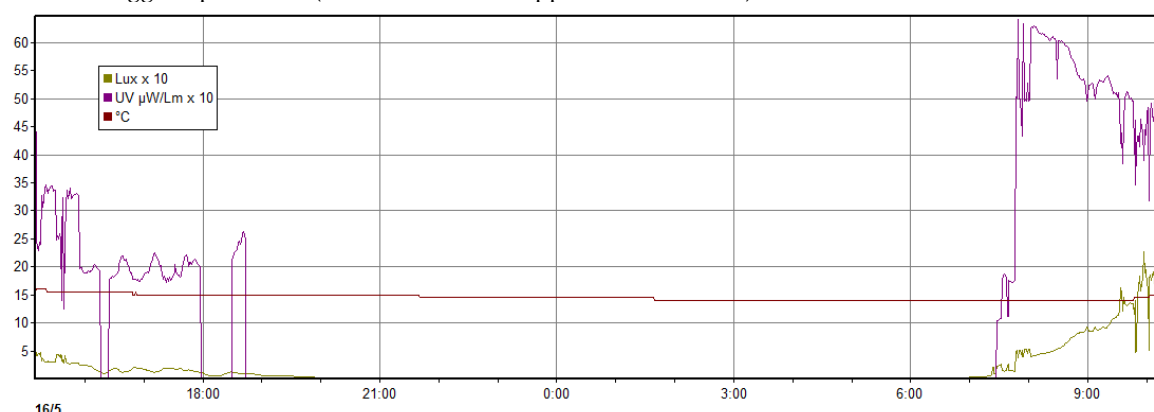
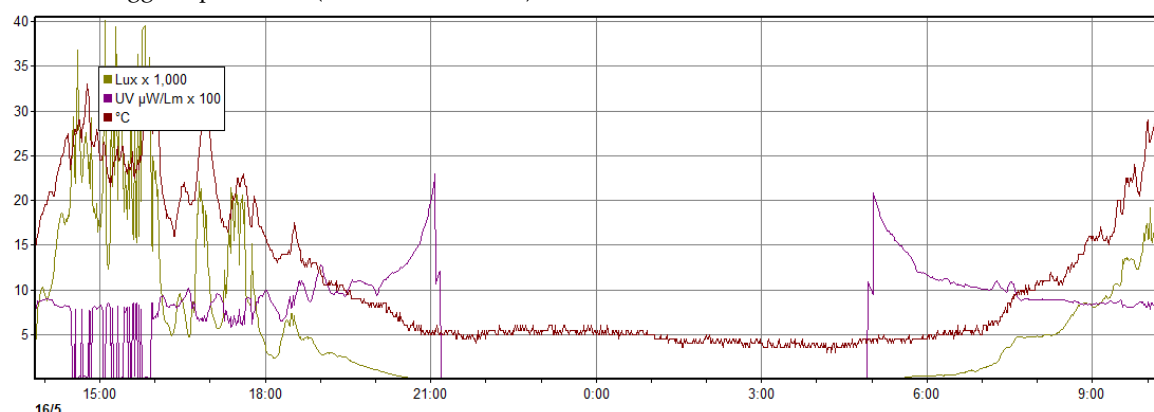
Results of the continual measurements of illuminance ($\text{lux} \times 1000$), UV radiation power and temperature are shown in Figure 14 for internal values at positions A and B as well as external measurements at position C. It is visible from the graphs that illuminance and temperature increase in the morning. Higher illuminance rise is from about 9:00. Afternoon illuminance is lower because of the salon windows' south-east orientation. The UV radiation power is greatest early in the morning at sun rise and in late afternoon during the sun set. It exceeds the limits of maximal permitted standards [25,26] $75 \mu\text{W}/\text{lm}$ [27] (Thomson, 1978) better $10 \mu\text{W}/\text{lm}$ [28] (Saunders 1989). It points to the fact that the Morning Salon windows should have solar shadings activated all the time in the morning and in the afternoon to protect fading and light damage of the salon interior.

Figure 14. Illuminance, UV radiation and temperature in the Morning Salon (monitored time from 16–17 May 2016).

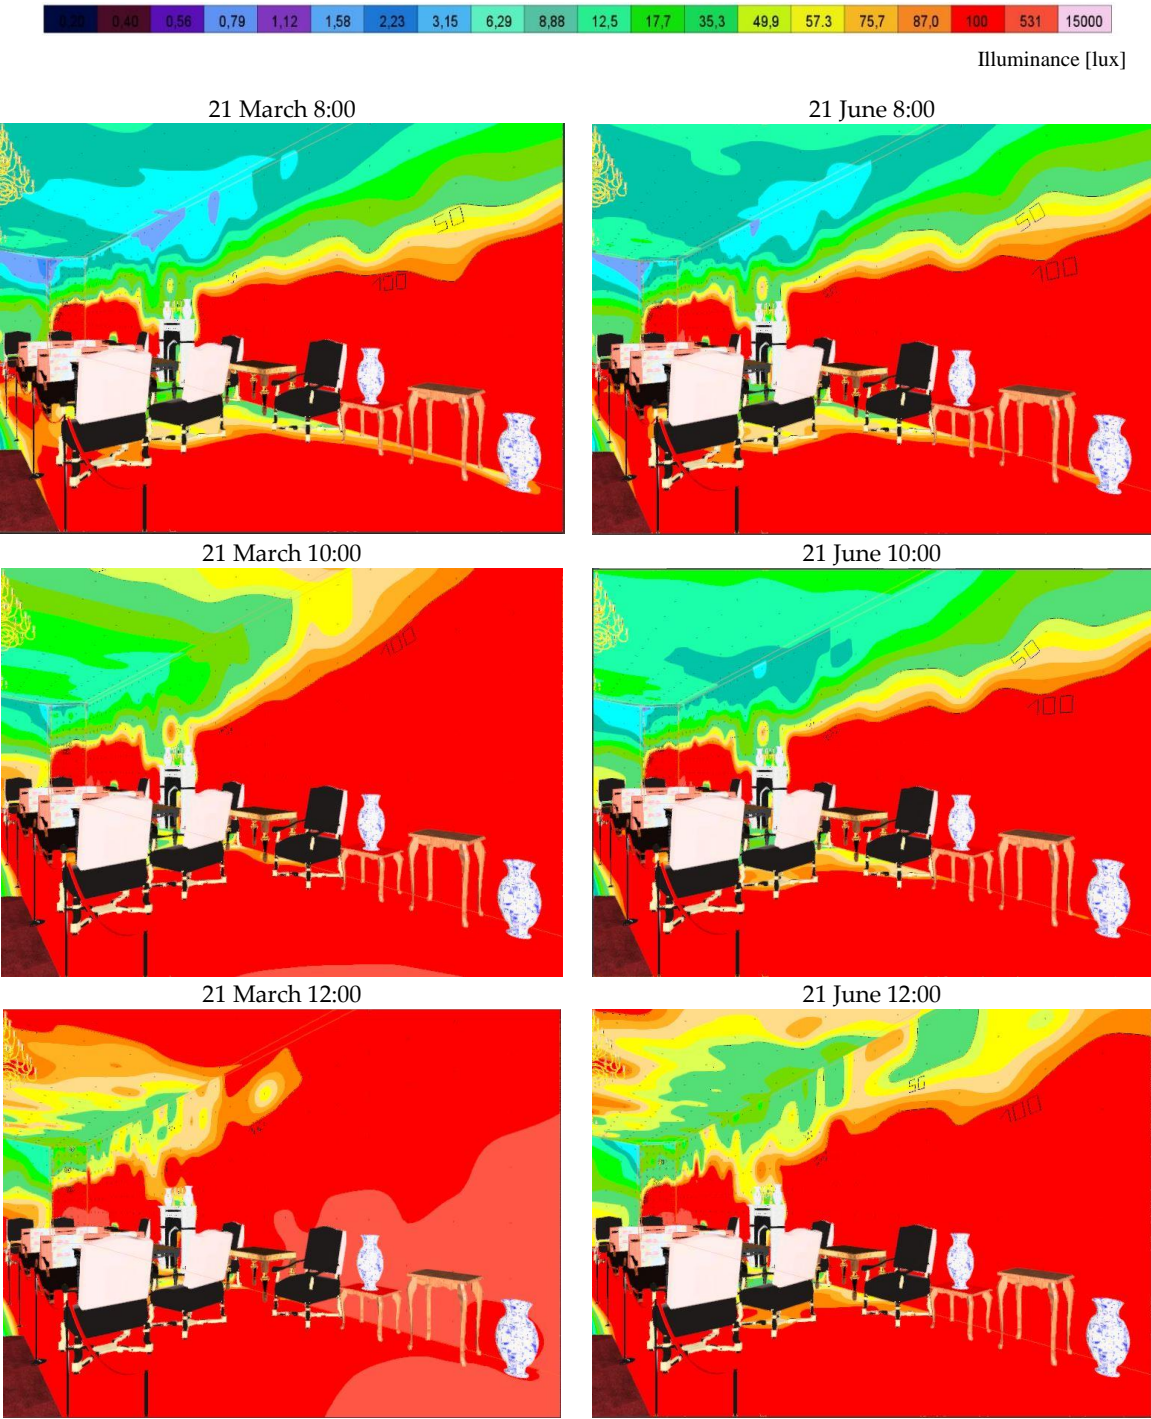
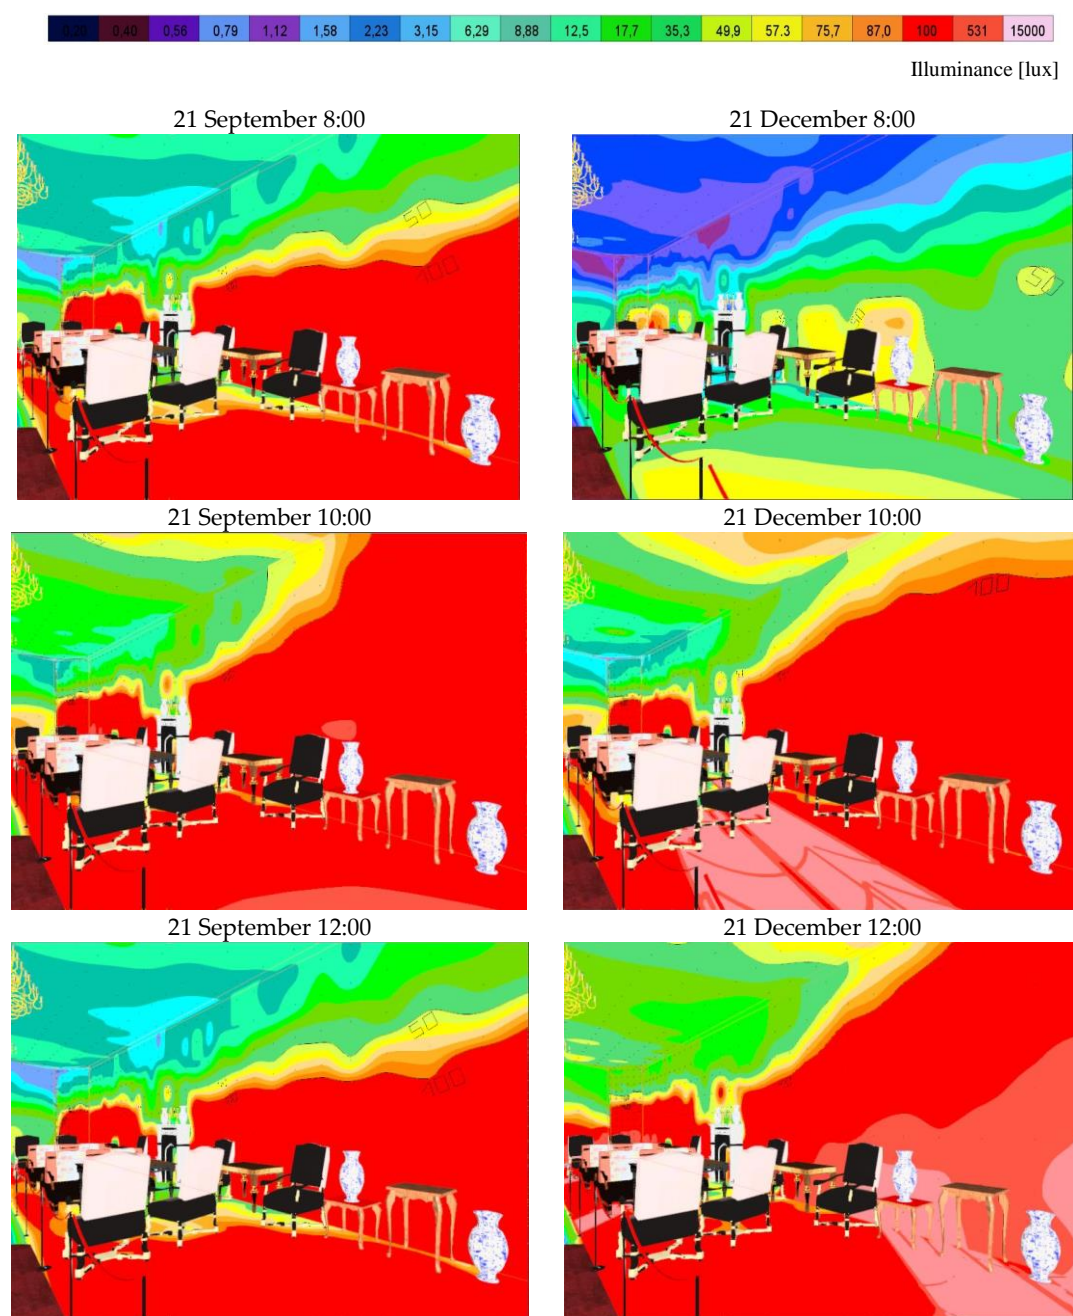
The false color schemes shown in Figures 16 and 17 give an overview of the illuminance in the viewed part of the salon. The light limit of 50 lux is shown in yellow; the orange part is for illuminance between 50 and 100 lux. The red color in the simulations means the places where illuminance level exceeds 100 lux. It means these parts are affected by very high illuminance, which is negative for the light-sensitive interior materials. It is obvious that the wide part of the wall with painting and floor and furniture in the morning time is exposed to very high light limits in case the windows are without shadings. The daylight simulations were completed for the variations with the window shading activation at 25, 50, and 75% (25% unshaded glazed area close to the window sill), simulated for noon (Figure 18).

Figure 16. View to the wall opposite to windows—illuminance (lux) levels for 21 March and 21 June.

Figure 17. View to the wall opposite to windows—illuminance (lux) levels for 21 September and 21 December.

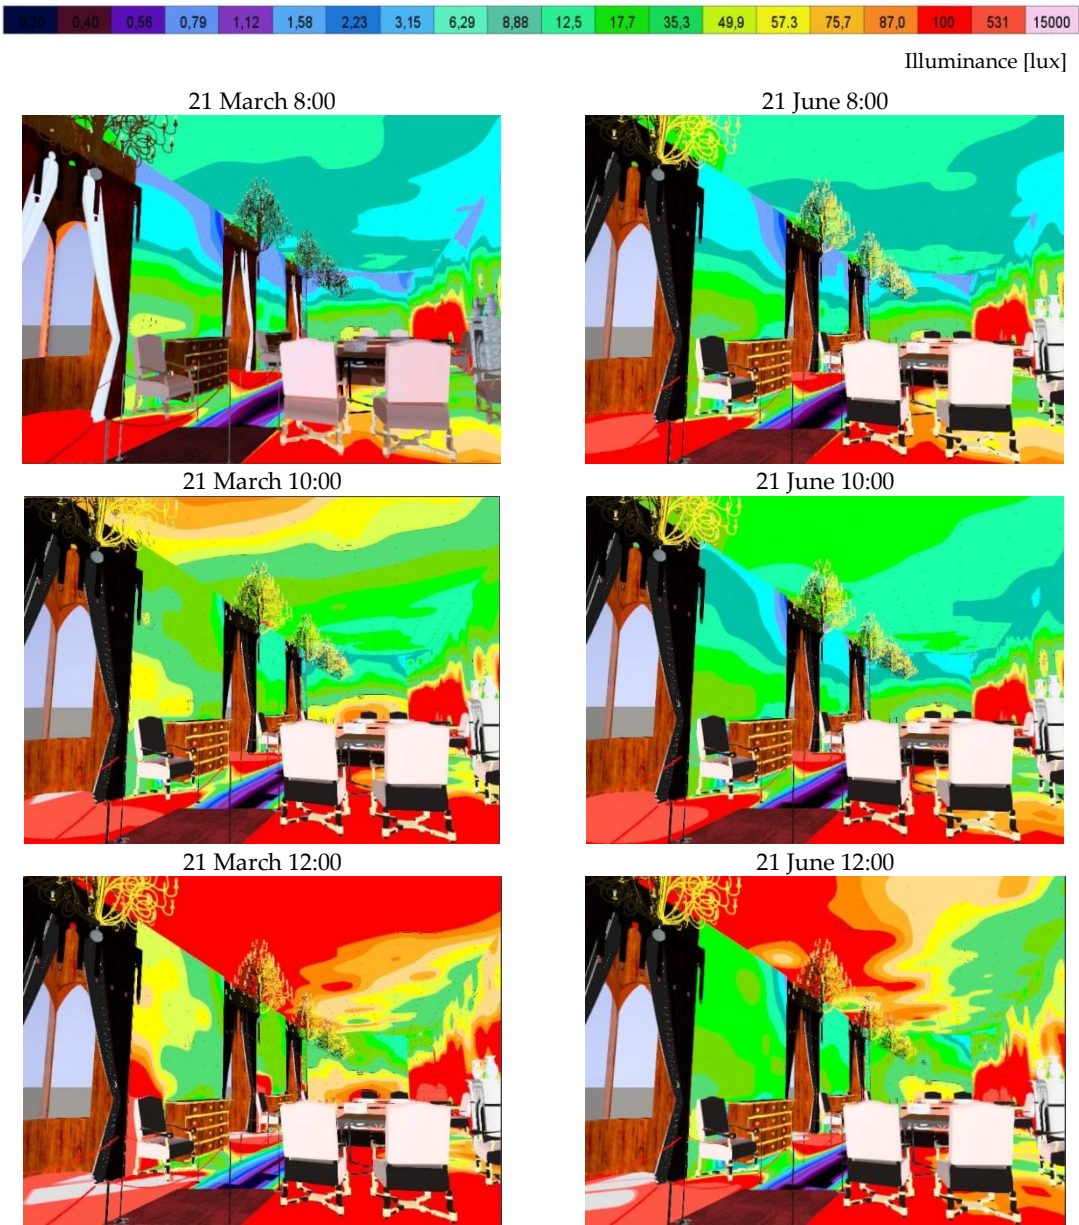
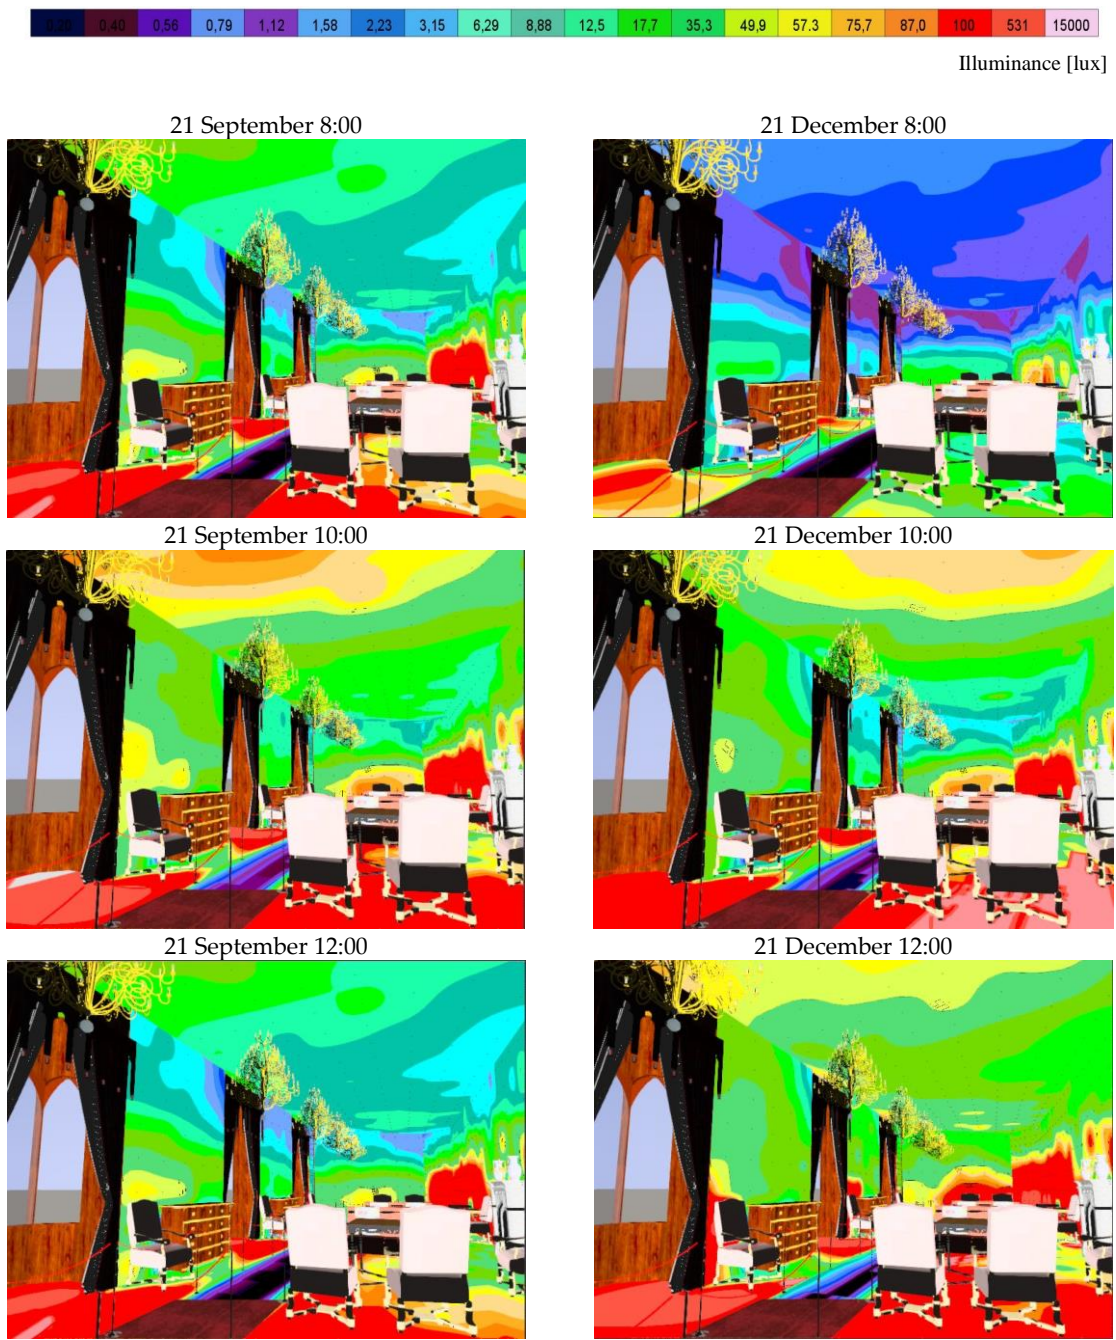
The simulations for the view to the windows shows that the high rise of illuminance is between 10:00 and noon. The floor area is highly affected. Ceiling soffit has increased illuminance level from March to June and between September to December. The view to the windows was also simulated for shading activation at 25%, 50%, and 75% (Figure 22).

Figure 20. View to window area—illuminance (lux) levels for 21 March and 21 June.

Figure 21. View to window area—illuminance (lux) levels for 21 September and 21 December.

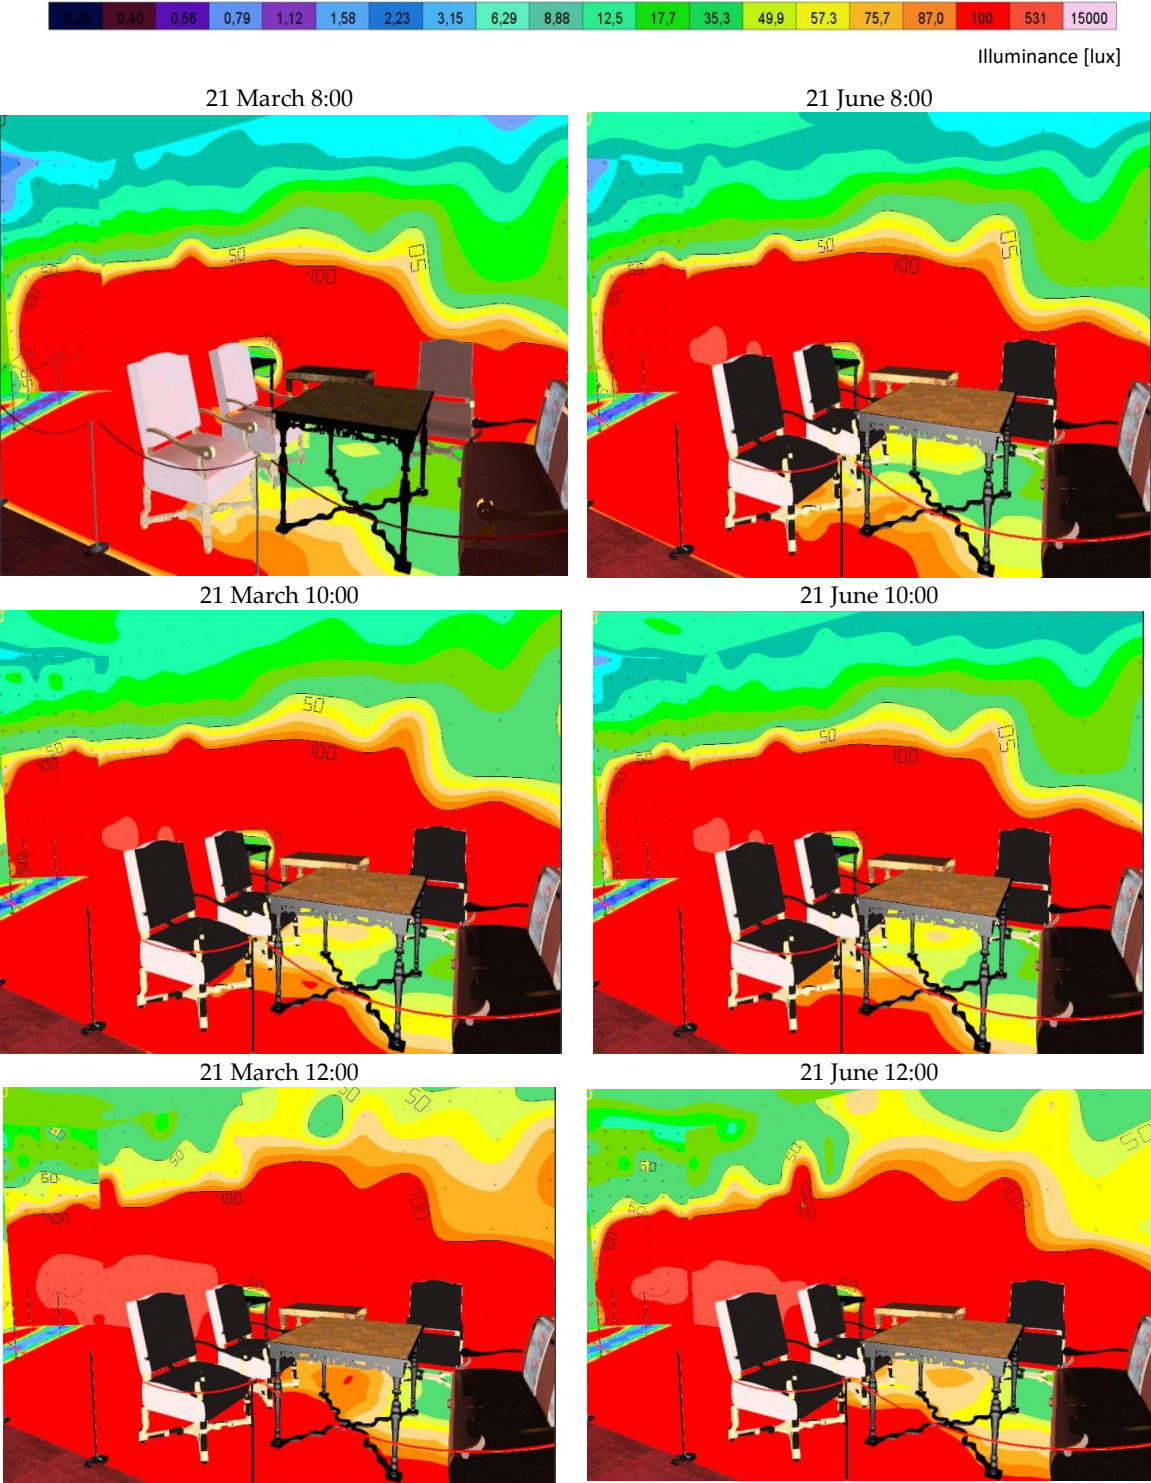
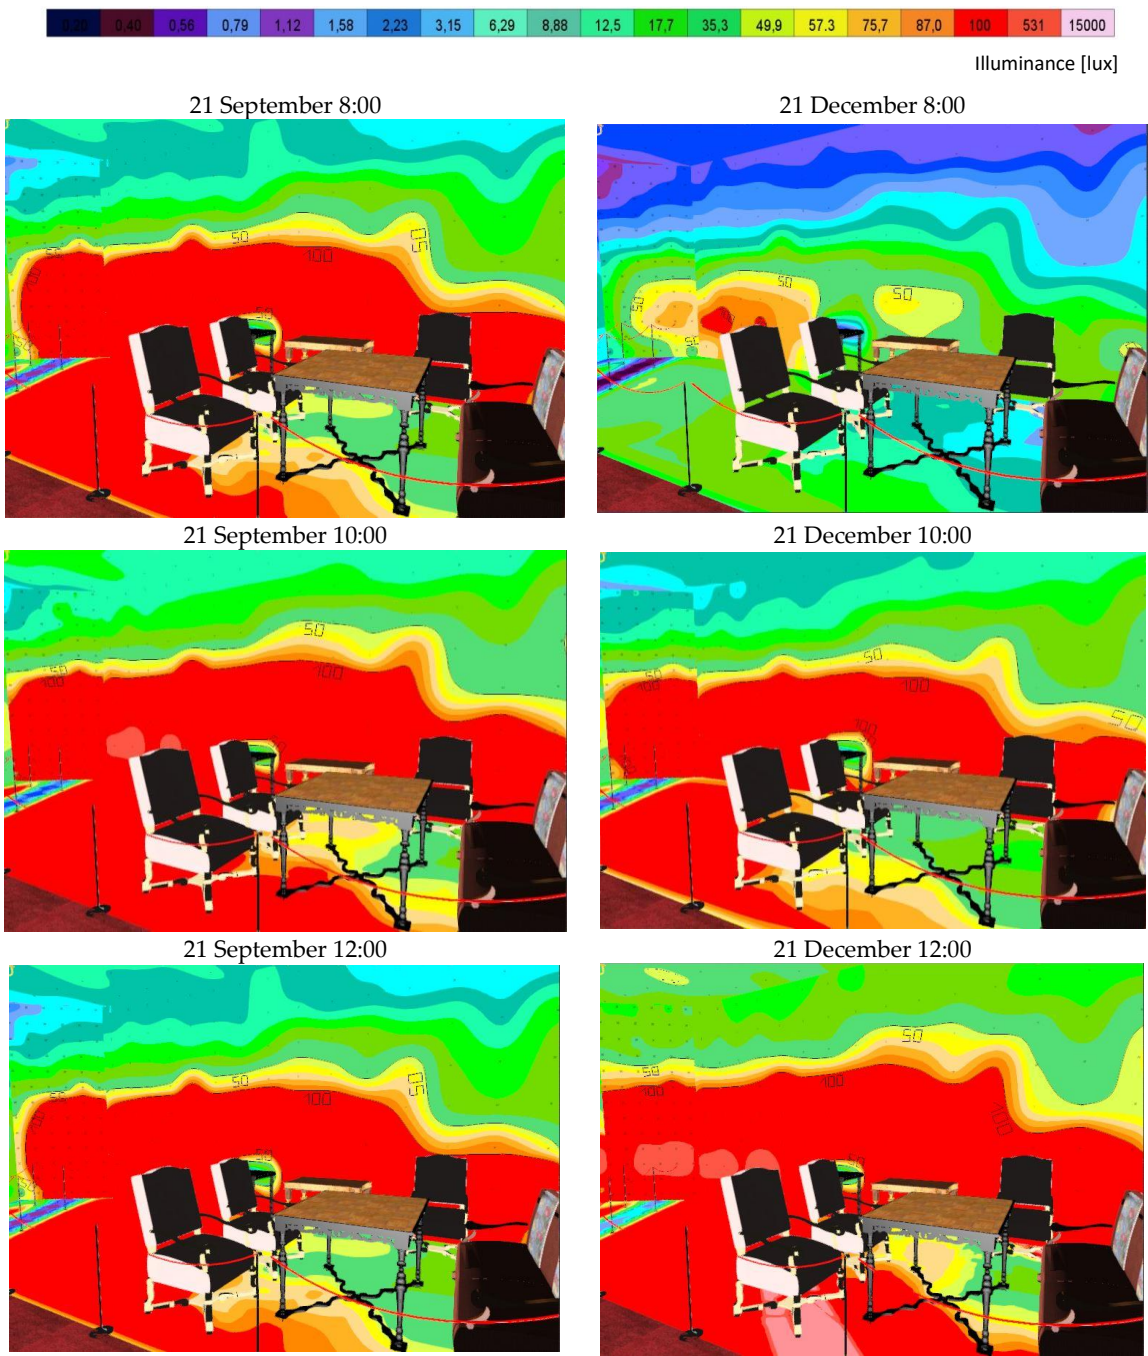
The area of the furniture location in the middle of the salon is all the time exposed to high illuminance level, as it is seen from the simulations in Figures 24 and 25. This is a problem influencing the quality of textiles of armchairs and sofa upholstery in the salon. The furniture area was also simulated for variations with the window shading activation for 25%, 50%, and 75% shown in Figure 26.

Figure 25. Furniture—illuminance (lux) levels for 21 September and 21 December.

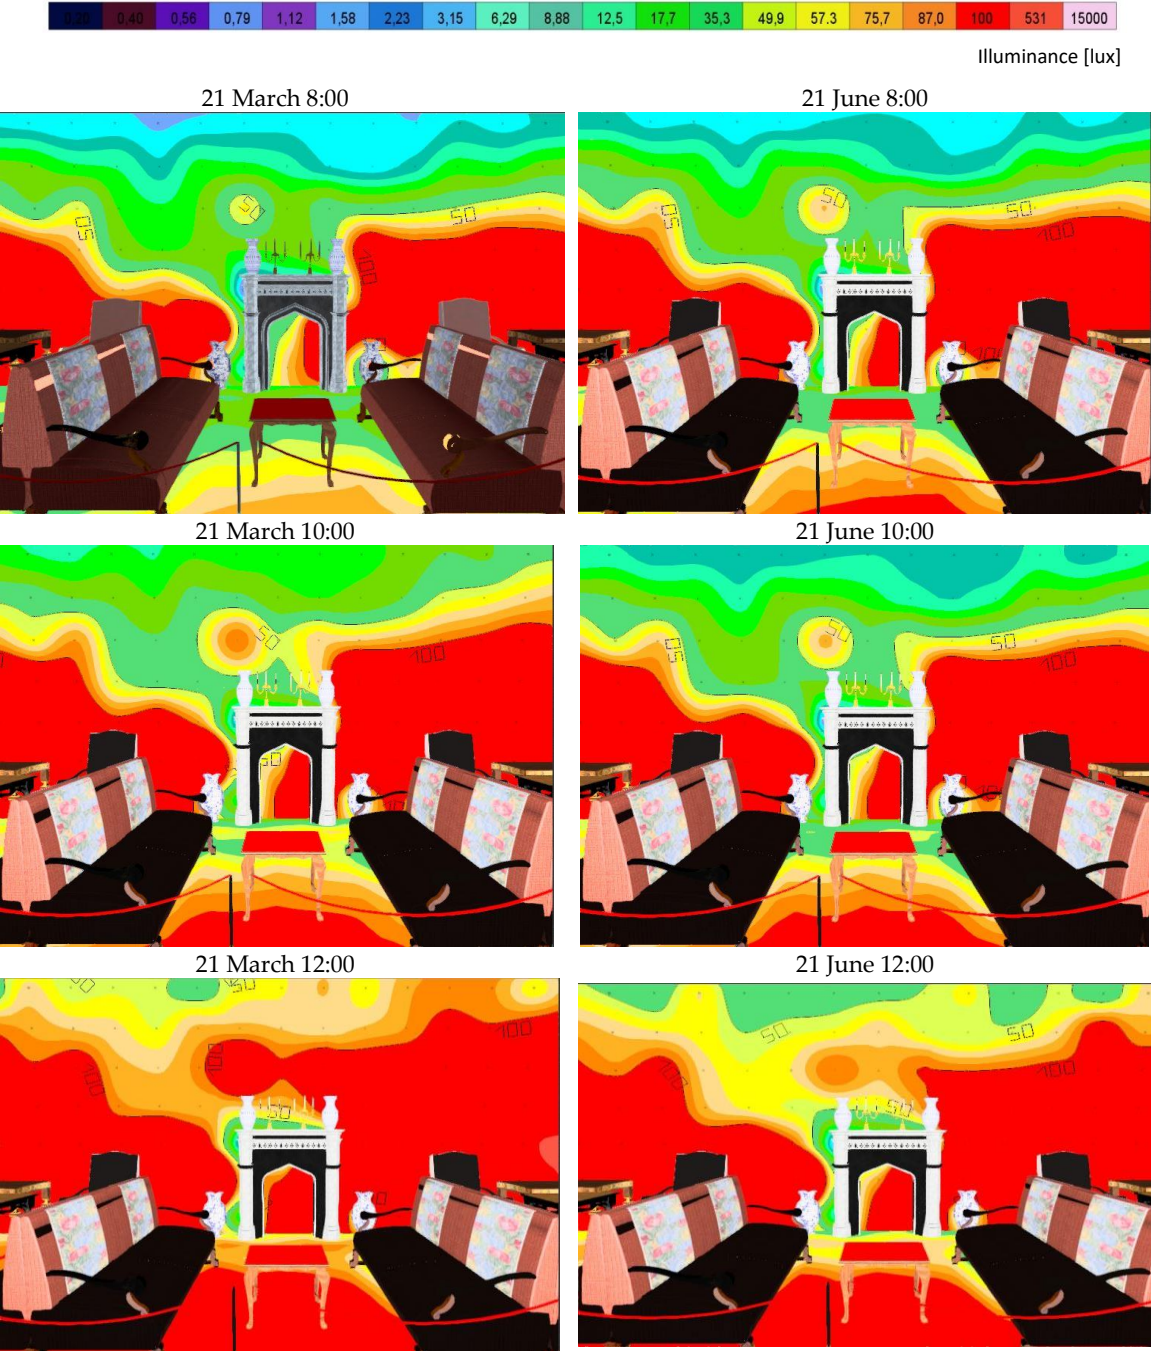
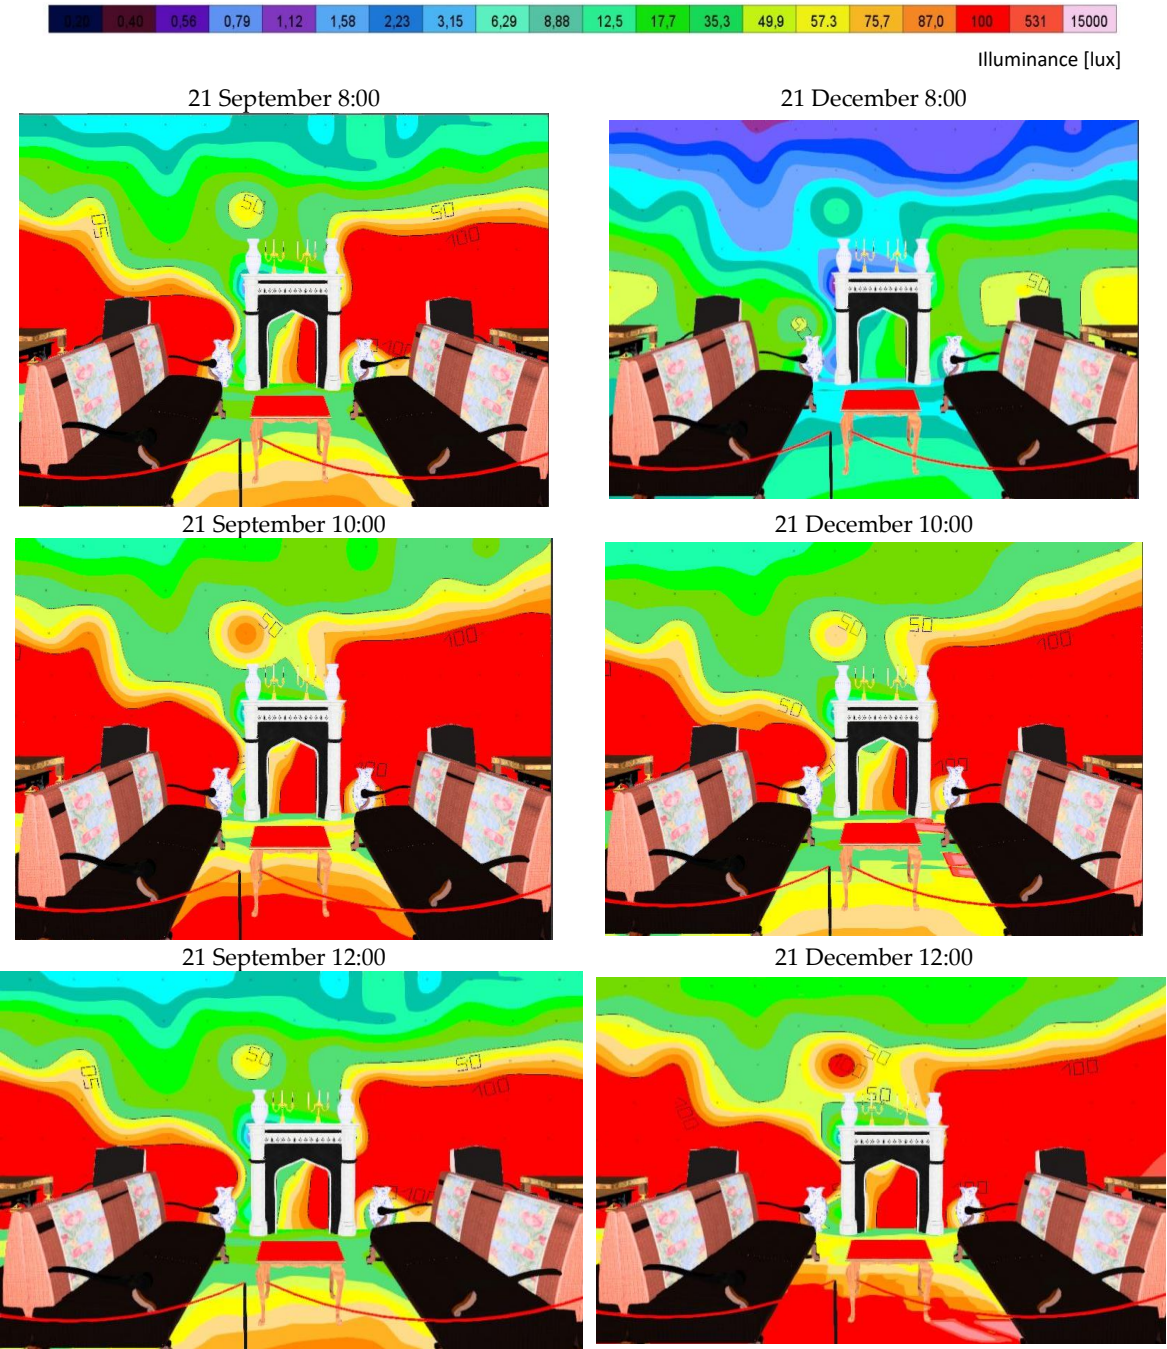
The area of the painting is overexposed for a substantial part of the year. It represents a high potential damage of painting degradation and color bleaching. The view of the painting was simulated for shading activation at 25%, 50%, and 75%, as shown in Figure 30. The light level on the vertical plane close to the painting (Figure 31) is shown in detailed evaluation in Figures 32 and 33.

Figure 28. View to the painting—illuminance (lux) levels for 21 March and 21 June.

Figure 29. View to the painting—illuminance (lux) levels for 21 September and 21 December.

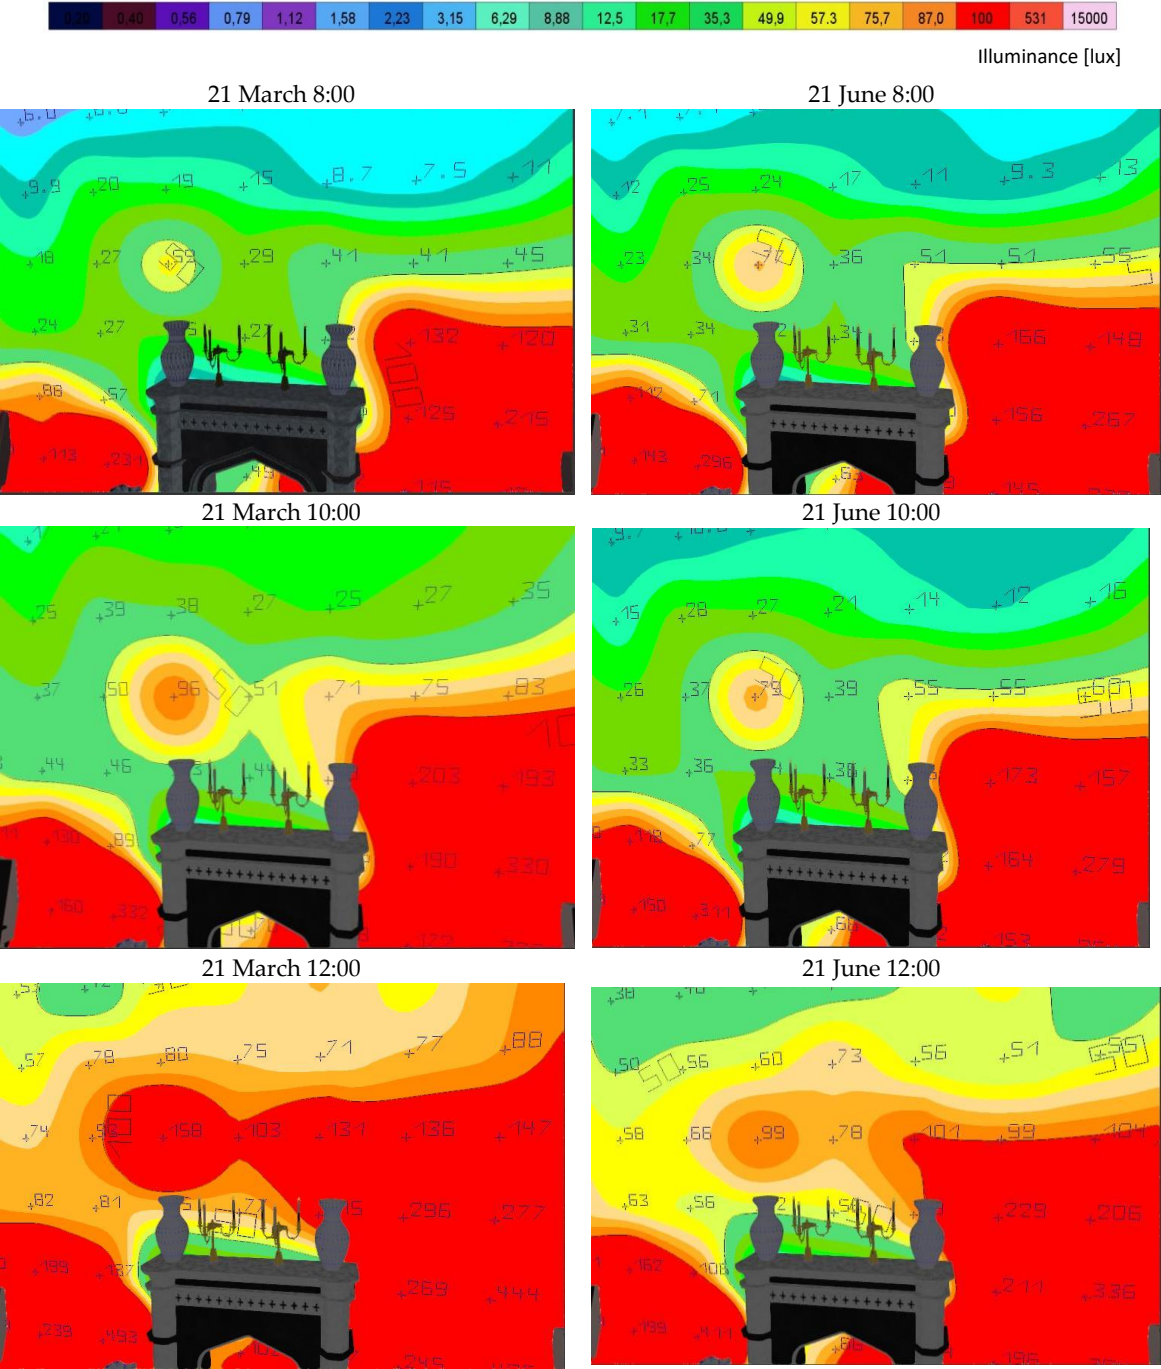
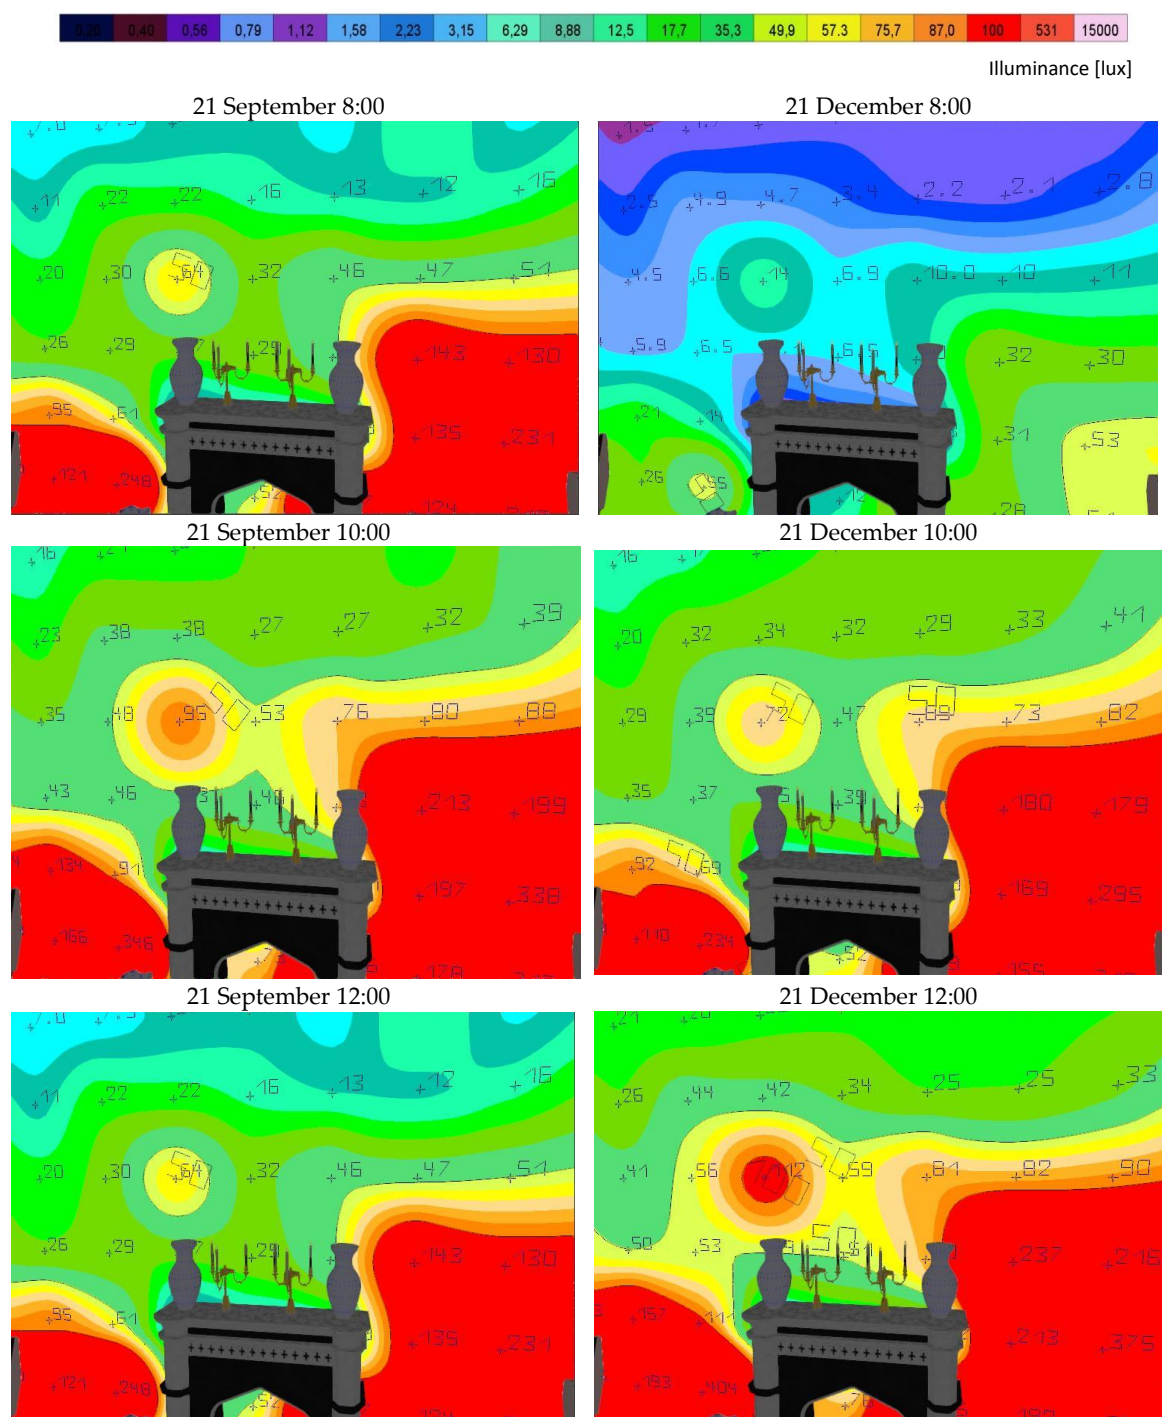
Figures 32 and 33 give an overview of the illuminance level of a part of the vertical plane close to the painting is over the 50-lux limit all year except in the early morning time in December. The painting light exposition was also studied for window shading activation at 25%, 50% and 75%, as shown in Figure 34.

Figure 32. Detail view to the painting—illuminance (lux) levels for 21 March and 21 June.

Figure 33. Detail view to the painting—illuminance (lux) levels for 21 September and 21 December.

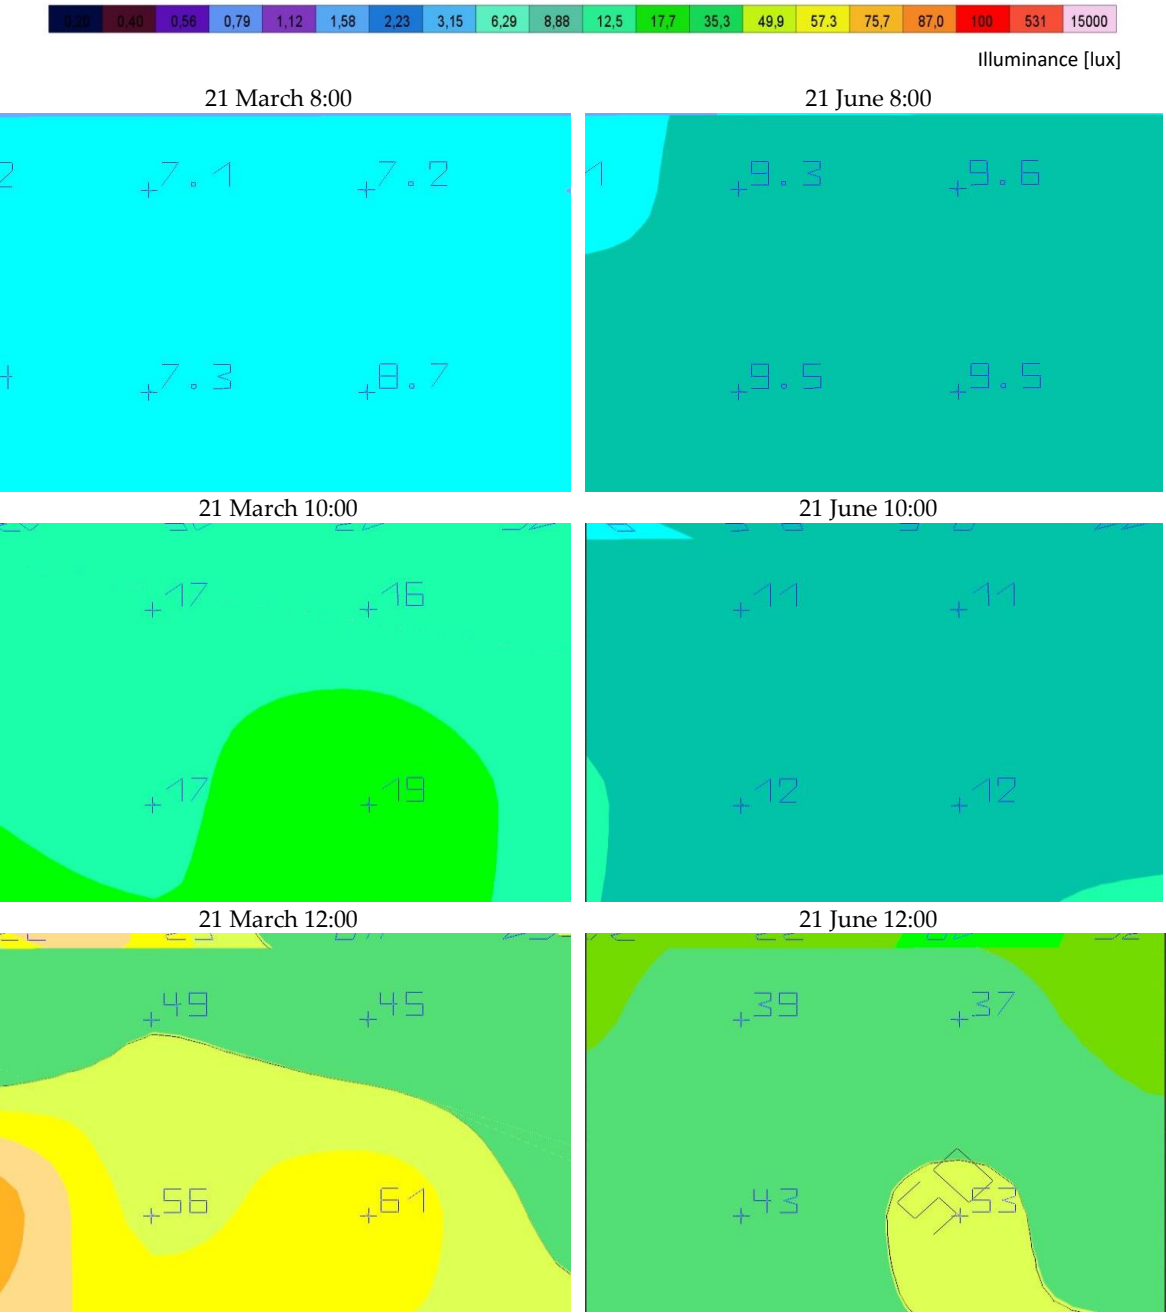
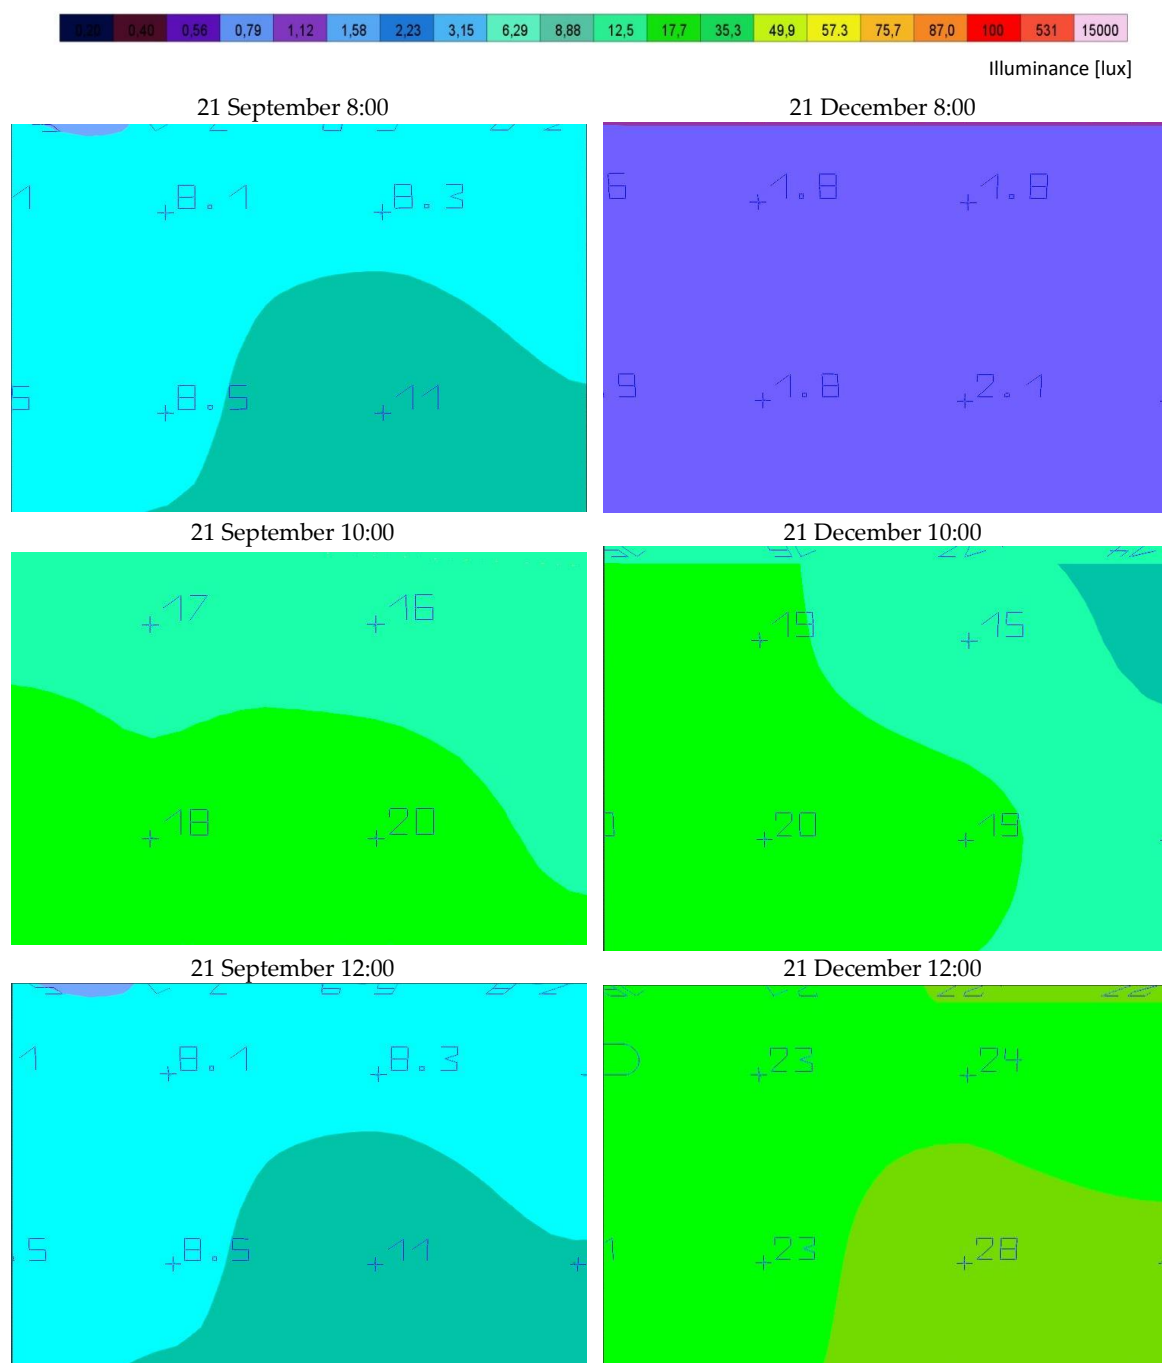
The simulation outputs in Figures 36 and 37 show that the wallpapers are exposed to higher illuminance levels in the period of year between March and June at noon. The rest of the year the wallpaper decoration is not damaged because illuminance level close to the ceiling wallpaper surface is not for more than 50 lux.

Figure 36. Detail view to the wallpaper—illuminance (lux) levels for 21 March and 21 June.

Figure 37. Detail view to the wallpaper—illuminance (lux) levels for 21 September and 21 December.
