Seismic Strengthening of the Bagh Durbar Heritage Building in Kathmandu Following the Gorkha Earthquake Sequence

Keywords: seismic assessment; Greco-Roman construction; masonry building; seismic retrofitting; heritage construction; structural restoration

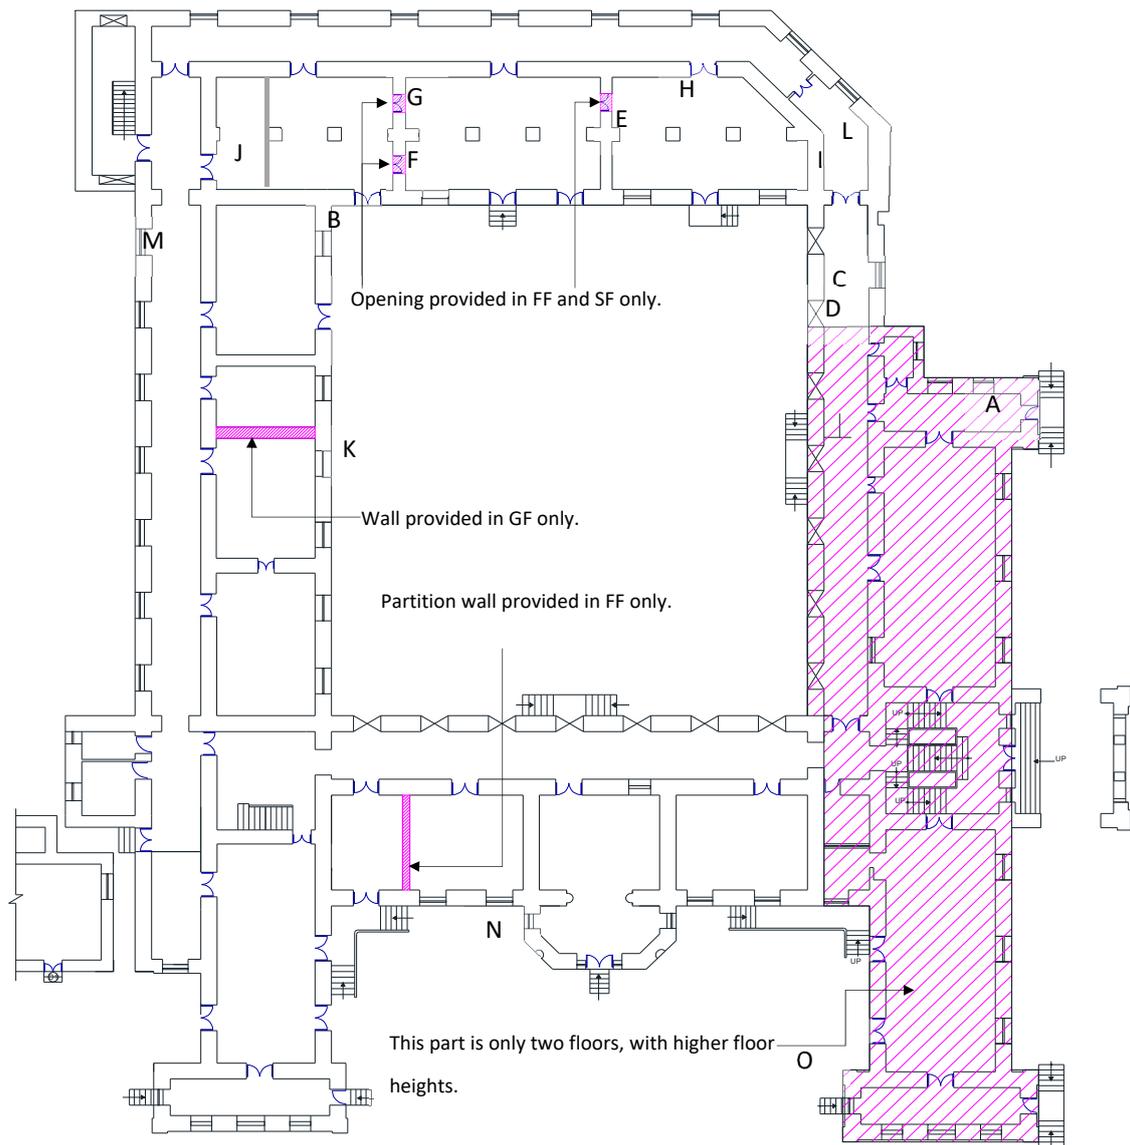
The non-structural damage can be categorized as “Moderate” and structural damage can be depicted as “Slight” which yields the overall damage grade-2 (moderate) per the EMS-98 scale of damage grading [23]. Nevertheless, it is worth noting that intrinsic characteristics of the building and its value from an architectural standpoint made unrealistic the possibility of achieving immediate occupancy performance of the building under design as suggested by the Nepal Building Code (NBC)-105 [24], according to the seismic classification of the site. As the monument was constructed before the inception of design codes of practices, as well as by-laws, no seismic considerations were inputted during the construction, which led to the building being vulnerable in case of moderate to strong earthquakes, to which the codal provisions were formulated. Therefore, restoration of damaged components must be combined with seismic upgrading interventions capable of ensuring increased seismic performance and therefore preserving the monument. In this sense, the design process complies with relevant rules provided for architectural and historical heritage in some European countries (i.e., Italy), where specific guidelines have been released in recent years to combine property safety and conservation of monuments (e.g., [25]). Details of intervention and Finite element (FE) analysis after the introduction of retrofit design are presented in the following sections. Main damage locations are represented by uppercase letters in Figure 2 and the field evidence is presented in Figures 3–6. Figure 6a shows the damage led by the higher deflection which caused the corner separation and damage to the arch. Damages were mainly noted in terms of shear damage and corner separation.

Figure 2. Major damage locations in the monument (capital letters represent the damage mechanisms as shown in Figures 3–6). In the figure, GF, FF, and SF respectively represent the ground floor, first floor, and the second floor.

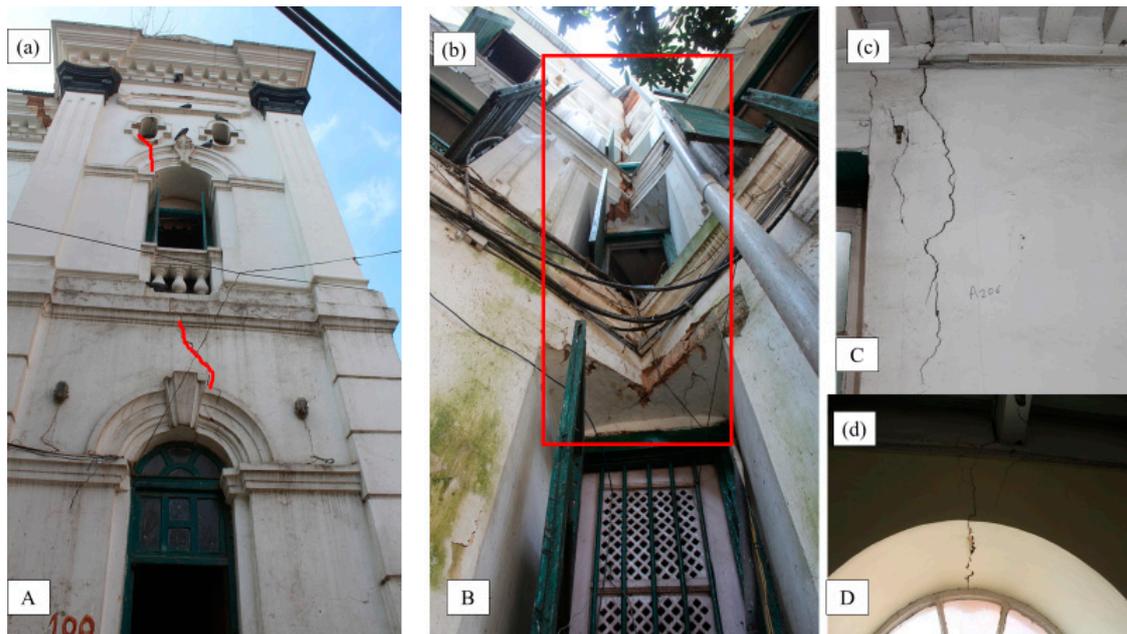
Figure 3. Local damages in the monument (a) damage above the crown of arches, (b) corner damage at the junction of north and west lounge, (c) vertical crack, (d) crown damage (uppercase indications at the bottom of the structures are the location indications as shown in Figure 2).

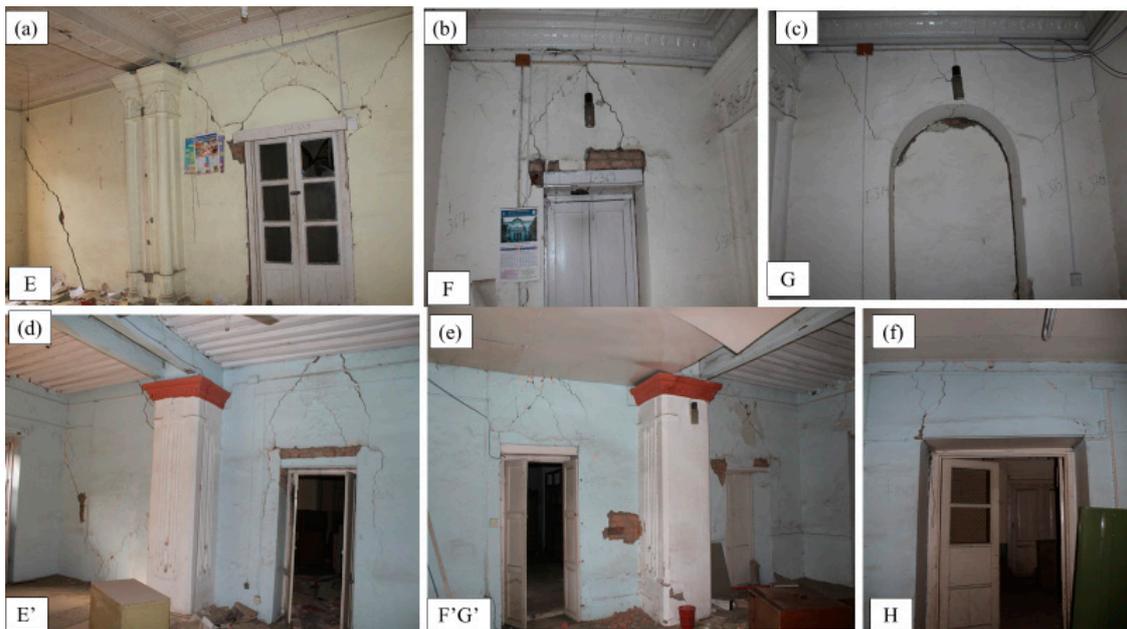
Figure 4. Local damages in the monument (a) diagonal cracks on cross-wall, (b) damaged wall above the opening, (c) damage above the crown of the arch on cross wall, (d–f) damages around the openings (uppercase indications at the bottom of the structures are the location indications as shown in Figure 2).

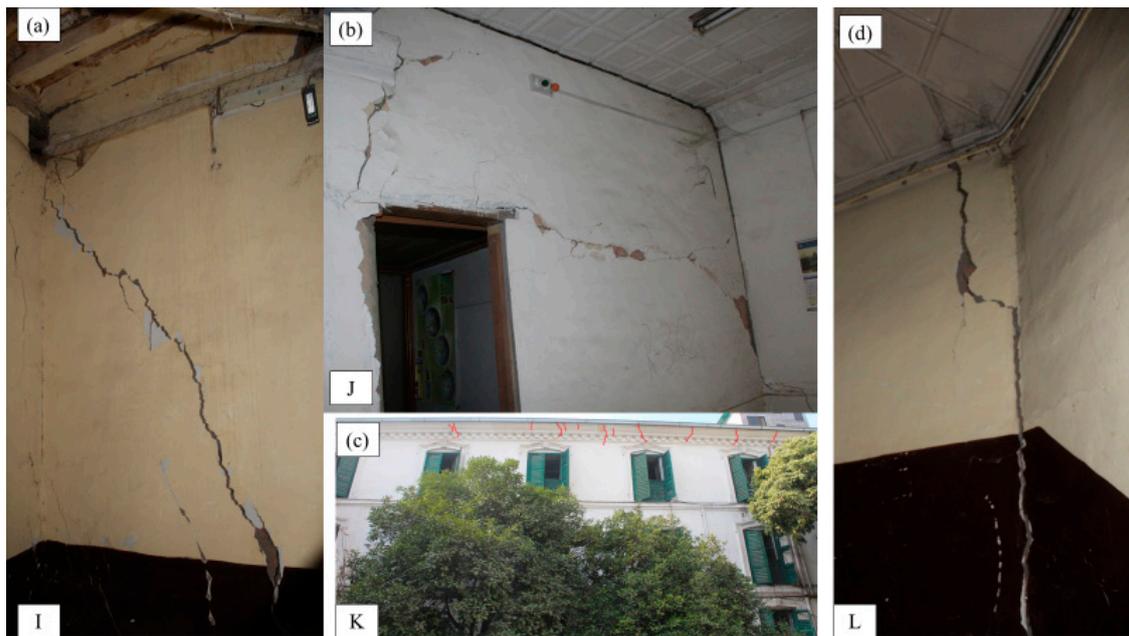
Figure 5. Local damages in the monument (a) diagonal crack on the third-floor wall, (b) horizontal and vertical cracks beside the opening, (c) exterior wall damage at the top floor, (d) corner damage (uppercase indications at the bottom of the structures are the location indications as shown in Figure 2).

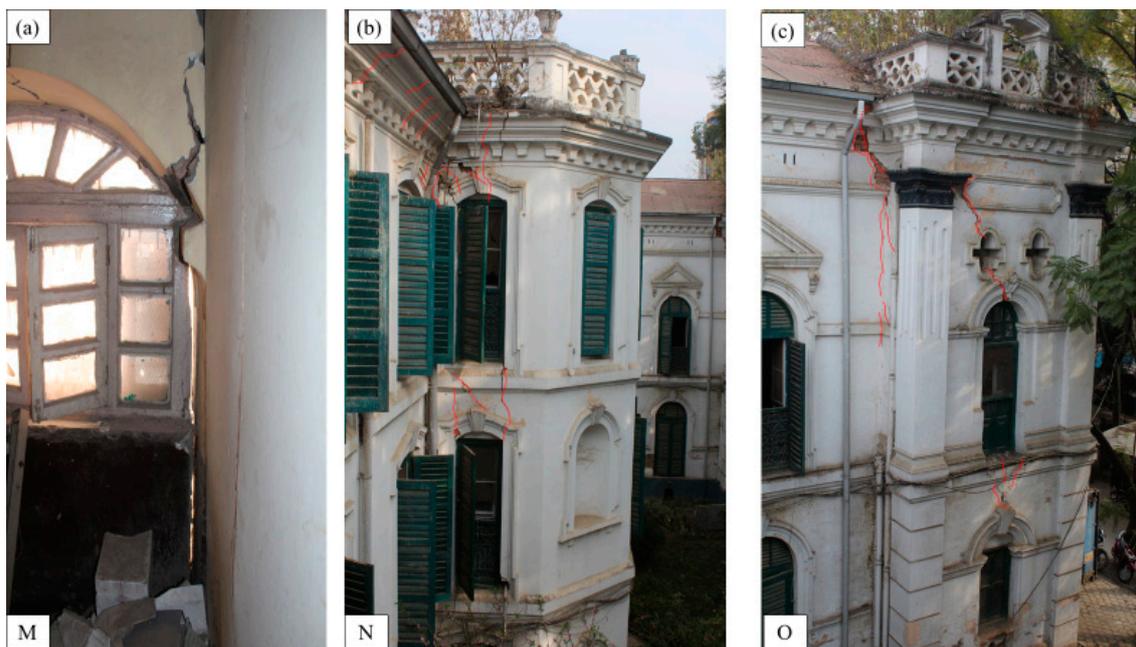
Figure 6. Local damages in the monument (a) corner damage, (b) corner damage and crack propagation in the projection part, (c) cracks developed above the arch. In figure, uppercase indications at the bottom of the structures are the location indications as shown in Figure 2.

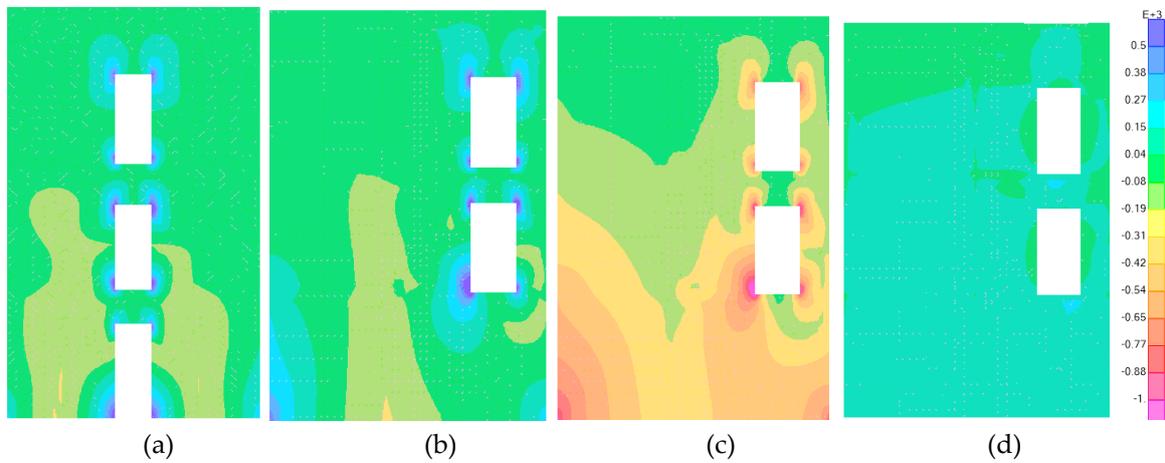
Tensile stresses were concentrated around opening and pier edges only due to the in-plane action of the earthquake load as indicated by Figure 14. There was an uplift in some portion of the piers, but due to development of tensile cracks, stresses were redistributed. Vertical steel plates are provided along the edges of each pier to take these stresses. Hence, tensile cracks are not allowed to propagate and subsequently prevent the masonry degradation in the cyclic load. Compressive stresses were also concentrated around opening, corners, and pier edges (see Figures 14–16). Although average compressive stress was obtained to be less than the average compressive strength of the walls; it was still higher than the permissible design stress. The provided steel plates that are stiffly anchored to walls take part in the compression of the wall to keep the stress within safe limits. Further, the confinement with vertical and horizontal steel bands increases the ductility and compressive strength of the wall, which is not considered in the calculation, and regarded as an additional factor of safety. Most masonry piers experienced higher shear stress than their design capacity. However, the design capacity of the wall was identified as ~ 0.1 MPa, but because of high damping in mud-mortar structures, the actual damages would be generally lesser.

Figure 14. Force per meter under load combination dead + live + response spectrum-x (a) tensile force at section cut-1, (b) tensile force at section cut-2, (c) compressive force at section cut-2, and (d) shearing force at section cut-2. (See Figure 10 for section cuts).

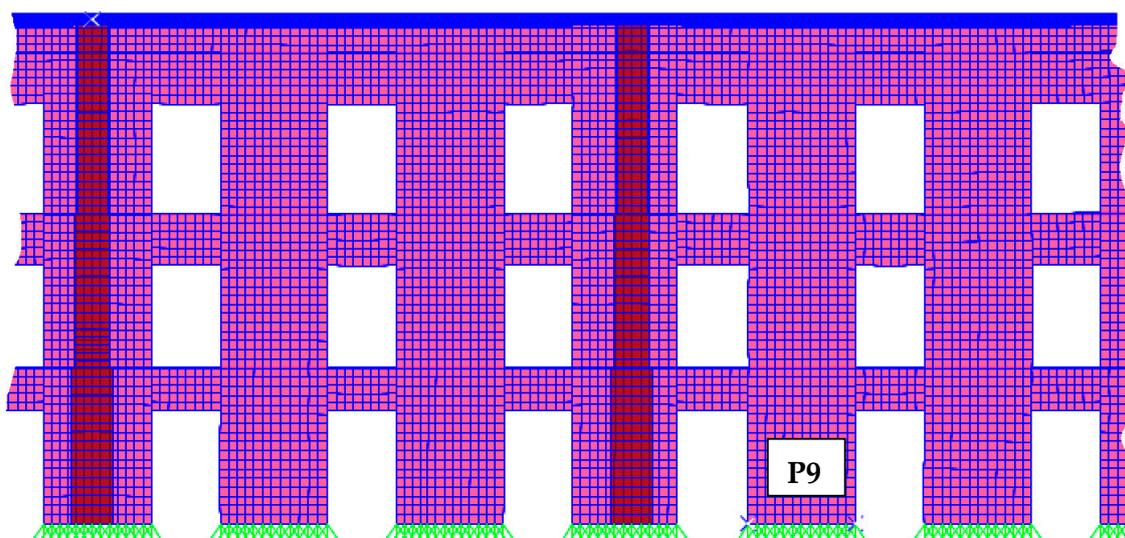
Figure 18 shows the three-dimensional view of the pier P9 indicated in Figure 10. The section cut force from the analysis for P9 shows an axial, shear, and moment demand of 743 KN, 181 KN, 332 KN-m respectively. Meanwhile, there was no direct tension on the pier. The analysis further showed that the pier was deficient in compression capacity and rocking shear capacity. To this end, 100 × 8 mm vertical steel plates were provided at pier ends on both faces in addition to the horizontal plates at lintel and sill levels. Analysis including the strength of steel plates showed that the aggregate capacity exceeds the demand forces. The same approach was used for all piers and safety checks were performed.
