Monitoring Moisture Performance of Cross-Laminated Timber Building Elements during Construction

Evan Schmidt and Mariapaola Riggio *

Wood Science and Engineering Department, College of Forestry, Oregon State University, Corvallis, OR 97331, USA; evan.schmidt@oregonstate.edu

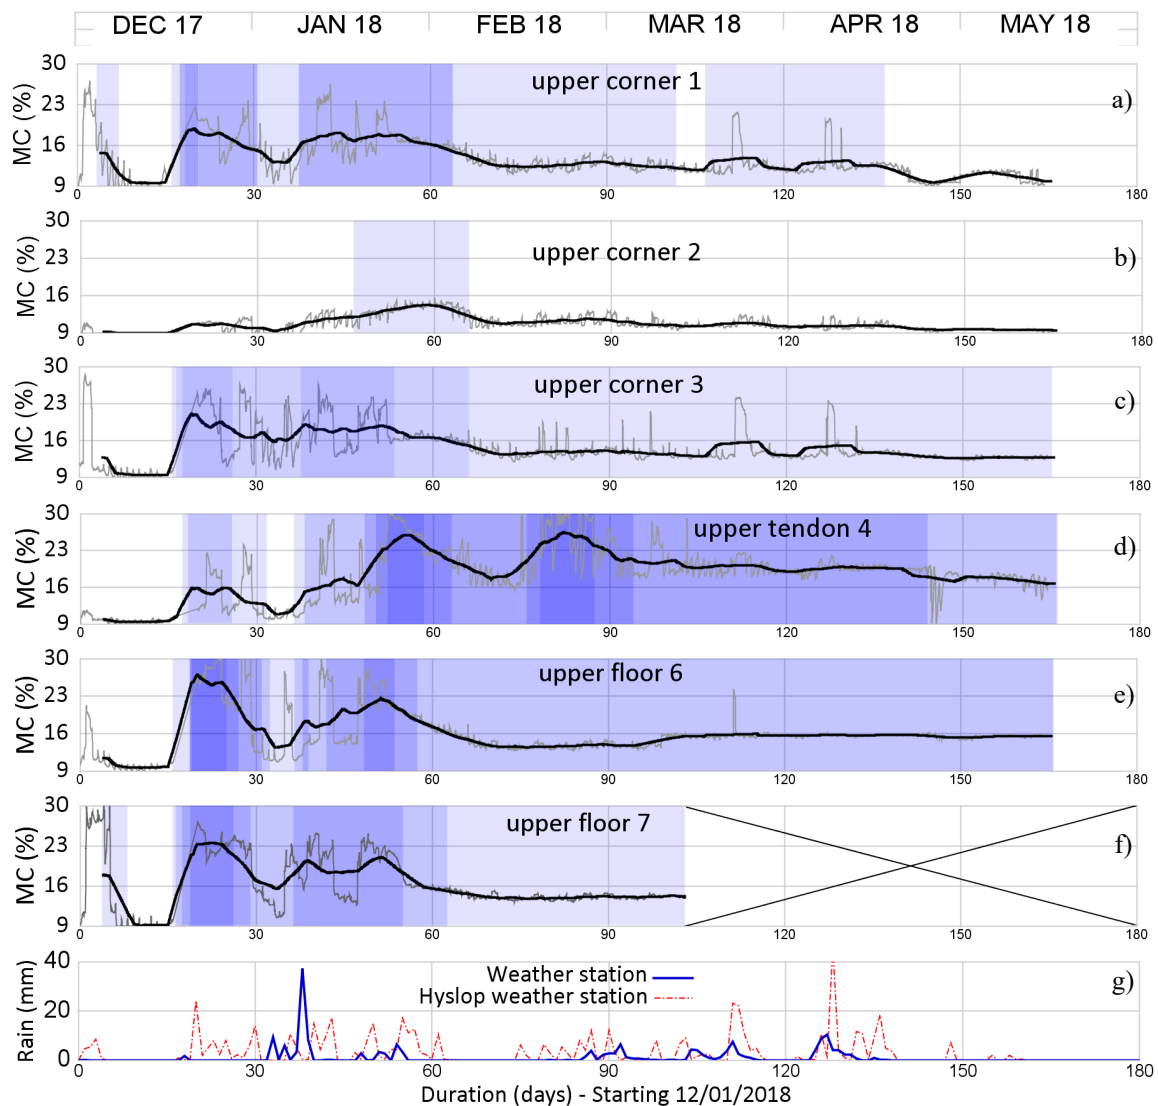
Moisture measurements at Upper_corner_1,2, and 3 showed higher moisture levels in late January (days 50–60, plies 1 and 3 peaking about 18% and ply 2 peaking about 15%), quick drying to the 10%–14% MC range (over about 2–4 weeks), and slowly decreasing MC levels thereafter (Figure 6–c). Moisture measurements at Upper_floorconnection_6, and 7 (North face) showed wetting and drying during the same periods as the latter sensors, but moisture levels were higher (peaking at about 21%) and remained higher (plateauing at about 15%) (Figure 6e,f). Upper_tendon_4 experienced the highest MC increases (>24%) and also dried more slowly than the others, to about 18% by May (Figure 6d).

Figure 6. Continuous moisture measurements taken at the upper shear wall. Locations are illustrated in Figure 3a: (a) upper corner ply 1, (b) upper corner ply 2, (c) upper corner ply 3, (d) upper tendon ply 4, (e) upper floor ply 6, and (f) upper floor ply 7. (g) Rainfall data. The first 55 days experienced higher levels of noise due to direct exposure of the sensors. Raw data is plotted in light grey. An eight-day moving average is depicted with a thick black line. The blue shading overlaying the graph represents tiers of MC—growing deeper in hue at 3% intervals (with <12% MC as white). Upper_floor_7 malfunctioned near day 100, demarcated by the “X” over the graphic.

Upper_tendon_4 (Figure 6c) and Lower_hardware_4 (Figure 8c), showed distinctly higher MC activity than the other continuous measurements. The former sat adjacent to the tendon chase, which could have, in effect, served as a ventilation shaft that would be conducive to maintaining low MC levels. On the other hand, this detail could also be conducive to moisture trapping if the shaft were not well ventilated and/or allowed liquid entry or condensation. Lower_hardware_4 showed large exaggerated fluctuations that closely followed precipitation events and resembled sensor shorting behavior, which coincides with the fact that it is the least sheltered position on the shear wall. A look at the lower moisture contents that the measurements return suggests that this location was likely relatively dry (circa 12% MC) by day 70. More observations are needed to assess risk at these types of locations, particularly at the tendon chases.

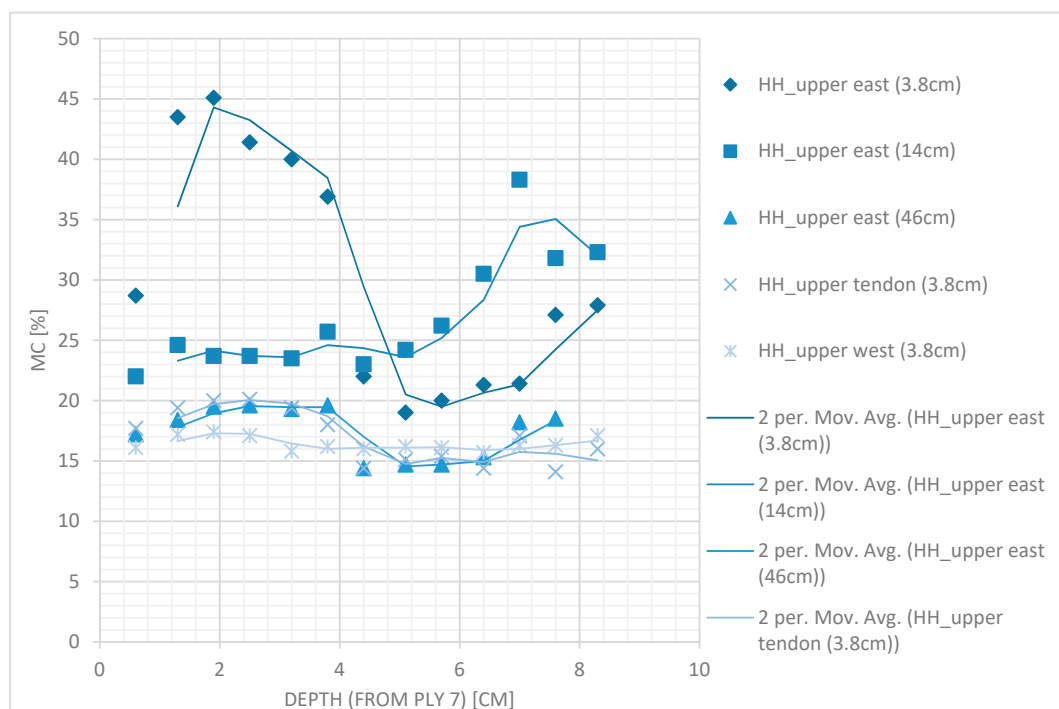
Discontinuous measurements taken at HH_upper_3.8 cm and 14 cm consistently showed MC values approaching or exceeding the fiber saturation point (Figure 7). When considering all measurements taken at the upper North face, nearly every discontinuous measurement was greater than 16% (64/75 measurements). Additionally, about half of the measurements were above 20% (38/75), and a fifth (15/75) were approaching or beyond the fiber saturation point (i.e., >27%). Measurements at HH_upper_tendon and HH_upper_west, further from the exterior of the structure, registered somewhat lower moisture contents than the east side (together averaging 18% at ply 7, 16% at ply 6, and 16% at ply 5).

Figure 7. Discontinuous moisture measurements taken at the upper section of the monitored shear wall, from the North face side. Continuous lines are moving averages. Dimensions in the data labels (e.g., “3.8 cm”) indicate the distance the measurements were taken below the upper edge of the panel, while the depth of measurement shows the gradient of MC readings through the thickness of the panel (0.6 cm increments, from ply 7 to ply 5). Locations depicted in Figure 3a. Date of measurements: February 9 2018.

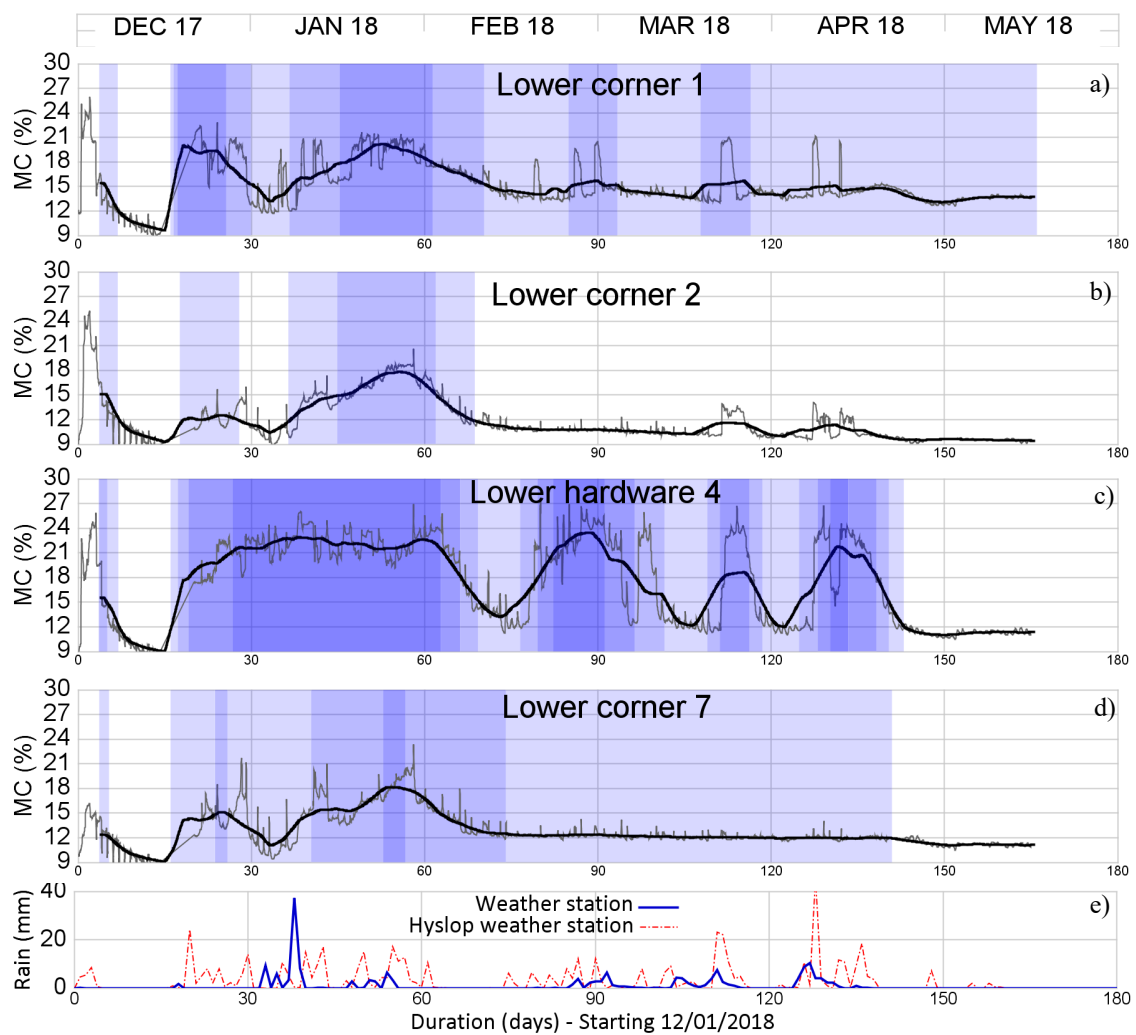
Continuous moisture measurements at the lower east corner of the shear wall (*Lower_corner_1*, *2*, *7*) showed trends similar to those for the upper corner location, though they generally peaked at slightly higher MCs (18%–20%) (Figure 8). *Low_hardware_4* showed large and rapid moisture content fluctuations between about 12% and 21% that correlated with precipitation and dry spells, suggesting sensor shorting (Figure 8c).

Figure 8. Continuous moisture measurements taken at the lower section of the shear wall. Locations are illustrated in Figure 3b: (a) Lower corner ply 1, (b) lower corner ply 2, (c) lower hardware ply 4, and (d) lower corner ply 7. (e) Rainfall data. Measurements for the first 53 days experienced higher levels of noise due to exposure of the sensors. Raw data is plotted in light grey. An eight-day moving average is depicted with a thick black line. The blue shading overlaying the graph represents tiers of MC growing deeper in hue at 3% intervals (with <12% MC as white).

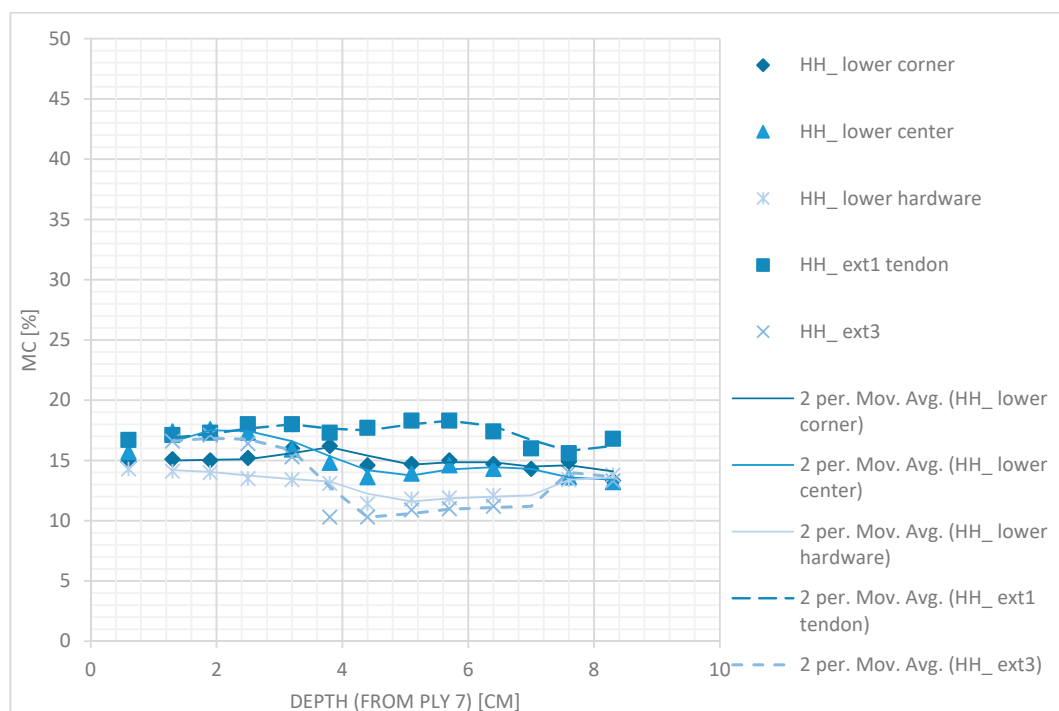
Figure 9. Discontinuous moisture measurements taken at the lower section of the monitored shear wall, from the North face side (continuous lines are moving averages), and of the adjacent, perpendicular shear wall (dashed lines are moving averages). Location depicted in Figure 2. The depth of measurement shows 0.6 cm increments, from ply 7 to ply 5. Date of measurements: February 9 2018.

Discontinuous measurements taken near the bottom of the adjacent shear wall (HH_ext1_tendon) averaged about 2.2%, 2.6%, and 2.1% higher MCs, than averages of those measured in the corresponding depths (ply 7, 6, and 5, respectively) in the lower corner of the monitored shear wall. These were anticipated to be even higher due to the greater exterior exposure and the observed wicking at the cementitious mortar.

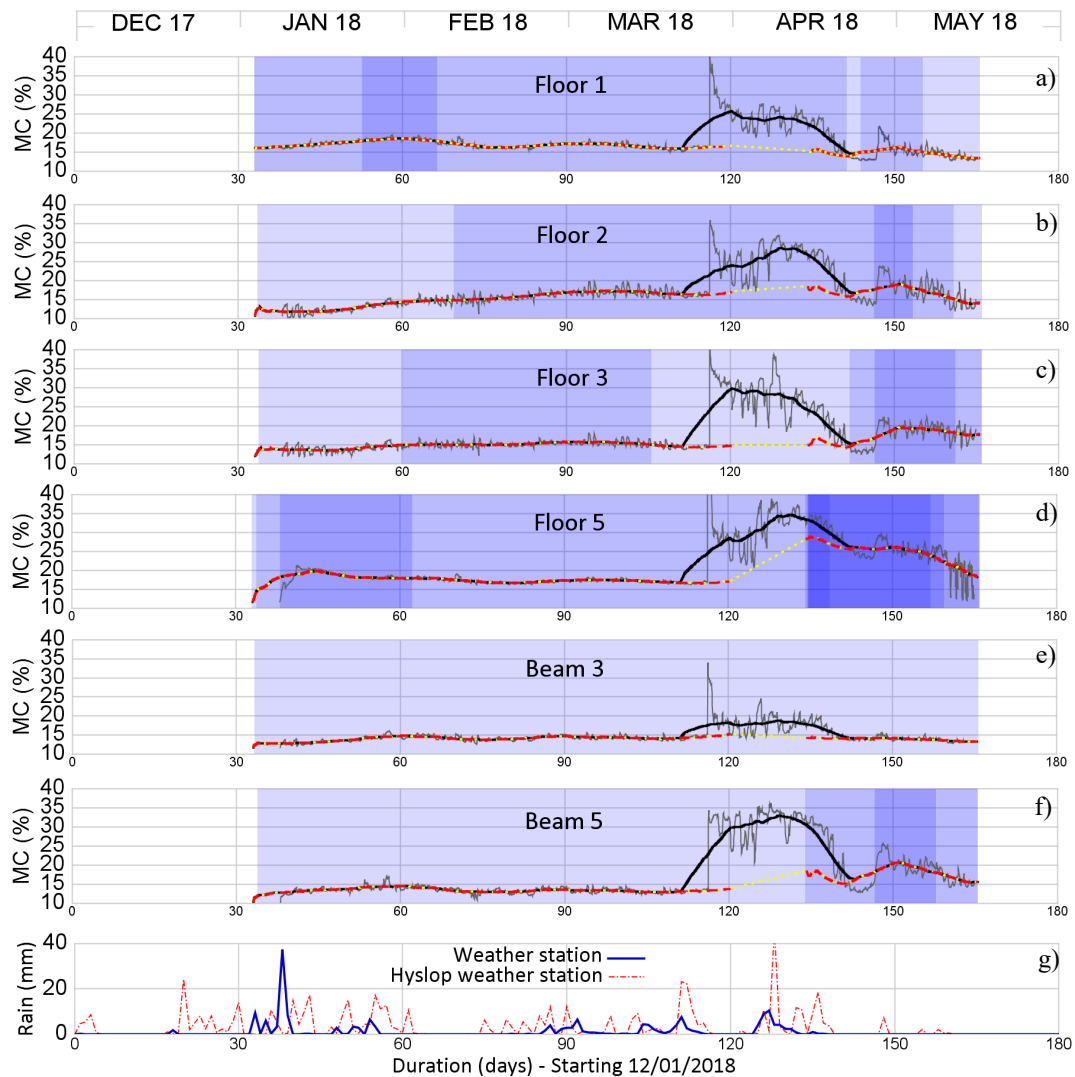
Floor sensors displayed stable behavior until the period between day 110 and 140, when values spiked upwards and remained semi-erratic (Figure 10). The same occurred to a lesser degree between days 147 and 160. The period of erratic behavior corresponds to the enclosure of the monitored detail at its end (exterior enclosure for drying of zone 1) combined with a period of exposure to rain from above (through a large window opening). It was observed that water tended to percolate short distances along the lower face of the CLT floor panels at the interface with the beams, as a result of water pooling at the connection during rain events. Evidence for sensor shorting is strong, since every sensor indicated a coordinated and nearly instantaneous increase in MC to above fiber saturation levels after enclosure of the details and a large rain event. The bottom-most ply of the floor panel (“Floor 5”) in particular continued to show high moisture contents (24%–30% range), while the other sensors returned to lower and relatively more stable levels.

Both of the outermost floor plies (“Floor 1” and “Floor 5”) showed the greatest levels of moisture gain and loss (Figure 10a,d). The bottom-most ply was the wettest throughout the monitoring period and never dropped below 16% MC. The uppermost ply (“Floor 1”) was also above 16% MC throughout most of the monitoring period, although it peaked at only 18% and appeared to dry quickly (e.g., a recorded loss of 2% MC in just two weeks in February, when conditions were sunny and dry). Plies 2 and 3 (“Floor 2” and “Floor 3”) exhibited slower overall wetting rates and lower MCs during wetting events, although moisture content also continued to increase even after some covering and drying (Figure 10b,c). These observations of latent increase at the interior plies were similar to those in previous studies [11,12,37,38]. MCs measured at the two glulam beam locations displayed little change over time, remaining around 14% \pm 1% MC. “Beam 3,” located slightly closer to the moisture trapping interface of the beam and the CLT panel, experienced a slightly higher MC increase (circa 2%) than the location in the middle of the beam (“Beam 5”) during the stable period of monitoring (days 0–110) (Figure 10e,f). Discontinuous measurements near the floor location (Figure 11) were taken on

Figure 10. Continuous moisture measurements taken at the floor location. “Floor” indicates readings in the cross laminated timber (CLT) panels, “Beam” in the glulam beam. Progressive numbers in the label indicate the ply reached by the sensor (from the upper-most CLT ply and the external glulam lamina). Locations are illustrated in Figure 4c: MC in the CLT floor panel, (a) ply 1, (b) ply 2, (c) ply 3, and (d) ply 5. MC in the glulam beam (e) ply 3 and (f) ply 5. (g) Rainfall data. Raw data is plotted in light grey. An eight-day moving average is depicted with a thick black line, while a red dashed line depicts the same moving average with data omitted from the period of highest disturbance (approx. days 110–140). The blue shading overlaying the graph represents tiers of MC—growing deeper in hue at 3% intervals.

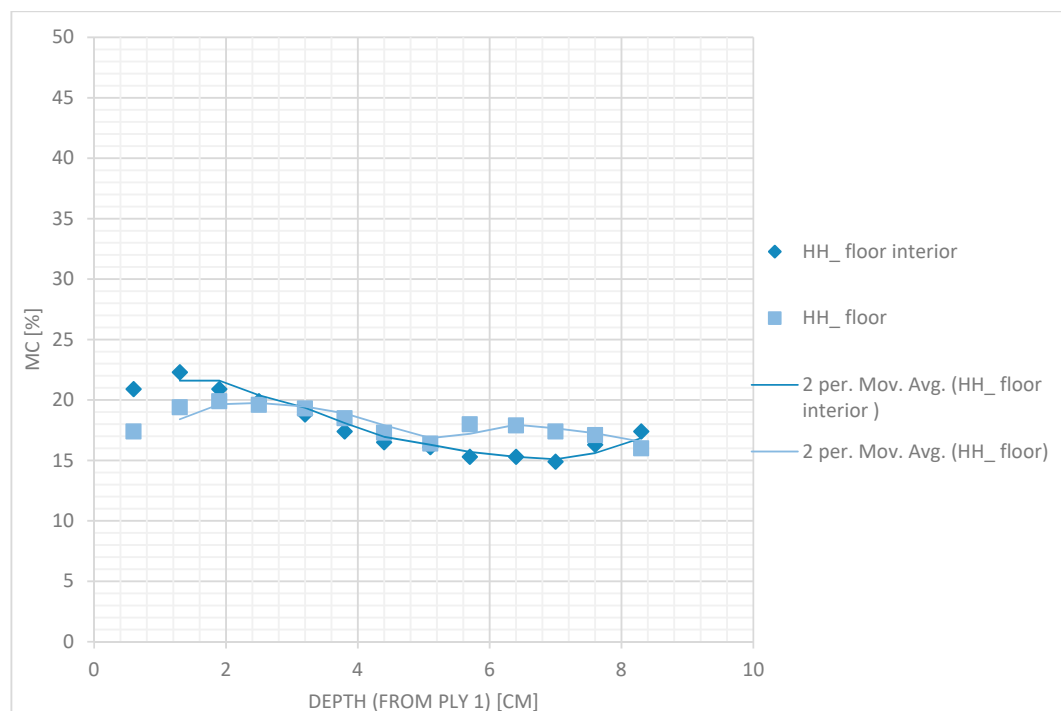
day 71, after a period of good weather and observable drying. These data suggest similar but slightly higher values than continuous measurements at ply 1 (avg. 19.1% HH vs. 18% continuous), ply 2 (avg. 17.6% HH vs. 15% cont.) and ply 3 (avg. 16.6% HH vs. 15% cont.). These differences can be accounted for by a combination of local moisture distributions, which can vary substantially over short distances (less than a cm) [11], sensor accuracy ($\pm 1\%$), as well as slight differences in species and temperature corrections between devices (algorithms and temperature used for correction). Additional discontinuous measurements taken in the CLT panel at the same floor detail, but in the interior of the building (HH_floor_interior) averaged 20.6% (ply 1), 15.9% (ply 2) and 16.9% (ply 3).

Figure 11. Discontinuous moisture measurements taken at the floor location at different depths in the floor panel with 0.6 cm increments (from the upper-most surface) close to the continuously monitored points (HH_floor) and at the interior of the building (HH_floor interior). Continuous lines are moving averages. Date of measurements: 9 February 2018.
