# Preservation of Historical Underground Sites in Soft Rock: A Case Example

**Abstract:** Rehabilitation works are often needed to preserve historical underground galleries built in soft carbonate rock. The Kalemegdan fortress galleries, located in Belgrade (Serbia) were built during the 18th century using the room-and-pillars method. Instabilities have been caused by the detrition and weathering of the rock which formed the pillars. Regardless of the fact that they lost their bearing capacity, the main requirement of the authorities was that the pillars be preserved in their current state. This controversial and difficult task was achieved by the suspension of the roof in the gallery using a combination of pre-stressed geotechnical anchors and passive rock bolts. Control of the mobilization of the anchors and the geodetic survey of the target benchmarks proved that the rehabilitation was successful in the long-term. The results of the geological investigation of the site, research solutions and remedial works are described in this paper.

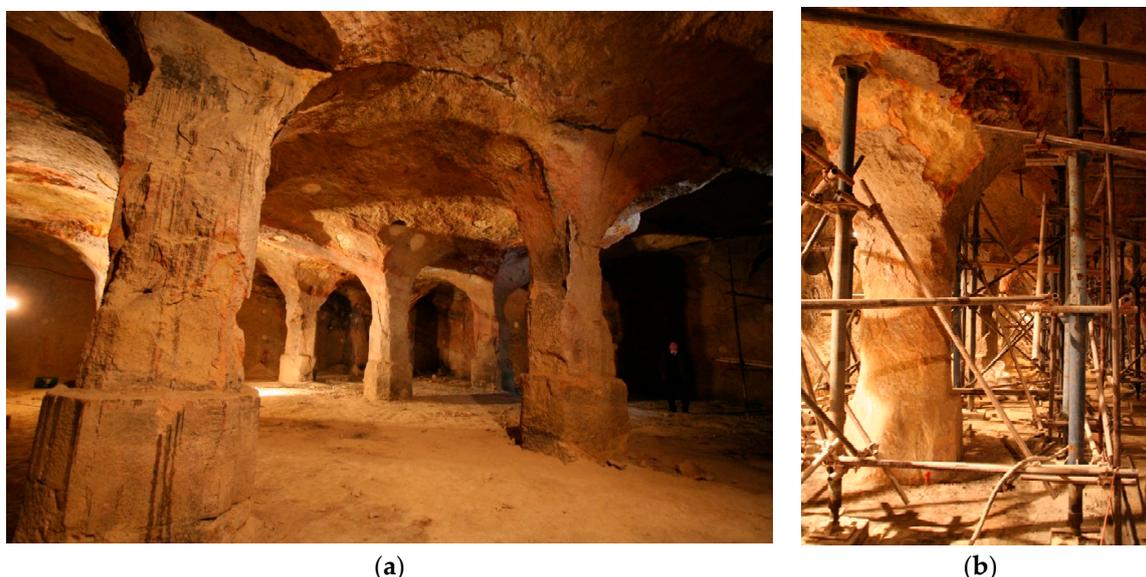
**Figure 3.** Photographs of the gunpowder depot in Room 2: (a) after the completion of remedial works and (b) during the period of scaffold support (the failure modes of columns can be seen in both photos).

Seasonal changes in temperature and humidity, as well as the infiltration of rainwater over the course of time have resulted in moistening and dissolution of the weak clayey bonds of the carbonate rock. As emphasized by other authors [7], there is a high probability that variations in the original

thermo-hygrometric balance conditions caused chemical weathering by invoking several processes of crystallization, hydration, dehydration and polycyclical changes in the mineralogical phases. The main result of weathering was the loss of bearing capacity of the rock mass in the long term.

The weathering caused the columns to peel off gradually and thus reduce in size. One of the columns in Room 2 (No. 3 annotated in Figure 1.) collapsed together with a part of the ceiling. There were therefore eight columns left in a damaged state in Room 2. Lessening of the active bearing surface caused the overloading of the columns, which resulted in partial buckling around the newly formed vertical discontinuities. In order to preserve the current state in Room 2 the client installed temporary scaffolding with the aim to aid the stability of the ceiling, as shown in Figure 3b.

Since the replacement of the columns was not an option, the designers' mission was to achieve the long-term stability while preserving the appearance of the inner space of the galleries. In the search for the most appropriate preservation method several variants were considered (ground improvement, construction of an upper gallery to reinforce the columns from the top, replication of the columns using natural stone and others). Due to aesthetic reasons, the client did not allow the use of reinforced concrete block columns clad by the same limestone, which was a considered solution applied for the preservation of some rock-hewn underground openings in Cappadocia [8].

The final solution was to suspend the ceiling by mobilizing the unused capacity of the rock mass above the gallery. This was achieved by using the combination of the active geotechnical anchors and the passive rock bolts. The research task was to anticipate the appropriate cumulative active force to suspend the deadweight of the material above the columns. At the same time, and adding to the complexity, the full covering of the deadweight was not desired, as some proportion of the load was beneficial to remain acting on the columns (once the mobilized normal stress in the columns drops to zero, the shear resistance strength in friction will diminish).

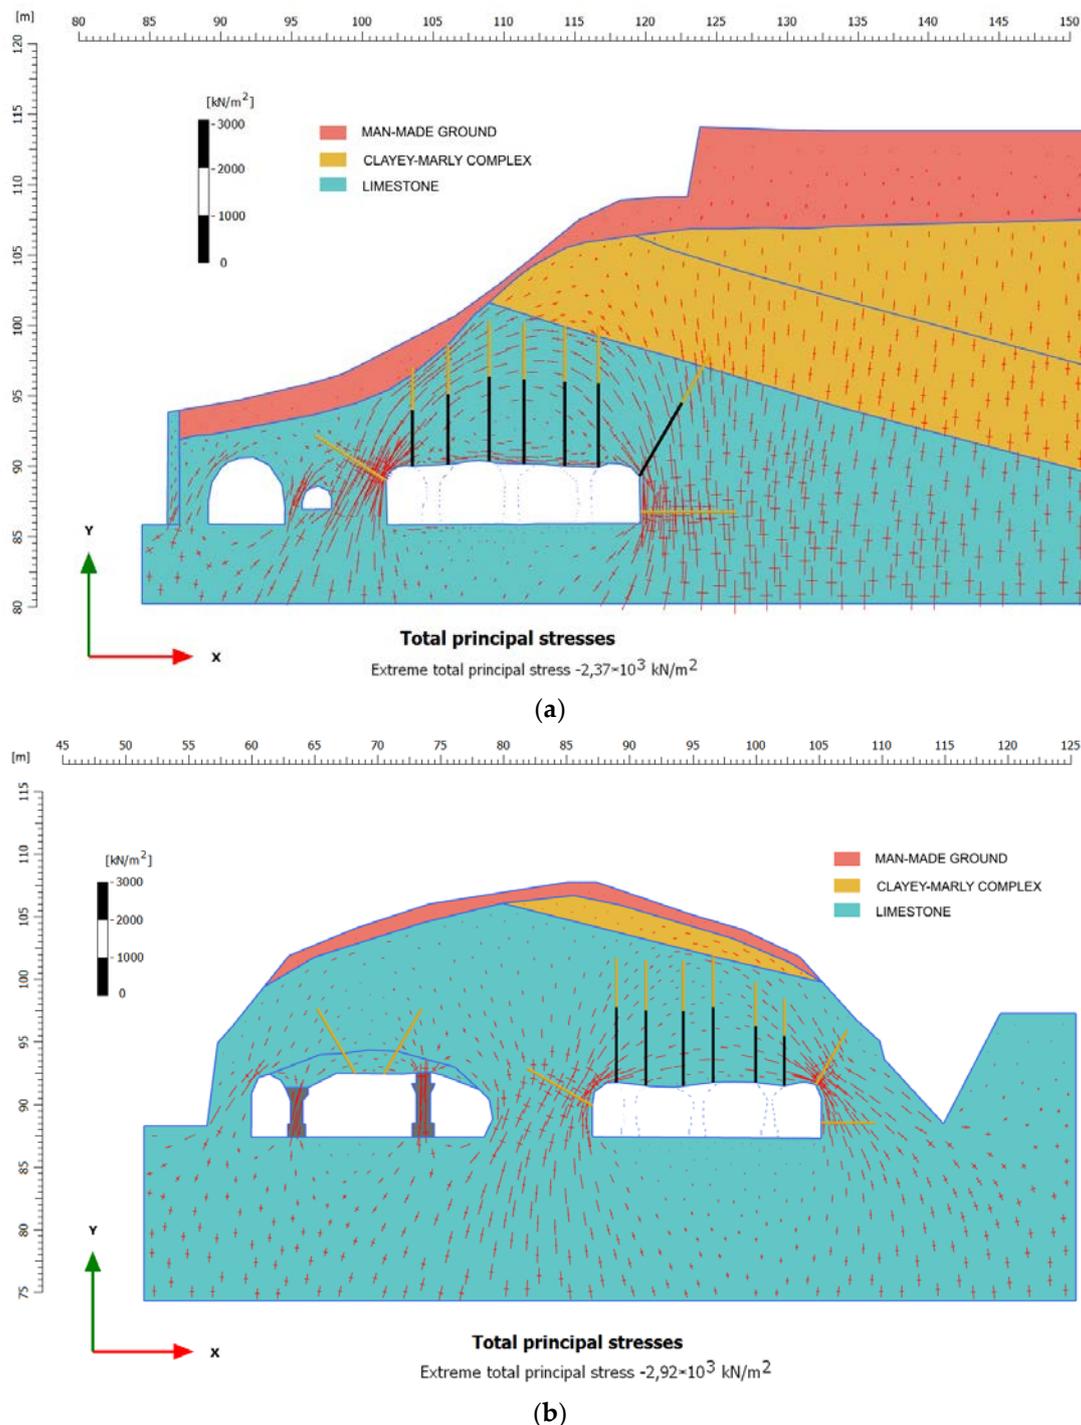
The characteristic results of the analyses for sections II-II and VI-VI are shown in Figure 4 in the form of a distribution of the directions of the principle stresses. The results of the analyses show that the decay of the pillars and the proportional loss of their load capacity would cause a formation of the new static system in the surrounding rock mass. The characteristic feature of the new static system was that the inner forces in the rock mass would form a natural arch in the form of 3D vault, rising from the sides of the room and arching above the stress-relieved rock mass. This is seen in Figure 4a,b as the arching effect of the principal stresses situated above the low stressed area. As the new static system is formed, the stress-relieved rock mass becomes unstable due to the loss of the confining stresses. The

confining stress was needed to provide the shear strength along the discontinuities and in the rock mass itself. In static terms, the unloaded rock mass below the 3D vault becomes an additional dead load for the columns. Additional load caused the damage of the columns, which was further amplified by the weathering process.

**Figure 4.** The calculated directions of principal stresses after the application of rehabilitation measures (columns in Room 2 are modelled as fully unloaded) in the cross sections: (a) VI-VI and (b) II-II.

Analyses showed that the pre-stressed anchors should be fixed in the area of principal stress arch, where the higher confining stresses are concentrated. They needed to be distributed evenly and predominantly in the vertical direction to counteract the deadweight of the stress-relieved roof. The

Generally, the analyses showed that passive anchors should be distributed systematically in the area in which the stress concentrations were detected. Five to eight meters long rock bolts of nominal capacity of 250 kN were installed perpendicular to the curved walls of the room to counteract the tension stresses, as indicated in Figure 4a,b.

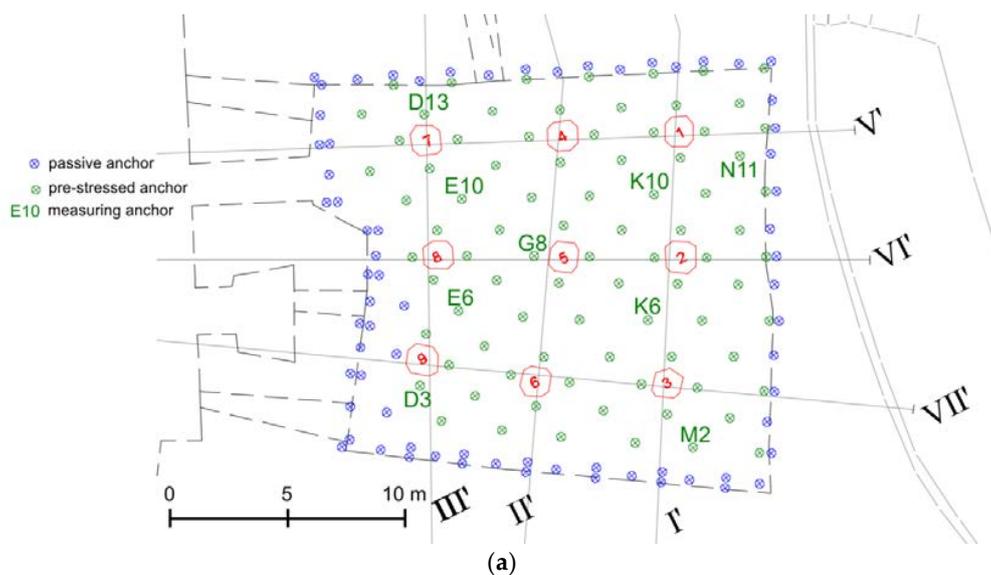
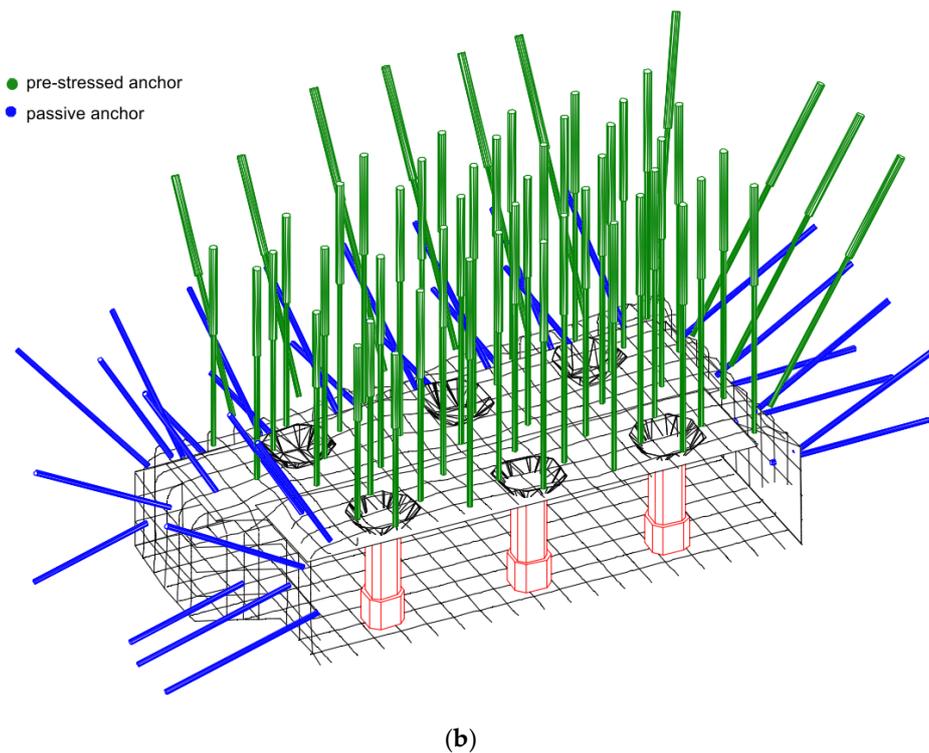
**Figure 5.** Schematic of the installation of the anchors in the roof and the walls of Room 2 (green color indicate pre-stressed anchors and blue color indicate passive anchors); (a) the layout and annotation of measuring anchors (b) the axonometric view of the eastern half of the room.

The approximate spatial position and the distribution of both types of anchors is schematically presented in the form of a layout presented in Figure 5a and as an axonometric view of the eastern half of Room 2 in Figure 5b (for the sake of clarity only the eastern half is shown; the western half is almost symmetrical). A total of 84 pre-stressed anchors were installed following an approximate pattern of 2.5 m × 1.5 m. The action of each column was directly supported by the four vertical anchors installed next to it, as indicated in the figure. The active anchors contained two steel tendons of diameter Ø 15.7 mm (0,6") with yield and maximal capacity in tension of  $f_y/f_{tk} = 1650/1860 \text{ N/mm}^2$ , leading to the maximal anchor capacity of about 550 kN. Given that the anchors were pre-stressed between 130 kN and 200 kN they were only mobilized up to 35–40% of their full capacity. The rest of the capacity was regarded as a necessary reserve, which will be activated in the case of the complete loss of capacity of the columns in the long-term.

Approximately 80 passive anchors were installed at the edges and perpendicularly on the contour of Room 2 to complement the action of the pre-stressed anchors. Another 32 passive anchors were installed in Room 1 to prevent the local wedges instabilities along the section IV-IV, as previously commented.

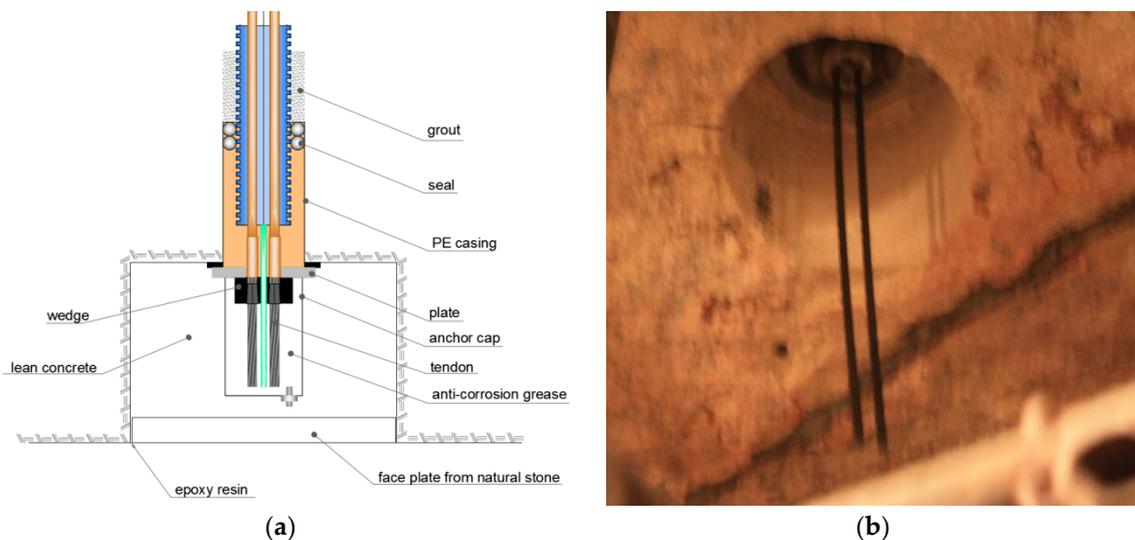
**Figure 6.** The pre-stressed anchor head embedded in the rock mass: (a) cross-section and (b) installation.

In order to preserve the appearance of the ceiling the heads of the anchors were embedded in the rock mass, as shown in Figure 6. Boreholes of up to 30 cm in diameter were covered using rock material of almost the same characteristics and colour so that the visual impact of the rehabilitation on the ceiling was low. As seen in Figure 3a, the locations of the anchors can be recognized as yellow dots on the ceiling, but clearly these do not disfigure the original appearance of the gallery roof.

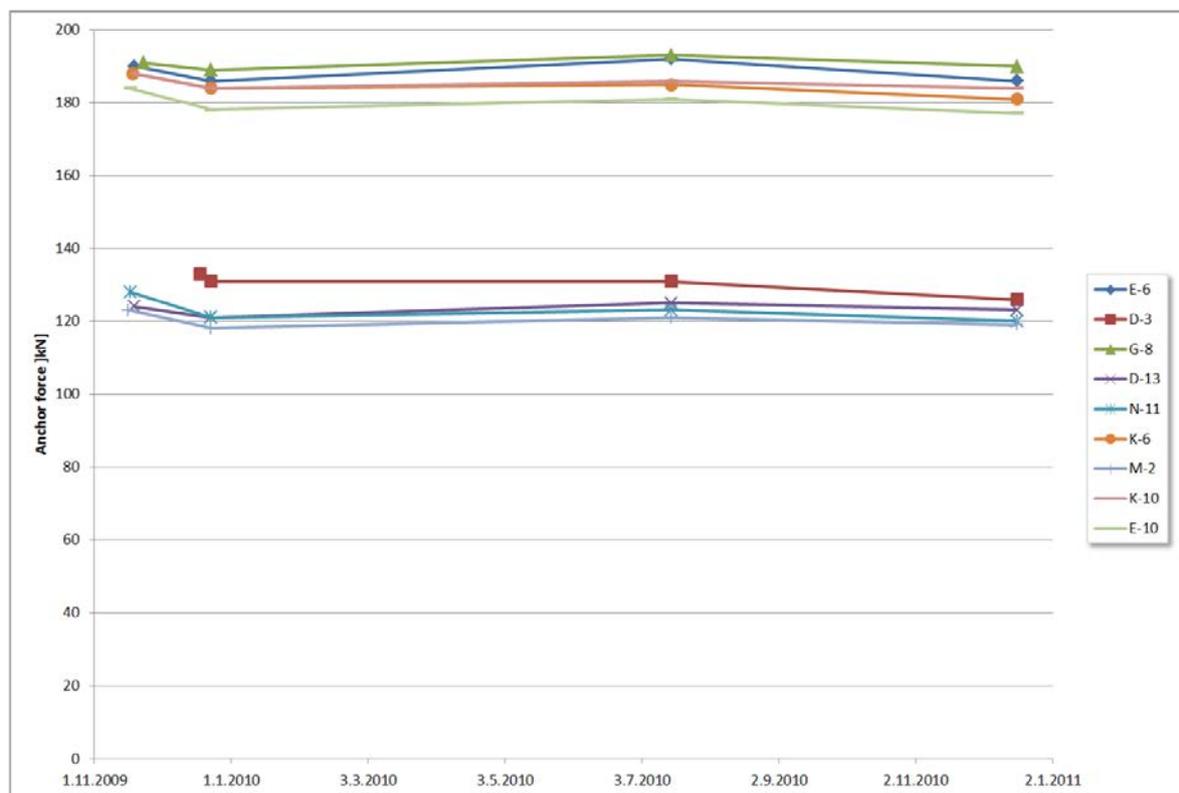
As part of the rehabilitation, a comprehensive monitoring system was installed. The following actions were carried out at regular intervals: (a) reading of the load cells, which were installed at nine control anchors (measuring locations are shown in Figure 5a), and (b) geodetic survey of the target points installed at the ceilings of both Room 1 and Room 2. The results of reading the load cells, including the zero measurement, are presented in the diagram in Figure 7 for the period of the first two years after the construction. As it can be seen, two years after the rehabilitation, the active forces in the anchors were predominantly constant. An oscillation of the active force of several per cent seen on the diagram is related to the seasonal oscillation of the external temperature. The geodetic survey showed the maximum settlement of the roof of some 3 mm, which was higher than predicted in the numerical analyses but still within reasonable expectation. The measurements carried out in the long-term up to 2020 did not show any significant deviations from these results.

**Figure 7.** Diagram of the measured forces in measuring anchors (measuring anchors are annotated in Figure 5a).
