# Reappraisal of the 1863 Huércal-Overa Earthquake (Betic Cordillera, SE Spain) by the Analysis of ESI-07 Environmental Effects and Building Oriented Damage

**Abstract:** This work reviews the 1863 Huércal-Overa earthquake (VI-VII EMS) based on the environmental seismic intensity scale (ESI-07) and oriented archaeoseismological building damage. The performed analysis identifies 23 environmental effects (EEEs) and 11 archaeoseismological effects (EAEs), completing a total of 34 intensity data-points within the intensity zone  $\geq$ VI EMS. The new ESI intensity data quintuplicate the previous intensity data-points  $\geq$ VI EMS (five localities) for this event. Sixteen of the identified EEEs indicate the occurrence of intensity VII-VIII within the Almanzora valley, south of Huércal-Overa, over an area of ca. 12–15 km<sup>2</sup>. Anomalies in water bodies, slope movements, hydrogeological anomalies, ground cracking, and other effects (gas emissions, tree shaking) are the more diagnostic EEEs—with one of them indicating a local maximum intensity of VIII-IX ESI-07 (Alboraija lake). Environmental earthquake damage of intensity  $\geq$ VI covers an area of c. 100 km<sup>2</sup>, comp

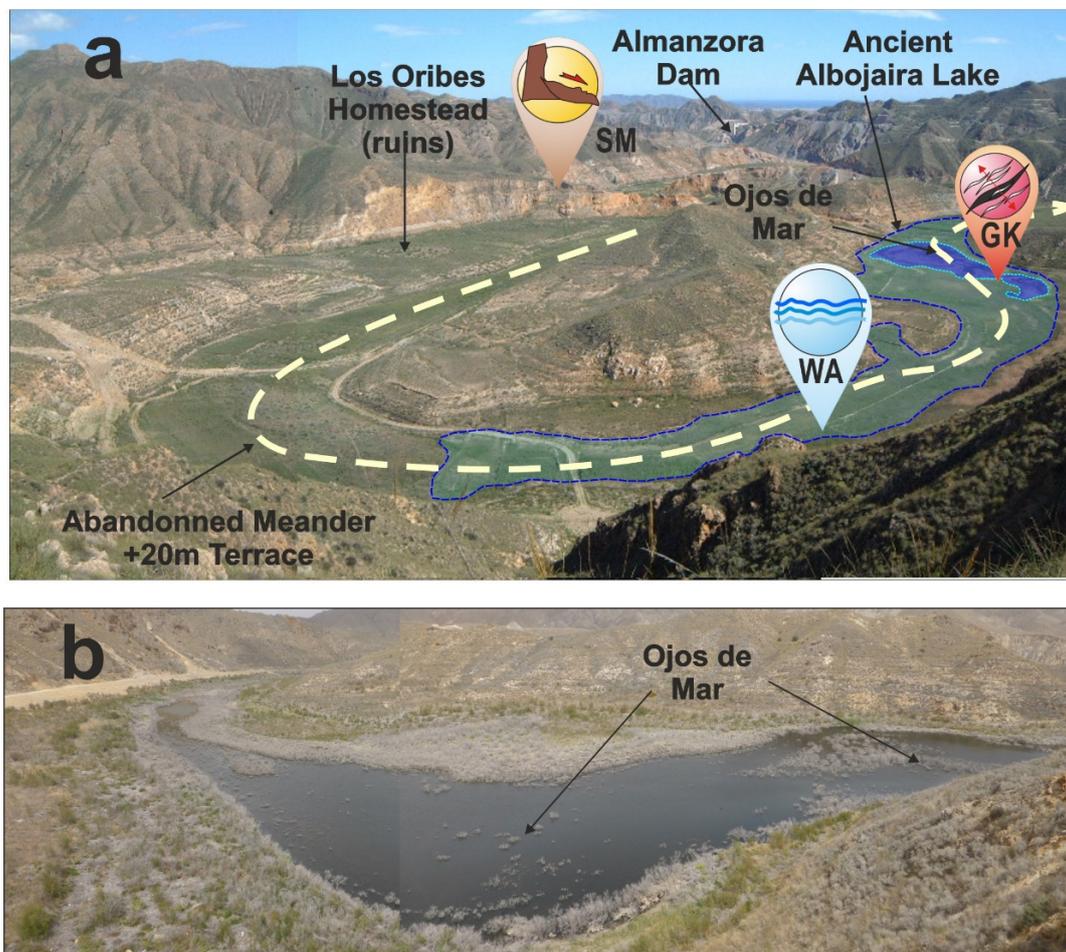
Outstanding anomalies in water bodies (WA), such as the Almanzora River channel or the ancient Albojaira Lake (Los Oribes) were reported by De Prado [4]. The original transcription by this author says: “The Almanzora River drastically diminished its water-flow inducing that some watermills stopped working during a short time (several minutes) around the ancient Obera zone” (Figure 2). As observed by De Prado [4] (pages 379–380) “in Los Oribes, a small ancient lake basin (“Laguna de Albojaira”) disappeared because of the formation of large ground cracks in its floor”. Only three zones that always retained the water even during the dry seasons, “Los Ojos de Mar” (Sea Eyes), remained ponded, but eventually also become dry during the aftershock sequence [4] (Figure 4).

The disappeared lake (c. 30,000 m<sup>2</sup> and 4–5 m depth) was located in an incised abandoned meander belonging to the +20m fluvial terrace of the Almanzora River [30] (Figure 4a) and feed by a perched aquifer susceptible to withdrawal by the large ground cracking occurred in the zone. The report by De Prado [4] indicates that “the dried lake ground displayed a very irregular cracked topography being impossible its accesses and survey for almost eight months, when the large ground-cracks were filled by alluvial deposits derived from strong rain-fall events occurred in February 1864”. Nonetheless, the report by De Prado [4] does not specify any preferent orientation of ground cracking, and it is impossible to relate this EEE to a case of secondary surface faulting or liquefaction-oriented phenomenon. Considering the dimensions of the ancient lake, the evacuated volume of water (c. 150,000 m<sup>3</sup>) and the resulting irregular topography, the reported ground cracks were probably metric in width and decametric in length. The reported features for these two related EEEs are in the range of intensity IX ESI-07, which is the minimum intensity for the disappearance of small water bodies [1,3] and the maximum local intensity assessment for this earthquake. However, local geological site conditions (perched aquifer, loose alluvial filling, etc.) could help to amplify environmental effects in this zone. In addition, the terminal zone of the abandoned meander is burying one of the most important tectonic contacts within the Almagro Range related to the occurrence of other hydrogeological EEEs (see below “Los Tres Pacos” EEE). This small lake basin is again temporarily functional because of the artificial water-table

**Figure 4.** The Albojaira Lake at Los Oribes within the Almanzora Canyon (Intensity VIII). (a) View of the abandoned meander of the Almanzora River (terrace +20 m) where was located the Albojaira (in Arab: *Al Bujaira*) Lake emptied during the earthquake as a consequence of large ground-cracking in the ancient lake floor. The location of main EEs and other geomorphological features, such as the ancient lake contour and the site of the “Ojos de Mar” (permanent water bodies) is also illustrated. (b) Southern view of the presently active “Ojos de Mar” due to the construction of a large dam within the Almanzora Gorge few kilometers downstream the site (artificially upraised groundwater table).

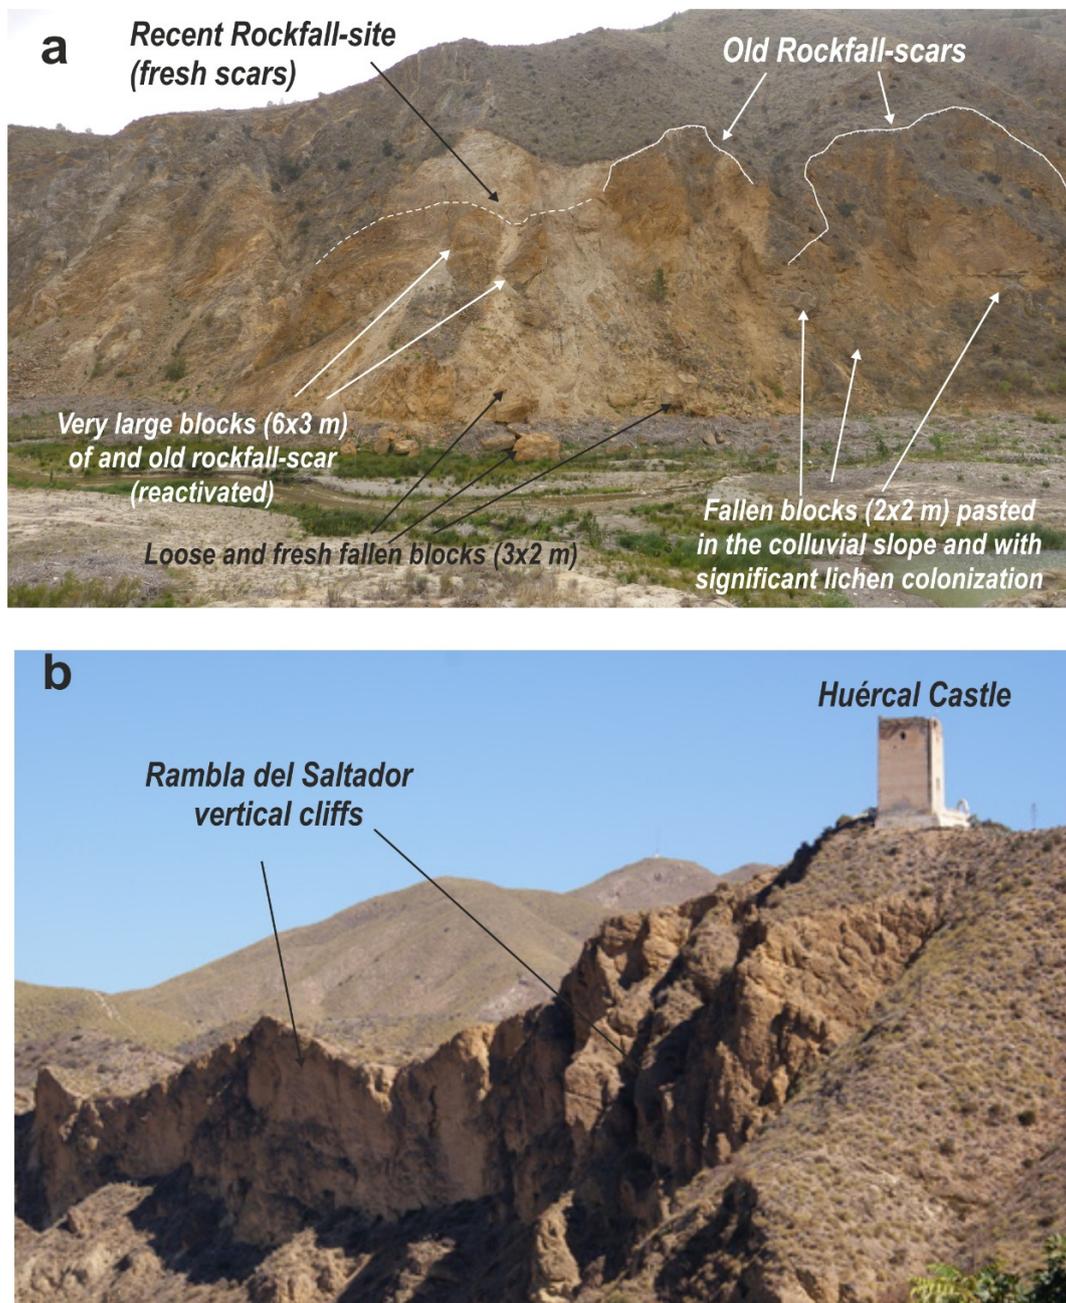
De Prado also reported the occurrence of large rockfalls in this sector of the Almanzora Gorge [4]. Analysis of aerial photographs (1955 American Flight) lead to the recognition of 11 zones where large rockfalls affect the valley slopes, but after field-survey, only two zones will be probably related to the studied earthquake since they are indicated in the reports or journals [4,5]. These zones present old scars, barely vegetated and large fallen blocks, with significant lichen colonization, pasted in an important colluvial slope at the toe of the cliffs (Figure 5a). The main rockfall zone is an E-W vertical cliff carved on Triassic dolomites and limestones opposite to the junction of the Bobara and Almanzora rambla-valleys (c. 4 km south of Huércal-Overa; Figure 2), where fallen blocks exceeding c. 250–500 m<sup>3</sup> are common, as well as landslide scars up to 100 m length and individual mobilized volumes of c. 60,000 m<sup>3</sup> (Figure 5). As illustrated in Figure 5a, recent and ancient rockfalls can be observed at this site, likely some of the old ones, probably related with the 1863 seismic serie, have been partially reactivated during more recent times. Accounts from newspapers [5] also indicate that similar rockfalls occurred in the environs of Los Oribes, about 2 km downstream within the Almanzora Gorge,

damaging a sheepfold down slope (Figures 2 and 4a). In the two considered cases the affected gorge cliffs are in the order of 800 m in length and the estimated volume of mobilized materials ( $\geq 10^4 \text{ m}^3$ ), indicating VIII ESI intensity. However, at present it is impossible to ensure that these rock volumes were not heightened by latter hazardous floods occurred in the area—consequently, an intensity  $\geq \text{VII}$  is assigned to these two rockfalls.

**Figure 5.** (a) Major rockfall site within the Almanzora Gorge near its junction with Bobara Rambla at la La Fuensanta site (Intensity VIII). Note the occurrence of fresh and ancient rockfall scars because of the repetitive nature (reactivations) of these slope processes at this site. (b) Vertical cliffs of El Saltador Rambla where rockfalls occurred during the earthquake. At the top of the cliff is the ancient Islamic Castle of Huércal (Intensity VII). This photo was taken before the recent reconstruction of the castle.

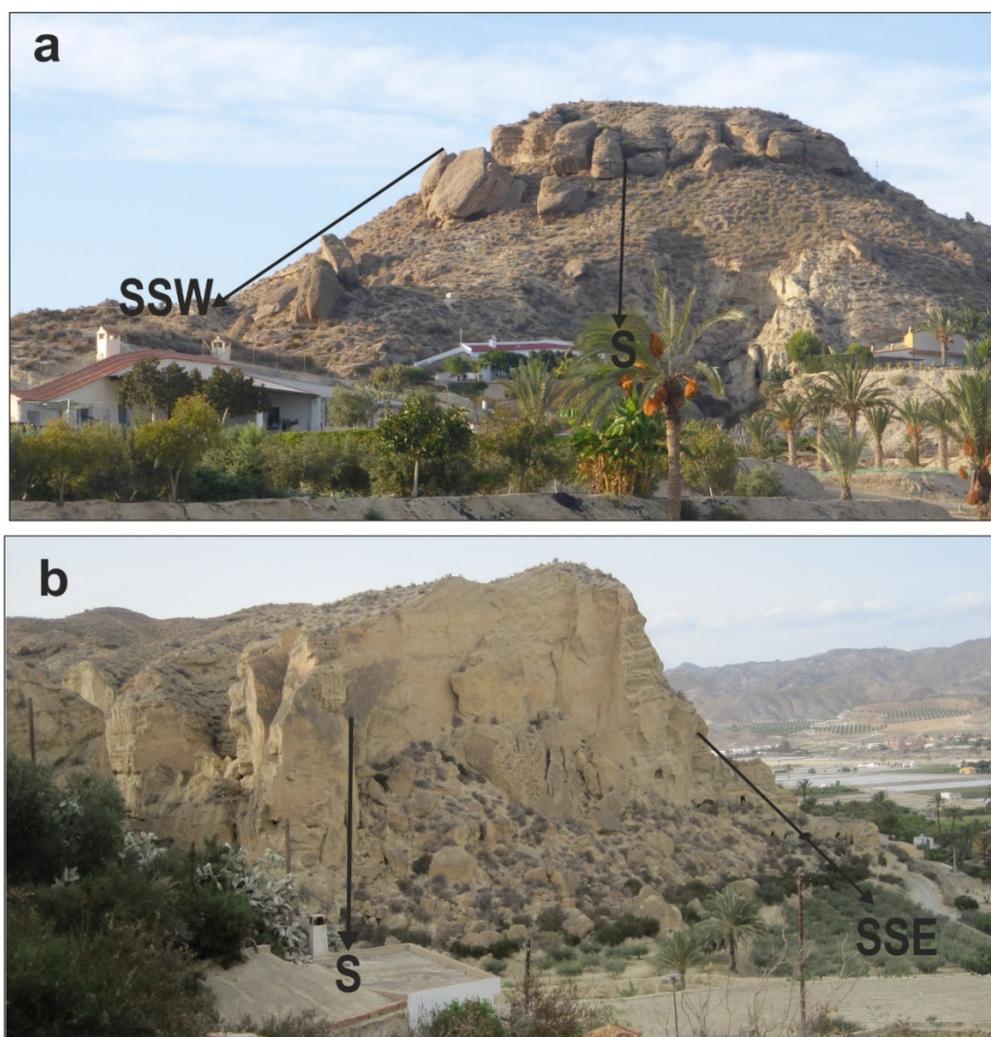
In Cuevas de Almanzora (VI EMS), about 9 km away from the epicenter (Figure 2), noticeable ground cracks and slope movements were documented [4,5]. Multiple ground cracks were recorded in the streets of this locality, the most relevant ones in a street adjacent to the City-Castle, 30 m in length and about 10 cm wide indicating a minimum intensity VI ESI-07 [1]. This large ground crack occurred in

the former “Isabel II Square”, presently the “La Libertad Square” (Figure 3b) founded on loose alluvial materials. As quoted in the epoch newspapers, sandstone cliffs and butte-like hills around the city suffered repeated rockfalls during the main event and the aftershocks producing large dust-clouds [5]. In detail, butte-like hills topped by well-cemented conglomerates display their caprocks fully cracked and disturbed around the whole area and show significant rockfalls in their NW and SW slopes, as is the case of “El Portillo Butte” east of Cuevas (Figures 2, 3b and 6a). These structural buttes display comparable geological features than those of the “El Espiritu Santo” butte, where the ancient city of Vera was seated and destroyed by the 1518 X EMS earthquake [21]. The significant environmental damage showed by these small flat buttes around the area was probably triggered by that previous strong event (6 km SSE of Cuevas). The shattered caprocks were only partially reactivated during the 1863 earthquake (Figure 6a), as it is difficult to relate intensity VI to the observed strong disruption of the buttes. As a curious information, Madoz [23] indicates that “*El Portillo hill was the old original site of the village of Cuevas, which was destroyed by earthquakes during the Islamic times*”. However, aside of the destructive 1518 Vera earthquake (X EMS), the only other catalogued earthquake in the area was in the year 1406 with intensity VII-VIII EMS [7,24,35].

**Figure 6.** Slope movements triggered by the earthquake around Cuevas de Almanzora, about 9 km SSE of the epicenter (Intensity VI). (a) El Portillo Hill (structural butte) displaying its strongly ruptured caprock and oriented rockfalls towards de ESE-SSE. (b) Rock-fall site in the vertical cliff of the Almanzora valley north of Cuevas de Almanzora affecting to ancient cave-houses. Note the occurrence of ancient and recent rockfalls.

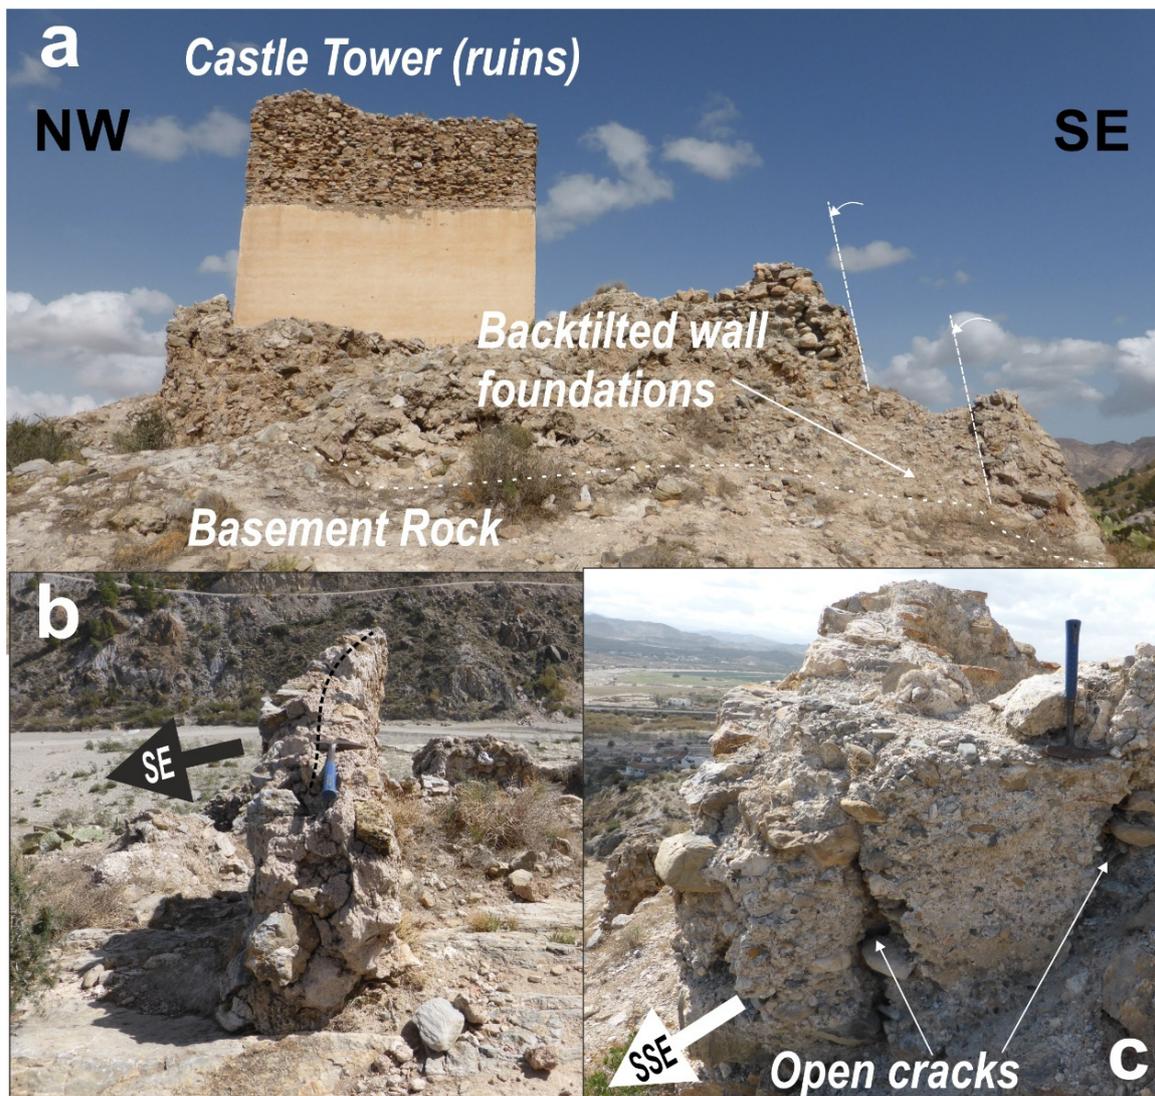
**Figure 7.** Archeoseismological damage in the ancient Obera Castle (Intensity VIII). (a) View from the west of the ruins of the tower, as well as the back-tilted wall foundations towards the SE as a consequence of slope movements. (b) Deformed and tilted wall-remain towards de SE. (c) Large open cracks in the tower foundations with displacement towards de SSE.

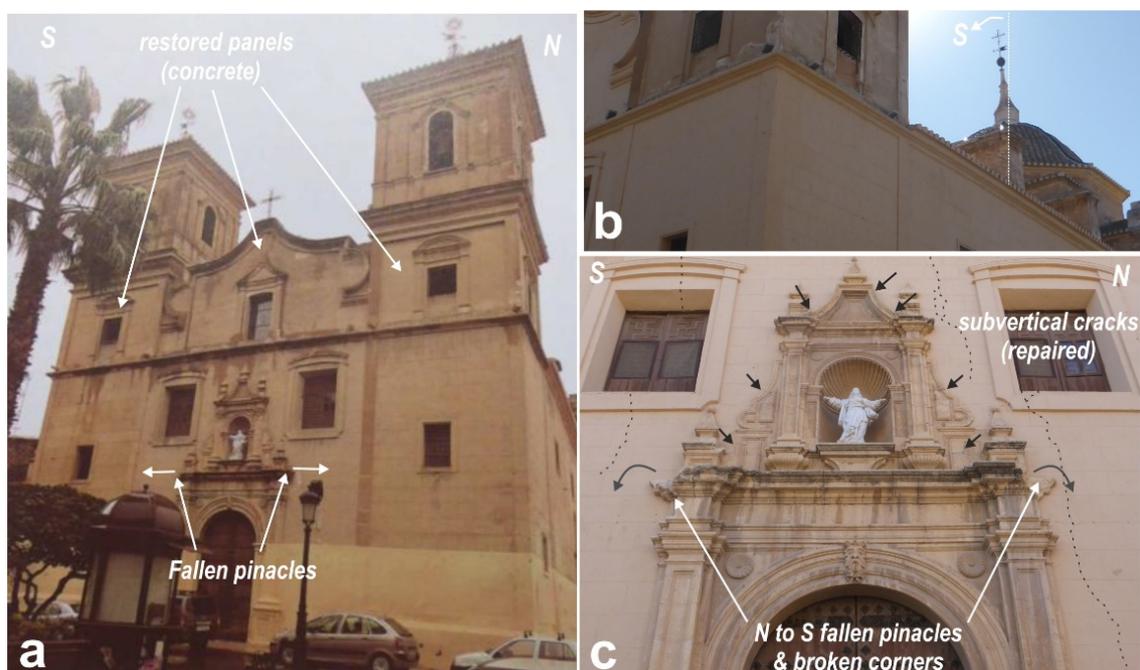
Research done for this paper shows that “La Asunción Church”, built in the year 1739, remained in the ruinous stage for several decades after the earthquake, used as warehouse and garage by the city council [6]. The edifice was repaired after the Spanish Civil War (1950s decade), but still there are signs of the EAEs reported in the journals [5,22,34]. Field research evidence that the entire building was coated with mortar, but especially the upper panels of the two towers and the façade, which were reinforced with concrete plates (Figure 8a). Although the restoration works, the southwards tilting

of the iron weathercock above the dome is still visible (Figure 8b). Field inspection of the building also shows the north and south broken corners of the portico, where stood the fallen stone pinnacles (Figure 8c).

**Figure 8.** Archaeoseismological damage in the “La Concepción parish Church” at Huércal-Overa (Intensity VII). (a) View of the eastern main façade of the church showing the location of the N to S fallen pinnacles of the portico and the restored upper panels of the towers during the 1950s decade. (b) View of the southwards tilted iron cross topping the dome of the church. (c) Detail of the eastern portico of the church displaying the broken cornices where was placed the fallen pinnacles (N-S). Dotted lines highlight still visible subvertical open cracks (mm size). Black arrows indicate the occurrence of cm-scale displacements and extrusions of the masonry blocks in the upper zone of the portico.

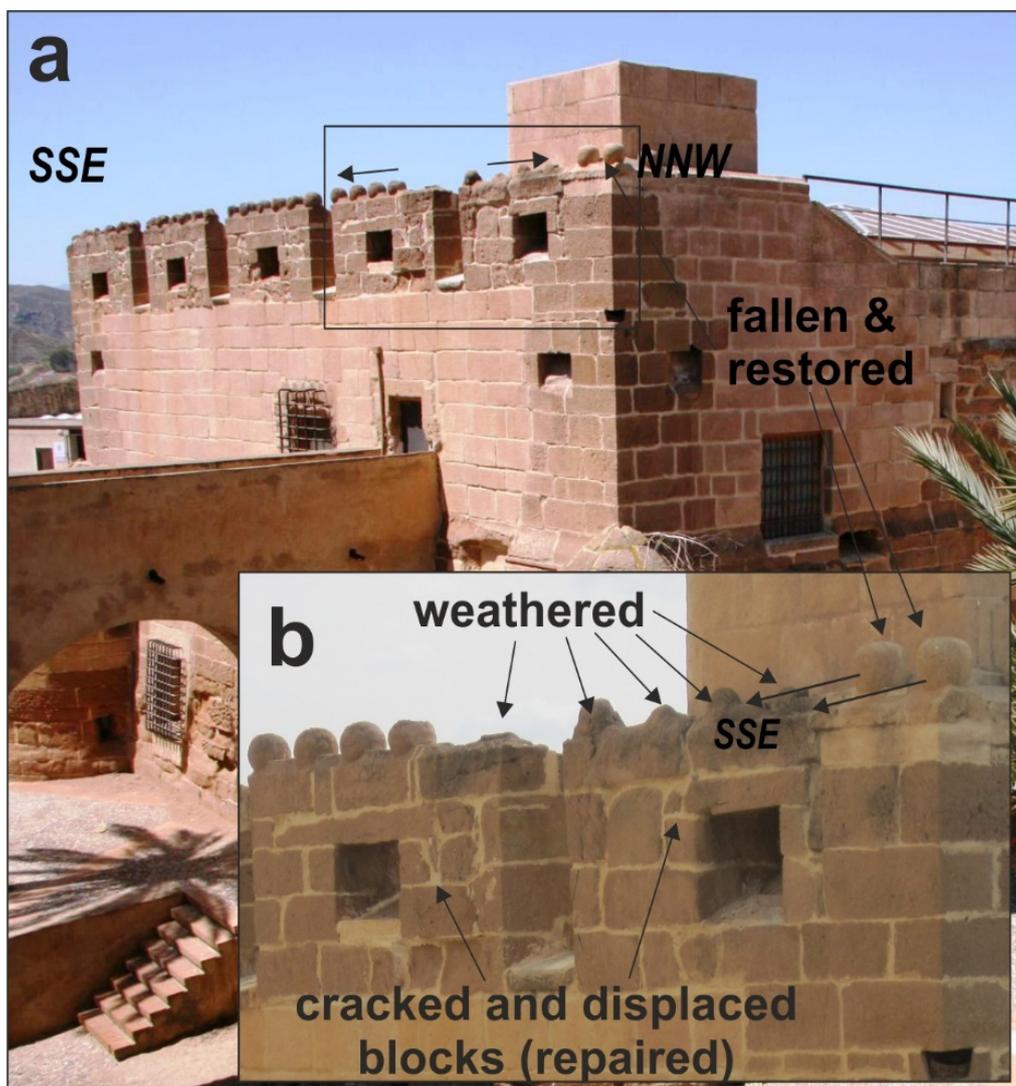
In Cuevas de Almanzora (V-VI EMS), about 9 km SSE of the epicenter, noticeable ground cracks and slope movements were documented, but also oriented damage in the “Villafranca Palace” within the village. The Palace was an ancient 12th century Islamic castle, rebuilt and enlarged in the 16th century after the “Spanish Reconquista” [35]. As indicated by De Prado [4]: “Two large stone balls inserted in iron strings fallen down suggesting a dominant ground movement from the NNW”. The inspection of the building shows that the affected zone of the castle was its NW corner. This is the only place of the building where the (missing) stone balls have been replaced for new ones (Figure 10a), and where the upper battlements of the adjacent eastern wall appear visibly crushed and cracked (Figure 10b). The stone balls and masonry blocks of the palace are made of Miocene sandstone from the area, resulting in a strong weathered stage of the original stone balls, which contrast with the fresh stage of the new replaced stone balls (Figure 10b). This NNW-SSE orientation of the ground shaking is consistent with the location of the macroseismic epicenter around the Almanzora Gorge proposed in the IGN catalogue [7], NNW of the Cuevas de Almanzora (Figures 2 and 3b).

**Figure 10.** Archeoseismological damage at the Villafranca Palace in Cuevas de Almanzora (Intensity VI). (a) Overall view of the Villafranca Palace showing its NW corner, where De Pardo [4] documented the fallen stone-balls decorating the battlements. Note the weathered stage of the original stone-balls and the fresh-one of the recently replaced fallen balls, as well as the overall cracked stage of the battlements of the eastern wall (especially those of the NW corner). (b) Detail of the NW corner of the palace illustrating the main features of building damage and repairation.
