# Reconnaissance of the Effects of the $M_W 5.7$ ( $M_L 6.4$ ) Jajarkot Nepal Earthquake of 3 November 2023, Post-Earthquake Responses, and Associated Lessons to Be Learned

**Keywords:** 2023 Nepal earthquake; Jajarkot earthquake; earthquake damage survey; building damage; aftershocks; masonry structures

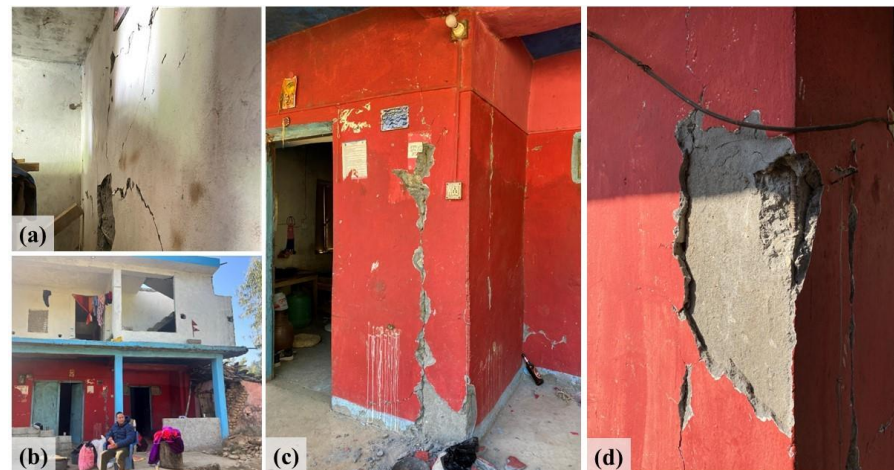
RC-framed buildings were found mostly undamaged during the earthquake, exhibiting only minor damage in most cases. The damage seen in a two-story RC-framed building in Raut Gaun is demonstrated in Figure 6. It was clear that poor quality concrete was used in the construction of these damaged buildings. Examples of low-strength concrete used in RC buildings are shown in Figure 6c,d. The concrete in these buildings was easily disintegrated by hand. The strength of the concrete materials appears to have been severely weakened using large-diameter aggregates. Furthermore, the aggregates seemed to be poorly or uniformly graded, resulting in a honeycomb pattern in the cast concrete and further reducing its strength.

**Figure 6.** Damage to RC frame building: (a) cracks in the walls; (b) front view of the two-story building; (c,d) separation of column from the masonry infills ( $28^{\circ}41'55''$  N,  $82^{\circ}13'45''$  E).

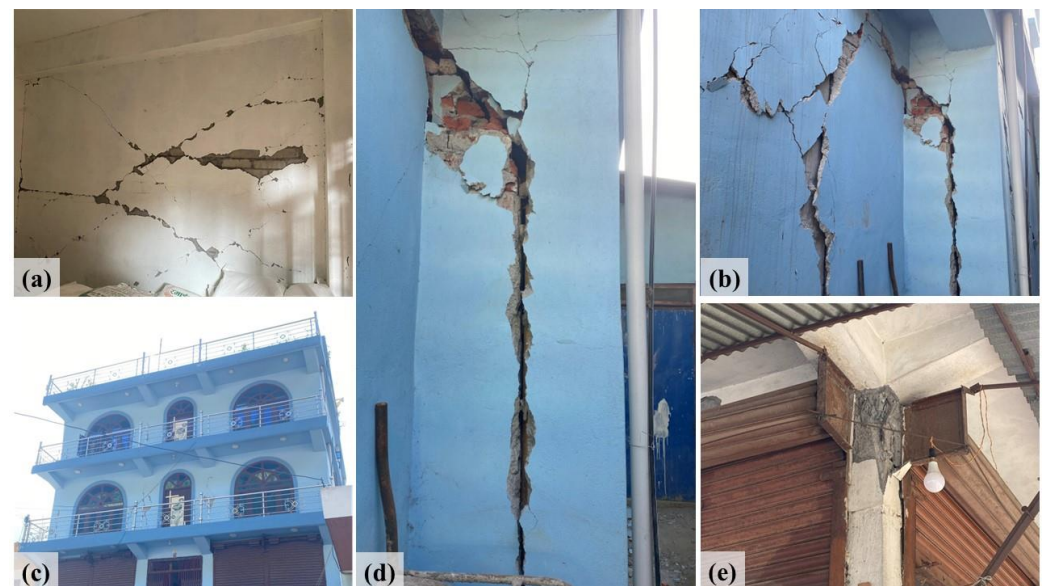
The four-story RC building located in Rimna Bazaar was damaged by the Jajarkot earthquake, as shown in Figure 7. Diagonal fissures on the brick infill wall of the building are depicted in Figure 7a. Furthermore, Figure 7b,d illustrate a poor connection by showing a noticeable space between the walls of the original structure and an attached expansion. These improper connections lead to the overall deformation of the main building because the extensions experience impact loads that cause severe damage. The strong beam and weak column connections are shown in Figure 7e. This type of connection is commonly found in RC buildings that have collapsed or sustained damage. Generally, when columns show weakness relative to beams, the overall ductility of the structure decreases. The weak column strong beam mechanism experiences a significant degradation in post-yield behavior, characterized by a significant loss of strength and limited displacement capacity. This emphasizes the vulnerability of buildings with strong beams and weak columns.

**Figure 7.** Damage to RC frame building: (a) diagonal cracks; (b) vertical and diagonal cracks; (c) four-story building with cracks in exterior walls; (d) separation of column from the wall; (e) joint failure in column ( $28^{\circ}41'55''$  N,  $82^{\circ}16'46''$  E).

Further, the RC building with rolling shutters exhibited extensive damage attributed to column failure, as shown in Figure 7. During the installation of rolling shutters, the cover of RC columns is removed at specific locations along the column axis, revealing the primary reinforcement bars, which are then welded to the guide of the shutter. The introduction of rolling shutters markedly altered the stiffness and moment capacities of the RC columns by (1) diminishing the cross-sectional area of the column and (2) decreasing the strength and stiffness of the reinforcement bars due to overheating induced by the welding procedures. Similar observations were observed in the 2015 Gorkha earthquake in Nepal [7].

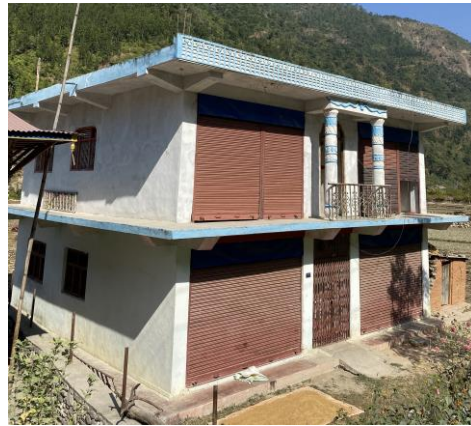
on its proper design, following building codes, and the incorporation of seismic elements. Existing RC buildings (Figure 8) that do not adhere to the national building code should undergo retrofitting to ensure preparedness for future earthquakes.

**Figure 8.** RC-framed building in West Rukum with no adherence to building code guidelines.

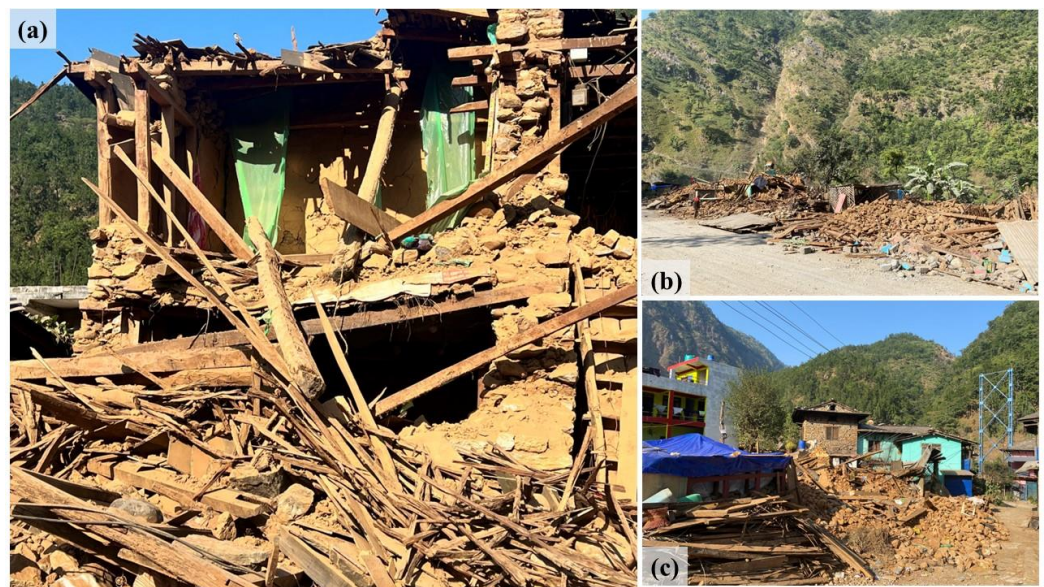
**Figure 9.** (a) Close-up view of collapsed stone masonry building, (b), series of completely collapsed residential stone masonry buildings, and (c) collapsed and intact stones masonry building.

The dominant cause of damage in masonry structures is the use of weak mortar during construction [34]. In these buildings, unreinforced masonry is common, resulting in walls being disconnected from the floors and roofs as well as from each other. Typically, these structures lack earthquake-resistant elements such as corner stones and horizontal ties

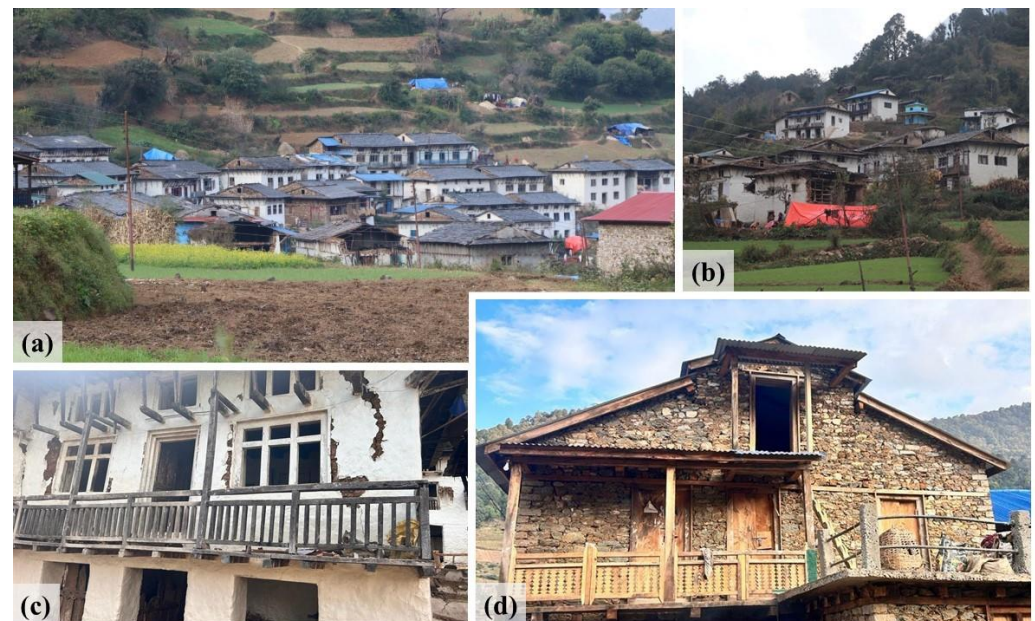
Some of the village's structures that were destroyed by the earthquake are shown in Figure 10b,c. In the post-earthquake observation (Figure 10d), the Sherpa village construction showed a heightened safety level compared to neighboring settlements.

**Figure 10.** (a,b) Sherpa Village near the epicenter (Ramidanda); (c) vertical and joint shear cracks; (d) undamaged building with wooden bands (28°55′11″ N, 82°15′03″ E).

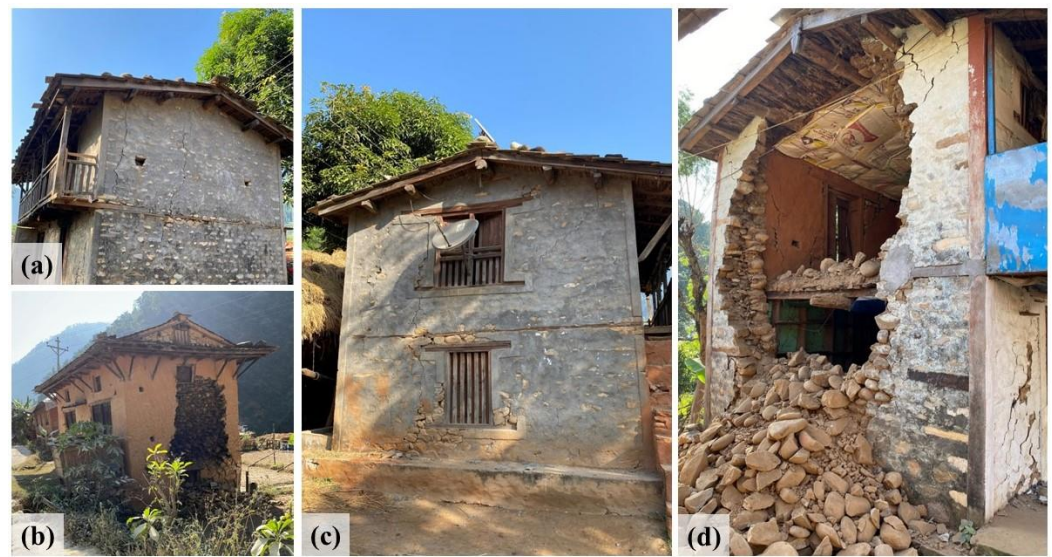
In general, buildings in the affected area had damage to their masonry walls, evident in the form of vertical or inclined shear cracks, as shown in Figure 11a,c. Figure 11b highlights the critical issue: the presence of cavities in the structural walls. These cavities seriously impair the capacity of walls to withstand flexural and shear stresses during seismic events, leading to damage. Additionally, when building thick walls, the use of small rubble rather than stones caused the wall to separate vertically. Figure 11d shows an out-of plane failure in the load-bearing structure. This causes the failure of one face of the wall and occurs due to the insufficient bonding between the adjacent walls. When the seismic wave travels along the crest surface, the face perpendicular to the direction of the seismic wave cannot generate significant lateral force. This happens because the wall facing the wave has a reduced width, resulting in a low moment of resistance. It was observed that gable walls are highly susceptible to drift and out-of-plane lateral loads, primarily because they function as unsupported infill walls detached from the roof structures. A significant cause of damage to unreinforced masonry buildings is the collapse of these gable walls. The failure of gable walls can potentially lead to the subsequent failure of the shorter lateral walls. Considering their poor performance under such conditions, it is advisable to replace stone masonry gable walls with lighter materials, such as wooden planks or steel sheets, as a recommended measure. This substitution aims to enhance the overall structural resilience and mitigate the risk of gable wall failure in the face of lateral loads.

**Figure 11.** Damage in masonry buildings: (a) vertical cracks ( $28^{\circ}41'52''$  N,  $82^{\circ}13'45''$  E) (b) vertical separation of wall ( $28^{\circ}44'26''$  N,  $82^{\circ}17'27''$  E) (c) vertical cracks and damage at window (d) out of plane collapse of stone masonry wall ( $28^{\circ}41'55''$  N,  $82^{\circ}13'46''$  E).

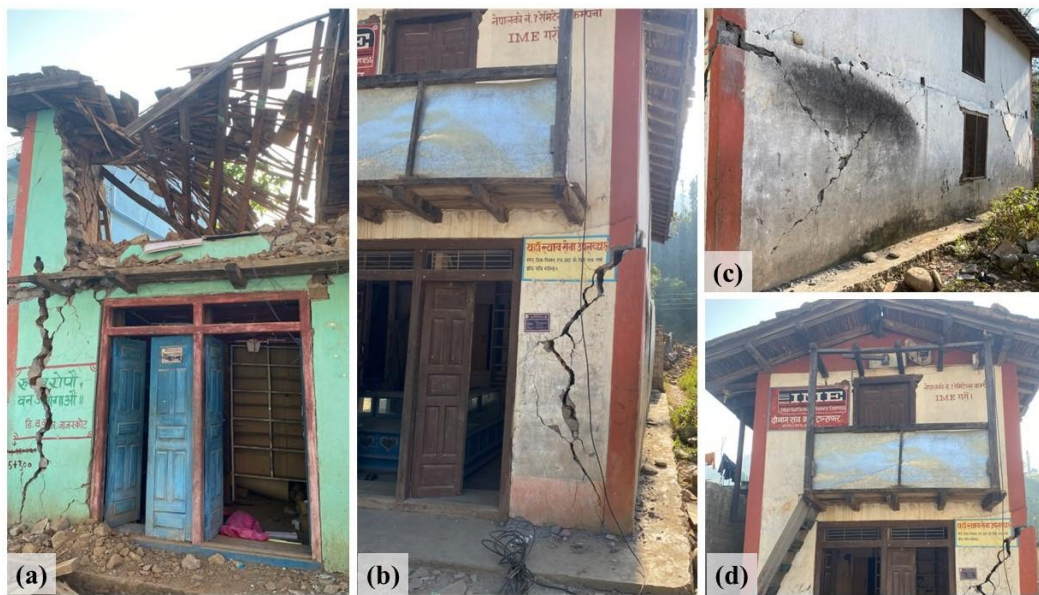
In Figure 12a, the failure of supporting walls and the collapse of the roof are recorded. Additionally, uneven foundation movement, inadequate connections between walls and floors, or out-of-plane bending brought on by seismic stresses perpendicular to the walls were also observed. Figure 12b illustrates observed failure and cracks at the corners, possibly stemming from these issues. The diagonal fractures in the masonry wall originating from the opening are shown in Figure 12c. The presence of apertures obstructs the load passage, leading to increased shear stress at lintel and sill levels, causing the formation of shear cracks. The poor connection between a stone masonry wall and the roof contributed significantly to structural failure during an earthquake. In seismic events, the dynamic forces exerted on a building can cause differential movement between the rigid stone masonry walls and the roof structure, especially if there is inadequate or improper anchoring and bracing. The lack of robust connections allowed for the independent movement of the wall and roof elements, leading to structural disintegration. The heavy mass of stone, combined with the brittle nature of the material, makes it particularly vulnerable to seismic forces. Without effective connections, the roof may have exerted additional stress on the stone masonry walls, leading to the development of cracks, separation at joints, or even the collapse of sections of the structure.

**Figure 12.** Damage in masonry buildings: (a) collapse of roof and failure of supporting walls of the building; (b) failure at the corner; (c) diagonal cracks; (d) vertical separation of masonry pier at corner ( $28^{\circ}41'57''$  N,  $82^{\circ}16'44''$  E).

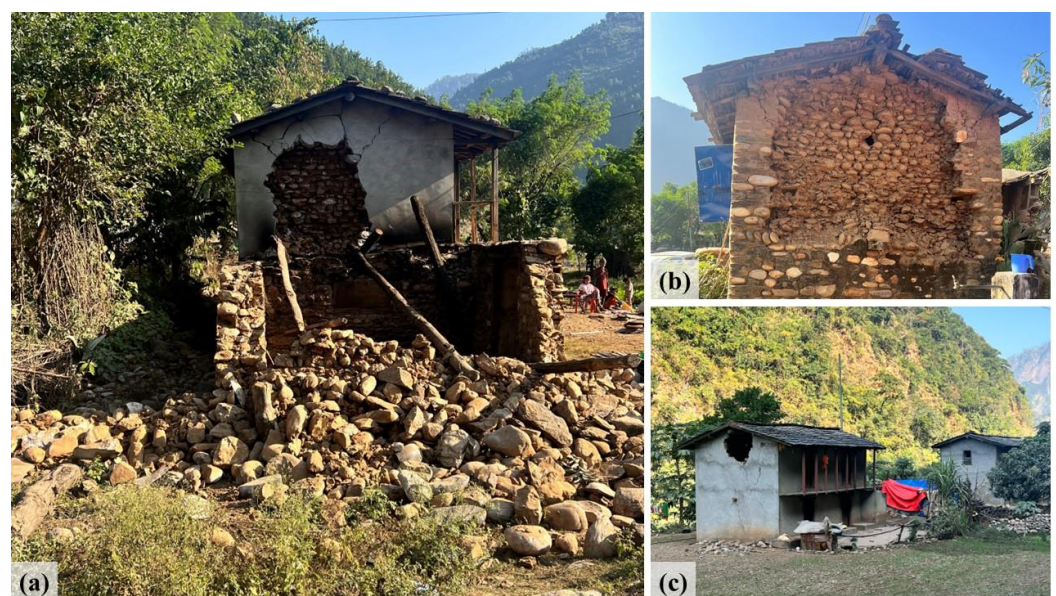
Additionally, Flexural out-of-plane failure is a major risk factor for unreinforced masonry structures, particularly in cases where there is a lack of proper wall-to-floor connection. This can lead to the collapse of entire wall panels or substantial sections when exposed to lateral seismic forces. The out-of-plane failure of load-bearing walls, caused by the failure of one wall face, is shown in Figure 13. This kind of collapse is made worse when there is inadequate bonding between neighboring walls, especially when seismic waves pass over the crest surface. The face perpendicular to the seismic wave experiences less lateral force due to its smaller breadth, resulting in a reduced moment of resistance. The disadvantages of employing rounded stone units are illustrated in Figure 13b, where it is shown how the smooth, rounded shapes of the units diminish bonding between them, allowing cracks to spread through weak mortar joints.

**Figure 13.** Damage in masonry buildings: out of plane collapse of stone masonry wall (a) ( $28^{\circ}41'56''$  N,  $82^{\circ}16'46''$  E) (b) ( $28^{\circ}41'54''$  N,  $82^{\circ}13'45''$  E) (c) ( $28^{\circ}42'42''$  N,  $82^{\circ}16'59''$  E).

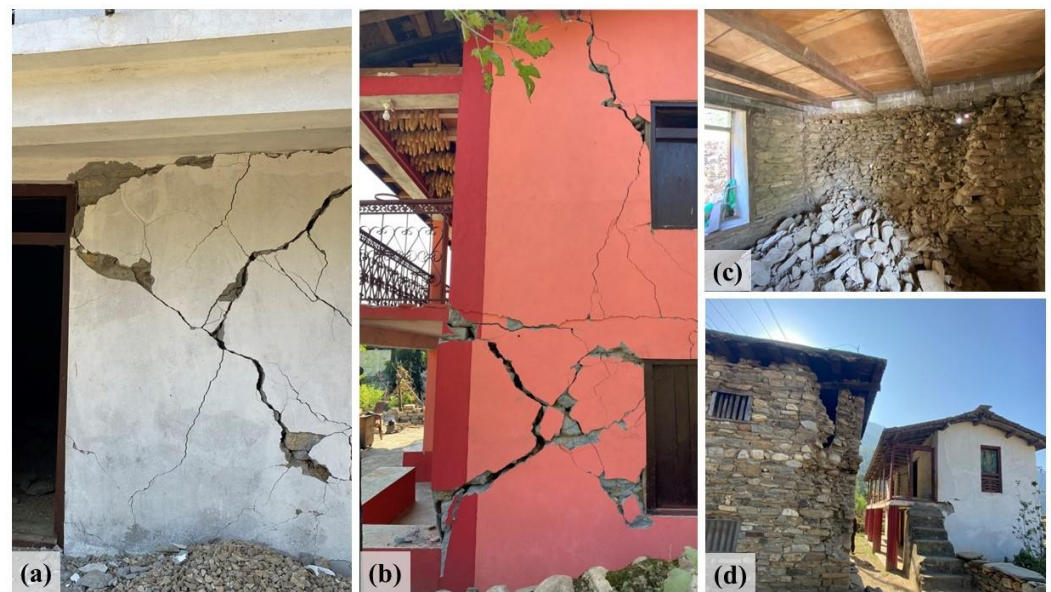
In stone masonry using cement mortar, shear damage frequently causes the separation of perpendicular walls, as shown in Figure 14a,b. This is particularly prevalent in cases where cornerstones are missing, which usually give some support. Figure 14c shows the out-of-plane failure of a stone masonry wall, and Figure 14d shows a failure between the walls due to inadequate bonding, which causes walls to separate from one another. A leading factor contributing to these sorts of connection failures is the insufficient number of connections.

**Figure 14.** Damage in masonry buildings: (a) wall pier diagonal cracking; (b) vertical and diagonal shear cracks in walls; (c) out of plane collapse of stone masonry wall ( $28^{\circ}41'58''$  N,  $82^{\circ}15'42''$  E); and (d) connection failure of the wall ( $28^{\circ}41'35''$  N,  $82^{\circ}14'03''$  E).

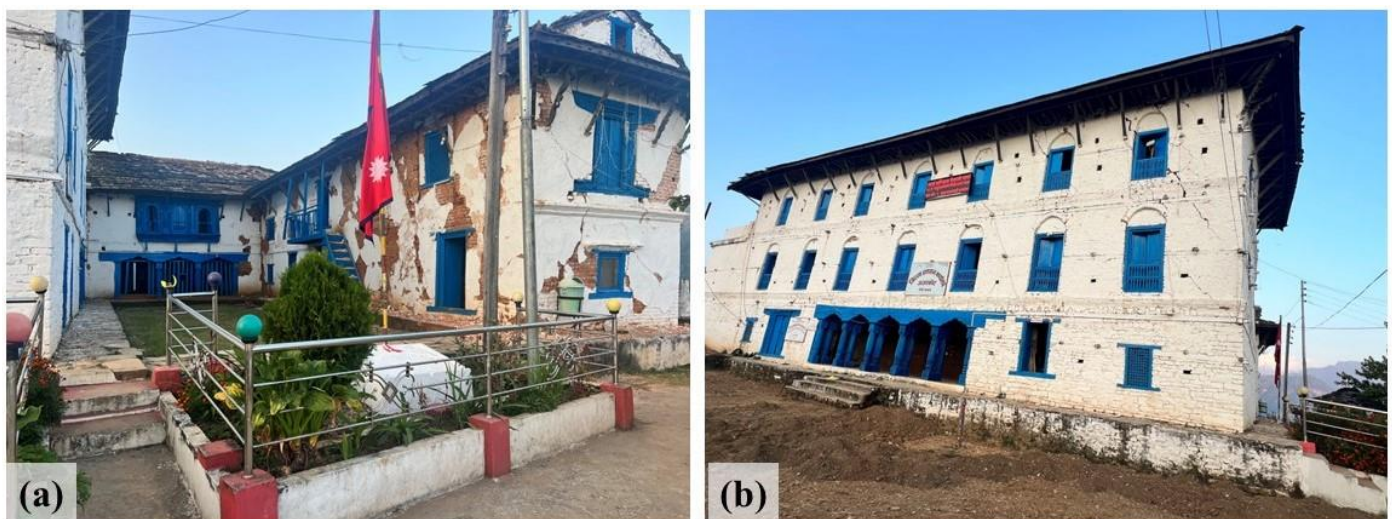
The Jajarkot Palace, an architectural and historical marvel constructed in 1825 B.S. by King of Jajarkot Hari Shah, suffered partial damage in the earthquake of 2023 (Figure 15). The minor damage could also be attributed to its recent retrofitting following the 2015 Gorkha earthquake. Popularly known as the ‘White Palace’, it holds immense cultural significance and is listed among the government’s designated tourist destinations. Unfortunately, the earthquake has not spared the nearby buildings of over a century in age, bearing historical value, as they too have incurred damage.

**Figure 15.** Damage to historical Jajarkot Palace, Khalanga, Jajarkot ( $28^{\circ}41'56''$  N,  $82^{\circ}12'01''$  E) (a) plaster spalling with several diagonal cracks and (b) cracks on the wall.

Corner wall collapses were seen at the heritage site, with the torsional effect being the primary cause of damage. The presence of step-type shear cracks in unreinforced masonry (URM) walls not only contributed to the separation at corners but also posed a risk to the overall structural integrity. A noteworthy exception was seen in the district administration office in Jajarkot, where the installation of a timber band on the roof and

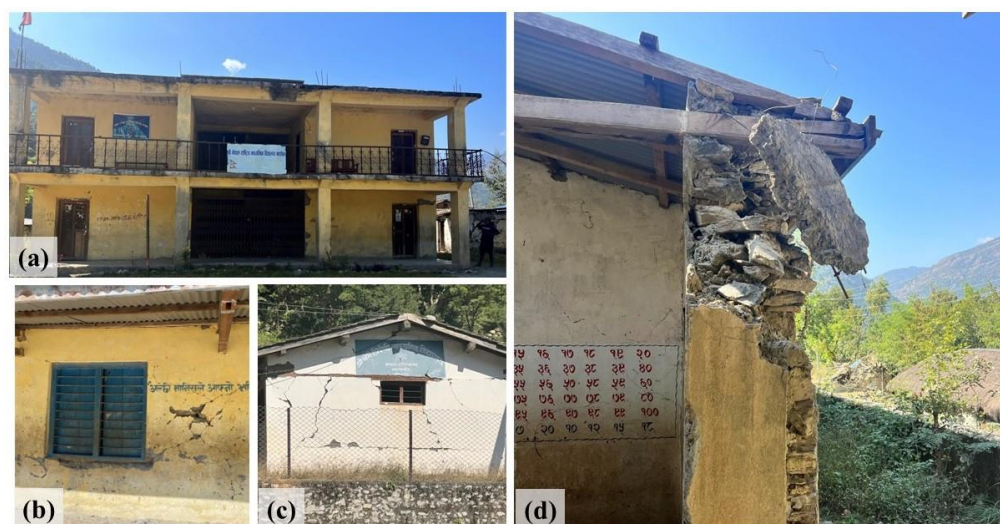
As of 20 November, the seismic event affected 898 school buildings; 294 sustained total damage, and 604 experienced partial damage. Additionally, 89 school toilets suffered partial damage due to the earthquake. This extensive destruction has directly impacted the education of 125,000 students [5]. An initial assessment carried out by the education cluster of Karnali Province identified that 65,867 students require urgent education assistance, including 5765 textbooks, to tackle the educational challenges brought up by the disaster. Figure 16 shows the damage suffered by the school infrastructure in Jajarkot and West Rukum districts due to the earthquake.

**Figure 16.** (a–d) Damage to school buildings of Jajarkot ( $28^{\circ}41'53''$  N,  $82^{\circ}16'20''$  E) and West Rukum ( $28^{\circ}47'06''$  N,  $82^{\circ}18'55''$  E).

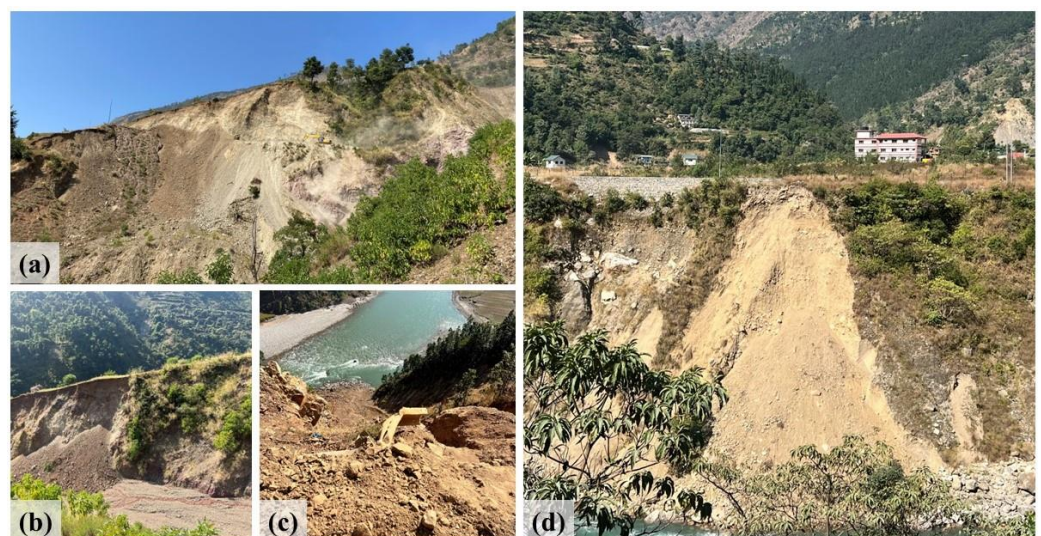
As shown in Figure 18a, a typical shallow landslide occurred on a steep slope near Nalgad Bazar. The debris was mostly composed of rocks, silt, and sand, as depicted in Figure 18b. Figure 18c shows the landslide that occurred along the lower section of the Midhill Highway close to China Bazar. An excavator was quickly mobilized to remove the obstruction caused by the landslide from the road. Furthermore, a shallow dry landslide near the Bheri Riverbank is seen in Figure 18d.

**Figure 18.** (a,b) Roadside shallow landslide along Bheri Corridor near Nalgad Bazaar ( $28^{\circ}48'07''$  N,  $82^{\circ}17'22''$  E) (c) Roadside landslide along Midhill Highway near China Bazaar ( $28^{\circ}42'14''$  N,  $82^{\circ}15'31''$  E) (d) Shallow landslide on the Bheri riverbank ( $28^{\circ}47'05''$  N,  $82^{\circ}17'58''$  E).

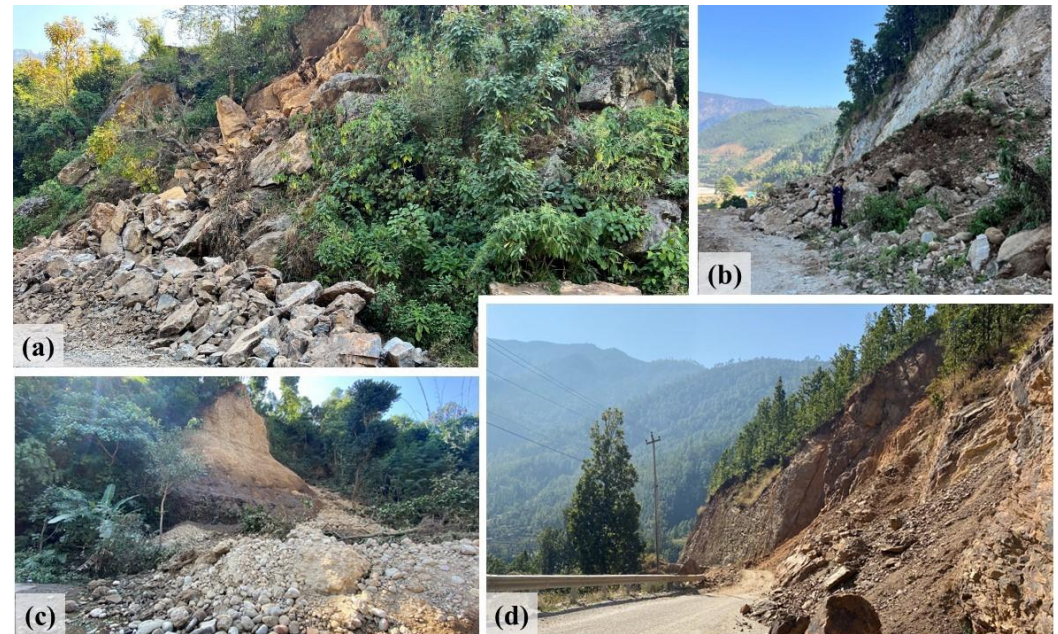
The earthquake-induced rockfalls on the road disrupted the smooth flow of traffic; however, temporary clearance of the road was undertaken during the survey period. In Figure 19a, an example of a weathered rock formation is depicted. Observations revealed rock masses of diverse sizes near the edge of the rockfall, suggesting the involvement of multiple rocks or the fragmentation of a primary boulder into smaller pieces as it descended the hill.

**Figure 19.** (a) Rockfall ( $28^{\circ}42'29''$  N,  $82^{\circ}14'17''$  E) (b) ( $28^{\circ}41'19''$  N,  $82^{\circ}13'52''$  E) (c) ( $28^{\circ}41'54''$  N,  $82^{\circ}15'46''$  E) (d) ( $28^{\circ}42'14''$  N,  $82^{\circ}15'31''$  E).

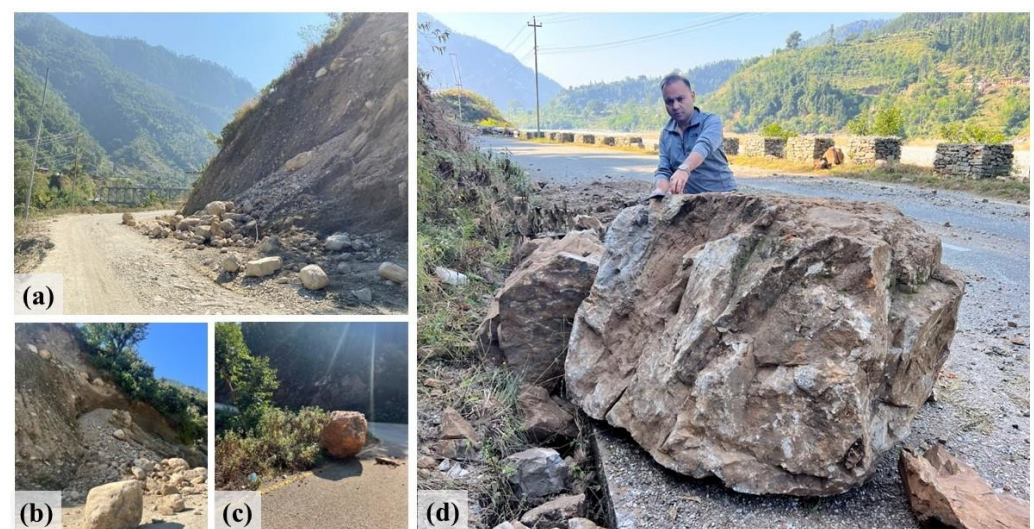
Rock falls were observed at various sections of the survey route, as shown in Figure 20. The rocks were of different sizes, varying from medium to large ( $0.5$  to  $5.8\text{ m}^3$ ) in the Bheri Corridor, as seen in Figure 20b. Along the Midhill highway, notably larger rockfalls, reaching sizes up to  $1.73\text{ m}^3$ , were observed, as shown in Figure 20d.

**Figure 20.** (a) Road obstruction due to continuous rock fall ( $28^{\circ}46'51''$  N,  $82^{\circ}17'33''$  E) (b) medium to large size rockfall ( $28^{\circ}46'50''$  N,  $82^{\circ}17'33''$  E) along Bheri Corridor (c) rockfall ( $28^{\circ}42'22''$  N,  $82^{\circ}15'17''$  E) (d) large size rocks fall up to  $1.73\text{ m}^3$  ( $28^{\circ}42'17''$  N,  $82^{\circ}14'08''$  E) along Midhill Highway.

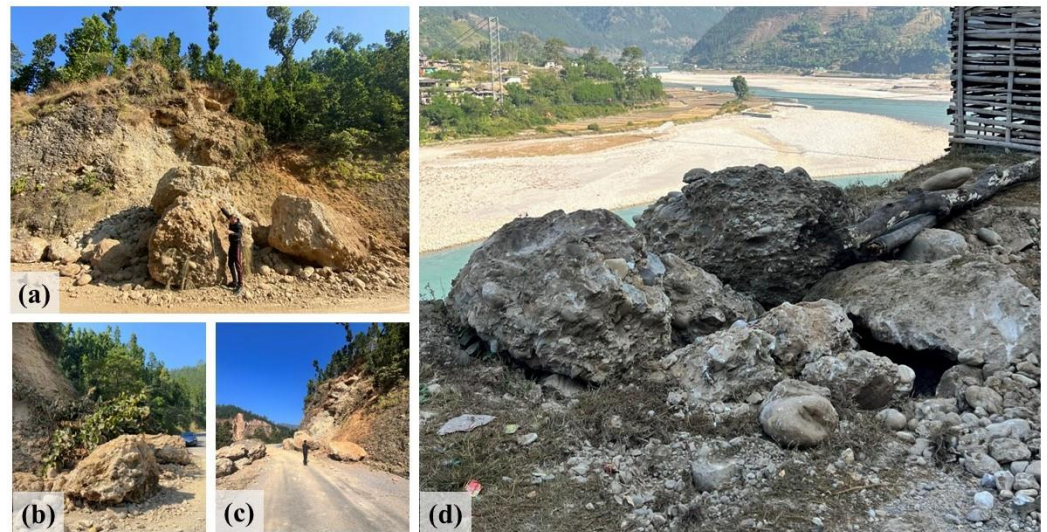
Substantial rocks of considerable size were discovered along the Bheri Corridor, as indicated in Figure 21a,c. These rocks exhibit a maximum size of approx.  $5.8 \text{ m}^3$ . Additionally, Figure 21b,d depict rocks found alongside the Midhill Highway.

**Figure 21.** Large size rocks fall along Bheri Corridor (a,c) maximum size of  $5.8 \text{ m}^3$  ( $28^\circ 42' 09'' \text{ N}$ ,  $82^\circ 15' 45'' \text{ E}$ ) and Midhill Highway (b) ( $28^\circ 41' 59'' \text{ N}$ ,  $82^\circ 15' 39'' \text{ E}$ ) (d) ( $28^\circ 41' 12'' \text{ N}$ ,  $82^\circ 13' 39'' \text{ E}$ ).

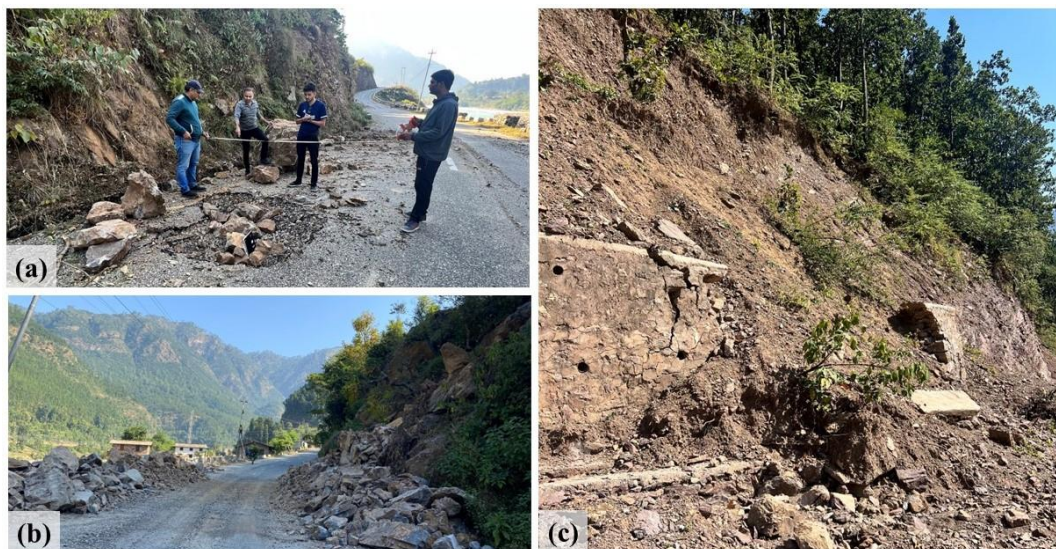
These rockfalls caused substantial damage to the road infrastructure, as depicted in Figure 22, leading to the formation of a large pothole in the pavement, measuring up to  $1.8 \times 2.3 \text{ m}$ , as illustrated in Figure 22a. The resultant road blockage due to the rockfall along the Midhill highway is visible in Figure 22b. Additionally, Figure 22c showcases the collapse of retaining walls on a local road at Nalgad Bazaar along the roadside slope.

**Figure 22.** Damage in road infrastructure: (a) rockfall caused large size pothole in pavement, with maximum size up to  $1.8 \times 2.3 \text{ m}$  ( $28^\circ 42' 17'' \text{ N}$ ,  $82^\circ 14' 08'' \text{ E}$ ) (b) road blockage due to rock fall ( $28^\circ 42' 29'' \text{ N}$ ,  $82^\circ 14' 17'' \text{ E}$ ) along Midhill Highway (c) failure of roadside slope retaining wall ( $28^\circ 48' 05'' \text{ N}$ ,  $82^\circ 17' 25'' \text{ E}$ ) along local road nearby Nalgad Bazaar.

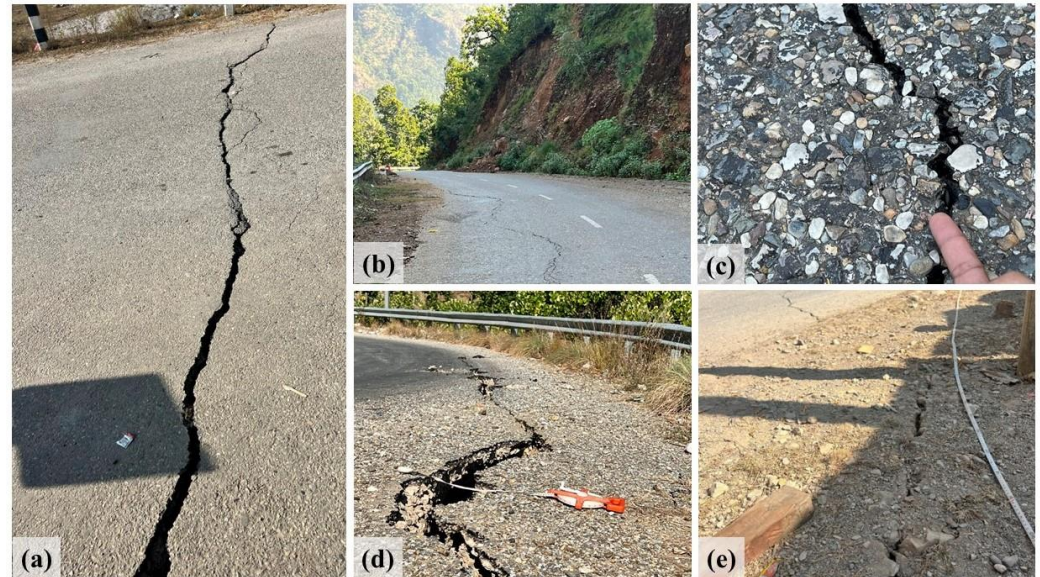
The earthquake inflicted structural damage on the road pavement, as illustrated in Figure 23. Figure 23a reveals a large transverse crack spanning the entire road, indicative of lateral ground movement during the seismic event. This type of cracking results from

horizontal movement in the Earth's crust, causing the pavement to fracture perpendicular to the road. Furthermore, Figure 23b displays longitudinal cracks with a maximum length of 120 m, suggesting shearing force or horizontal ground movement along the road during the earthquake.

**Figure 23.** Road subsidence and pavement cracks along different sections of the highway: (a) transverse crack throughout the road ( $28^{\circ}41'57''$  N,  $82^{\circ}16'45''$  E) (b) longitudinal cracks extending up to 120 m ( $28^{\circ}42'21''$  N,  $82^{\circ}15'19''$  E) (c) transverse crack ( $28^{\circ}42'13''$  N,  $82^{\circ}14'07''$  E) (d) edge crack and depression with maximum width 0.45 m and depth 1.82 m due to downslope slip nearby China Bazaar ( $28^{\circ}42'01.6''$  N,  $82^{\circ}15'32''$  E) (e) diagonal crack nearby the Rimna Bridge ( $28^{\circ}42'03''$  N,  $82^{\circ}16'46''$  E).

The edge fracture and depression near China Bazaar, measuring 0.45 m in width and 1.82 m in depth, are shown in Figure 23d. This specific damage is attributed to the downslope slip phenomenon, in which seismic pressures weaken and fracture the pavement material at the margins, resulting in a sizable dip and edge crack. Figure 23e shows a diagonal crack near the Rimna Bridge, emphasizing the complex interaction between compressive and shearing forces during the earthquake-induced ground displacement.

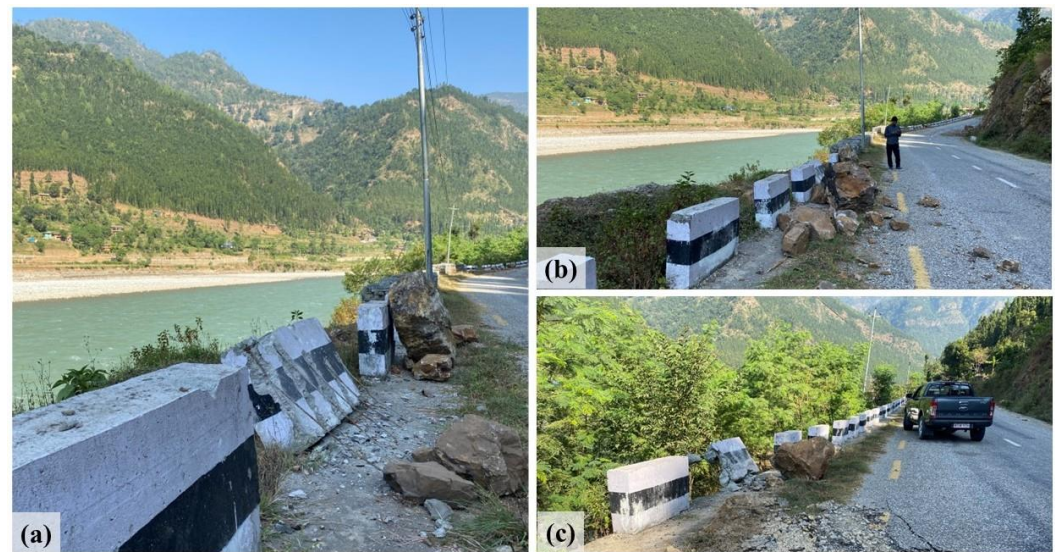
The impact of earthquake-induced rockfalls and landslides is apparent in various sections. Figure 24 illustrates the earthquake's effect on roadside concrete barriers along the Midhill highways in West Rukum. The 0.6 m high and 0.2 m wide concrete barrier suffered damage from falling boulders and debris, resulting in cracks, fractures, fissures, and dislodgments. This observed damage underscores the vulnerability of roadside infrastructure to seismic events, emphasizing the critical importance of targeted mitigation strategies and robust design in earthquake-prone areas like Nepal. More importantly, the study of KC et al. [36,37] highlights that the effect of earthquake preconditioning becomes apparent in the post-earthquake monsoon period, as evidenced by an increased rate of landslide disasters since the 2015 Gorkha earthquake. Thus, proper consideration of earthquake-affected vulnerable slopes is a must.

**Figure 24.** Damage to roadside concrete barriers in different sections along Midhill highway, West Rukum district (a,b) ( $28^{\circ}42'15''$  N,  $82^{\circ}14'07''$  E) (c) ( $28^{\circ}42'17''$  N,  $82^{\circ}14'08''$  E).

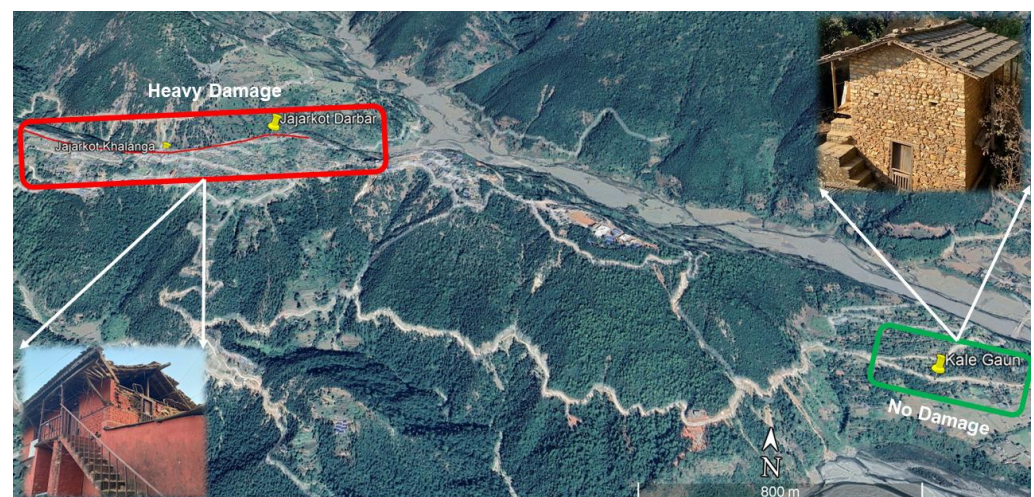
The terrain and soil of the area clearly had an impact on this earthquake. Figure 25 shows that the Jajarkot Khalanga ridge was the focal point of major infrastructure destruction, indicating the occurrence of topographic amplification. On the other hand, Kale Gaun, which is located on the hill's lower slope, sustained little damage from the earthquake. A similar ridge effect was noted at Barekot, Limsa. As seen in Figure 2, most of the damaged places that were inspected, including Raut Gaun, Rimna Bazaar, Radi Bazaar, and Nalgad Bazaar, were established on river deposits and were situated along the Bheri River corridor. The substantial damage in these regions further indicated the impact of the local soil characteristics. Thus, the localized ground effects observed align with findings reported by [38–40] in other earthquake studies (Pohang Earthquake, Sonitpur Earthquake). Sharma et al. [23] have also discussed the similar effects of surface geology and topography on the damage severity during the 2015 Gorkha Nepal Earthquake.

**Figure 25.** Damage in Khalanga, Jajarkot area indicating ridge effect due to earthquake.

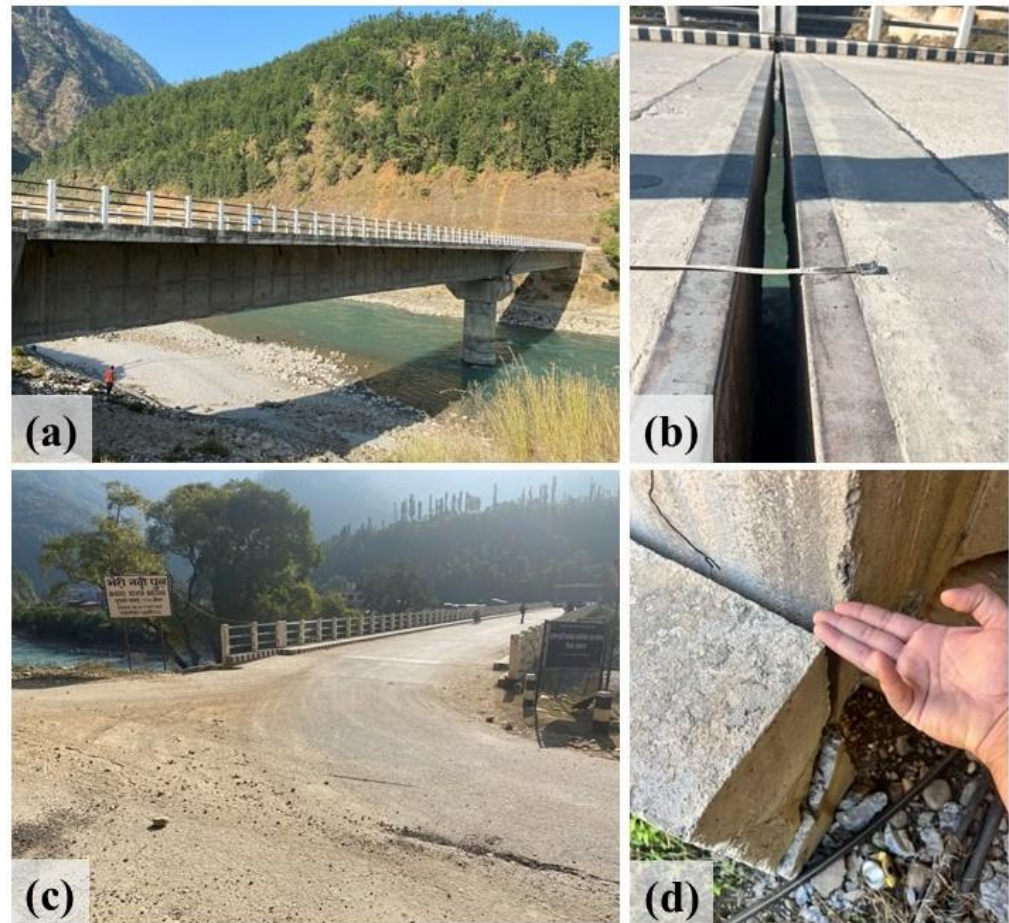
**Figure 26.** (a) Partial damage in Bheri River bridge, Rimna ( $28^{\circ}42'03''$  N,  $82^{\circ}16'42''$  E) (b) displaced expansion joints, (c) cracks on approach road, and (d) damage to stoppers.

The reconnaissance visit revealed several observations about the bridge's condition. The bridge utilizes POT-PTFE fix-free bearing arrangements, and despite broken bolts at both abutments, the superstructure securely remains on the bearings. Notably, rotational movement at the expansion joint was observed, causing a significant increase in the gap at the center and a reduction at the end of the left span. Additionally, the stoppers on the upstream side were found to be broken diagonally at both abutments due to the impact of the superstructure. Despite these issues, the abutment, pier, and superstructure displayed minor damage, with no observed cracks in critical structural components. However, the approach road exhibited various cracks, particularly in the backfill of the abutments and the natural ground in the United Region. The inspection highlighted specific concerns, including broken bolts, rotational movement at the expansion joint, and damage to stoppers, emphasizing the immediate need for a bearing replacement plan followed by correcting the superstructure's dislocation.
