# Impacts of a Moderate-Sized Earthquake: The 2023 Magnitude ( $M_w$ ) 4.7 Leyte, Leyte Earthquake, Philippines

Department of Science and Technology, Philippine Institute of Volcanology and Seismology (DOST, PHIVOLCS), Quezon City 1101, Philippines

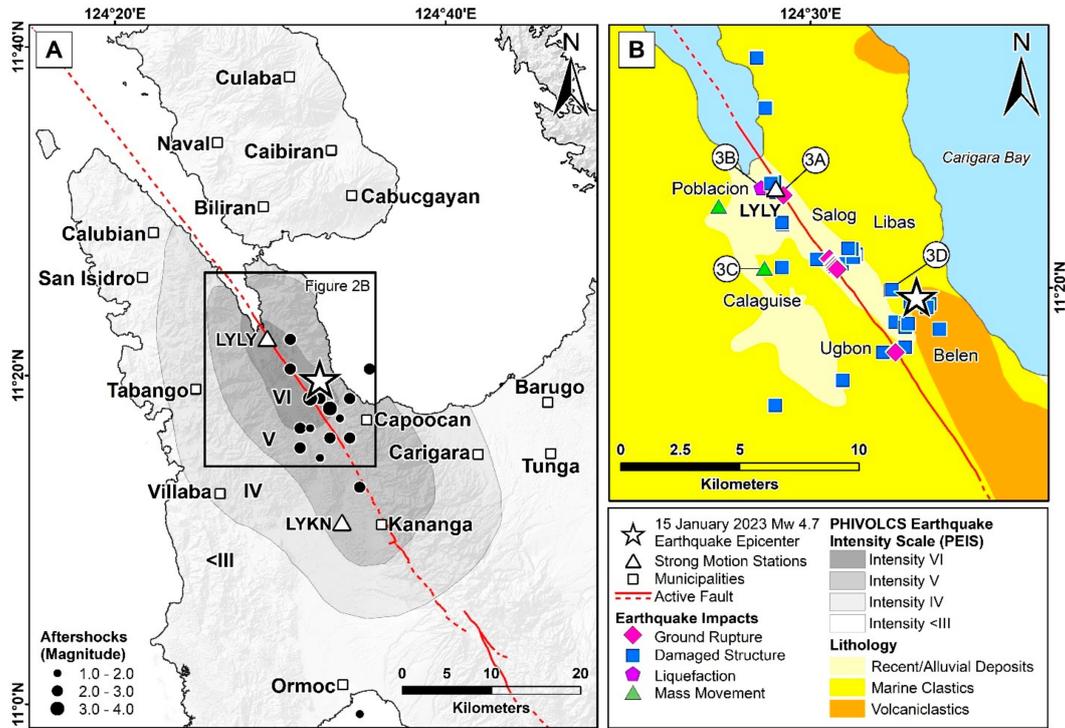
**Figure 2.** The 2023  $M_w$  4.7 Leyte, Leyte Earthquake isoseismal, aftershock distribution, and earthquake impact maps. (A) The isoseismal map was based on the latest earthquake information from DOST-PHIVOLCS [12] and the detailed intensity survey and impact assessment conducted in this study. Aftershock distribution (black circle) from 15 to 23 January 2023 was recorded by the Philippine Seismic Network [12]. (B) Spatial distribution of documented damages and geologic impacts (ground rupture, liquefaction, and mass movement). The geologic map was modified from Aurelio and Peña [13]. Circles with letters and numbers show the locations of photos in Figure 3. The active fault trace (red line) was obtained from Tsutsumi and Perez [10].

To verify the limited reported intensities, we conducted a detailed intensity survey and damage assessment in the affected area. Table 1 shows the result of our survey and is illustrated as an isoseismal map in Figure 2A, while Figure 2B summarizes the location of the geologic and structural impacts.

Based on the Rapid Damage Assessment and Needs Analysis report conducted by the municipality of Leyte, there were about 434 residential houses and 26 public infrastructures, including schools and government buildings, affected by the earthquake [25]. The DOST-PHIVOLCS QRT documented damaged structures, which are summarized in Figure 2B. Our assessment revealed that most of the damages were located near the epicentral area and could be attributed to poor-quality or substandard construction materials, such as CHB and reinforcing bars (Figure 4D). Notably, most of the damaged structures were located in alluvial and recent deposits (Figure 2B).

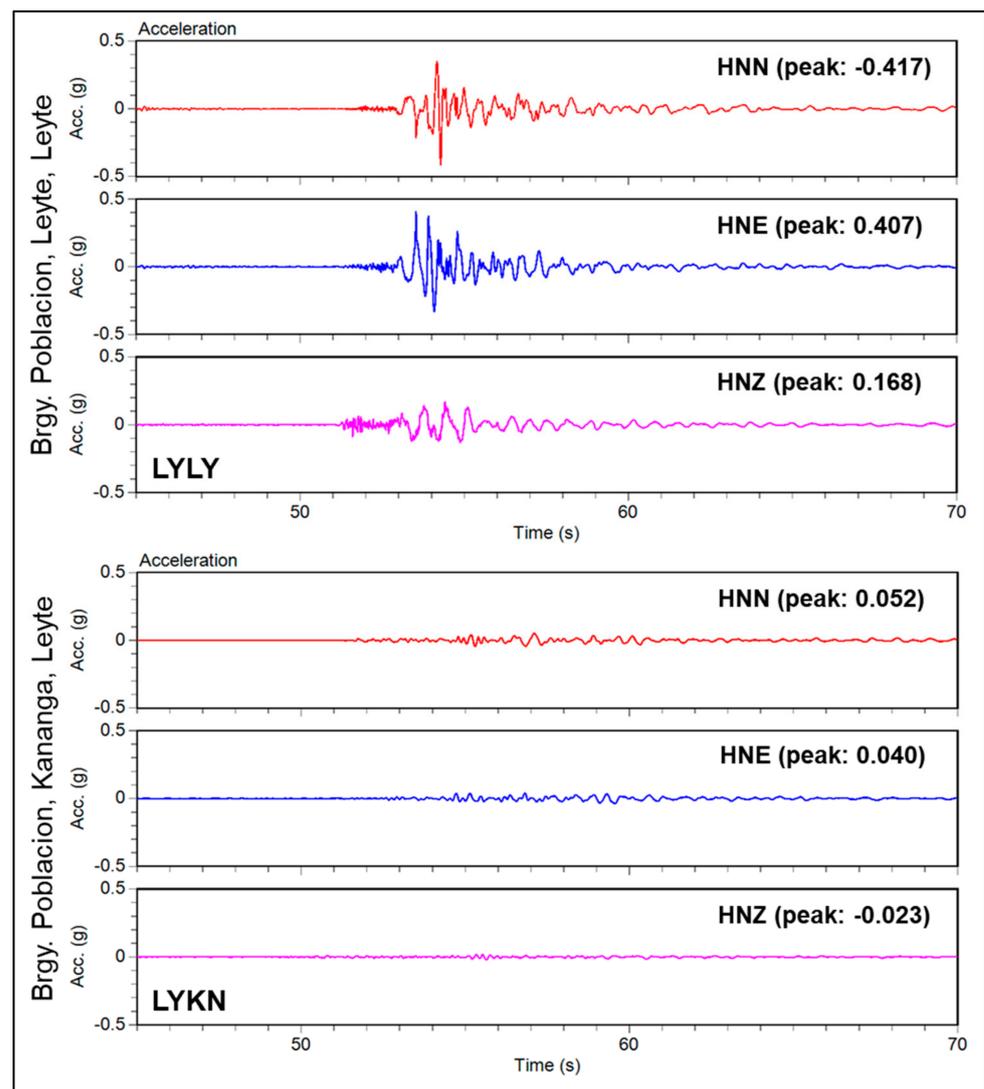
**Figure 3.** Peak ground acceleration (PGA) record from the Philippine Strong Motion Network (PSMNet) stations in Brgy. Poblacion, Leyte (station code: LYLY) and Brgy. Poblacion, Kananga (station code: LYKN). PGA values for the two sites correspond to the expected ground shaking felt in the area and were influenced by the soft sediment subsurface, as manifested by the geology and geomorphology of the area. Refer to Figure 2 for the location of the two (2) accelerographs.

For a more detailed assessment of the ground motion, data from two (2) accelerographs positioned near the epicenter were examined, both belonging to the PSMNet (refer to Figures 2 and 3). The first accelerograph (station code: LYLY) was located in Brgy. Poblacion, Leyte, and ~7 km NW of the epicenter. It recorded a peak ground acceleration (PGA) of 0.407 g, equivalent to PEIS VIII (very destructive) [23], while the second accelerograph (station code: LYKN), located in Brgy. Poblacion, Kananga and ~16 km southeast of the epicenter, recorded a much smaller PGA, 0.052 g, equivalent to PEIS V (strong) [23].

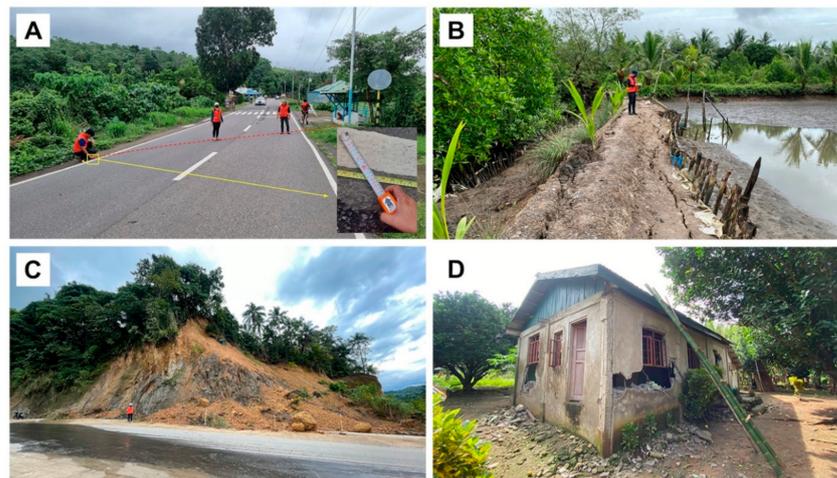
It is uncommon for an earthquake of magnitude  $< 6$  to have surface rupture [24]. However, our field investigation revealed an 8 km long northwest-trending discontinuous rupture associated with the 2023  $M_w$  4.7 Leyte, Leyte Earthquake that occurred along the previously mapped Philippine Fault—Leyte segment [10,16,17]. Detailed ground and drone surveys conducted during the investigation showed that the surface rupture affected at least three barangays (Brgys. Poblacion, Salog, and Ugbon) in Leyte (Figures 2B and 4A). The surface rupture manifested as a continuous crack with discernable left-lateral

displacement or parallel *en-echelon* visible cracks identified as Riedel shear structures. Measured displacements ranged from 1.5 to 2 cm. Figure 4A shows a portion of the surface rupture manifested as hairline cracks along a road with 2 cm horizontal displacement, coinciding with the previously mapped active fault. Eyewitness accounts verified that the hairline cracks were caused by the earthquake. It also affected residential houses traversed by the active fault. These residential houses had also previously been identified to be damaged by fault creeping in past studies [16,17]. A detailed discussion of this rare surface rupture is presented in Llamas et al. [26].

**Figure 4.** Geologic and structural impacts of the 2023  $M_w$  4.7 Leyte, Leyte Earthquake. (A) Observed road cracks (red line) along the national highway in Brgy. Poblacion, Leyte, coinciding along the trace of the Philippine Fault—Leyte segment [10]. Inset: 2 cm left-lateral displacement measured along the offset road paint. (B) Lateral spreads (cracks) formed on the earth dikes beside fishponds in Palaypay District, Brgy. Poblacion, Leyte. (C) A shallow landslide consisting of soil rock and debris partly covered a road in Brgy. Calaguise, Leyte. (D) Damaged house (concrete hollow block) in Brgy. Belen, Leyte. Refer to Figure 2B for the locations of photos.

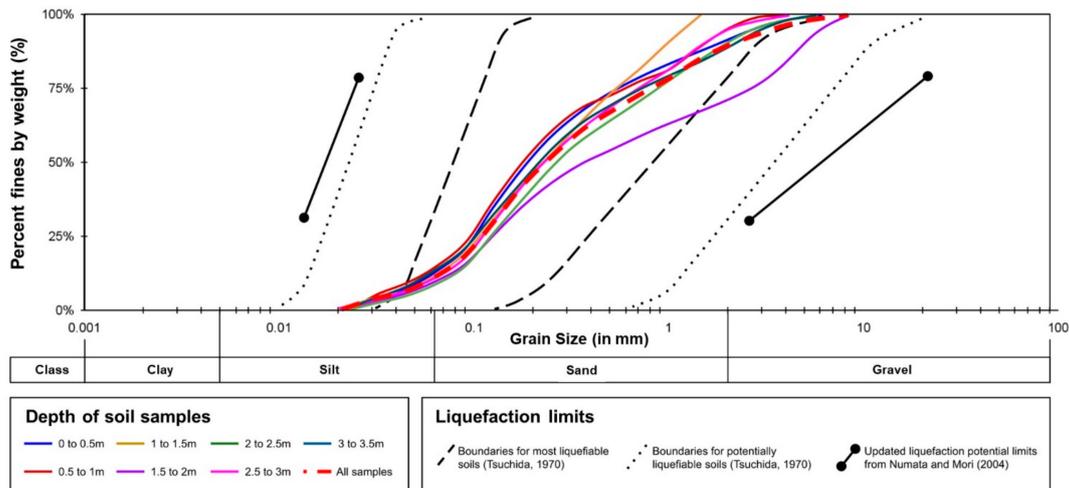
Figure 5 shows a summary of the grain size analysis of soil samples which we collected and compares it to liquefaction limits on grain sizes suggested by Tsuchida [27] and Numata and Mori [28]. The majority of the collected soil samples had grain sizes ranging from very fine to very coarse sand (0.0625 to 2.0 mm), and were within the boundaries of most liquefiable soils (Figure 5) [27–29]. While, for the soil sample collected from 1.5 to 2 m depth, 30% of its grains were granule- to pebble-sized (2.0 to 8.0 mm), this is still within the boundary for potentially liquefiable soils. With these soil properties and geomorphology coupled with the measured PGA of 0.407 g (recorded by LYL, 500m from Palaypay District) (Figures 2A and 3), and as evidenced by the subsidence and tilting of some buildings and lateral spreads on some earth dikes, we are therefore more certain that liquefaction occurred in these soils.

**Figure 5.** Grain size analysis of soil samples taken on the earth dikes that liquefied in Palaypay District, Brgy. Poblacion, Leyte, with liquefaction limits set by [28,29].
