Article

Evaluation of Slope Stability Considering the Preservation of the General Patrimonial Cemetery of Guayaquil, Ecuador

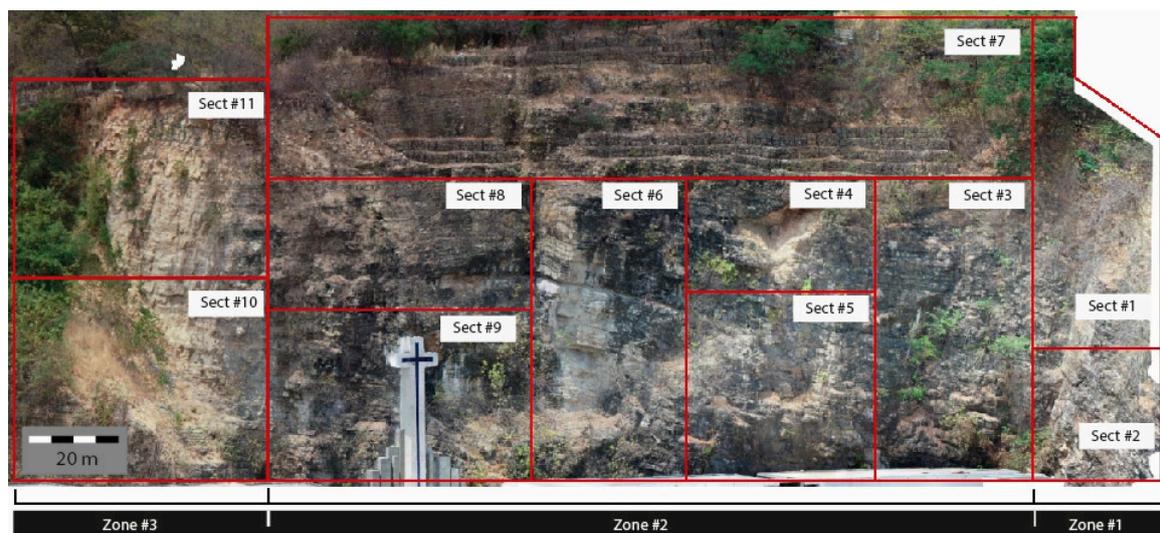
Figure 3. Frontal view of the 3D model of the slope. Division of the slope into zones and sectors.

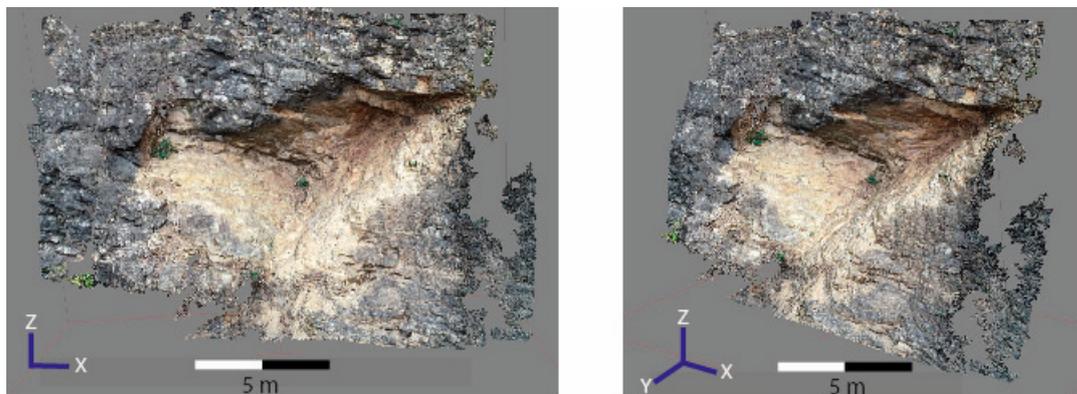
Figure 6. Front and right views of Sector 4.

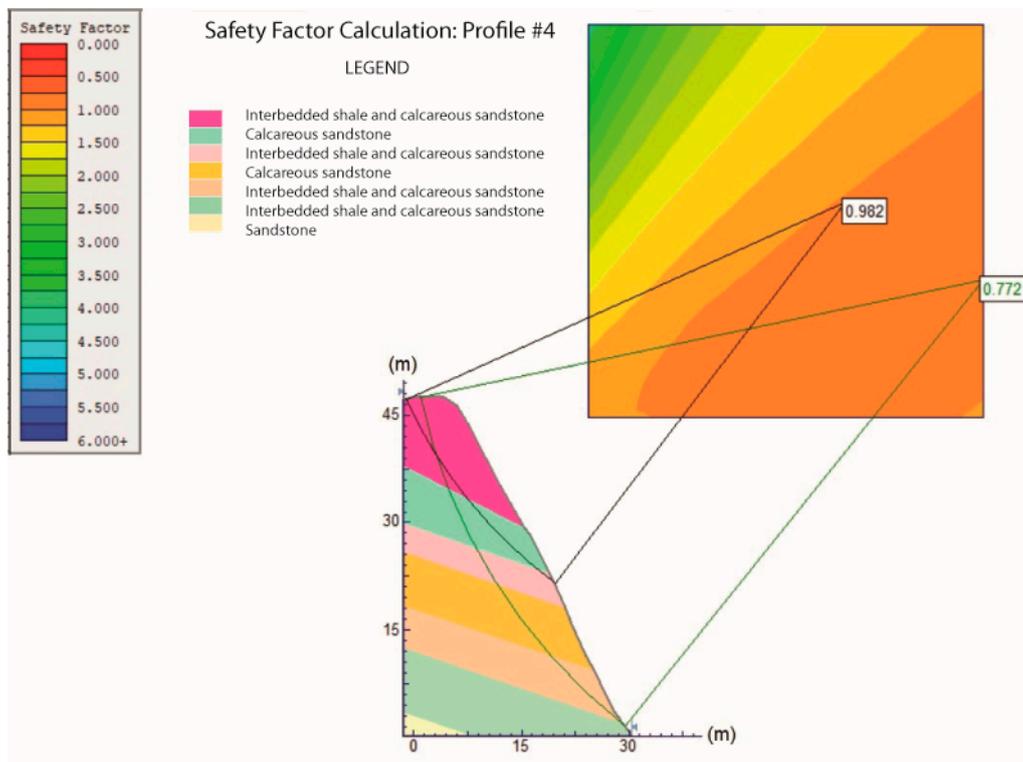
Figure 9. Safety factor calculation for the topographic profile no. 4.

A safety factor with a value lower than 1 indicates that the slope is unstable [40]. Two safety factors were calculated for each topographic profile. The first one was a hypothetical SF, which was obtained considering a detachment plane that corresponded to the entire height of the slope. This situation was clearly unrealistic as the slope would fail way before. The second, “real” SF identified the critical point where the instability of the slope might start.

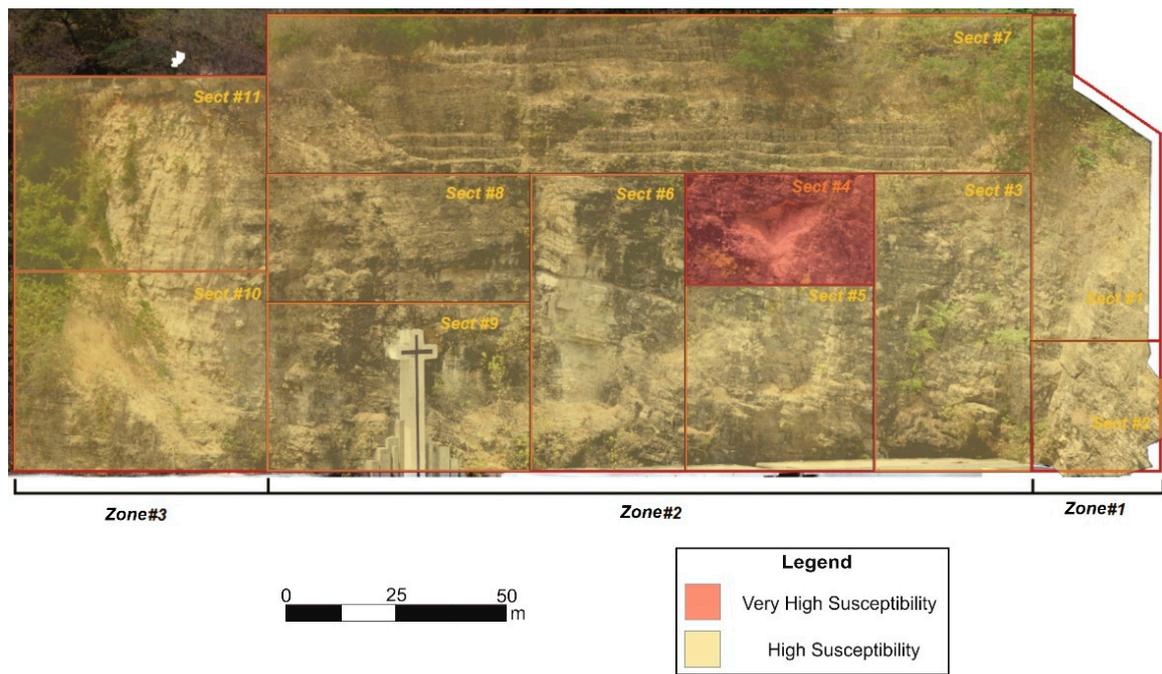
Figure 10. Susceptibility to normal conditions.

The results obtained, considering no precipitation and without seismic influence, yielded very high susceptibility in Sector 4, while the other sectors have a high susceptibility to detachment. When high precipitations were considered together with the possible effect of seismic activity (taking into account that Guayaquil is located in a seismically active area), the detachment susceptibility was found to be very high for Sectors 3–8 and 11 and high for the others.

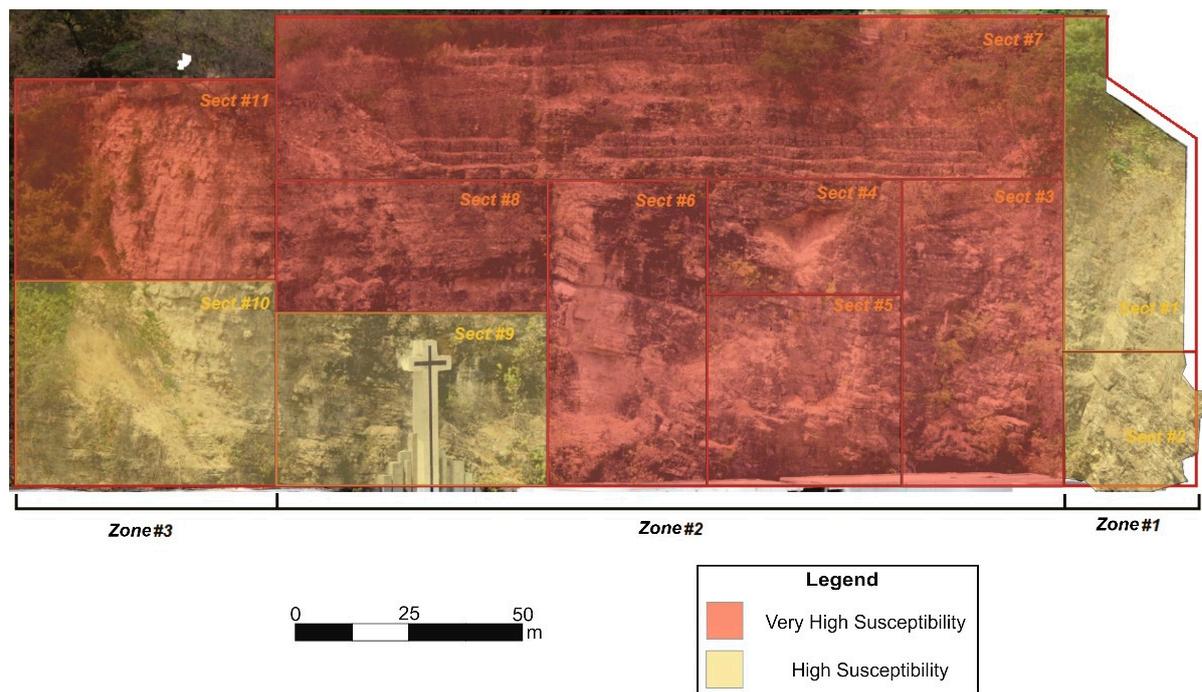
Figure 11. Susceptibility to extreme conditions.

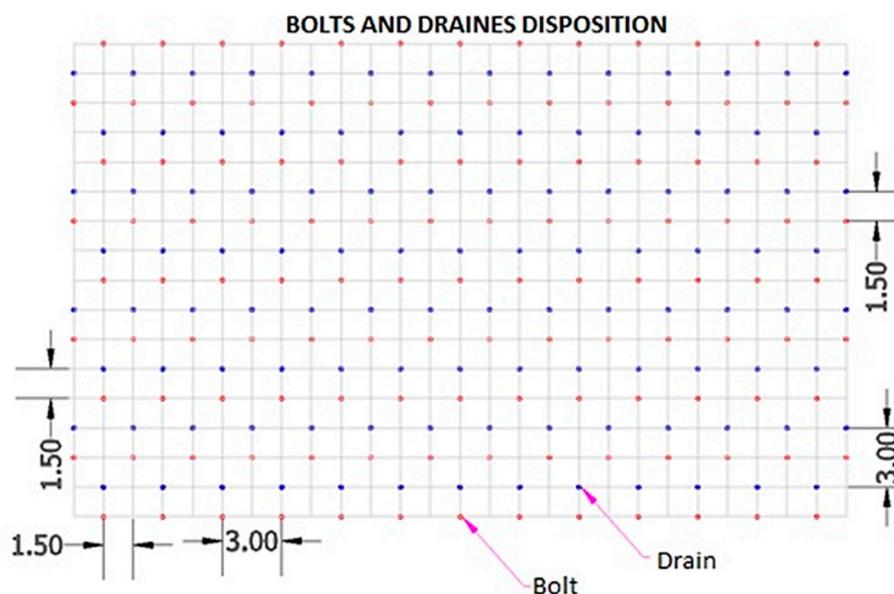
Figure 12. Distribution system of bolts and drains. Red dots represent bolts while the drains are shown in blue. Measures are given in meters.

The slope should be stabilized using a bolting technique with uniform distribution over the entire surface of the slope (Figure 12), applying gunite (shotcrete) placed in two layers. Due to the conditions of certain parts of the cemetery, the use of metallic meshes is also recommended in order to avoid the detachment of rock fragments.
