Brief Report

# Chemical Release Accident Caused by the Abnormal Reaction of Potassium Permanganate Mixtures during Optical Film Manufacturing: A Brief Case Review

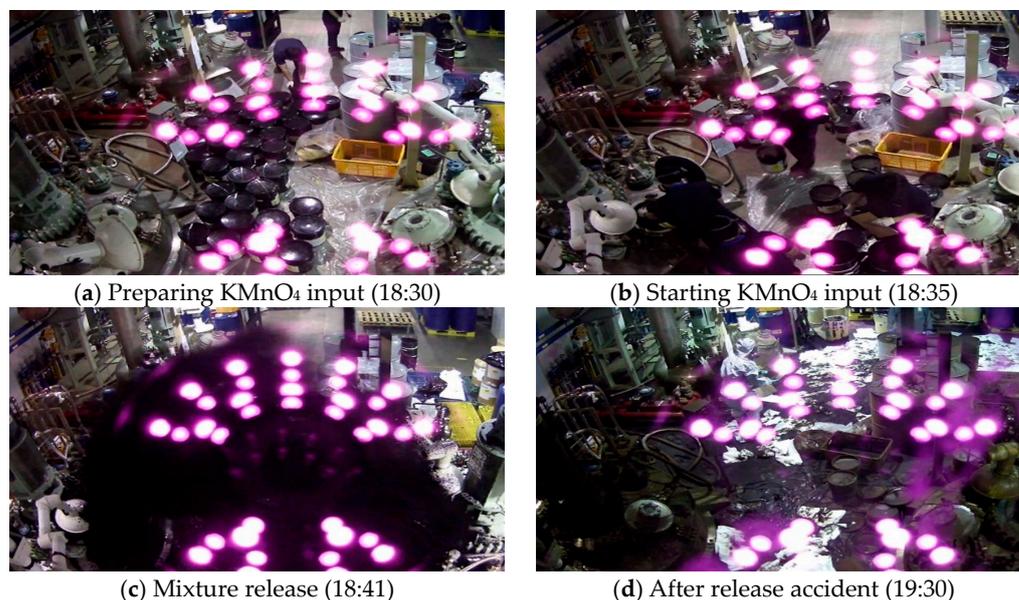
The work conditions at the time of accident were recorded through closed-circuit television (CCTV), and the workers present at the site at the time of the accident were interviewed (Figure 2). A team of four workers added t-BuOH (976.3 kg) and DW (1250 kg) into the reactor and moved the KMnO<sub>4</sub> drums, while increasing the temperature of the mixture (t-BuOH and DW) to 60 °C. Two workers opened the reactor cover and added 675 kg of KMnO<sub>4</sub> powder into the reactor. However, the workers stated that different from the usual conditions, the added KMnO<sub>4</sub> powder was in the form of agglomerated bulk. The KMnO<sub>4</sub> is usually added in the form of a fine powder, but in this case, some of the powders were partially agglomerated into a bulk form at the time of the material input. The origin of this KMnO<sub>4</sub> powder agglomeration was not identified. After approximately

6 min, the mixtures suddenly bumped outside the reactor for 1 min. We estimated that approximately 2500 kg out of 2900 kg of the mixture had spilled (bumped) outside the reactor and injured four workers with dermal burning.

**Figure 2.** Work conditions before and after the accident in the chronological order.

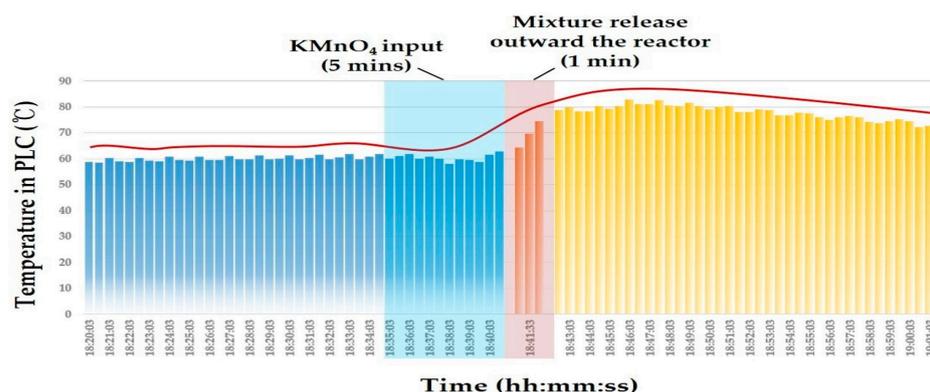
The temperature variation in the mixtures in the reactor with time was automatically logged in a programmable logic controller (PLC). The internal temperature of the reactor was maintained at 60 °C for the initial few minutes after the addition of KMnO<sub>4</sub> (18:35–18:40). However, the temperature increased rapidly to above 70 °C with bumping due to unknown causes (18:41–18:42). After a massive release of the mixture for approximately 1 min, the temperature of the reactor increased continuously to  $78.0 \pm 2.7$  °C (18:43~). In particular, it increased up to approximately 82 °C, which is the boiling point of the mixture, in the initial 10 min after the release event (Figure 3).

**Figure 3.** Temporal variations recorded in the PLC system before and after the accident.

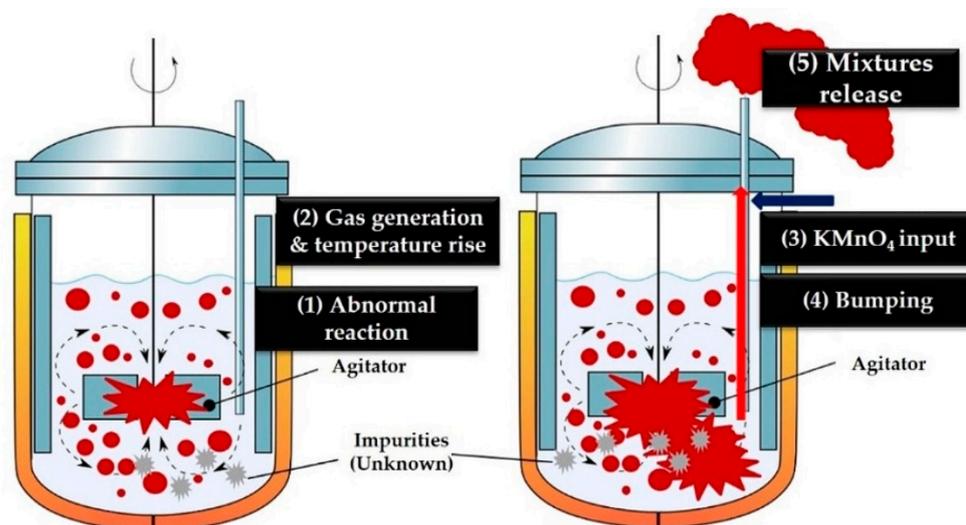
When the internal temperature of the reaction vessel rises, the risk of fire or explosion increases, because  $\text{KMnO}_4$  generates a large amount of oxygen. Moreover, many organic substances react with  $\text{KMnO}_4$ ; therefore, unknown impurities or foreign substances may have contributed to the abnormal reaction (Figure 4). When  $t\text{-BuOH}$  is used as a solvent, it is often recycled through reaction, collection, and distillation. However, recycled  $t\text{-BuOH}$  may contain a few impurities that may have flown into the reactor at each stage. The concentration of the recycled  $t\text{-BuOH}$  was 96.54% in the reactor, and the reactor contained a residual amount (3.56%) of  $\text{MeOH}$ , as revealed by quantitative analysis.

**Figure 4.** Schematic outline of the abnormal reaction after the input of raw materials in the rotational reactor.

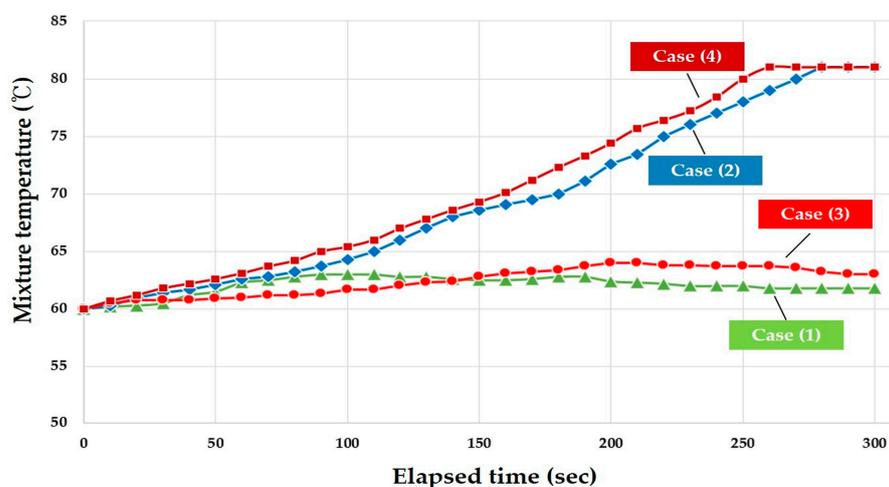
increased slightly to 63 °C, but no rapid reaction or boiling was observed in the laboratory test (Figure 5).

**Figure 5.** Variations in the temperatures of the test mixtures with time after the initial temperature of 60 °C in each scenario for 5 min.

When recycled t-BuOH (96.0%) containing MeOH (4.0%) was used, abnormal reactions were observed (Cases (2) and (4), as shown in Figure 5). After  $\text{KMnO}_4$  and glycerin were added to the mixture, the internal temperature increased to  $70\text{ }^\circ\text{C}$ , and the reaction suddenly proceeded more rapidly. The internal temperature finally reached approximately  $80\text{ }^\circ\text{C}$  with a rate of  $1\text{ }^\circ\text{C}$  per 10 s. We also observed that the internal volume of the mixtures in the test flask expanded by approximately a factor of two due to boiling. Thus, based on the results of the laboratory tests, MeOH is suspected to be a key factor influencing the rapid abnormal reaction. In this process, the following reactions may have occurred, accompanied by the release of both bubbles and gases:

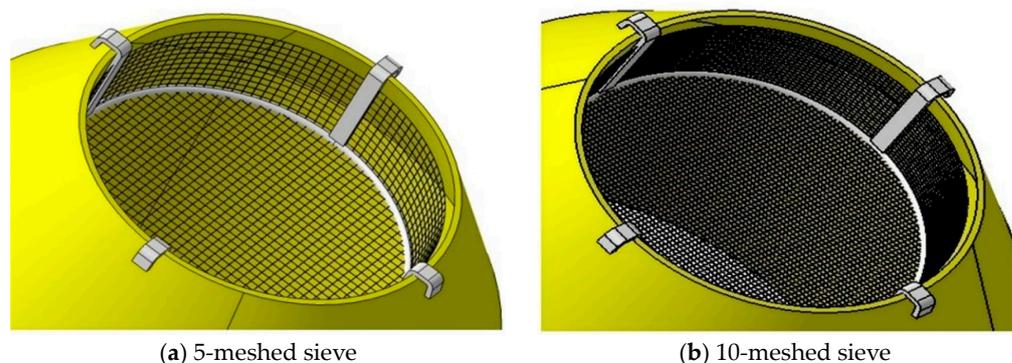
**Figure 6.** Examples of meshed sieves to control the input of bulky raw materials.

The seal oil also may have caused the abnormal reaction. The glycerin (13%) in the seal oil leaked out of the reservoir and reacted with the mixture, increasing the internal temperature and pressure of the reactor. The input amount can be controlled by using a reactor with a safer design, for example, by employing a meshed sieve or a hopper with materials that do not generate static electricity (Figure 6). In addition, when selecting the
