Experimental Investigations on the Effects of Fatigue Crack in Urban Metro Welded Bogie Frame

Abstract: The welded bogie frame is the critical safety part of the urban metro vehicle. This paper focuses on finding out the factors inducing the fatigue cracks initiated from the positioning block weld toe of metro bogie frame. Fracture morphology and metallographic analysis were conducted to identify the failure modes, and on-track tests about the dynamic stress at the positioning block weld toe and vibration acceleration were performed. The typical signals of dynamic stress and acceleration were analyzed from time and frequency domain. The relationship between wheel polygon, rail corrugation, running speed and dynamic stress in amplitude and frequency are investigated in details. Research results show that the micro cracks induced by welding at the weld toe of positioning block propagate to the spring sleeve under relatively high alternating dynamic stress, which is strongly influenced by the wheel polygon, rail corrugation and the train running speed.

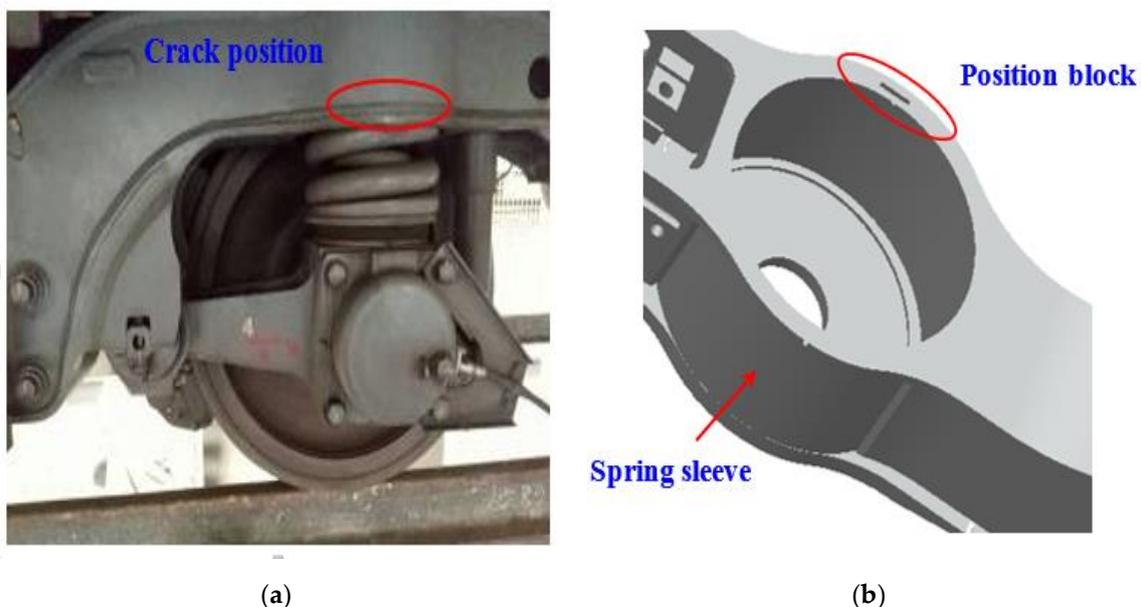
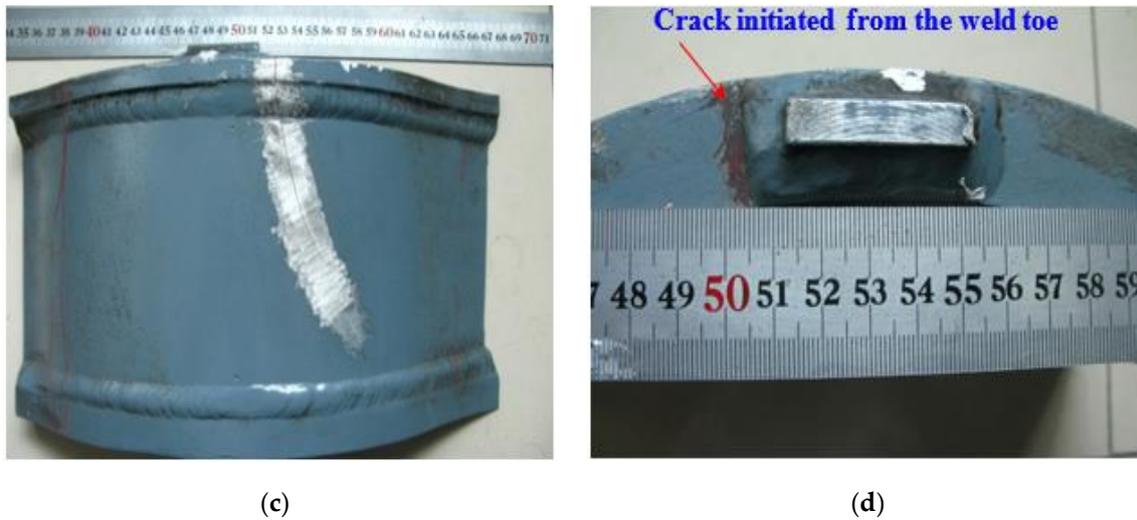
A crack was found at the spring sleeve of one metro bogie frame (as shown in Figure 1a) and the service life is less than 200,000 km. The spring sleeve of the frame side beam is welded by upper cover, lower cover and circular plate. The positioning block is welded to the spring sleeve lower cover by four welds, as seen in Figure 1b. The crack initiated from the weld toe of the positioning block and then propagated to the spring sleeve circular plate with maximum 110 mm in length, as shown in Figure 1c,d.

Figure 1. The crack position and the Macro morphology of the crack: (a) the crack position found in site; (b) the model of bogie frame and the positioning block; (c) and (d) the macro pictures of crack initiated from the weld toe of positioning block.

(1) The weld toe of positioning block was the cracking initiation site, in which micro cracks were observed.

(3) The fractography and the on-track tests show that optimizing the weld technology, improving the weld quality, profiling the wheels, grinding the rails and decreasing the train running speed are all effective to reduce the failure probability and elongate the bogie frame life.

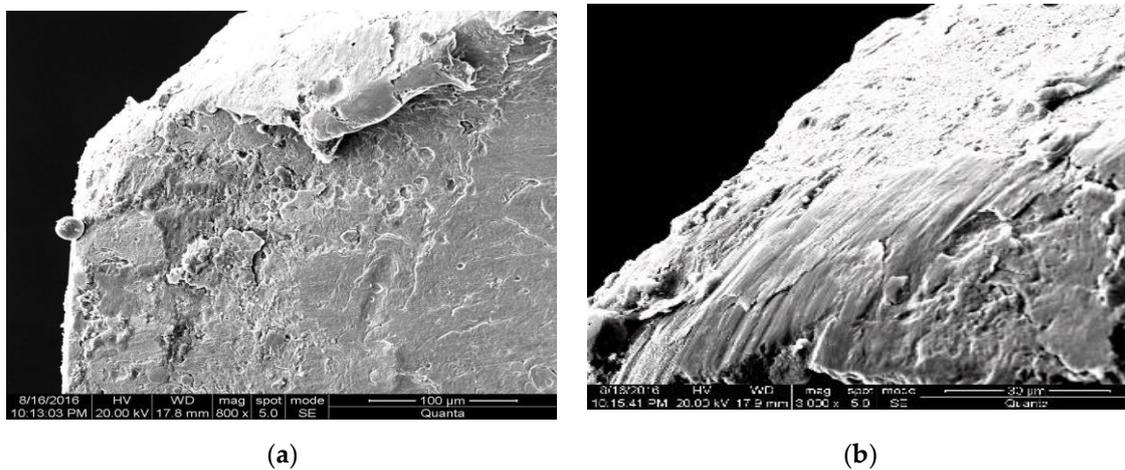
The fracture morphology of the cracking zone was examined by scanning electron microscopy (SEM) as shown in Figure 2. It can be clearly observed that some parallel marks are available near the weld toe, which indicates a notable fatigue damage feature during operation. Metallographic specimens were thus prepared at the critical cracking position. Columnar grains were clearly found in the weld and the heat-affected zone, which are composed of lamella ferrite and featherlike widmanstatten structures, as shown in Figure 3. The SEM observation of weld toe shows that the micro crack starts from the surface of the lower plate and propagates internally, and it includes several discontinuous sections and branches appear around the main crack (Figure 4).

Figure 2. Micro-fracture morphology of the crack source and the fatigue striations: (a) 800×; (b) 3000×.

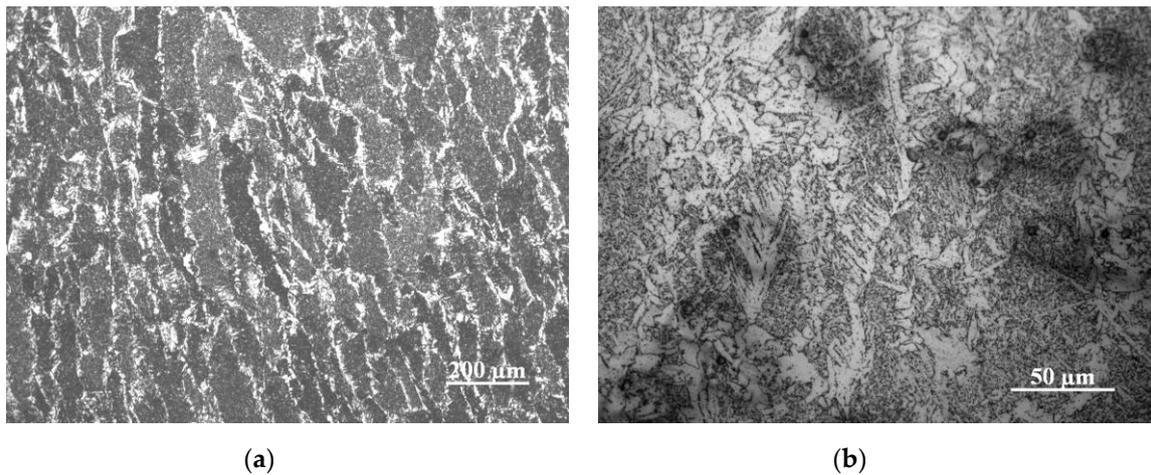
Figure 3. Microstructure of weld: (a) columnar grains enclosed by ferrite; (b) lamella ferrite and featherlike widmanstatten structure.

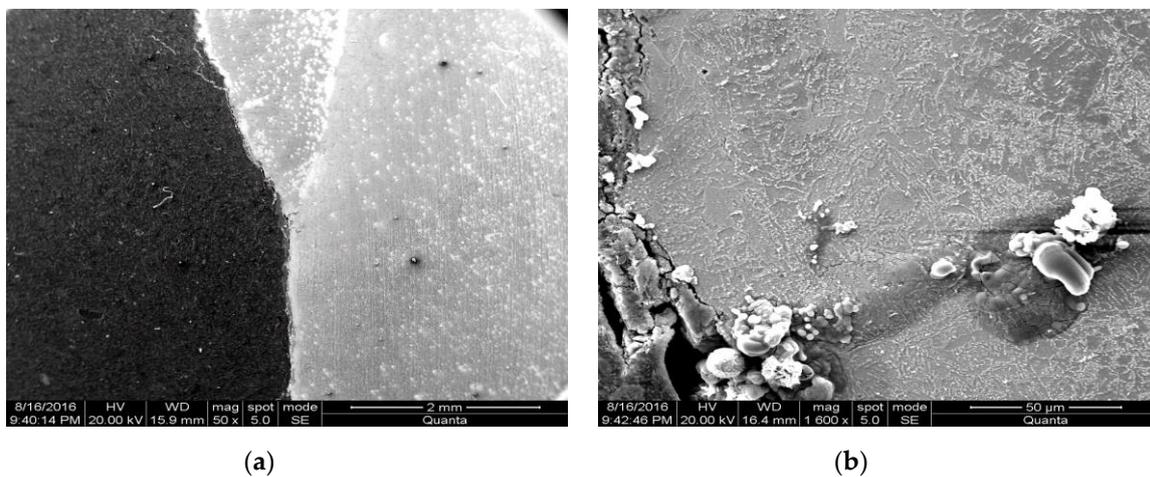
Figure 4. SEM of weld toe: (a) 50x; (b) 1600x.

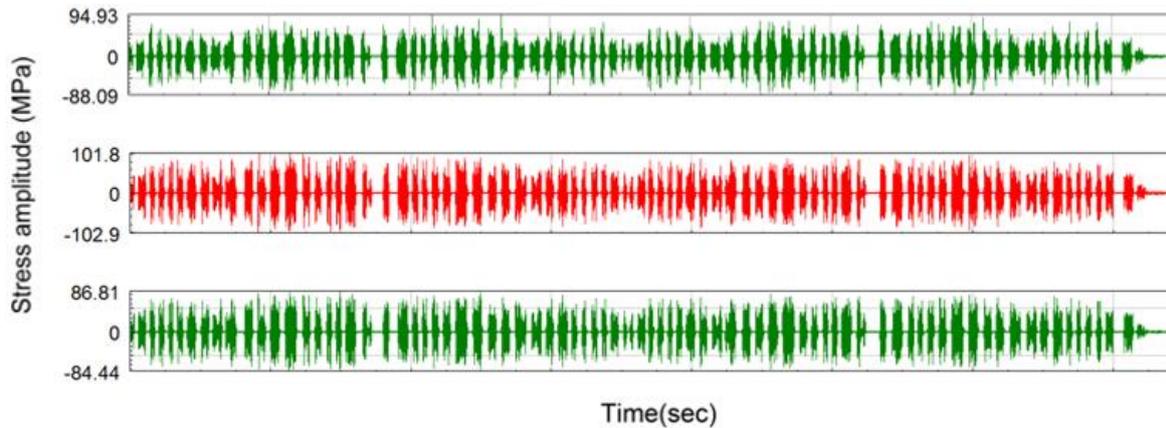
The full-range dynamic stress waveforms of point D02, D11 and D17 are shown in Figure 7. The maximum stress amplitudes of D02, D11 and D17 are 91.5 MPa, 102.4 MPa and 85.6 MPa respectively. According to the stress-time history of each point, the stress spectrum can be obtained by adopting rain-flow counting method. Thus, with *S-N* curve and Miner’s rule of accumulative damage, the damage of each point can be calculated. The results indicate that the damages of these testing points at the weld toe of positioning block are all larger than 1, which provide evidence of initiation and propagation of fatigue crack.

Figure 7. Full-range dynamic stress waveforms of D02, D11 and D17 (from top to bottom separately).

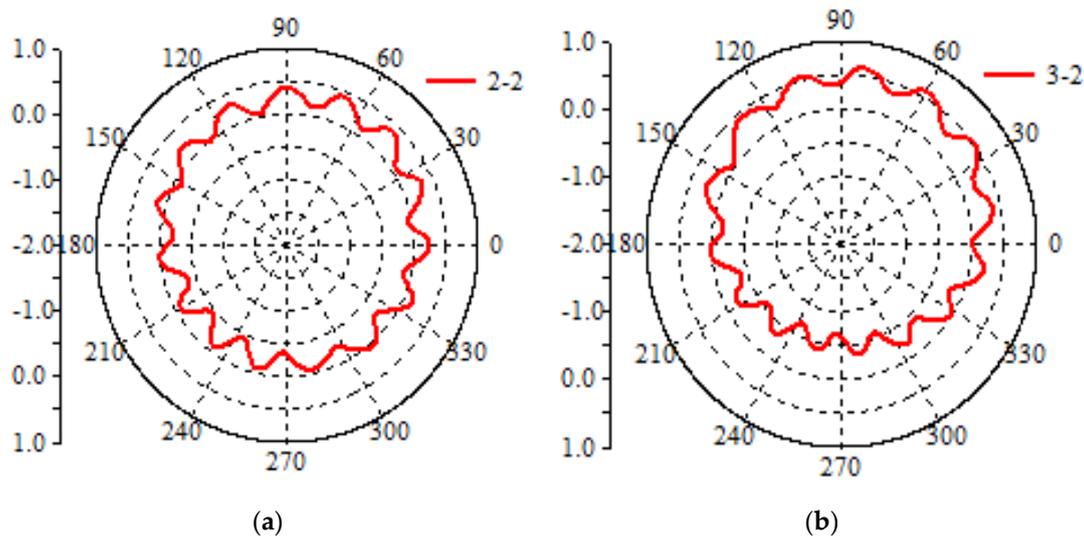
The roundness measurement results of No.1 and No.2 wheels installed on the tested bogie are shown in Figure 12a,b. No.1 wheel was a worn wheel after profiling, showing a good state. No.2 wheel was a worn wheel before profiling, demonstrating a significant polygonal worn phenomenon, with eccentric characteristics and 14- to 16-side polygon.

Figure 12. Polar diagram of roundness: (a) No.1 wheel; (b) No.2 wheel.

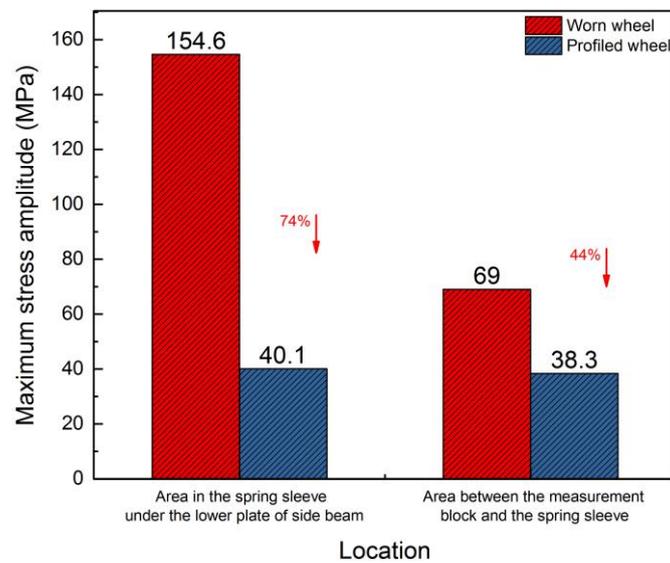
Figure 15 shows the comparison of the maximum dynamic stresses at D11 of the profiled and worn wheels. It can be observed that the maximum stress amplitude of the profiled wheel is significantly lower than that of the worn wheel, and the maximum reduction is 74%, indicating that the wheel polygon has a significant influence on the stress amplitude of the frame.

Figure 15. The comparison of the maximum stress amplitude of the profiled and worn wheels around the cracked area.

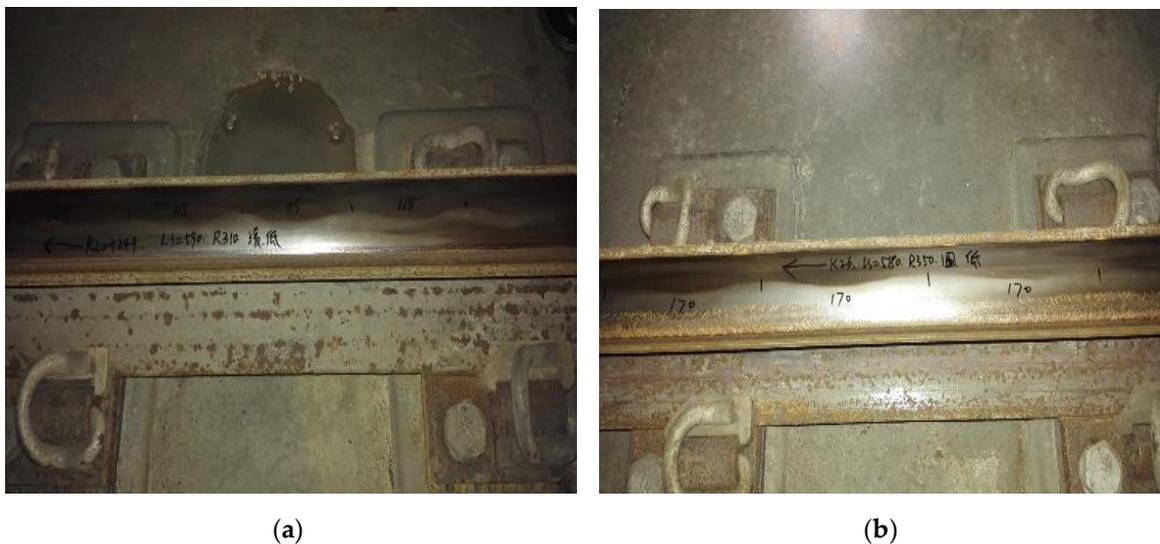
The investigation of the rail condition indicates that the different rail types show different corrugation characteristics, and the obvious rail corrugation area is mainly occurred on the curve with the radius below 600 m (denoted as R600). Figure 16 exhibits the rail corrugation diagrams in different sections, which indicates significant rail corrugation phenomena on the rail surface.

Figure 16. Rail corrugation in different sections: (a) section 1; (b) section 2.

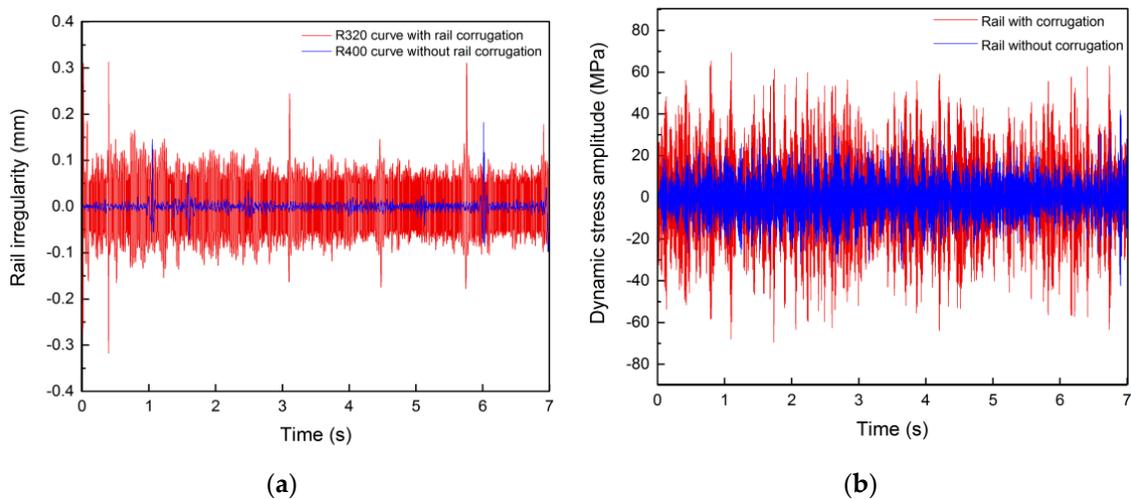
Figure 17 illustrates the comparison of the dynamic stress in the cracked area with and without rail corrugation, where R320 section exists corrugation phenomenon but R400 section does not exist. The operating speeds are both 54 km/h. It can be observed that in the corrugation section, the maximum rail irregularity is 0.31 mm, and the maximum dynamic stress is 72.8 MPa. While in the non-corrugation section, the maximum rail irregularity is 0.18 mm, and the maximum dynamic stress is 41.6 MPa. Obviously, the dynamic stress amplitude of the measurement point with rail corrugation increases by 75% than that without rail corrugation.

Figure 17. The relationship between rail irregularity and the dynamic stress amplitude: (a) degree of rail irregularity; (b) dynamic stress.
