# Damage Investigation of Carbon-Fiber-Reinforced Plastic Laminates with Fasteners Subjected to Lightning Current Components C and D

**Abstract:** The damage induced by lightning strikes in carbon-fiber-reinforced plastic (CFRP) laminates with fasteners is a complex multiphysics coupling process. To clarify the effects of different lightning current components on the induced damage, components C and D were used in simulated lightning strike tests. Ultrasonic C-scans and stereomicroscopy were used to evaluate the damage in the tested specimens. In addition, the electrothermal coupling theory was adopted to model the different effects of the arc and the current flowing through the laminate (hereinafter referred to as the conduction current) on CFRP laminates with fasteners under different lightning current components. Component C, which has a low current amplitude and a long duration, ablated and gasified the fastener and caused less damage to the CFRP laminate. Under component C, the heat produced by the arc played a leading role in damage generation. Component D, which has a high current amplitude and a short duration, caused serious surface and internal damage in the CFRP laminat

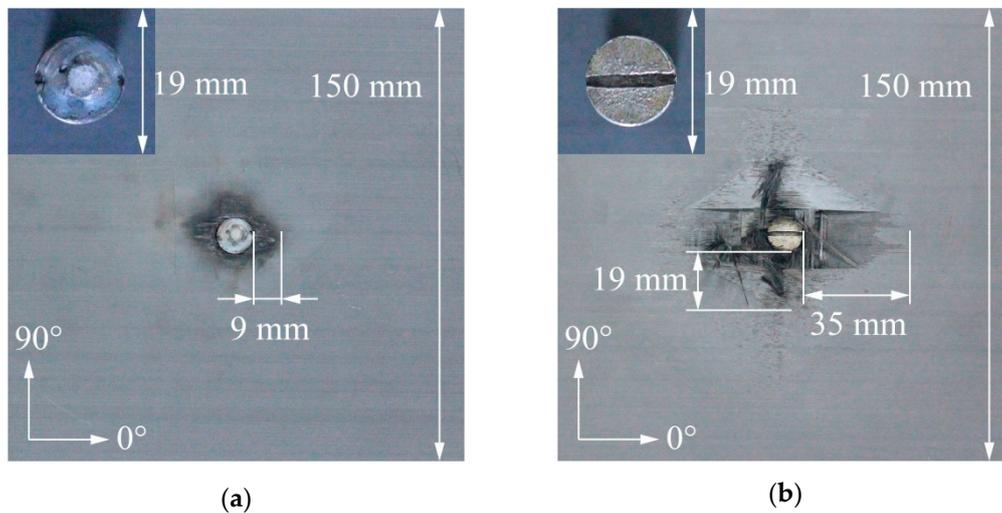
**Figure 5.** Surface damage in the specimens after lightning strike: (a) component C; (b) component D.

For component C, serious ablation damage occurred on the top of the fastener, which was still tightly connected to the laminate. The damage in the laminate was located within a distance of 9 mm around the fastener. Resin discoloration was observed but very few fibers were exposed or warped.

For component D, no obvious damage was observed on the top of the fastener, but the fastener was loose and slightly sunken. Fiber tufts, fiber breakage, resin sublimation, and resin discoloration appeared on the surface of the laminate. These forms of damage extended 35 mm along the fiber direction and 19 mm orthogonal to the fiber direction. In addition, flaky fiber shedding was observed along the fiber direction.

When the gap between the discharge electrode and the laminate is broken down, an arc will be generated, forming a high-temperature ionization region at 30,000 K [15]. For component C, the high-temperature arc, which has a long duration, acts on the fastener. The accumulation of heat makes the fastener gasify. Figure 5a shows that the fastener has sustained serious ablation damage. For component D, because of the short duration, the heat of the high-temperature arc seldom accumulates in the fastener; thus, Figure 5b shows that the fastener has minor ablation damage under component D.

Figure 5b shows that resin damage occurs on the surface of the laminate far from the fastener after component D is applied. This damage should be caused by dielectric surface discharge [12]. The dielectric breakdown model considers that the discharge direction is determined by the local electrical potential gradient. During the lightning strike, a large amount of induced charge will accumulate on the surface of the specimen. When the electric field intensity generated by the accumulated charge exceeds the critical value, discharge will occur on the surface of the material, causing damage to the resin. For component C (Figure 5a), due to the low amplitude of the discharge voltage, dielectric breakdown is less likely to occur; thus, the resin damage on the specimen surface should be caused by the metal droplets splashing and attaching to the surface after the fastener has melted.

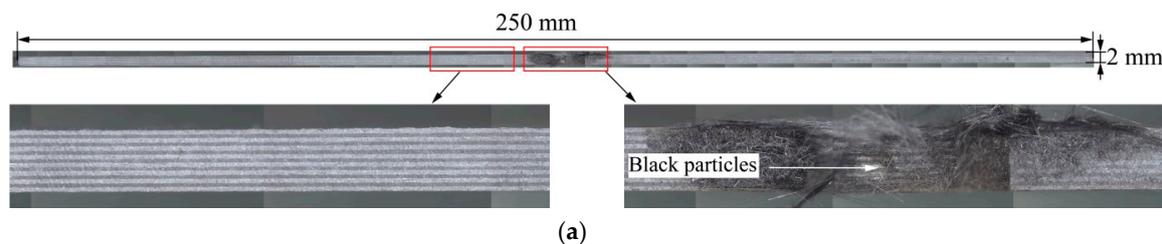
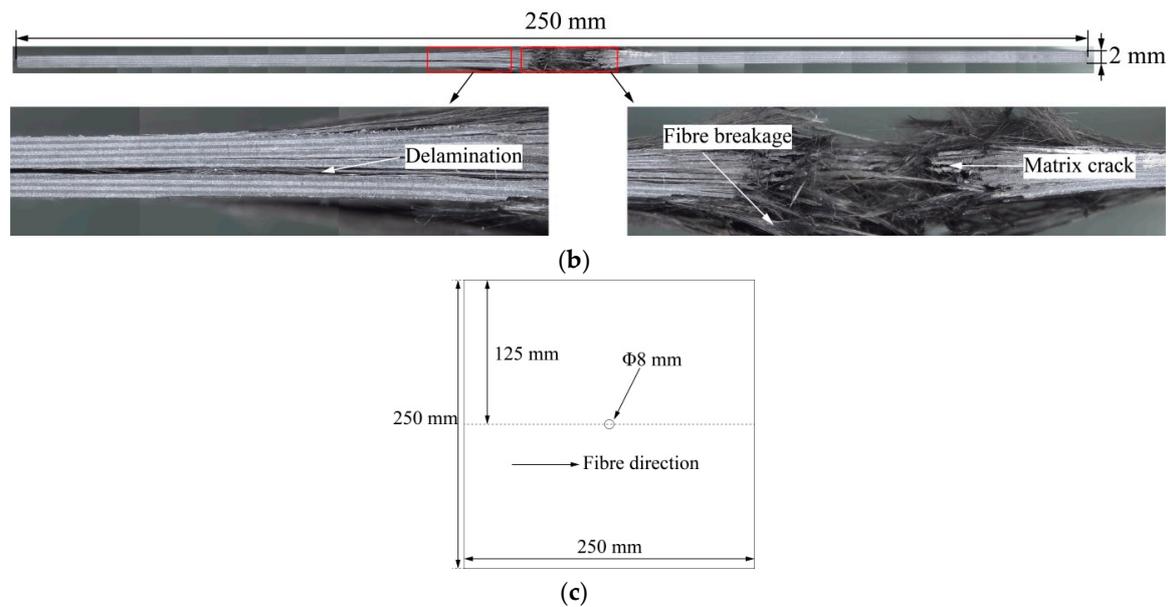
**Figure 6.** Damage in the fastener hole of the specimens after lightning strikes: (a) component C; (b) component D. (c) Specimen cutting diagram for microscopic evaluation.

For component C, black particles cover the surface of the inner wall of the fastener hole and few fiber breakages or cracks are observed between the layers, which indicates that the temperature of the inner wall of the hole was not high when the specimen was subjected to a lightning strike and that the amount of resin vaporized by the lightning strike was not substantial.

For component D, Figure 6b shows extended delamination damage away from the hole. Resin matrix cracks and fiber breakages are observed around the hole, and black particles also appear in the hole. As the fastener penetrated the laminate, the delamination damage near the hole became extremely serious.

During a lightning strike, the resin on the inner wall of the fastener hole is pyrolyzed and gasified, which generates high-temperature, high-pressure gas [37]. The heated gas expands rapidly, producing a high-speed gas flow doped with black particles, which may be the product of carbon fiber sublimation and pyrolysis carbonization at high temperatures [38]. Some of the black particles entered the fastener nut through the gap, whereas the rest remained on the inner wall of the fastener hole (Figure 6).

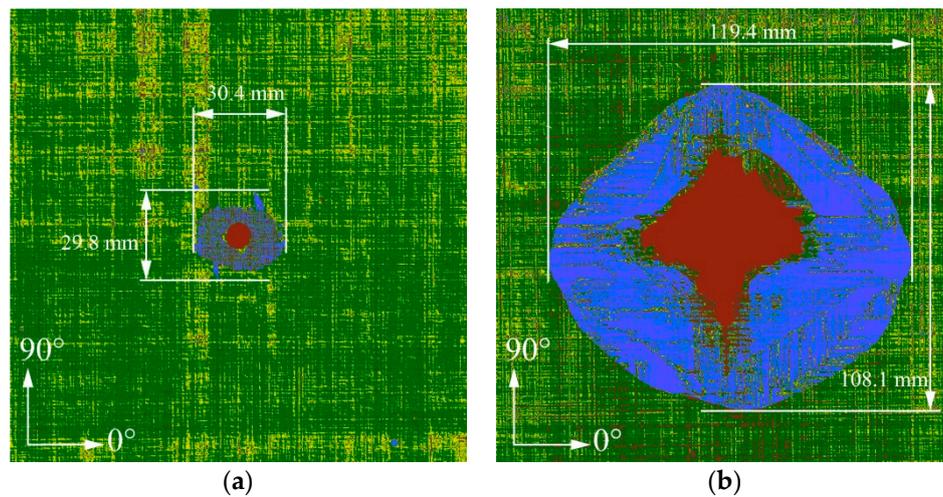
Figure 7a,b show the internal damage morphology under the action of components C and D, respectively. These figures show that the damage expands from the fastener to the delamination boundary after the lightning strikes. The damage within the delamination boundary in Figure 7 consists of two zones. One is the thermal decomposition damage and ablation damage, where the material is pyrolyzed and vaporized (marked with dark red, hereinafter referred to as the decomposition damage). The other is speculated to be delamination (marked with blue), where the damage of the interlayer structure is caused by the internal pressure generated by the rapid expansion of pyrolysis gas [34].

**Figure 7.** Ultrasonic C-scan results of specimens after lightning strikes: (a) component C; (b) component D.

For component C, the damage area inside the specimen is small, the damage lengths in the  $0^\circ$  direction and  $90^\circ$  directions are approximately 30 mm, and the difference between the two directions is small (in Figure 7a, the damage length in the  $0^\circ$  direction is 30.4 mm, whereas the damage length in the  $90^\circ$  direction is 29.8 mm). This finding indicates that a small amount of resin in the specimen has undergone pyrolysis and gasification during the lightning strike.

For component D, a large area of damage is observed in the specimen, and the damage lengths in the  $0^\circ$  and  $90^\circ$  directions are greater than 100 mm, which indicates that during the lightning strike, component D induces more resin pyrolysis and gasification than component C. Moreover, an internal explosion occurs under component D. The rhomboid-shaped damage area might be caused by the orthogonal stacking structure of the specimen.

Figure 7 shows that there is a great difference in the internal damage of the laminates under different lightning components.

For component C, the current amplitude is 200 A. Due to the high current density around the fastener, a large amount of Joule heat can be generated. Moreover, the arc heat will spread to the laminate through the fastener (see Figure 9(a1,a3)). The combined effect of the Joule heat and arc heat results in resin pyrolysis. In the zone far from the fastener, the current density and the arc heat decay rapidly, and no internal damage in this zone can be observed under the C-scan. The internal damage caused by component C is concentrated in a small area around the fastener, as shown in Figures 7a and 8(a1).

For component D, the fastener spreads the conduction current to all the layers, and this current is approximately 6.7 kA per layer. These conduction currents can generate large amounts of Joule heat, allowing the resin to pyrolyze over large areas and release gas. According to Figure 6b, Figure 7b, and Figure 9b, it can be speculated that these high-temperature, high-pressure gases trapped inside the CFRP laminate may cause an internal explosion when the gas pressure reaches a critical level, which will result in serious delamination damage.

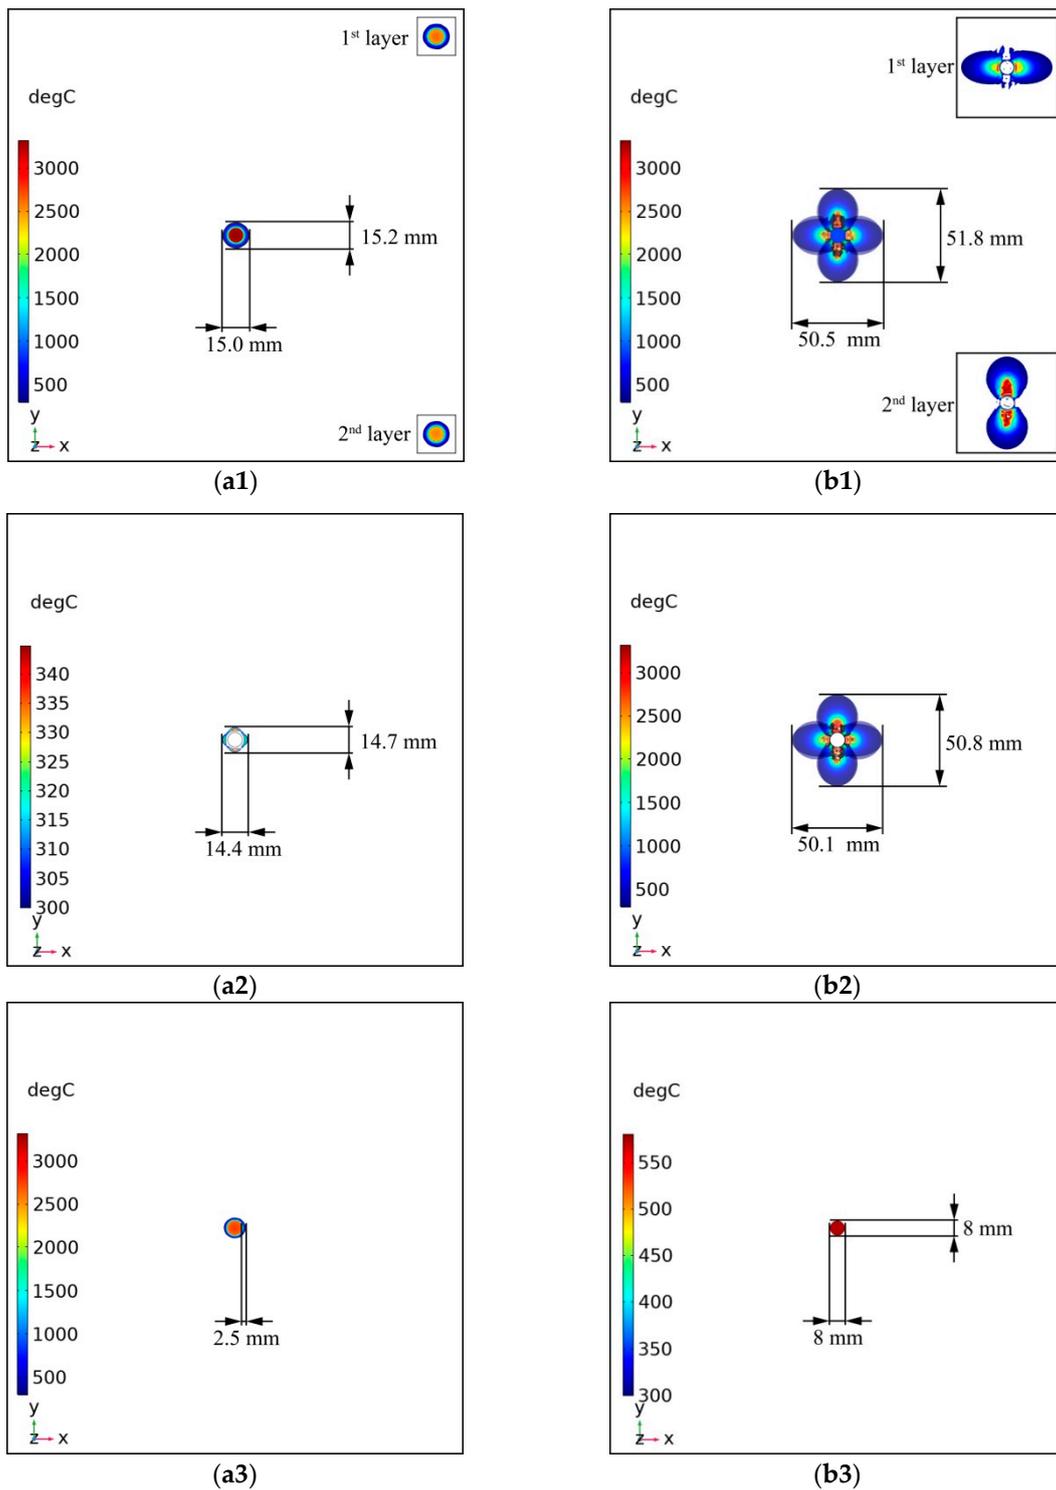
Figure 8(a1–a3) are the temperature profiles of the specimen under component C in the conduction current + heat flux, conduction current, and heat flux simulation models, respectively. Figure 8(a1,a2) indicate that the decomposition damage shape and size of the laminates are similar to each other and that the damage shape is circular. Such decomposition damage shapes, which are similar to the dark-red area in Figure 7a, do not reflect the anisotropy of the CFRP laminates because component C has a long duration, providing Joule heat in sufficient time to spread in all directions. The first layer ( $0^\circ$  direction) and the second layer ( $90^\circ$  direction) are two orthogonal layers, and their temperature distributions are shown in the upper-right corner and lower-right corner of Figure 8(a1), respectively. The decomposition damage shapes of the two layers are almost identical.

**Figure 8.** Temperature profiles of specimens under different simulation models and different lightning current components: component C in the (a1) conduction current + heat flux model, (a2) conduction current model, and (a3) heat flux model; component D in the (b1) conduction current + heat flux model, (b2) conduction current model, and (b3) heat flux model.

In addition, the temperature of the top of the fastener (in the center of Figure 8(a1)) exceeds 3000 °C after the combination of the conduction current and the heat flux. This temperature is much higher than the melting temperature of the fastener and causes severe ablation damage to the fastener. Figure 8(a3) shows the temperature distribution when using the heat flux model. In this model, the damage to the

laminates caused by heat flux is approximately 2.5mm, and the temperature of the fastener is similar to that in the conduction current + heat flux model, which means that the ablation damage of the fastener under the action of component C has an important relationship with the heat flux.

Figure 8(b1–b3) are the temperature profiles of the specimen under component D in the conduction current + heat flux, conduction current, and heat flux simulation models, respectively. Figure 8(b1,b2) show that the decomposition damage shape and size of the specimen were similar, and that the decomposition damage was centered on the fastener and fanned out along the 0° and 90° directions.

The decomposition damage in both directions exceeded 50 mm. This decomposition damage shape, which resembles the dark-red area in Figure 7b, reflects the anisotropy of the CFRP laminates because component D has a short duration, which does not provide sufficient time for the Joule heat to spread evenly in all directions. The first layer ( $0^\circ$  direction) and the second layer ( $90^\circ$  direction) are the two orthogonal layers, and their temperature distributions are shown in the upper-right corner and lower-right corner of Figure 8(a1), respectively. Both layers showed that the decomposition damage in the fiber direction was substantially greater than that perpendicular to the fiber direction. In addition, Figure 8(b1,b3) show that no noticeable temperature rise occurred at the top of the fasteners from the heat flux. Figure 8(b3) is the temperature distribution when the heat flux model is used. In this model, the highest temperature at the top of the fastener is approximately  $550^\circ\text{C}$ , which does not ablate the fastener. There are no visible signs of damage around the fastener, which means that the heat flux has little contribution to the damage of the CFRP with fasteners when component D is applied.

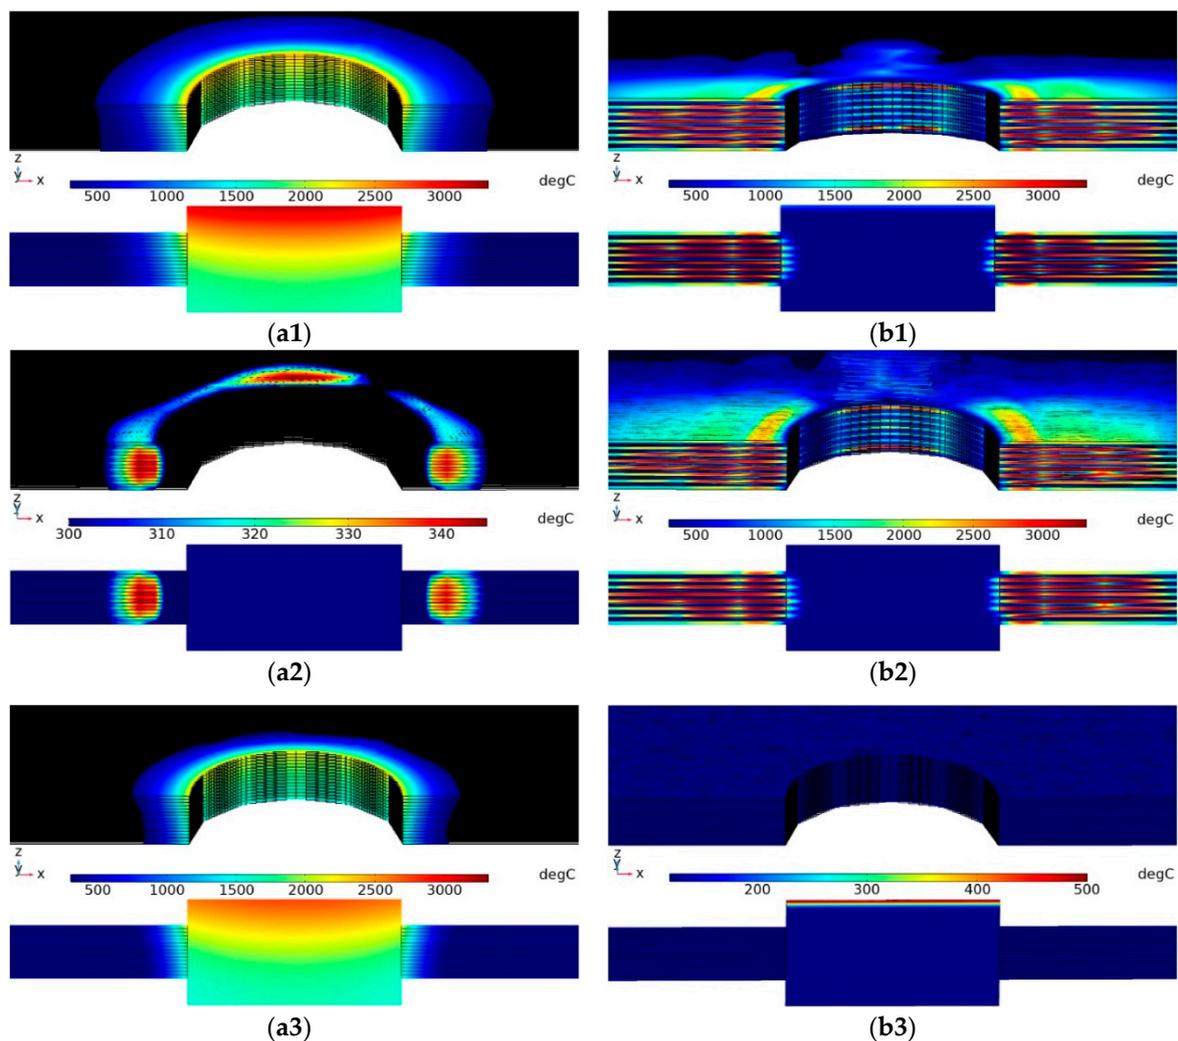
Figure 9(a1–a3) are the cross-sectional temperature profiles of the specimen under component C in three simulation models. The heat diffusion can be inferred from the temperature gradient of the fasteners in Figure 9(a1,a3); heat is transferred to the CFRP laminate along with the fastener, causing the material temperature around the fastener to increase. In Figure 9(a2), the temperature of the fastener is far less than 300 °C and the decomposition damage occurs in a small area around the fastener. Because the damage occurs in the conduction current model, it is completely caused by the Joule heat generated by the conduction current. According to the results of Figure 5a, Figure 8(a1–a3), and Figure 9(a1–a3), a small area of CFRP laminate damage and serious fastener damage will clearly occur under component C. Thus, arc heating (heat flux) is the main cause of fastener damage under component C.

**Figure 9.** Cross-sectional temperature profiles of the fastener hole under different simulation models and different lightning current components: component C in the (a1) conduction current + heat flux model, (a2) conduction current model, and (a3) heat flux model; component D in the (b1) conduction current + heat flux model, (b2) conduction current model, and (b3) heat flux model.

Figure 9(b1–b3) are the cross-sectional temperature profiles of the specimen under component D in three simulation models. The cross-sections of the specimens in Figure 9(b1,b2) show that the Joule heat generated by the conduction current caused the massive decomposition damage area in the laminate, whereas the fasteners remained at a lower temperature. According to the results of Figure 5b, Figure 8(b1–b3), and Figure 9(b1–b3), large CFRP laminate decomposition damage and minor fastener damage will occur under component D. Thus, the Joule heat generated by the conduction current is the leading factor for CFRP laminate decomposition damage under component D.

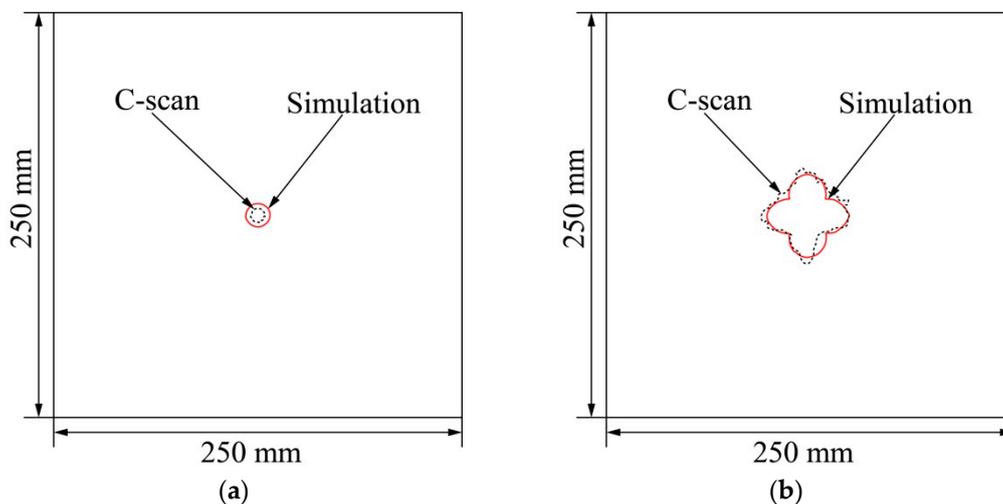
Figure 10 compares the damage profiles in the conduction current + heat flux model (marked with the solid red line) with the thermal decomposition damage and ablation damage profiles in the ultrasonic C-scans (marked with the black dotted line). The damage in the specimen caused by component D is much greater than that caused by component C. Figure 10a,b show that the FEA results are in good agreement with the experimental results. Therefore, it is reliable to study CFRP laminates with fasteners by FEA.

**Figure 10.** Damage comparison between simulated lightning strikes and finite element simulations: (a) component C; (b) component D.
