# Rolling and Rolling-Sliding Contact Fatigue Failure Mechanisms in 32 CrMoV 13 Nitrided Steel—An Experimental Study

**Abstract:** The aim of this work is to characterize the rolling and rolling-sliding contact fatigue failure mechanisms on the 32CrMoV13 nitrided steel. During rolling contact fatigue tests (RCF), two general features were observed: specimens presenting short lives and rough and sharpened spalling damage and specimens presenting long lives and only microspalling marks. It was possible to determine a contact fatigue limit of 3 GPa. During rolling-sliding contact fatigue tests (RSCF), a clearly different behaviour between the two specimens in contact has been observed: the driver shows circumferential and inclined cracks and only inclined cracks appear in the follower. This behaviour can be understood if the effect of the residual stress state in near-surface layers is considered. Before RCF tests, the residual stresses are compressive in all near-surface layers. After RCF tests, strong residual stress relaxation and even reversing behaviour was observed in the axial direction, which facilitates the surface crack initiation in the circumferential direction at rolling

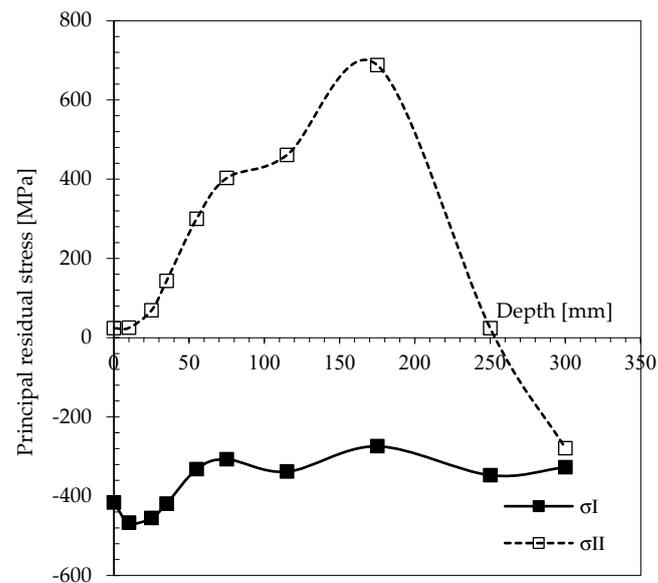
**Figure 5.** In-depth residual stress profile after RCF tests ( $P_H = 3.1$  GPa,  $N = 6 \times 10^4$  cycles,  $\Lambda = 0.367$ ), of specimen A.

The in-depth residual stress distribution, after RCF, in specimen A, can be observed in Figure 5. Low stress relaxation in the longitudinal direction after the RCF tests, expressed by the circumferential compressive residual stresses ( $\sigma_{11}$ ), is observed, as also reported by Marion Le et al. [32]. These stresses are relieved near the surface and present a constant value around  $-400$  MPa in the first  $300$   $\mu\text{m}$  depth. However, we should emphasize the tensile behaviour of the axial residual stress ( $\sigma_{22}$ ), throughout a depth of  $\sim 250$   $\mu\text{m}$ , induced by the rolling contact loading.

Comparing Figures 4 and 5, it is observed that residual stress in the axial direction reverses its sign after the RCF tests, changing from compressive to tensile. A maximum tensile stress value of approximately  $+680$  MPa occurs at  $\sim 180$   $\mu\text{m}$  depth. The explanation for the appearance of such high tensile stresses is not clear and not fully understood. This behaviour may be explained by the plastic strain heterogeneities induced by the cyclic Hertz contact stresses, coupled with the characteristics of the nitrided layers. Coules et al. [33] performed a numerical simulation of the rolling process, in a locally-rolled aluminium alloy specimen, using finite element analysis, in order to predict the residual stress field and to study the pattern of plasticity, which occurs in the specimen during and after rolling. The residual stress prediction of their FEM model was compared with an experimentally obtained one using neutron diffraction. According to the obtained results, interesting findings were reported. This included the appearance of tensile residual stresses in the transverse direction (axial direction) of the samples, in particular at border and ends of the rolling tracks, but also at their centres, even of lower magnitudes. In any case, tensile residual stress normal to the plane of a crack-like defect is highly beneficial for crack propagation (stress ratio increase). Therefore, the presence of high tensile residual stresses is highly undesirable. Thus, in this case, appearance of longitudinal cracks leading to fatigue damage could be of high concern during contact fatigue of nitrided components.

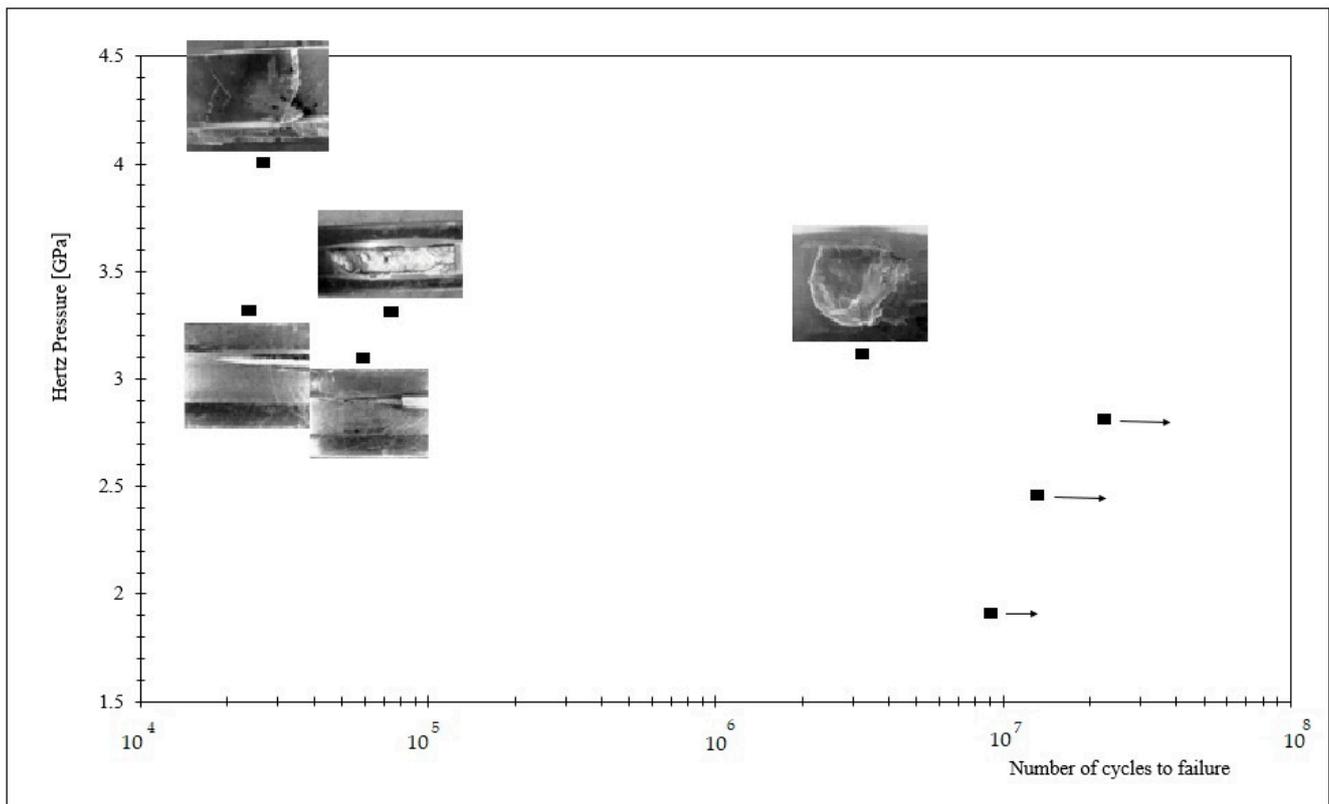
The S-N curves and the fracture images of some RCF tests are shown in Figure 6 where the arrows mean that the specimen did not fail, that is, it reached at least 10 million cycles. There are two groups of fractured specimens: one with a high value of Hertz pressure ( $P_H > 3$  GPa) and short life regime ( $< 10^5$ ) and the other with low Hertz pressure ( $P_H \leq 3$  GPa) and long-life regime ( $> 10^6$  cycles). Therefore, it seems that a contact fatigue of about 3 GPa exists, for the 32 CrMoV 13 nitrided steel studied. Figure 7 shows the surface's micrographs corresponding to the second mentioned behaviour ( $P_H \leq 3$  GPa).

**Figure 6.** S-N curve and fracture images of the nitrided specimens in RCF tests.

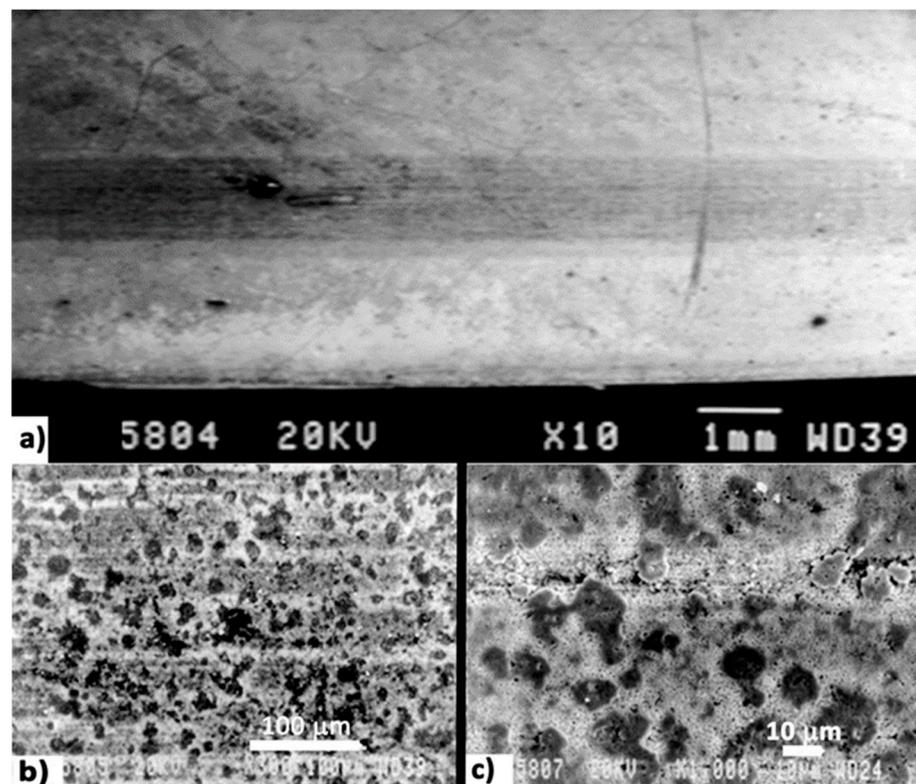
The rolling contact track surface can be seen in the Figure 7a). Two magnifications of this rolling track show a flattening of the white layer (Figure 7b) and the beginning of a superficial circumferential crack (Figure 7c). All specimens subjected to a Hertz pressure below the referred contact fatigue limit (3 GPa) have presented a similar track morphology and very high service life.

**Figure 7.** (a) Rolling track's SEM micrographs after RCF tests ( $P_H = 1.9$  GPa;  $N = 9 \times 10^6$  cycles;  $\Lambda = 0.407$ ); (b) flattening of the white layer (300 $\times$ ); (c) beginning of superficial circumferential crack (1000 $\times$ ).

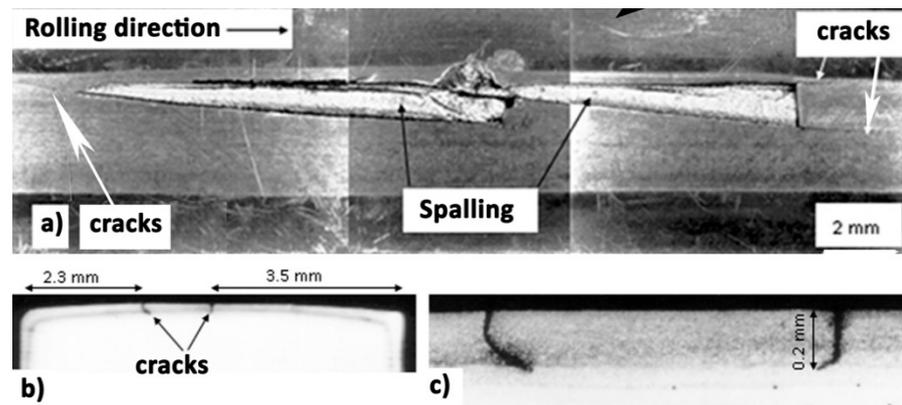
When the Hertz pressure increases, the contact stress exceeds the contact fatigue limit, and a distinct behaviour appears. Specimens present a short life, and the crack nucleation happens at the surface at the border of the rolling contact surface. This is probably caused by the tensile stress that is expected in this region, in accordance with the results of Fernández-Valdés [7] and Coules [33]. At the surface, the crack propagates in the circumferential direction (rolling direction, Figure 8a), probably related to the tensile stresses, while in depth it grows perpendicular to the rolling track (Figure 8b,c). After a given small depth, cracks bend almost 45 degrees (Figure 8c) in a direction to the rolling track centre, probably due to the action of the shear stress and the material's softening induced by the plastic deformation. The spalling phenomenon occurs when two or more cracks find each other, or a critical strength area is attained, which is a characteristic brittle fracture of the nitrided surfaces.

**Figure 8.** Surface morphology after RCF tests. (a) Circumferential cracks and spalling, (b) transversal cracks in the cross-section and (c) zoom of (b) ( $P_H = 3.3$  GPa;  $N = 2.43 \times 10^4$  cycles;  $\Lambda = 0.362$ ).

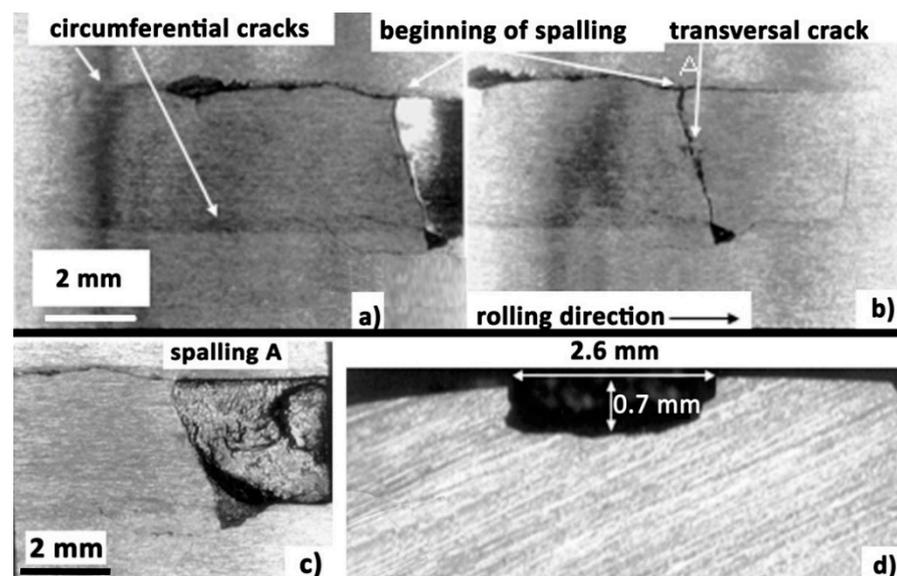
To better understand the evolution of this process, one test was continued, after crack detection, until the spall appearance. Figure 9 shows optical micrographs of the rolling contact surface of this specimen tested at  $P_H = 3.7$  GPa and  $1.8 \times 10^5$  loading cycles.

**Figure 9.** Morphology of the rolling contact surface after RCF test ( $P_H = 3.7$  GPa;  $N = 1.8 \times 10^5$  cycles;  $\Lambda = 1.234$ ). (a) Circumferential cracks at the borders of the rolling contact track; (b) circumferential and transversal cracks at the point A, in the rolling contact surface, before the spalling phenomenon appearance shown in (c); (d) cross section of the spalling shown in (c).

The observation of Figure 9 leads to the conclusion that the spalling phenomenon can be described in three stages. A first stage, characterised by the circumferential surface crack nucleation at rolling contact track border (Figure 9a), where the appearance of tensile residual stress in the axial/transverse direction should potentiate the process, is followed by a second stage where, simultaneously, cracks propagate in circumferential and in-depth directions (Figure 9b). The in-depth propagation near the surface, i.e., in the hardened layer, occurs perpendicularly to the surface, which is a typical feature of brittle fracture behaviour occurring in planes perpendicular to the maximum principal stress. A third stage begins when a given critical depth is attained. This stage is probably related to the depth where the maximum hertzian shear stress occurs (which for this contact conditions is 1180 MPa at a depth of 0.453 mm) and with the softening material due to the plastic deformation, where the cracks bend in the direction of the rolling track centre, with a slope of  $\approx 45$  degrees as

it occurs in ductile materials in planes where the shear stress attains a maximum. This is a typical feature of the materials presenting a ductile fracture behaviour. After this stage, when the crack attains a critical length, the remaining area does not support the contact pressure and the material is pulled up, which is a well-known characteristic of spalling phenomena (Figure 9c,d). Note that the spalling damage at the rolling track is delimited by transversal cracks, which will be linked to the existing circumferential ones (Figure 9b).

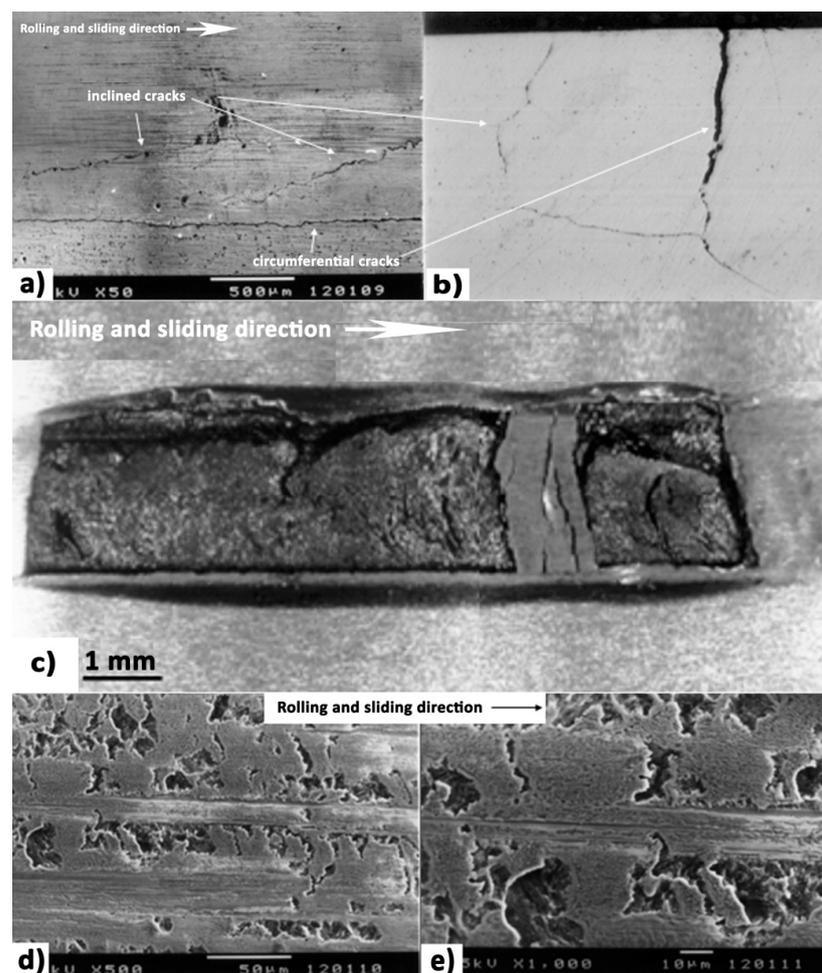
Beyond the rolling contact fatigue tests, some specimens were subjected to rolling-sliding contact fatigue tests (RSCF). The main goal was to identify the damage mechanisms that occur in these contact conditions in the driver (where the rolling and sliding directions are the same) and follower (where the rolling and sliding directions are opposite) specimens. Two kinds of damage morphology, depending on applied loading, has been verified. For high Hertz contact pressures and fast linear contact velocities, spalling and circumferential cracks were the main damage mechanisms. For lower Hertz contact pressure, no cracking was observed and only microspalling appears, increasing for the slower specimens (follower) due to different rolling and sliding directions. In the driver specimens two kinds of surface cracks exist, appearing side by side at rolling track borders: circumferential cracks and inclined cracks, as Figure 10a,b shows.

**Figure 10.** Surface of faster specimen (driver) after RSCF tests ( $P_H = 3.7$  GPa;  $N = 3 \times 10^4$  cycles;  $\Lambda = 0.937$ ;  $\lambda = 6.4\%$ ). (a) SEM micrographs of surface circumferential and inclined cracks; (b) cross-sectional optical micrograph showing circumferential and inclined cracks; (c) surface double spalling; (d) microspalling in the rolling track; (e) microspalling in the rolling track.

Circumferential cracks in the rolling track are bigger and deeper than the inclined ones (Figure 10b), which are outside of circumferential cracks and propagate to out of the rolling track. As consequence, in the damaged zone, two spallings, separated by a little distance, can be seen in Figure 10c. Spallings present a rectangular shape and the smaller side covers the whole rolling track width, being one of the greater sides perfectly rectilinear and its opposite side slightly curved. Microspalling can also be seen in the contact surface of driver specimens, as Figure 10d,e shows. Damage mechanisms in the follower specimens are different than those already described for the driver specimens. In this case, no circumferential cracks have been detected and only inclined cracks appear. However, the initiation crack occurs clearly inside of the rolling track, although at the end its propagation spreads to out of the rolling track, contrary to the observed behaviour in the driver specimens, where inclined cracks are initiated at rolling track borders and propagate to out of the rolling track. The surface and the cross section of these specimens can be seen in Figure 11.

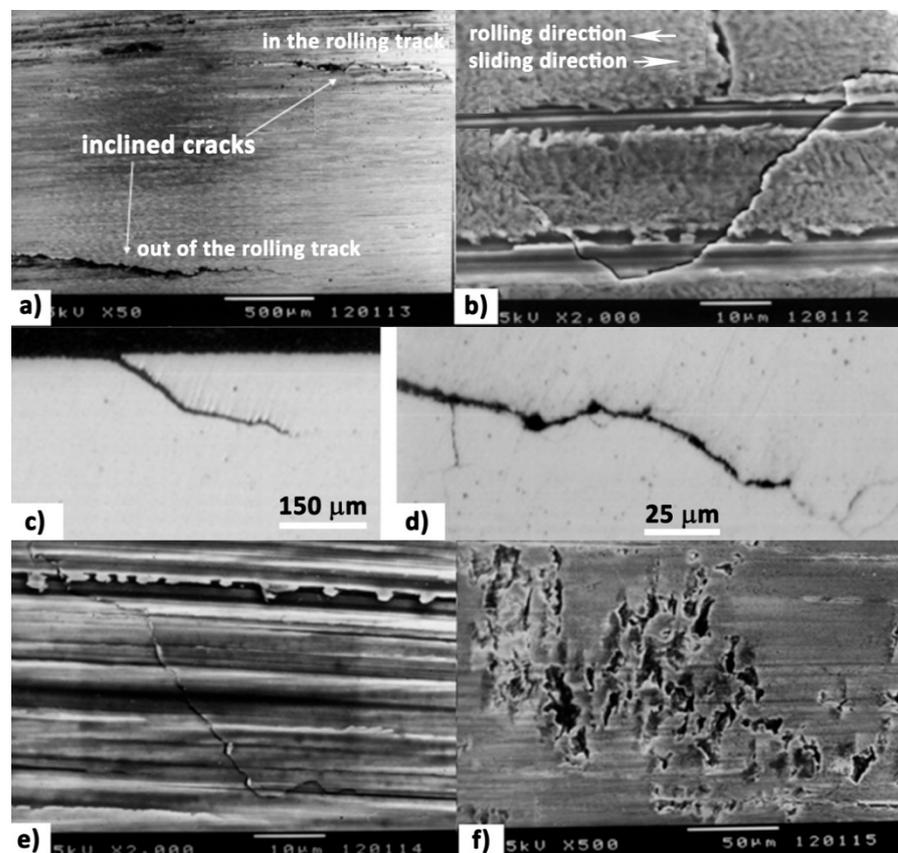
**Figure 11.** SEM and optical micrographs of superficial inclined cracks in a slower (follower) specimen after RSCF tests ( $P_H = 3.7$  GPa;  $N = 1.8 \times 10^5$  cycles;  $\Lambda = 0.958$ ;  $\lambda = 6.4\%$ ); (a) the upper crack appeared inside the rolling track and the bottom crack appeared outside the rolling track; (b) crack nucleation inside the rolling track; (c) optical cross-section micrograph of the inclined crack; (d) zoom of the front crack showed in (c) and corresponding secondary cracks; (e) superficial inclined crack out of the rolling track; (f) microspallings in the rolling track.

The inclined surface cracks in the follower specimens show a different behaviour when compared to the driver specimens. These cracks can appear inside of the rolling track (Figure 11a) as well as outside of the rolling track (Figure 11a,e). These cracks are also inclined through the depth (Figure 11c,d). Indeed, for driver specimens, the in-depth propagation happens perpendicularly to the rolling direction (Figure 10b). The surface

shear stresses induced by the rolling-sliding contact should be responsible for this observed behaviour. Multiple microspallings have also been observed, as shown in Figure 11f.

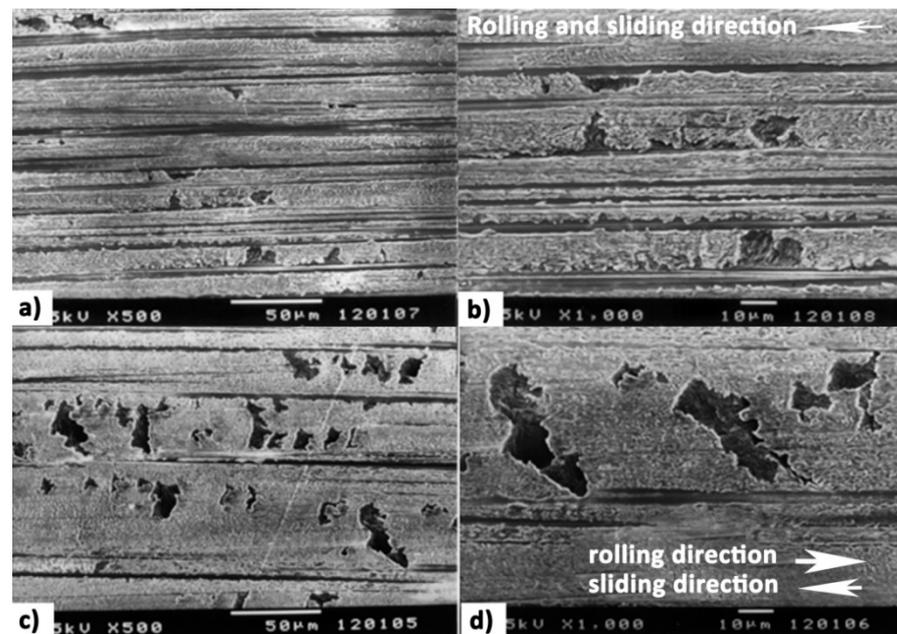
For Hertz contact pressure equal or lower than 3 GPa, only microspallings have been observed. Not enough damage occurred to originate cracks or spalls. The results are shown in Figure 12. In the driver specimens, most of the observed microspallings seem to have originated in the grooves of the rolling track due to the fine grinding procedure imposed on the specimens after the heat treatment of nitriding (Figure 12a,b). In the follower specimens, the microspallings appeared in any part of the rolling track, as seen in Figure 12c,d.

**Figure 12.** SEM micrographs after RSCF tests ( $P_H = 3$  GPa;  $N = 9.9 \times 10^6$  cycles;  $\Lambda = 0.979$ ,  $\lambda = 6.4\%$ ). (a,b) Microspallings and grooves in the rolling track of the faster specimens (driver); (c,d) microspallings and grooves in the rolling track of the slower specimens (follower).
