# Seismic Evaluation and Methods of Rehabilitation of Old Masonry Buildings in the Bay of Kotor (Montenegro)

**Citation:** Tomanović, D.; Marković, L.; Gadžić, N.; Rajković, I.; Aleksić, J.; Tomanović, T. Seismic Evaluation and Methods of Rehabilitation of Old Masonry Buildings in the Bay of Kotor (Montenegro). *Appl. Sci.* **2021**, *11*, 3544. <https://doi.org/10.3390/app11083544>

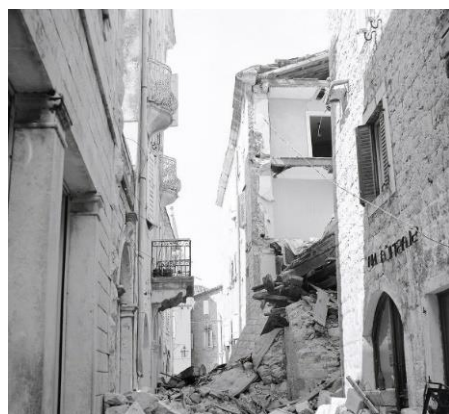
**Figure 1.** Collapse of row houses in urban environment (Kotor).

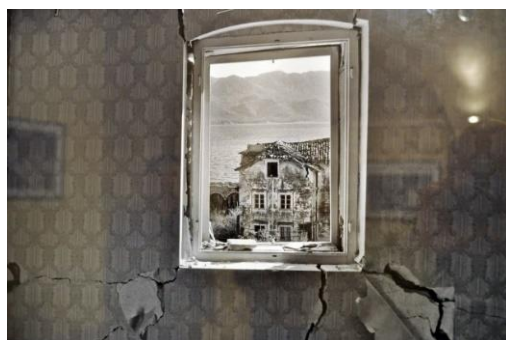
**Figure 2.** Openings in the walls (doors, windows) showed their vulnerability in the 1979 earthquake.

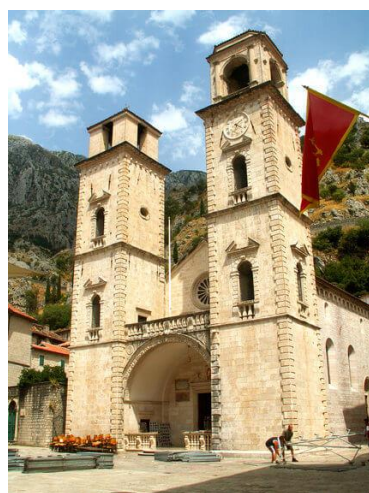
As tall buildings are very rare in traditional construction (towers, bell towers), cases of overturning are also exceptional. Such a catastrophic case happened in 1667 with the Romanesque bell towers of the Cathedral of St. Tryphon (Figure 3a,b), which collapsed and damaged nearby buildings on the square. The extent to which this earthquake influenced the strengthening of the local aseismic culture has been demonstrated by the fact that the present bell towers, built at that time, did not show the slightest constructive damage in the 1979 earthquake.

**Figure 3.** (a) Cathedral of St. Tryphon—Romanesque bells collapsed in the 1667 earthquake. (b) The cathedral was designed as the three-aisled basilica.

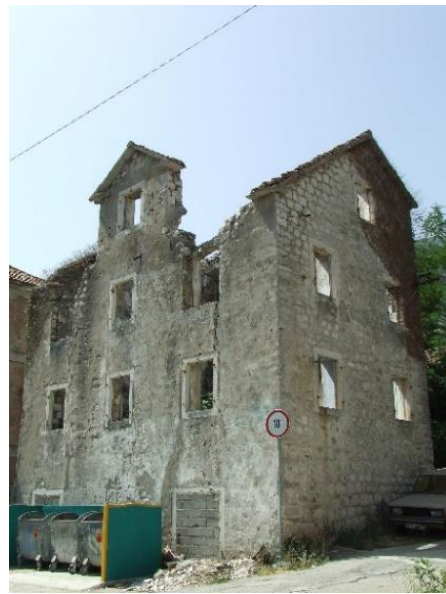
The most representative single houses of the bay have the so-called belvedere room in the attic, which is the prominent central part of the facade with a pair of window shafts. Despite the original trend that was later chiefly abandoned, to connect this part of the facade with the rest of the structure using wood beams—tie rods and iron anchors (*ital. capochiave*), during the earthquakes, a concentration of stress would occur, causing cracks along the horizontal joint with even the case of the whole belvedere structure collapsing at the point of discontinuity, that is, the place where the wall facade canvas narrows (Figures 8 and 9). Cracking and collapse of the front and back facades during earthquakes is the most frequent failure of the system caused by this fragility [9].

**Figure 8.** Cracking of belvedere structure in Prčanj and Stoliv.

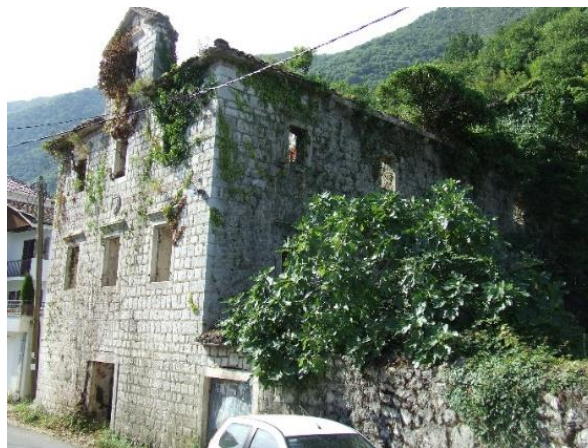
**Figure 9.** Cracking of belvedere structure in Prčanj and Stoliv.

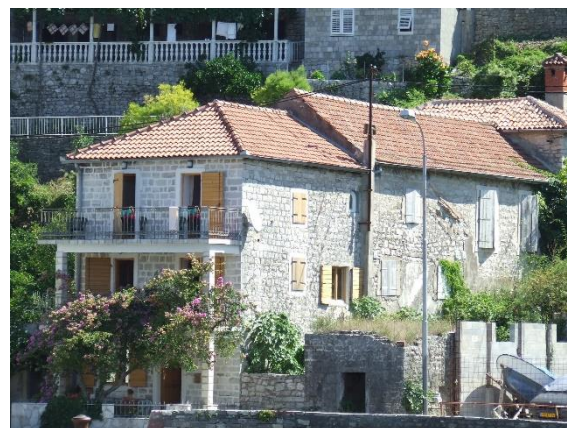
**Figure 22.** Posttensioning of the building was done using steel  $\Phi 20$  mm rods.

The tightening of the building, which shows smaller cracks in the stone walls and does not indicate any major damage, was done with steel bars  $\Phi 20$  mm, anchored to the fitting steel 10 mm thick plates or transverse reinforced concrete beams, to ensure its durability (Figure 23).

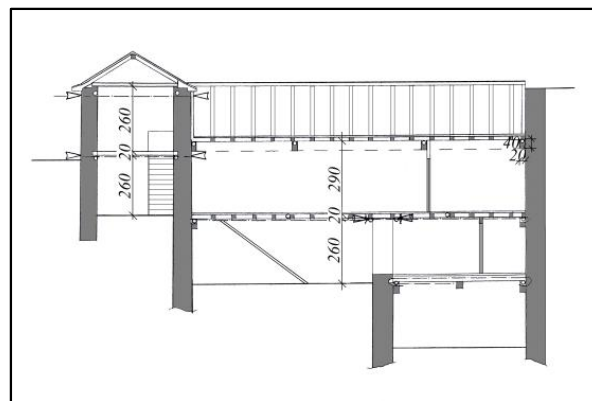
**Figure 25.** Version with interior ring beam fixed at the positions that suffered severe damage.

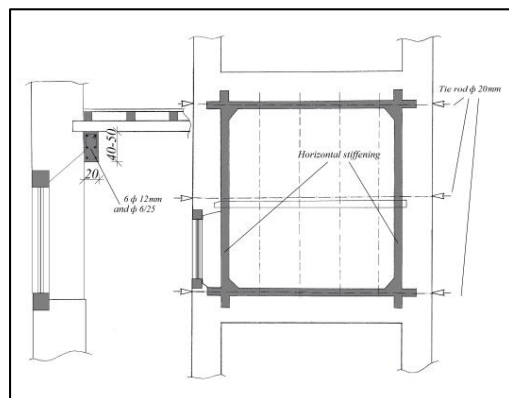
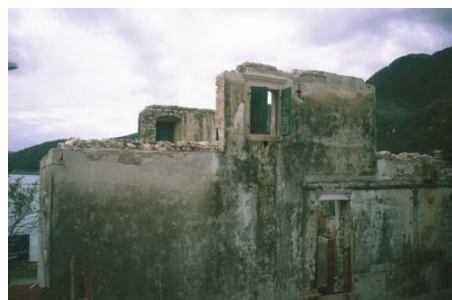
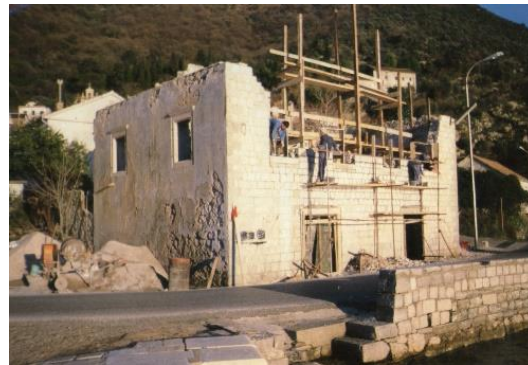
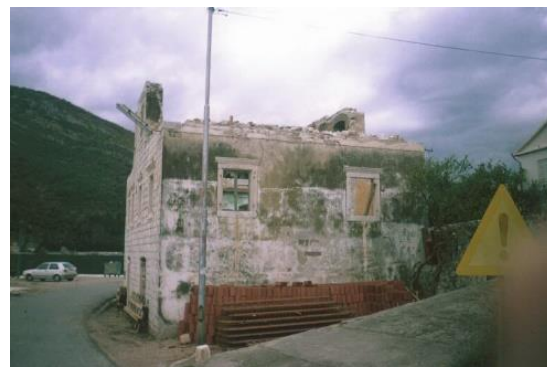
The condition of the building before the beginning of the reconstruction was that effectively the only thing left of the building was the outer walls (Figures 27–30). They were also damaged, especially the front wall with a visionary and a height of 9 m. The walls were made of carved or ashlar stone blocks with a filling of small stone (lat. sauornam) [23]. Mortar joints generally represent “weak spots” in the wall, especially when poor quality mortar is used for masonry [24]. Traditional construction knows different types of lime mortars: with the addition of old oils, crushed bricks, red earth (Italian terra rossa), and so on [25].

**Figure 27.** Captain's house dating from 1842, before and at the beginning of reconstruction.

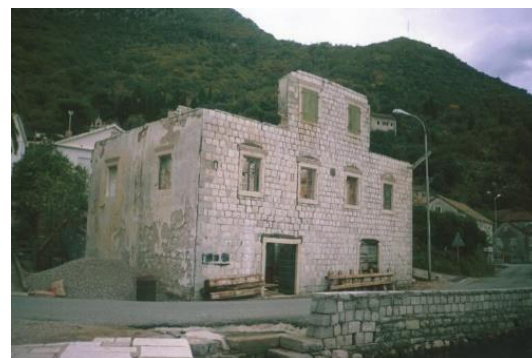
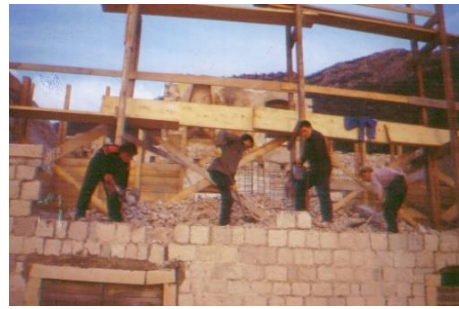
Since the house suffered visible damage in the 1979 earthquake (Figures 31 and 32), the rehabilitation is based on the reconstruction of vital load-bearing elements. Thus, the rigidity of the building is ensured by a pair of central massive RC canvases, which, with their continuity, close the entire building in height, with the peculiarity of structurally justified 50% reduction of cross-sectional areas of the canvas at the attic level. The RC canvases have been fixed so that their edging pillar width side would be entered into the stone façades, achieving the effective compound of the new and the existing old structure. In parallel with the RC canvases, from the foundation, that is, the bases of the ground floor, RC pillars extend vertically, ending at the level the first of the two attic RC ring beams. The cement mortar was injected into the cracked walls, followed by pointing. The disposition of the calculated seismic load implied the IX-degree effect on the MCS scale.

**Figure 31.** The façade had to be taken down due to the forced protrusion.
