Investigation of the Causes of Premature Rain Erosion Evolution in Rotor Blade-like GFRP Structures by Means of CT, XRM, and Active Thermography

Abstract: Premature rain erosion damage development at the leading edges of wind turbine rotor blades impair the efficiency of the turbines and should be detected as early as possible. To investigate the causes of premature erosion damage and the erosion evolution, test specimens similar to the leading edge of a rotor blade were modified with different initial defects, such as voids in the coating system, and impacted with waterdrops in a rain erosion test facility. Using CT and XRM with AI-based evaluation as non-destructive measurement methods showed that premature erosion arises from the initial material defects because they represent a weak point in the material composite. In addition, thermographic investigations were carried out. As it shows results similar to the two lab-based methods, active thermography has a promising potential for future in-situ monitoring of rotor blade leading edges.

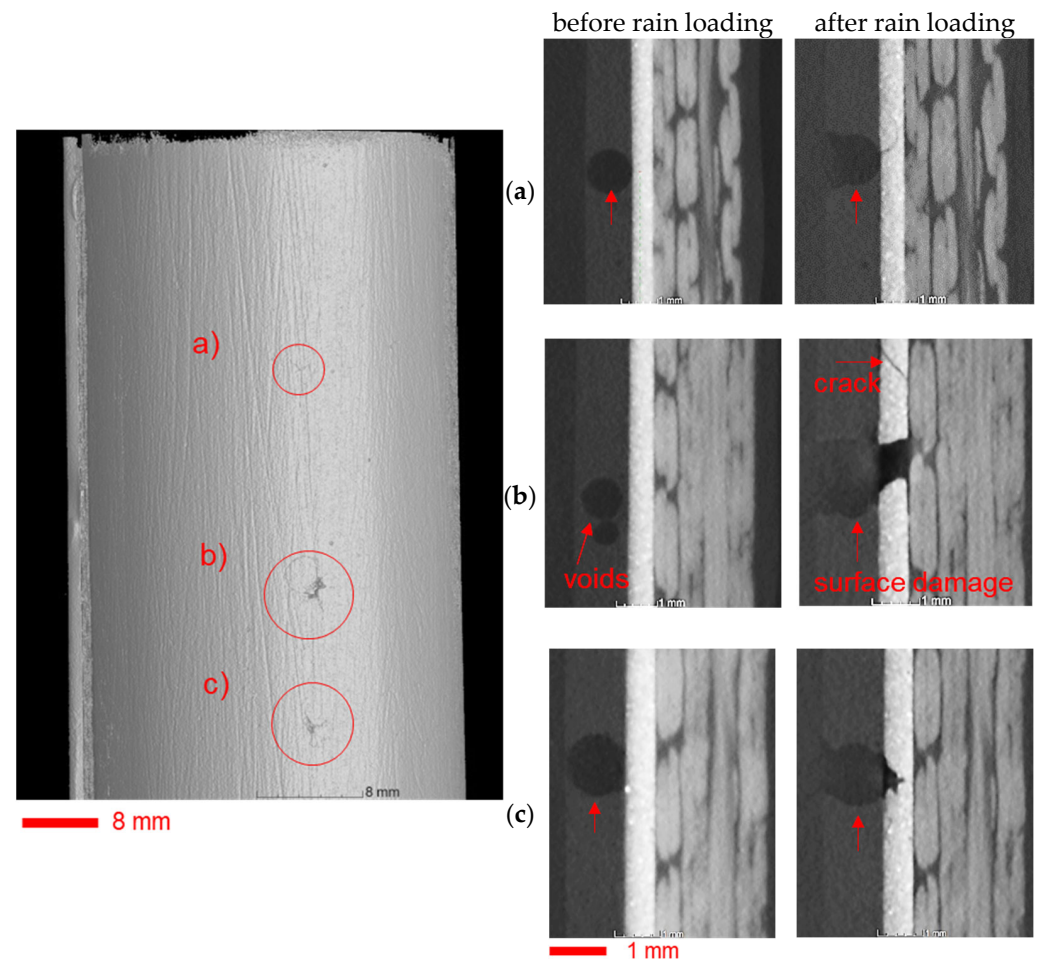
Figure 16. 3D representation of the loaded specimen (**left**) with marked positions (red circles) of the sectional view. The sectional views (**right**) show identical positions (a–c) before and after loading in the rain erosion test rig, adapted with permission from [19]. The red arrows mark voids in the GFRP, surface damage, or cracks in the material.

Corresponding sectional images showing the area before and after rain loading are shown on the right. Voids are present in the filler layer. It can be seen that the degree of degradation depends on the position of the pore, i.e., the distance to the air-coating layer interface, the size and number of voids, and the void volume. From the sectional images, a “time history” of the damage dynamics can be derived. At first, the coating layer gets broken and is therefore no longer present as protection of the filler, and cracks appear in the filler layer (Figure 16a). Second, the filler layer gets removed by abrasion or washed out (Figure 16c) until the GFRP structure is exposed (Figure 16b). Afterward, the bursting raindrops wash out the boundary layer between the GFRP and the filler, and cracks form outside the opening. The damage there is more extensive than the opening in the coating layer.

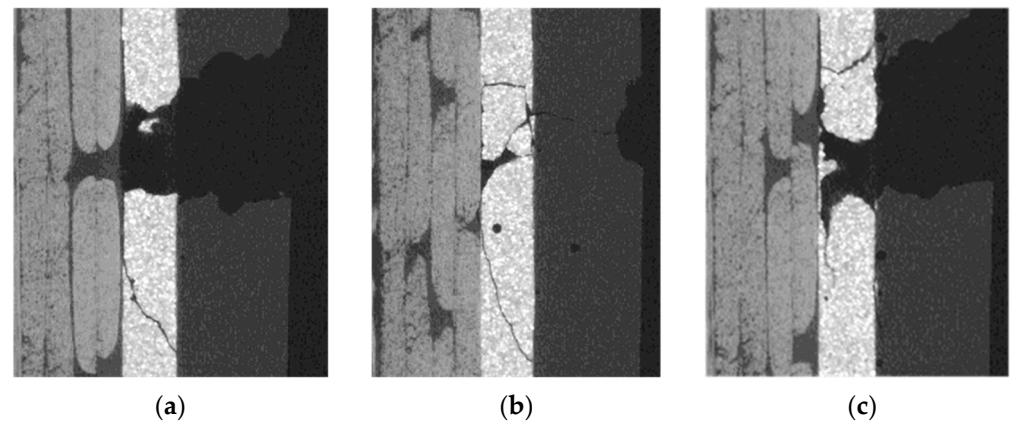
Figure 17 shows a cross-sectional view of the identical defect from Figure 16b at three different locations. Delamination can be seen along the interface between the GFRP and the filler (Figure 17a). The filler has been destroyed over a large area, and the extent is significantly greater than the opening in the coating layer (Figure 17b). A visual inspection of the defect from the outside would not capture the real extent of the destruction.

Figure 17. Cross-section of the identical defect (XRM, 9 μm pixel size) at three different locations (a) at the location with the deepest defect, (b) at the boundary location of the defect, and (c) at various locations of the defect [19].

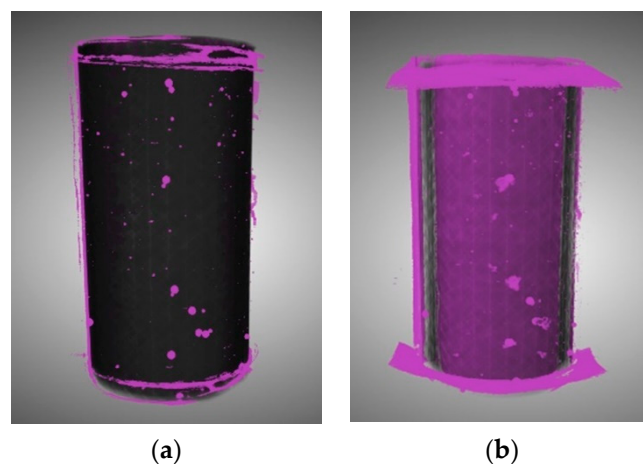
Figure 18. Defect detection (a) in the initial state and (b) after rain loading, adapted with permission from [19].

After loading the specimen with rain in the rain erosion test facility, the specimen was scanned again, and the same procedure was applied to the new data set. The results are displayed in Figure 18b. The effect of noise and ring artifacts is visible in this scan. Nevertheless, the defects were successfully located. The voids increased in size due to rain erosion. The trained CNN showed that the accuracy and training based on a handful of frames were sufficient for the segmentation of the whole data set. Another training strategy needs to be developed to ensure the robustness of the CNN. The training of neural

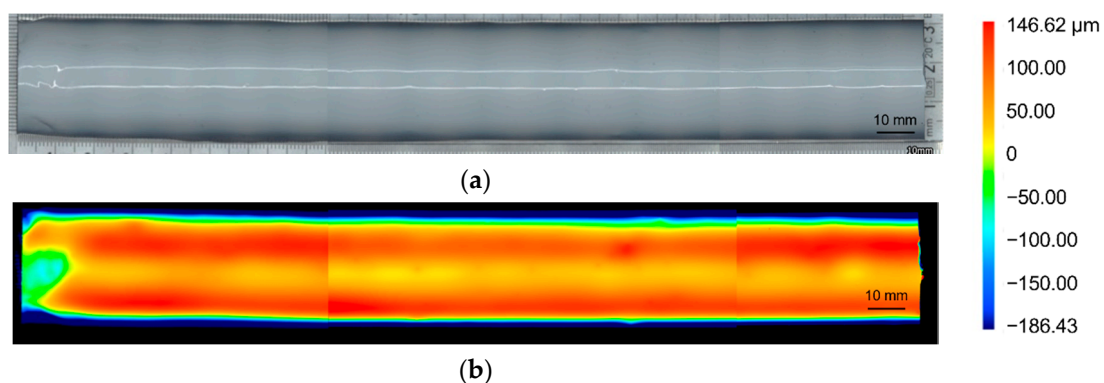
In addition to the computed tomographic measurements and AI evaluation, surface analysis using the fringe light projection method (3D profilometer) was carried out to generate an overview of the specimen surface and to document surface defects in their three-dimensional shape. The initial test specimen state is shown in Figure 19. Figure 19a shows a smooth surface based on the image recordings, which has a certain inhomogeneity in the form of an undefined waviness. This is also clearly evident from the 3D profilometer height representation in Figure 19b. In addition, individual defects introduced in the coating can be seen in the height image using slightly indicated local elevations on the surface, but not in the visual image.

Figure 19. (a) Visual image and (b) 3D profilometer height image of a test specimen with voids in the coating before rain loading.

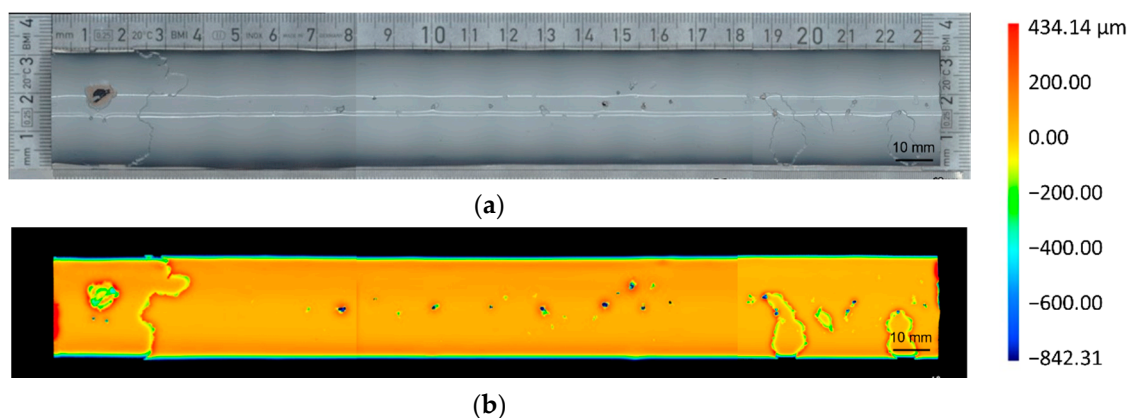
Figure 20 shows the damaged test specimen state after loading with rain. In both the visual image and the height image, the defects on the surface of the coating caused by rain erosion are visible. Small defects appear on the surface along the entire specimen, which is hypothesized to result from initially introduced defects since they weaken the material structure. Significant damage due to rain erosion is visible in the area of the marking hole of the GFRP specimen (about 1 cm to 1.5 cm from the left end of the specimen). In addition, a coating peeling is visible in the front area of the specimen (up to 3 cm from the left edge). These large-area coating peels are due to adhesion restrictions of the individual applied coating layers on this specimen.

Figure 20. (a) Visual and (b) 3D profilometer height image of a whole test specimen with voids in the coating after rain loading.

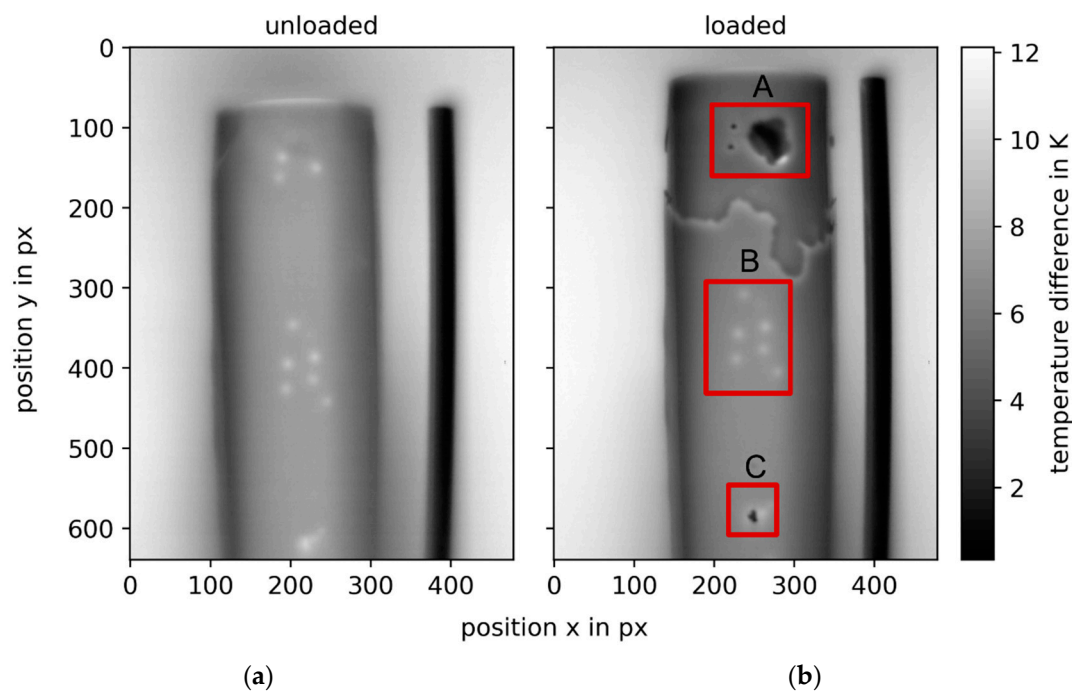
Figure 21. Thermogram of a specimen section with the environment at an excitation time of $t_{exc} = 10$ s; (a) unloaded condition; (b) loaded condition. The red boxes A–C show different defects; A: large surface damage, B: subsurface defects, C: pinhole.

Before rain loading, the introduced defects appear as bright or hot spots on the specimen, see Figure 21a. Since the thermal conductivity of air with $0.0262 \text{ W/(m}\cdot\text{K)}$ is significantly lower than the thermal conductivity of the coating with $0.2 \text{ W/(m}\cdot\text{K)}$ (estimated value based on polyurethane as base material, since no data is available for the coating in this respect), the heat introduced during excitation accumulates in front of the defects. Here, the coating heats up more strongly than in areas without defects. The thermogram after rain loading shows evolved surface damages (A) in addition to sub-surface defects (B). The surface damages are indicated by lower temperatures or darker areas; see Figure 21b. Special attention should be paid to the pinhole in the center of the specimen at pixel position $y = 600 \text{ px}$ (C). Here, according to the bright border area of the defect, the damage below the surface is larger than it is visible at the surface in a visual image.

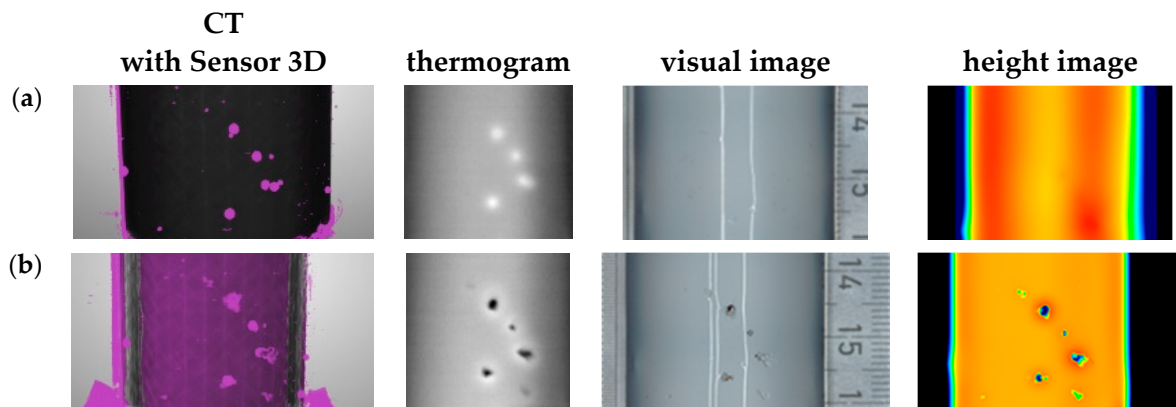
Figure 22. Result presentation of a section of a specimen with voids in the coating as a comparison between the applied measurement methods, including visual images, height images, thermography (normalized raw image), and the Sensor 3D segmentation results of the CT data, in (a) unloaded and (b) loaded condition.

Figure 22a shows the image section in the unloaded state. While no irregularities can be seen in the visual image and the 3D topography, the thermogram shows irregularities in the form of hot spots. These irregularities can also be seen in the CT. Since the specimen has inserted voids, it can be assumed that exactly these initial defects were detected. Therefore, the specimen's condition is not ideal, even if it appears to be so from the outside.

Figure 22b shows the same specimen section after a 4 h exposure to rain. In the visual image and the 3D profilometer, defects are now clearly visible on the surface of the specimen. In the thermogram, these defects can also be declared as surface defects in the form of dark spots. It is noticeable that the surface defects are surrounded by a bright border, which would mean that the defect under the surface is significantly larger than visible at the surface. A look at the CT image confirms that the defects have grown in size compared to before rain loading. Here, the defect size in the CT differs from the defect sizes in the visual images, indicating that the defects have also grown below the surface, which validates the thermographic results.

To conclude, the condition of a rotor blade's leading edge should therefore be inspected before it is used on a wind turbine. Active thermography, in particular, offers great potential as a measurement method since it is highly flexible compared to CT and can be used at various locations, including in the open field.
