Analysis of Characteristics of Roof Fall Collapse of Coal Mine in Qinghai Province, China

Abstract: This paper presents the roof fall collapse of a coal mine that occurred, causing 20 deaths and 1 injury, in Qinghai Province, China, on 14 August 2021. After the primary investigation of this incident and a brief description of the rescue action undertaken, this report discussed the possible reasons behind this disaster. The fissure water and damaged rock mass are the dominant triggering factors of this incident. Little concern for risk assessment and monitoring systems is one of the main man-made mistakes. Consequently, the reflections and suggestions are put forward to reduce or prevent the occurrence of roof fall incidents in coal mines. The noteworthy actions that are necessary in coal mine projects are conducting risk assessments based on geological condition and building proper support systems for coal mines considering the situation in situ.

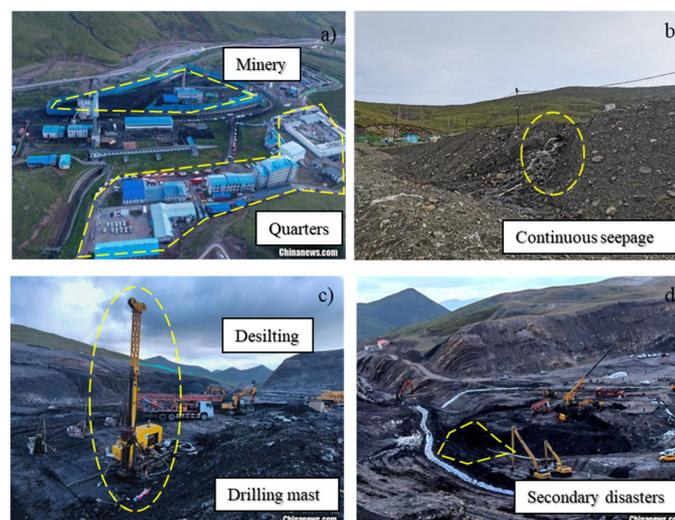
On 14 August 2021, the roof fall collapse of a coal mine occurred in Haibei Prefecture of Qinghai Province, China (see Figure 1a). Figure 1b depicts the disaster site. The accident occurred in the Chaidar coal mine, located in Gangcha County (see Figure 2a). The accident was caused by the mixing of fissure water and coal ash in the upper part of the working face to form coal slime, which poured into the working face. The mine was an open pit, 160 m deep, and had been backfilled to 80 m when this accident occurred. The backfill part is mainly sandy soil, and the geological conditions are complex and extremely unstable. The accident trapped the victims at a location about 1.2 km from the mine’s entrance, the vertical distance between the accident site and the ground surface is 90 m, and the mud flow backward is 70 m. At the time of the accident, 21 miners were working in the mine, 1 person was dead, 1 person was injured, and other 19 workers were trapped in the mine. Due to weather and seasonal factors, there was a constant seepage around the pit (see Figure 2b). The accident occurred at a high altitude and in the frozen soil, the coal mine roof is poor, and the coal seam is powdery. The rescue was extremely difficult. During the progress of drainage and desilting (see Figure 2c), the internal pressure of fluid changes, the unstable balance of coal slime in the upper part of the working face is broken, and coal slime continues to flow into the working face, resulting in secondary disasters (see Figure 2d) of coal slime gushing twice in two hours during the rescue and desilting the rescue team. By the early morning of September 13, the accident rescue work had essentially ended; all 19 trapped people had been found, no vital signs. According to the notice issued by the emergency management department of Qinghai Province (<http://yjt.qinghai.gov.cn/>

Figure 2. Roof fall collapse of coal mine: (a) full view of Chaidar coal mine (recreated based on [40]); (b) a continuous seepage (recreated based on [41]); (c) borehole desilting; (d) secondary disasters (recreated based on [42]).

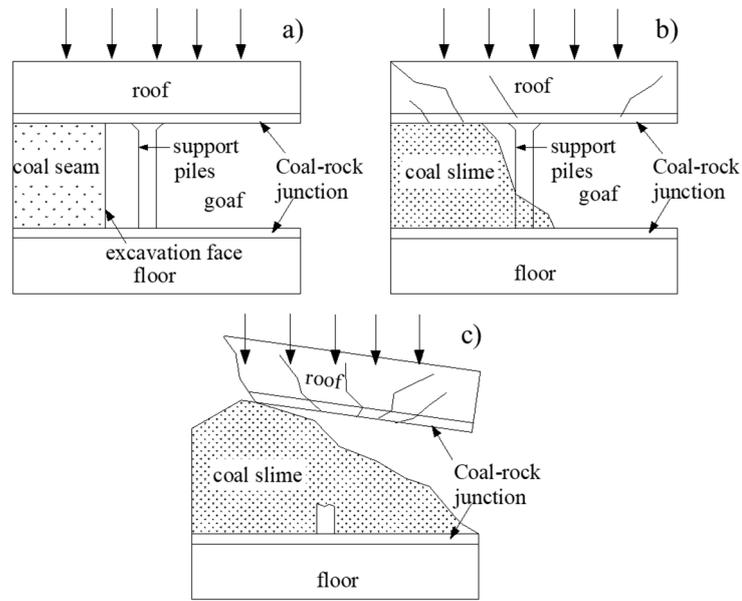
The roof fall accident was caused by the complex geological conditions and the coal slime formed by the upper fissure water and coal dust gushing into the working face. The strength of coal mine roof is weak, the roof is extremely fragile, and the joints and fissures are richly developed. The coal seam is powdery, and the water inflow of the working face is large, so that the rock mass is damaged under the action of accumulated pressure (see Figure 4). Secondly, the effective management at the working place is insufficient. The support system was not well designed and did not have a comprehensive understanding of the geological condition of the roof, especially on the formed coal slime. This meant that the working resistance of the designed support system was too weak to bear the pressure from the coal roof. Additionally, managers did little to ensure the quality of the monitoring system and personnel safety management during the mining process.

Figure 4. Mechanism of roof fall: (a) normal excavation face; (b) roof damaged, coal slime into the working face; (c) complete collapse of roof.

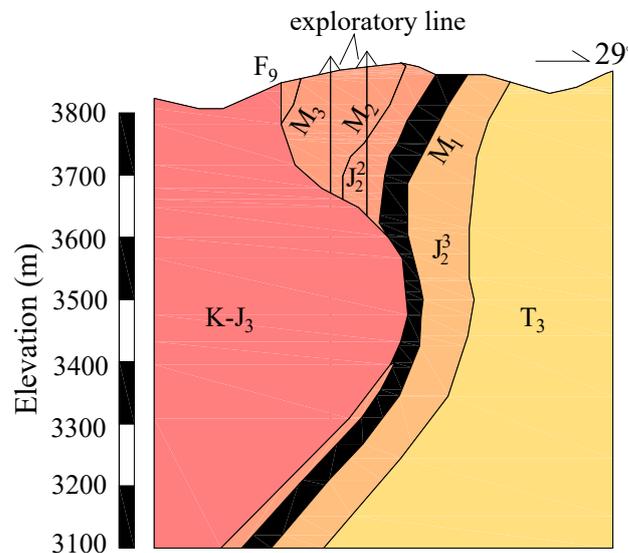
The Chaidar mine field in Haibei Prefecture, Qinghai Province, is mainly composed of nappe structures, which are generally tongue-shaped and shovel-shaped wedges from coal-bearing strata that overlap with each other. The properties of each nappe are the same, but the shapes are different. Its genesis is related to the uneven pushing of the fault into the mine field, resulting in the local stress concentration and the formation of a series of imbricate slip bodies [45]. The rest of the nappe bodies are in the process of formation, the residual energy is released, and the stress diffuses along the arc surface of the nappe to M1 (see Figure 5), resulting in the weakness and deformation of the coal seam and the sharp change in the occurrence of the roof and floor in a local range. Therefore, the nappe structure can affect the coal seam, roof and floor. The slope in the same working face changes many times, the mining process is blocked, and the safety factor is reduced [46].

Figure 5. Structural profile of nappe (recreated based on concept of [45]).

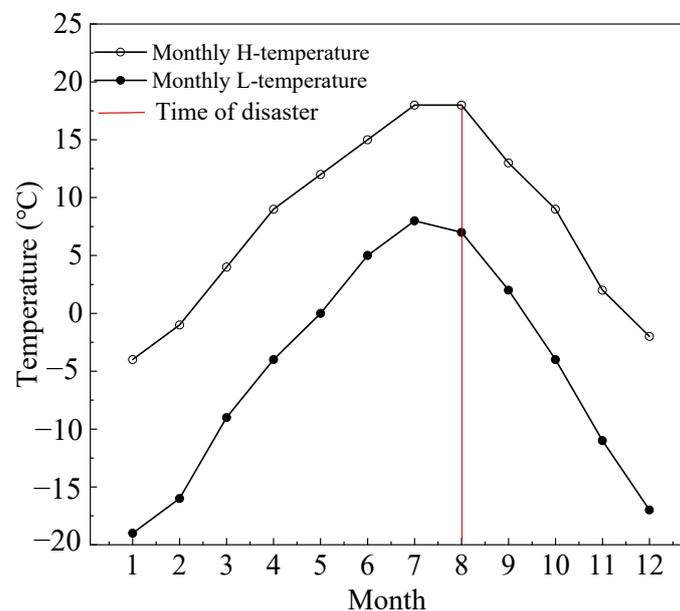
The Chaidar coal mine is dominated by alpine landform with discontinuous distribution of island frozen soil and seasonal frozen soil. The thickness varies from tens of centimeters to about 60 m. In summer, the thawing depth is only 1–2 m, and the local low-lying surface layer is mostly swamped. July–August in Gangcha county is the highest temperature period of the whole year (see Figure 6. data from https://www.tianqi.com/qiwen/city_gangcha/, accessed on 16 January 2022). Climate change causes seasonal frozen soil melting, changes soil moisture, and then affects the water runoff process. The water runoff at the ground surface and the upper part of underground soil would change as well. In addition, the mining of the coal mine breaks the process of water and heat exchange in the active layer and changes the surface water, shallow groundwater, and their migration. These can accelerate the melting of the frozen soil layer and increase the infiltration of surface water. Consequently, large-area ponding may occur in the pit [47,48].

Figure 6. Annual average temperature.

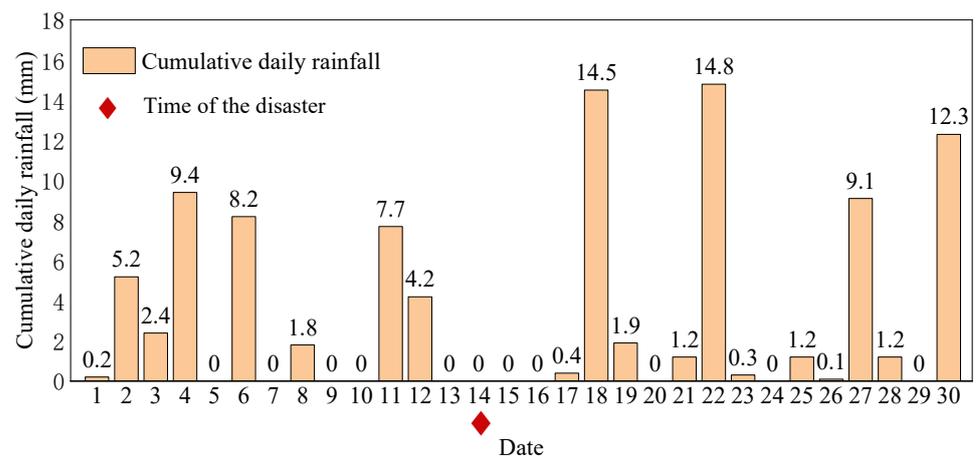
The groundwater in the mining area is mainly supplied by atmospheric precipitation and deicing water. Figure 7 (data from <https://www.tianqi.com/gangcha/>, accessed on 10 January 2022) shows the daily rainfall in August in Gangcha county. It can be observed that, before this accident, there were seven days of light rain in the two weeks. These rainfalls can change the pore water pressure of the surrounding soil, which may weaken the unstable roof. After the accident, the daily rainfall on the 18th, 22nd and 30th exceeded 10 mm. These can further reduce the strength of the surrounding soil and make the situation more unstable. These post-accident rainfalls may be the reason for the secondary disaster, which caused great difficulties and delayed the rescue time.

Figure 7. Cumulative daily rainfall in August in Gangcha County.
