Technological Aspects of a Reparation of the Leading Edge of Helicopter Main Rotor Blades in Field Conditions

Abstract: The Polish Air Force operates more than one hundred helicopters of the Mi family (manufactured by Mil Helicopters), equipped with metal main rotor blades. The main rotor blades are among the most stressed components of these structures. For this reason, they are subject to more frequent inspections during operation than other components. One type of damage detected during inspections is the local disbonding of fragments of the anti-erosion layer from the leading edge. This harmless-looking damage is very dangerous, since it quickly leads to the complete detachment of the layer. The leading edge, unprotected by the metal cover, erodes rapidly. The detached layer, when thrown away at high speed, endangers other parts of the helicopter, such as the tail rotor, and may cause damage to other helicopters if flying in formation. The technology supplied by the manufacturer to date has not encompassed the field repair of this type of damage. Therefore, efforts were made to develop repair technology for rapid repairs of blades in field conditions during missions of the Tas

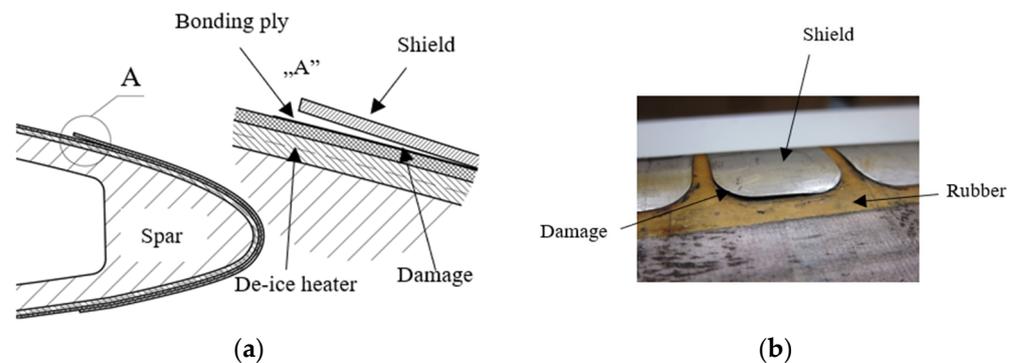
During maintenance work on the main rotor blades, damage is detected in the form of a piece of the metal shield peeling off the leading edge (Figure 2). The detection of the damage makes it necessary to decide whether to repair the blade or to withdraw it from use.

Figure 2. Damage to the leading edge—debonding shield from the leading edge: (a) Diagram; (b) Damage to a Mi-2 helicopter rotor blade (series 22-2700-3000).

The analysis of helicopter documentation (internal materials of the Polish Air Force) revealed that damage (Figure 2) is most frequently found on the blades of helicopters flown aggressively during real military missions. Damage is particularly common during missions such as cargo transport, maritime search and rescue missions, and assault operations. Damage is less frequently detected on helicopters used for training and routine flights. Damage of this type is only very rarely detected on blades with a short service history. It is therefore concluded that the damage is influenced by the intensity of operation, which consists of mechanical loads and environmental conditions.

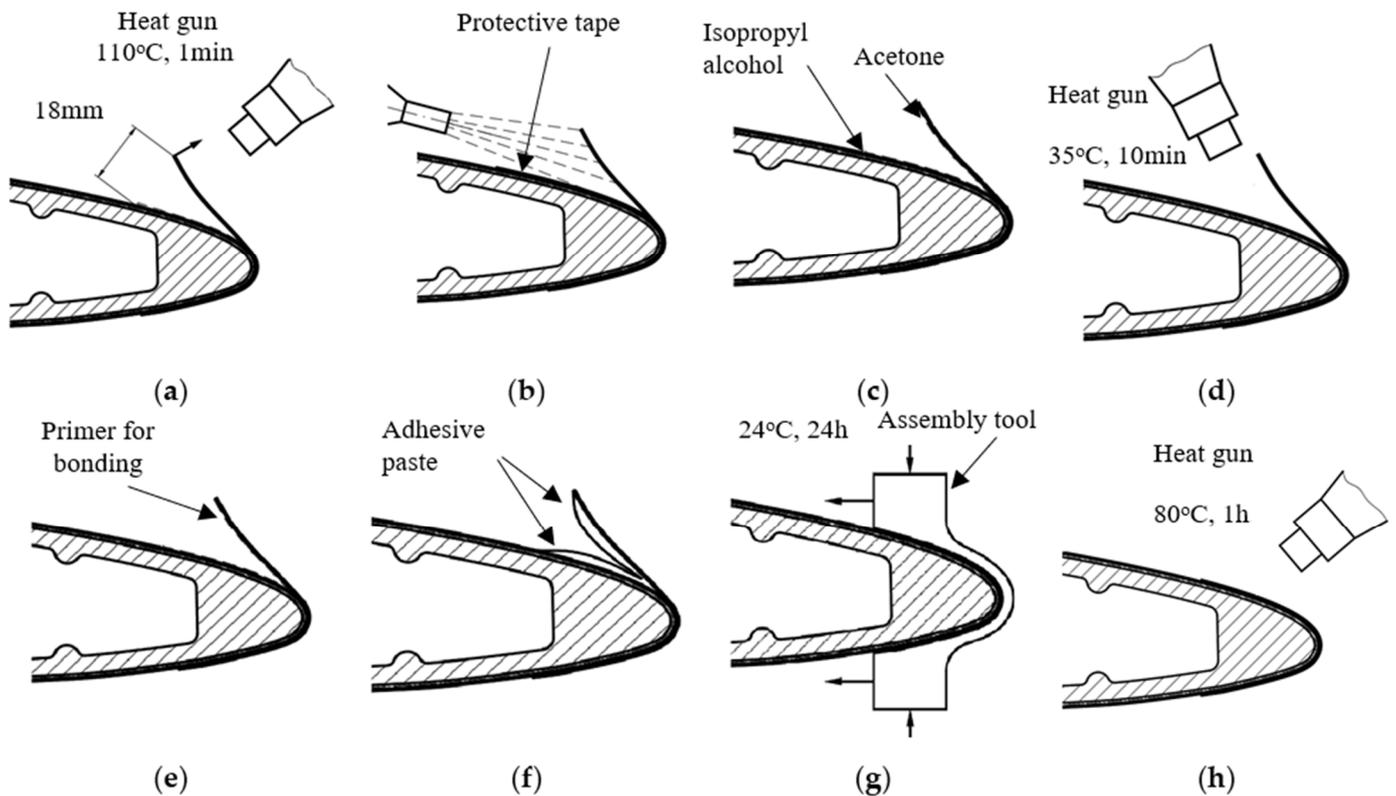
Figure 7. Technological process of repairing the leading edge of a rotor blade: (a) Separation of the damaged piece of shield from the rubber; (b) Sandblasting; (c) Cleaning; (d) Drying; (e) Applying a primer; (f) Applying adhesive paste; (g) Curing; (h) Post-curing.

In order to properly prepare the surface for bonding, the faulty shield must be separated from the rubber (Figure 7a). Based on the DSC analysis (Figure 6) and a number of tests, it was found that heating the shield to 110 °C softened the bonding paste so that it could be peeled off with a medical wooden spatula.

Therefore, the decision was made to treat the titanium surface in a way that is feasible in field workshop conditions, consisting of surface degreasing and sandblasting (Figure 7b). Sandblasting using a 6 mm-diameter nozzle, 0.4 mm-grade corundum sand, and 10 bar working pressure at 2 m³/min, resulted in a roughness of Ra = 1.05 µm. Before this operation, the rubber was protected by isolation tape, which was removed after sandblasting.

The surfaces have to be dried by a heat gun (Figure 7d) after chemical cleaning (shield with acetone and rubber with isopropyl alcohol). Although the fact that the solvents used evaporated easily, drying requires quite a long time to remove them from porous structures—sandblasted metal and rubber. Based on experience, 10 min at 35 °C was assumed to be sufficient. After the cooling of the surfaces, the primer is applied by a brush (Figure 7e). The primer is cured in ambient conditions for 8 h [32,33].

The last step was the curing process—hardening (Figure 7g) and post-curing process—improvement properties (Figure 7h). For typical epoxy adhesive paste, the curing temperature is 24 °C for 24 h and the post-curing temperature is 80 °C for 1 h. Epoxides are cross-linked polymers. The first crosslinking step occurs during curing through the action of the curing agent. The temperature treatment causes the bonds to strengthen, which translates into increased strength and durability of the bonding ply. The repaired leading edge area is shown in Figure 9d.

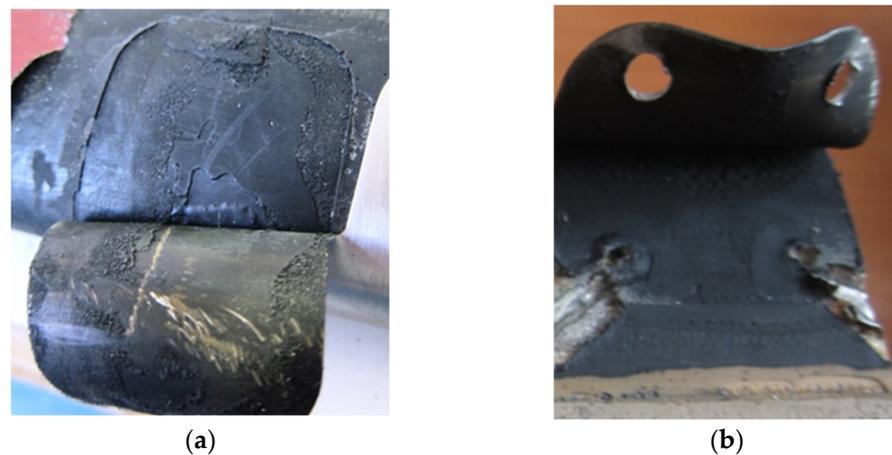
Contrary to appearance, the application of adhesive paste is a complicated process. The paste applied to the target surfaces should be as shown in Figure 7f, with the thickest layer being about 3 mm. In this way, when the elements are pressed together, the excess adhesive paste will flow out, leaving an even layer between them. Applying the paste in the same thickness on the entire surface (without the characteristic bulges) or leaving a layer containing air bubbles will cause the adhesive to be uneven when pressed, or air bubbles will form in the center (Figure 8).

Figure 8. Fracture surfaces of bonding layers: (a) Bonding ply with voids—wet adhesive paste was not properly applied; (b) Bonding ply without voids—wet adhesive paste was correctly applied.

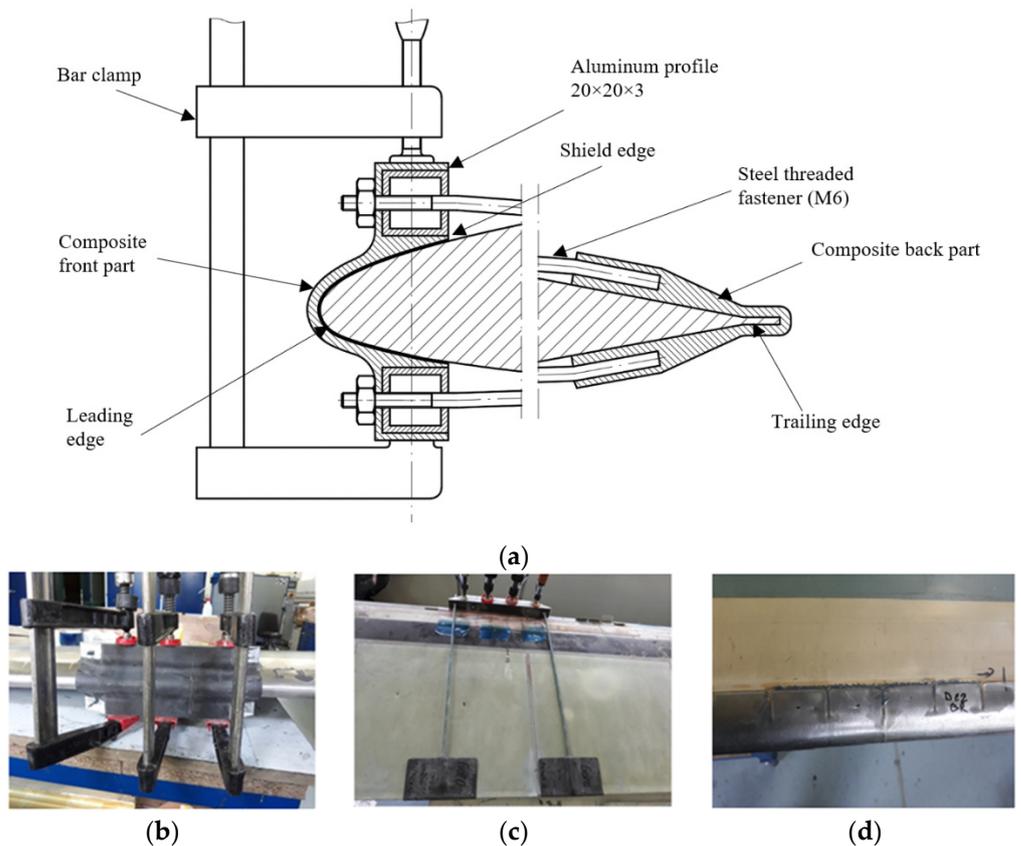
Figure 9. Bonding process: (a) Assembly tool—scheme; (b) Assembly tool—front; (c) Assembly tool—top/back; (d) Leading edge after repair.

The composite back parts of the assembly tool (Figure 9a) were installed on the trailing edge of the blade first. Next, the bonded shield was compressed to the leading edge using the composite front part of the assembly tool by hand after applying adhesive paste to the bonded surfaces of the leading edge under repair. Then, the front part of the assembly tool was joined to the back part of the assembly tool using a fastener (M6). Therefore, the shield was pressed to the leading edge. In order to additionally pressed the shield to the top and bottom of the leading edge, bar clamps were installed as the last step. The excess adhesive paste squeezed out was removed by a wooden spatula.

Tap-tests were carried out on the repaired structure (Figure 9d) as described above. The tests showed 100% adhesion over the entire area to be repaired—four sections of the shield. This means that the adhesive layer was evenly spread and the designed mounting tool applied the correct pressure.

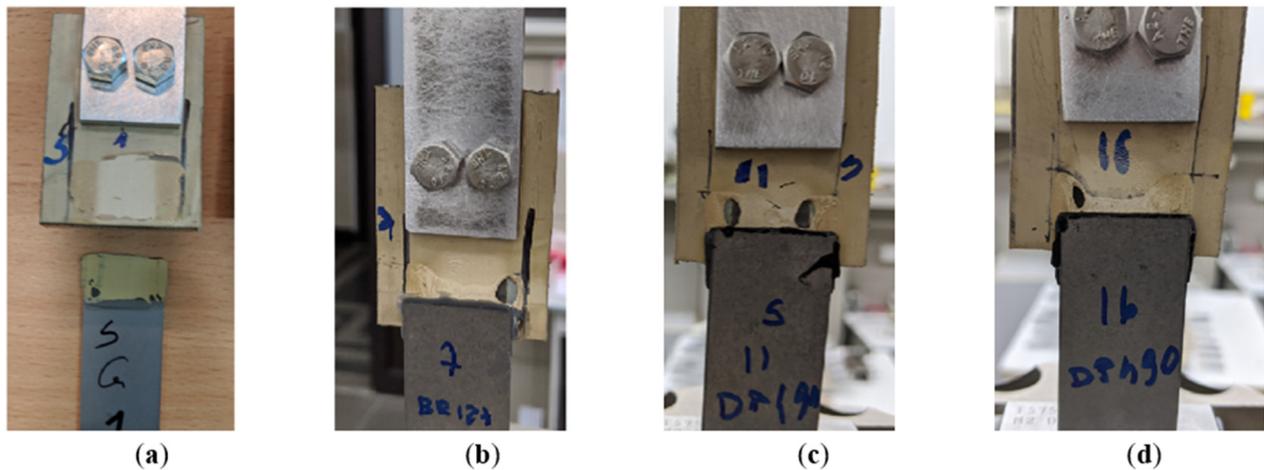
The shear strength test of bonding was carried out on an Instron Fatigue system. A constant speed of actuator movement equal to 2 mm/min was applied. Force was recorded as a function of displacement, on the basis of which the shear stresses were determined. The damage caused by the shearing of bonding 2216B/A + BR 127 primer after aging, was characterized by adhesive fracture surfaces between the bonding layer and rubber (Figure 14a). The rest of the samples were characterized by the cohesive fracture surface of the rubber (Figure 14b–d).

Figure 14. Characteristics of fractures during the shear strength test: (a) Bonding 2216B/A + BR-127 primer after aging; (b) Bonding 2216B/A + BR-127 primer without aging; (c) Bonding DP490 after aging, (d) bonding DP490 without aging.

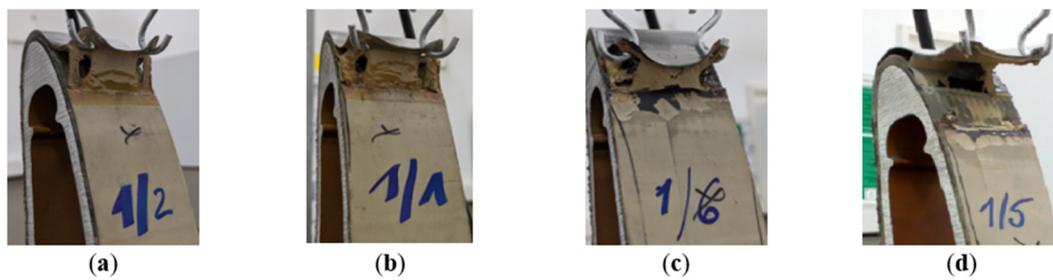
The test consisted of a comparison of the tearing force F (Figure 17) of the shield parts with the factory bonding and the bonding created according to the proposed technology (Bonding DP490). The test was also carried out on an Instron Fatigue system. The constant speed of actuator movement equal to 2 mm/min was applied. Force was recorded as a function of displacement. Five samples from each series were tested. Distinctive fractures of bonding are given in Figure 18. All the fractures were cohesive; therefore, the rubber was damaged.

Figure 18. Characteristics of fractures during tests of the tearing off of the shield from the leading edge: (a) Factory bonding sample without aging, (b) Factory bonding sample after aging, (c) Bonding DP490 sample without aging, (d) Bonding DP490 sample after aging.
