# Long-Term Durability of Cement-Treated Soil Used in Offshore Airport Island Construction

Hidenori Takahashi <sup>1,\*</sup>

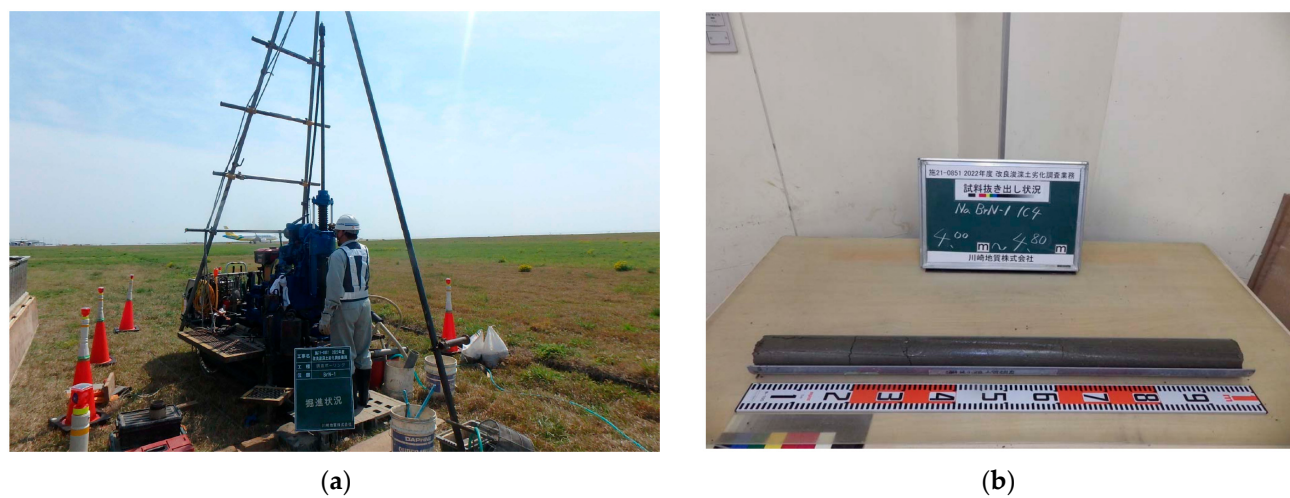
Figure 5. Boring and sampling: (a) boring operation; (b) core sample.

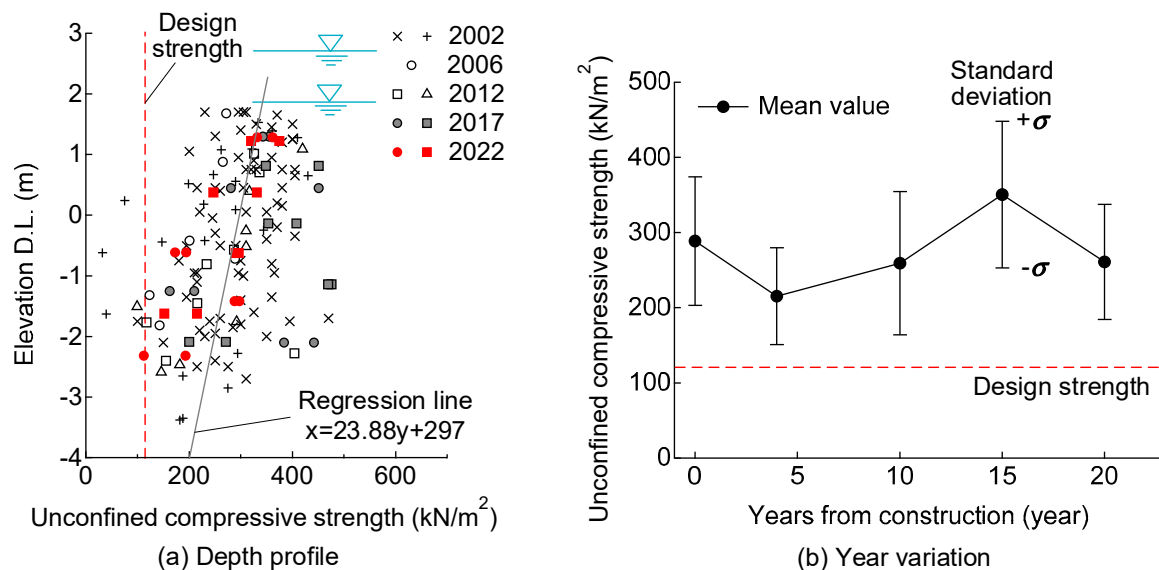
The distributions of the unconfined compressive strength of the treated soil in the depth direction obtained from the five surveys are shown in Figure 9, along with the mean variation over time. For the 2002 survey, only the results for the samples collected at sites P23 and H24 are shown. Figure 9a shows that although the results varied, they were generally distributed in the range of  $100\text{--}500 \text{ kN/m}^2$ , with most of the data exceeding the design strength of  $120 \text{ kN/m}^2$ . The average value of the variation was also higher than

the average value of  $157 \text{ kN/m}^2$  estimated at the time of the design. The figure shows the regression line of the unconfined compressive strength in relation to the depth. According to the regression line, the strength tended to decrease with an increase in depth. The above-mentioned distribution of water content showed that the water content tended to be slightly higher at deeper depths, suggesting that some water may have been taken in by the submerged casting. However, considering the design strength, the difference in strength in the depth direction was not a problem. Figure 9b, which shows the change in strength over time, indicates that there was no long-term decrease in strength, although small and large values were observed depending on the year of investigation. The range of standard deviations ( $1\sigma$ ) from the mean value is shown by error bars, and it can be seen that the mean value minus the standard deviation was larger than the design strength for all the survey years. From these results, it can be concluded that overall, the strength properties of the treated soil were almost stable.

Figure 9. Depth distribution and ageing of unconfined compressive strength.

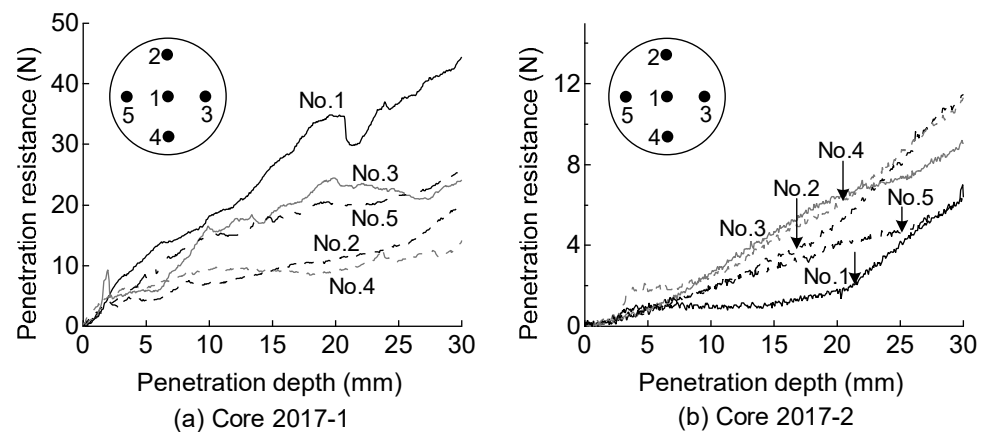
No signs of strength reductions were observed in the interiors of the treated soil samples during the investigations up to 2012, needle penetration tests were conducted on the surfaces exposed to the untreated soil from the 2017 survey onwards. The results of the 2017 survey, 15 years after construction, are shown in Figure 12. The test results were

obtained from vertical needle penetration tests against the exposed top surfaces of two cores (2017-1 and 2017-2). The results for core 2017-1 showed that penetration resistance was encountered immediately after penetration, with a large variation in values. The results varied depending on the penetration point. Visual observations of the specimens suggested that this was because the treated soil contained gravel. On the other hand, the results for core 2017-2 showed that the penetration resistance values were relatively stable, and it was possible to identify areas with a constant gradient. With the exception of penetration no. 3, points of change in the gradient can be seen, and their locations are indicated by arrows in the figure. The slope is smaller in the shallow section and larger in the deeper section. In other words, the strength of the shallow part was low, and this part was considered to have deteriorated. Consequently, the strength was considered to have decreased in the range from the boundary to a depth of approximately 16–25 mm.

**Figure 12.** Needle penetration resistances at the surface of cement-treated soil samples (15 year survey).

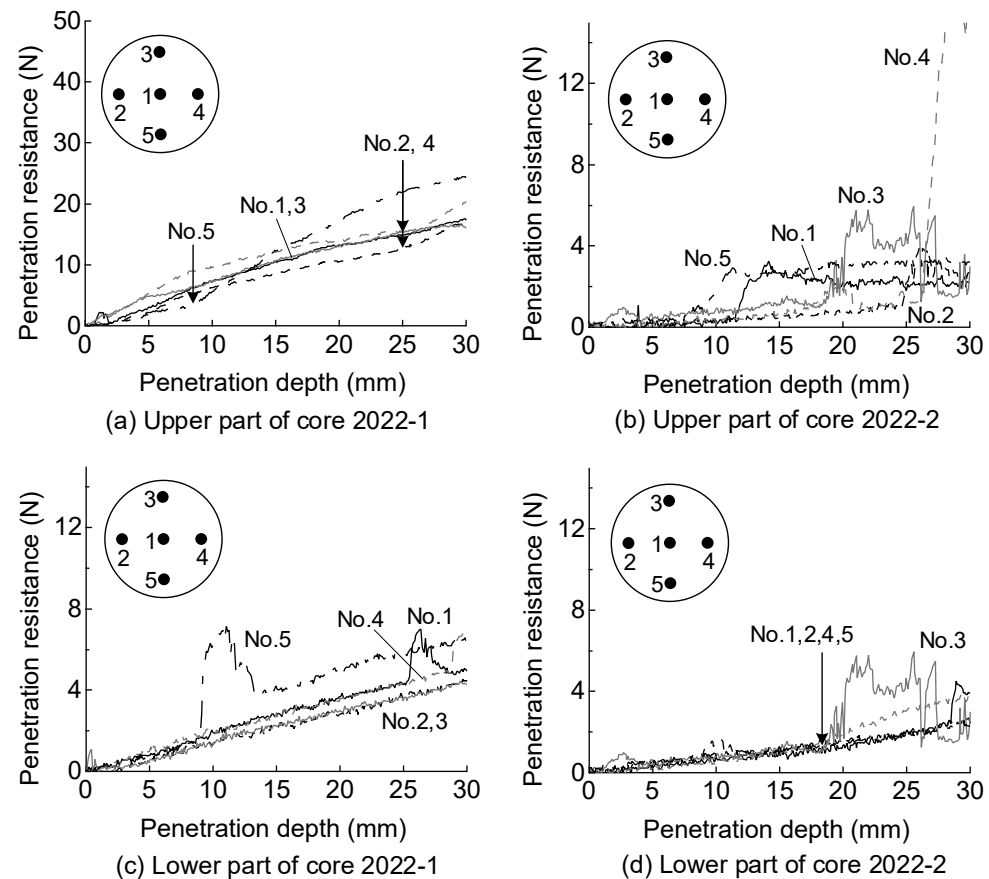
The results of the needle penetration tests conducted in 2022, 20 years after construction, are shown in Figure 13. The results were obtained by vertically penetrating the exposed surfaces at the tops and bottoms of cores 2022-1 and 2022-2. In the upper part of core 2022-1, the gradient was relatively large; however, there were differences in the gradients between penetrations. The arrows in the figure may be seen as points of change in the gradients at 8 and 25 mm, although these were difficult to determine because of the large variation. In the upper part of core 2022-2, there was a sudden increase in the penetration resistance, possibly due to the needle hitting gravel. In addition, the gradient was small and it was difficult to determine the point of change. Similarly, in the lower part

of core 2022-1, the gradient was small and there was no point of change, except where the needle struck gravel. Constant gradients were identified in the lower part of core 2022-2, and the points of change were at approximately 18 mm. However, the point of change of the gradient in these tests was unclear and, with the exception of the upper part of core 2022-1, the gradients were small, and the possibility could not be ruled out that the degradation had progressed deeper than the 30 mm penetration of the needle. Therefore, it was decided to implement lateral needle penetration tests at several depths in the sample, elemental mapping by EPMA, and a chemical analysis to investigate the degradation at a deeper depth.

**Figure 13.** Needle penetration resistances at the surface of cement-treated soil samples (20 year survey).

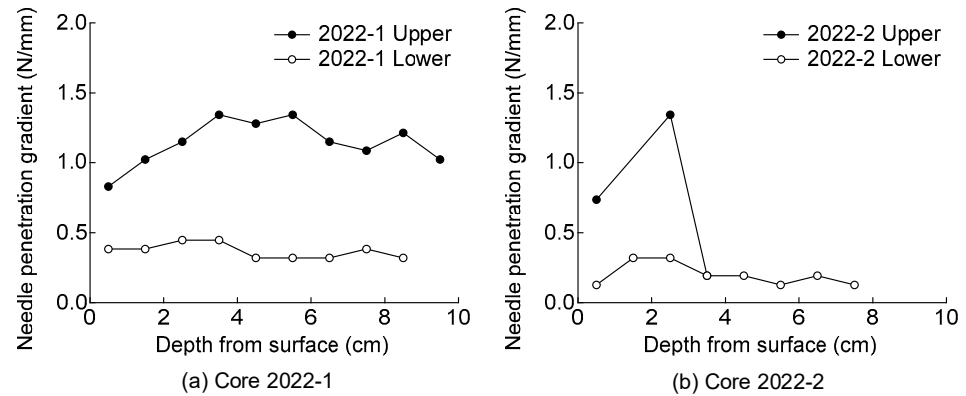
The results of needle penetration tests on the lateral side of a sample are shown in Figure 14. These are the needle penetration gradients for each depth from the exposure surface and are the average gradients up to a penetration depth of 10 mm. In the upper part of core 2022-1, the gradients were generally large; however, in the range of 10–20 mm near the exposure surface, the penetration gradients tended to decrease. On the other exposure surfaces, the gradients were generally small, and no tendency for the gradient to decrease was observed in the vicinity of the exposure surface. However, there was no sudden change in the needle penetration gradient up to a depth of 70–100 mm. It is unlikely that the treated soil had deteriorated at this depth. It can be concluded that the deterioration did not progress deeper than 30 mm, and the strength of the soil was low from the time it was cast. The results of the elemental mapping by EPMA are shown in Figure 15. An examination of the calcium content, which is correlated with the strength of the cement-treated soil, shows that the calcium content in the upper part of core 2022-1 was high, which was consistent with the high needle penetration gradient at that location. However, the calcium content was low in the lower parts of cores 2022-1 and 2022-2, which was consistent with the small needle penetration gradients at these locations. These analyses also suggested that the

cement-treated soil did not deteriorate at any depth, but that there was an overall variation in the strength of the treated soil from the beginning of construction, with localised areas of low strength.

**Figure 14.** Needle penetration gradients near the surface of samples (20 year survey).

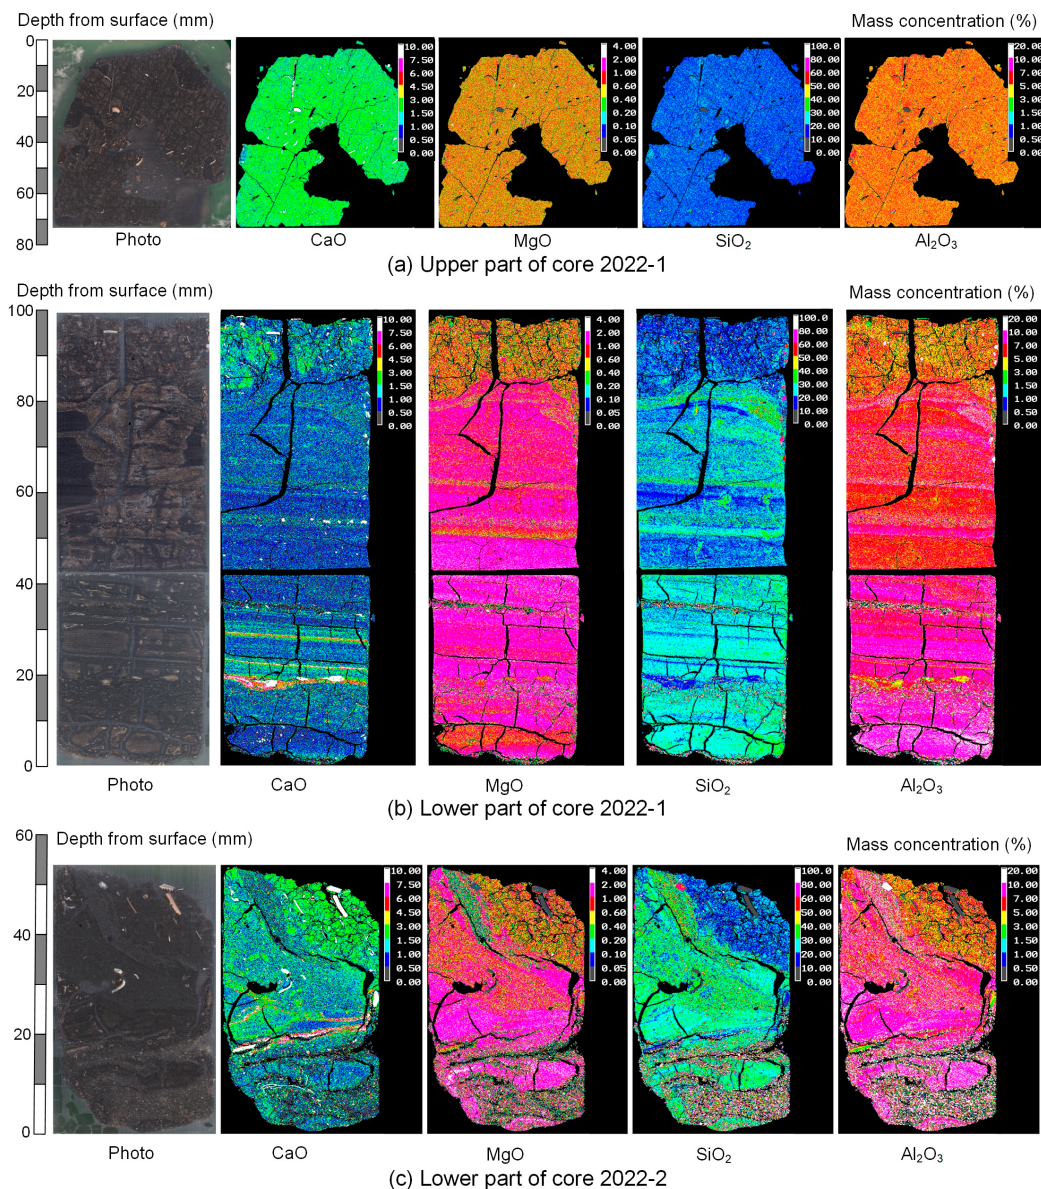
**Figure 15.** Elemental mapping results from an EPMA.

Based on the results of the needle penetration tests from the side of the sample described above, along with the EPMA images and chemical analysis results, only the area around the exposed surface of the treated soil was degraded. Based on the results of the needle penetration tests perpendicular to the exposed surface, a depth of approximately 18–25 mm could be considered as the depth of degradation.
