Quality Behaviour of Turnouts: Comparison, Problem Specification and Recommendation of Measures

Abstract: For future requirements, asset management of turnouts needs to rely on data-based assessment tools. These tools must enable the quantification of quality behaviour of turnouts and identify causes of poor behaviour. In this paper, we provide a toolbox addressing these requirements. We use track geometry as the main criterion for quality behaviour in combination with additional indicators, each associated with a different component, to understand turnout performance. The toolbox is applied to five similar turnouts to compare their performance. It is revealed that one of the turnouts performs significantly worse than the others. A deeper analysis can identify worn ballast in several areas of the turnout as the cause of poor performance. Problems in the ballast bed can be attributed to worn insulated rail joints as well as to stiffness changes in the transition areas of the turnout.

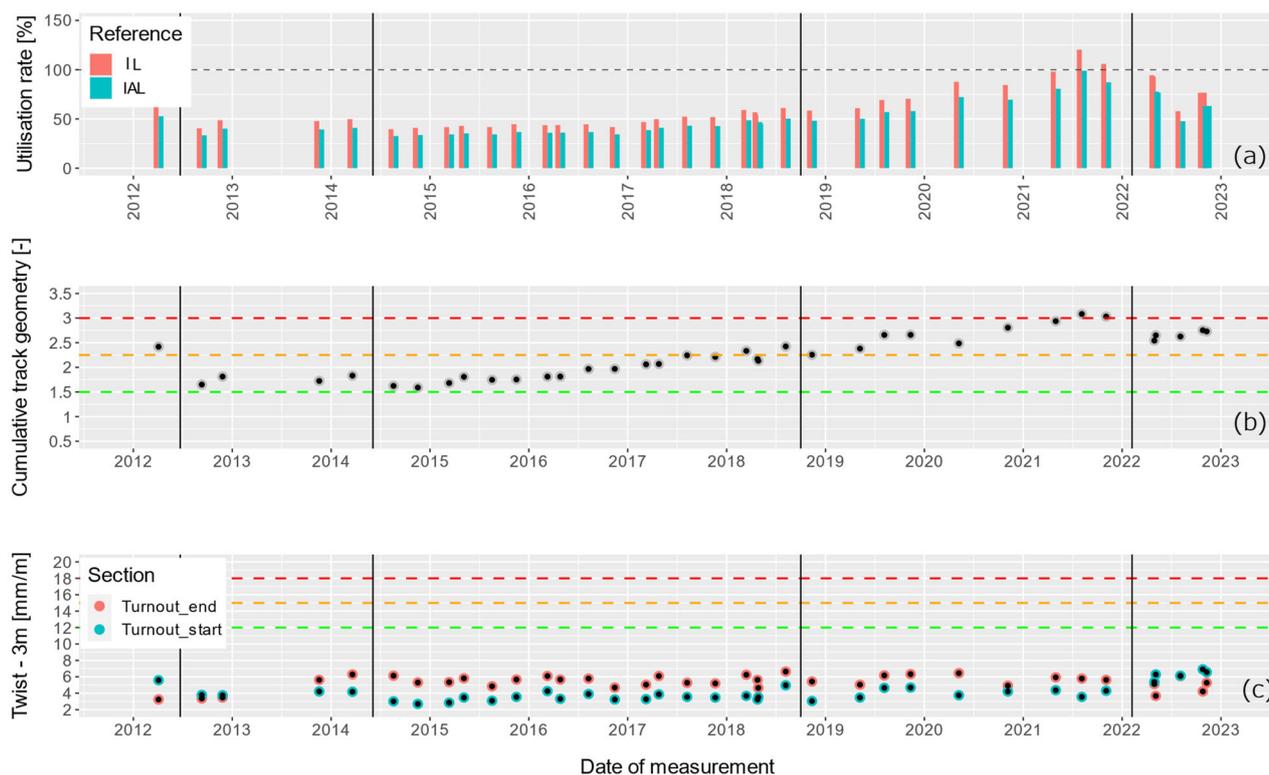
Figure 2. Utilisation rates for IL and IAL (a), cumulative track geometry index (b) and twist values (c) of turnout T_R4F_21.

As the turnout was renewed in 2011, the x-axis of the plot starts there. The index (grey dots) increases over time, reflecting deterioration of track geometry due to wear and tear. The coloured horizontal lines reflect quality ranges from excellent (green) to poor (red). These limits are an average over the turnouts analysed so far and are neither finalised nor directly linked to intervention recommendations. Nevertheless, solid approximations can be made with this classification. Vertical lines reflect tamping interventions carried out in the past. Some of these tamping measures have been documented in a database of ÖBB, while others have been detected by signal features using an algorithm developed for this purpose. Details on the detection algorithm can be taken from [31].

the front area of the turnout. The front area is usually not as critical as the rear part, but twist damage is also possible there. Figure 2c shows the development of twist over time for T_R4F_21. For this turnout, the standardised limit values are not reached over the monitored timespan; however, later evaluations will show that twist is an issue for some of the analysed turnouts.

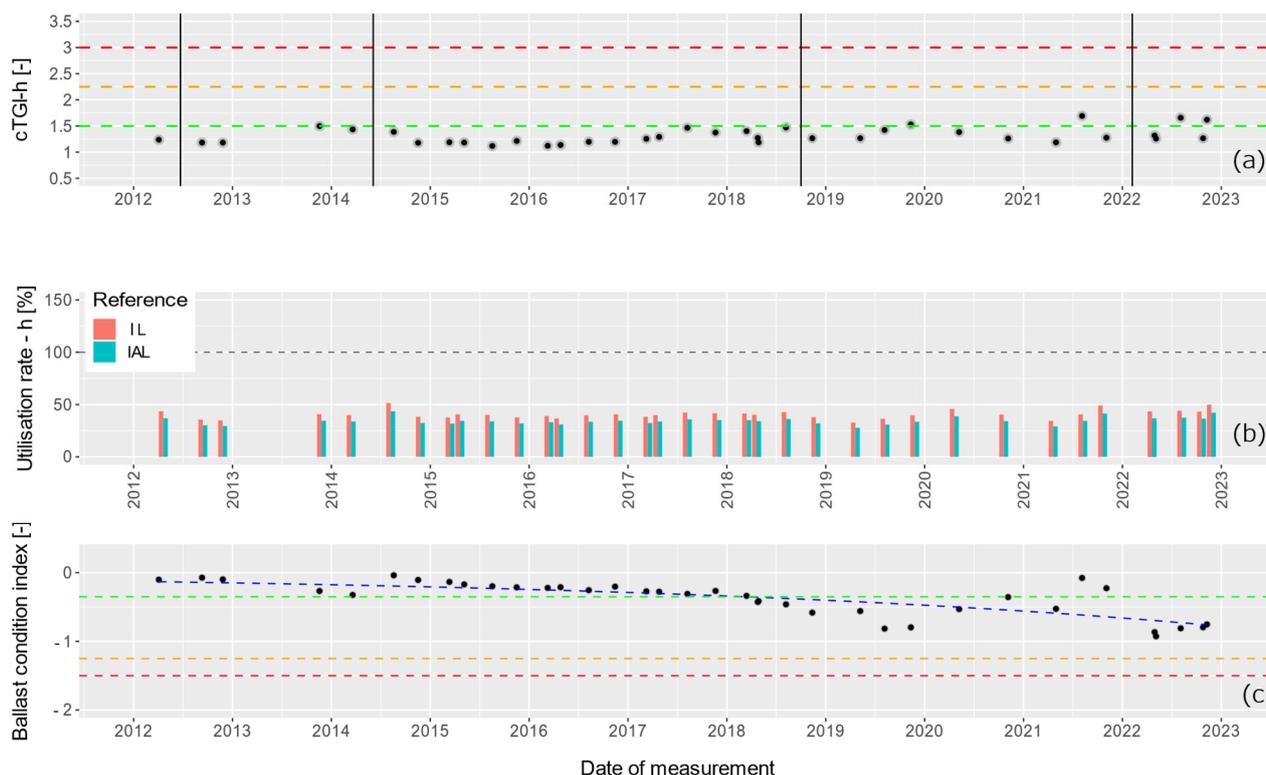
Figure 3. Cumulative track geometry index (horizontal) (a), utilisation rates (horizontal) for IL and IAL (b) and ballast condition index (c).

Two inferences can be made from the example. (1) The utilisation rarely reaches 50% over the entire measurement period so that limits are apparently not easily reached. The horizontal level therefore does not seem to be a critical parameter for the turnout under evaluation. (2) No clear deterioration of the horizontal level can be observed. Furthermore, tamping processes, which are clearly visible within the longitudinal level, do not seem to have any effect on the average horizontal level. However, as the quality of the horizontal level is good over the entire observation period, this is not a problem. Track geometry in the horizontal direction is also not a problem for the other turnouts analysed. For this reason, we will not include the horizontal quality parameters in the comparison. However, it is to be expected that these parameters be relevant for some other, presumably older, turnouts.

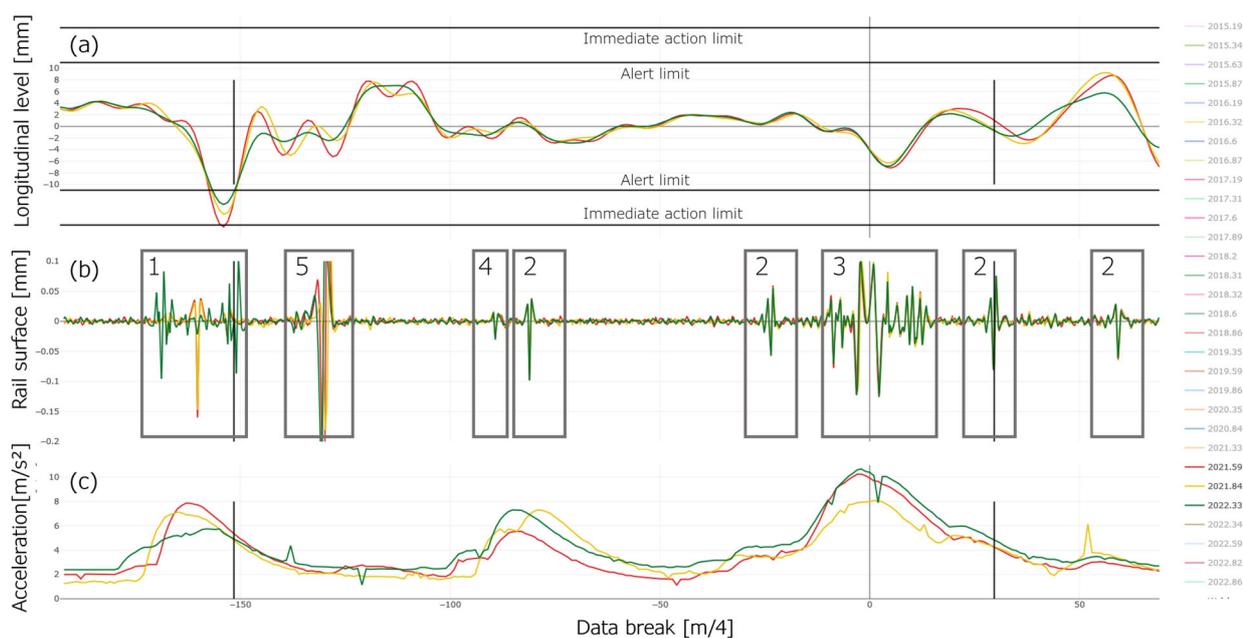
Figure 4. Longitudinal level (a), rail surface (b) and axle-box accelerations (c).

The figure is divided into the representation of the longitudinal level (a), rail surface (b) and axle-box acceleration (c). In practical use, it is useful to show and hide measurement runs depending on the needs of the evaluation. In this example, three of the measurement runs are faded in. Measurement run 2021.59 (red line) is the one where the immediate intervention threshold was exceeded (as discussed for Figure 2a). From the raw data, the exact position of the failure can be determined at the transition area in front of the turnout. The following measurement run 2021.84 (orange line) shows that a local measure was taken at this point, and the isolated defect of track geometry was reduced. However, this was merely a local emergency measure. The third measurement run 2022.33 (green line) shows continuous tamping, which improves track geometry quality of the entire turnout. It is also obvious that a measure was taken at the insulated rail joint close to the critical failure, which is evident from the rail surface signal (Figure 4b).

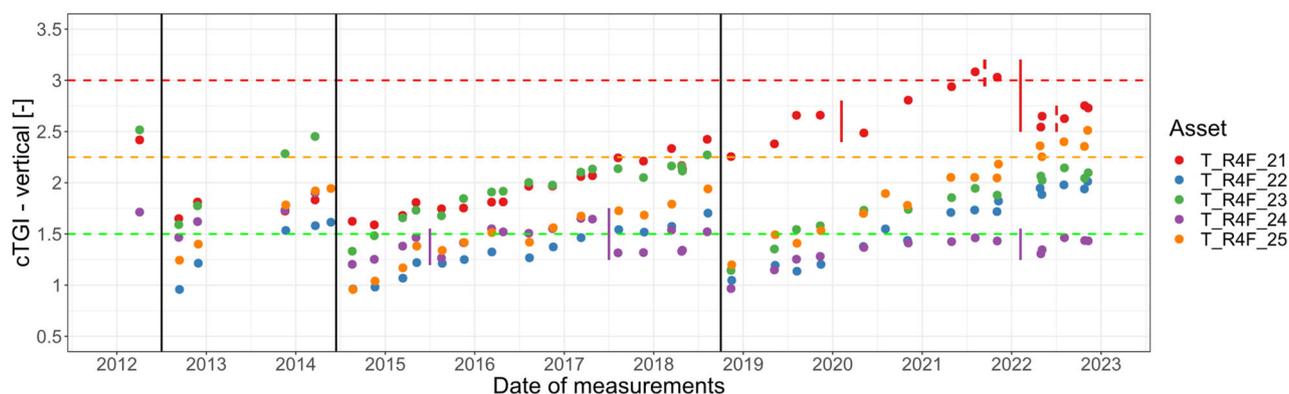
Figure 5. Development of the cumulative track geometry index—comparison of analysed turnouts.

The horizontal dashed lines represent the same quality levels as introduced in 2b. Maintenance actions affecting the track geometry are represented by vertical lines, with black lines representing the tamping of each turnout, coloured solid lines representing the tamping of the respective turnout and coloured dotted lines representing local actions at

critical spots. It can be seen that the average vertical track geometry of the turnouts behaves similar from 2012 to 2018.75. In the first years, track geometry deteriorates relatively quickly, but after tamping in 2014 quality of each turnout is good, and deterioration is also not excessive. A closer look at the period between 2014.5 and 2018.75 shows that two turnouts behave slightly worse than the others, namely T_R4F_21 and T_R4F_23. Their average track geometry is at a slightly higher level, and their deterioration rates are also slightly higher. Considering the daily load shown in Figure 1, this is not surprising as it is higher for these turnouts than for T_R4F_22 and T_R4F_25. However, it is surprising that T_R4F_24, which has a similar daily load to T_R4F_21/23, behaves better than T_R4F_22/25. When looking at the evolution of T_R4F_24, improvements can be seen in 2015.5 and 2017.5. Using interactive raw data visualisation confirms the assumption that there must have been additional tamping actions for this turnout. These actions cannot be explained with the available tools but do explain the quality behaviour of T_R4F_24.

Due to tamping work at the end of 2018, track geometry of all turnouts besides T_R4F_21, but especially that of T_R4F_23, could be brought back to a good quality. Since then, T_R4F_21 has behaved significantly worse than the other turnouts. Even an additional tamping task in 2020 could not solve the problem. Only after a tamping task in 2022.0 could track geometry of T_R4F_21 be slightly improved. Nevertheless, the average quality of T_R4F_21 is still worse than the quality of the other turnouts. Looking at utilisation rates and twist values improves the understanding of the described development. Figure 6 shows maximum twist values over time for the turnouts examined.

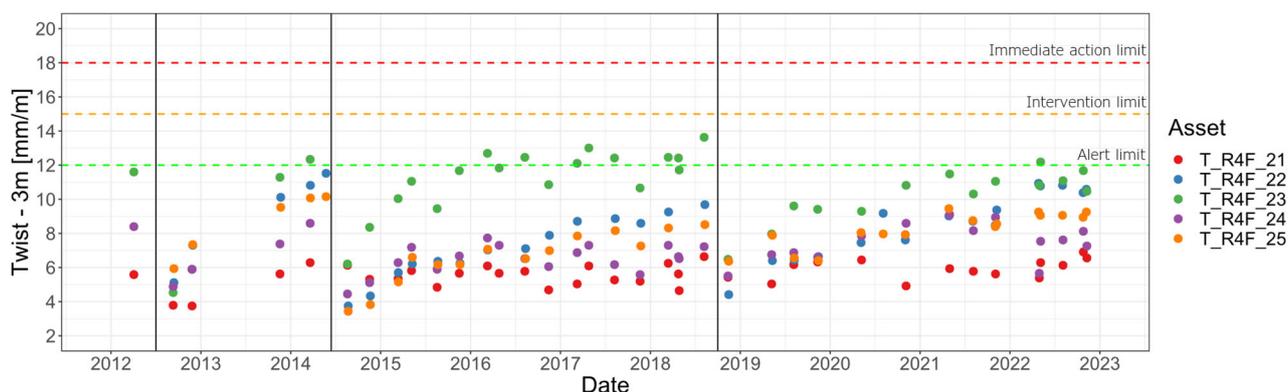
Figure 6. Development of maximal twist failure.

By including twist failures, it becomes clear why the average track geometry of turnout T_R4F_21 and turnout T_R4F_23 behaved similarly before 2018 and differently after tamping in 2018. For T_R4F_23, twist was the main problem until 2018; the alert limit was reached here. By eliminating the twist error in 2018, the main cause of poor track geometry was removed, and therefore average track geometry has improved significantly and sustainably. T_R4F_21, on the other hand, was not a problem for track workers in 2018, and no limits were reached. This is also confirmed by the utilisation rates, which are summarised in Table 1.

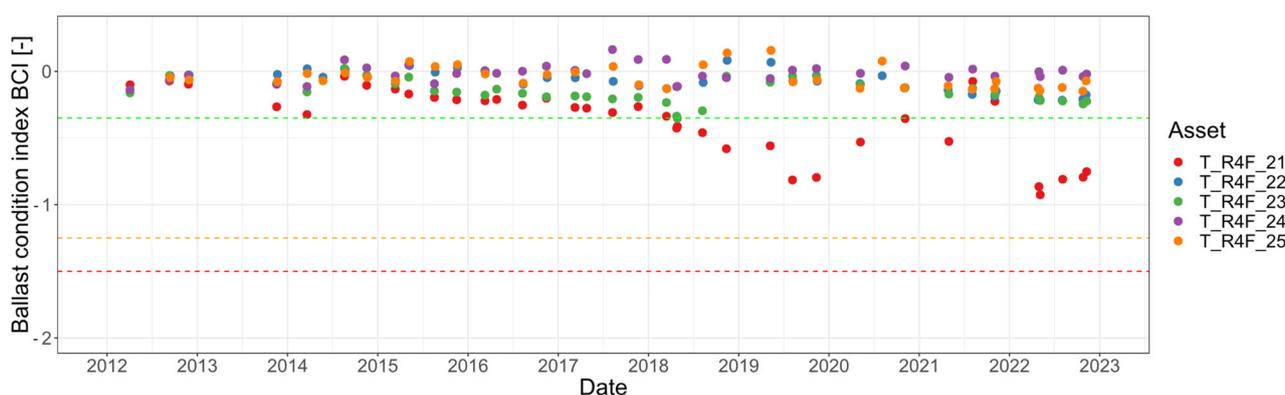
Figure 7. Ballast condition index; comparison of the analysed turnouts.

Horizontal dashed lines within the figure describe the quality areas described in chapter 2.1.2. While the indicators for the other turnouts are above the green line, the plot clearly shows that the ballast of T_R4F_21 has shown anomalies since 2018. This corresponds exactly to the previously analysed behaviour of track geometry, as problems at the turnout have been visible since 2018. The poor ballast condition explains both higher deterioration rates of track geometry and low effectiveness of tamping measures. As the turnout is relatively young and the trend of ballast deterioration is exponential, a solution to the problem cannot be achieved by tamping measures alone. The author's recommendation is to carry out ballast cleaning and thus stabilise system behaviour. However, consideration must be given to the cause of rapid ballast deterioration.

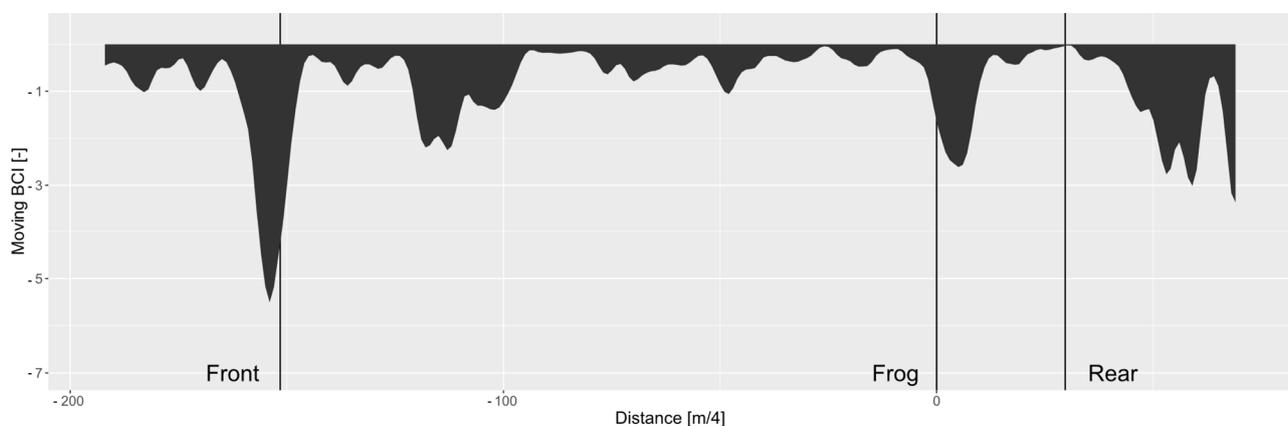
Figure 8. Sliding calculation of the ballast condition index.

Four critical areas can be identified with especially poor ballast condition. (1) The area around the crossing nose, (2) the transition zone in front of the turnout, (3) the transition zone to the rear of the turnout and (4) a spot within the switch panel of the turnout. Area 2 has the most serious problem and is therefore discussed in detail. Figure 9 contains footage from the ÖBB track component video and shows the transition area in front of the turnout.

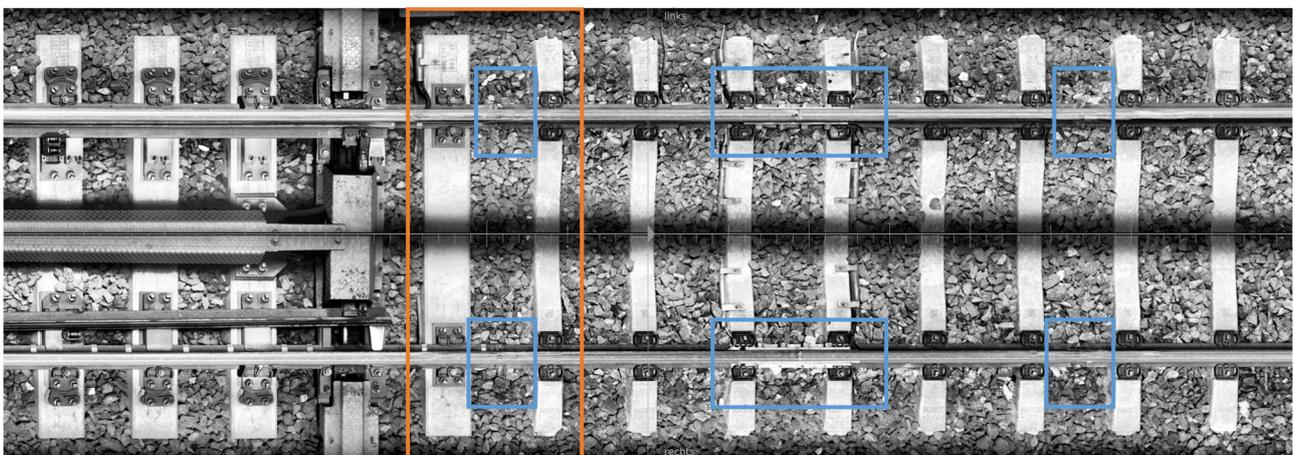
Figure 9. Transition area of turnout T_R4F_21.

The track component video shows two possible causes for a rapid degradation of the ballast: (1) a change in sleeper geometry with a corresponding change in system stiffness (orange rectangle) and (2) an insulated rail joint with its associated welds (blue rectangles), for each rail. One of the welds is located directly at the transition zone from track sleepers to turnout sleepers. The condition of the insulated rail joint can be evaluated with the rail surface signal.

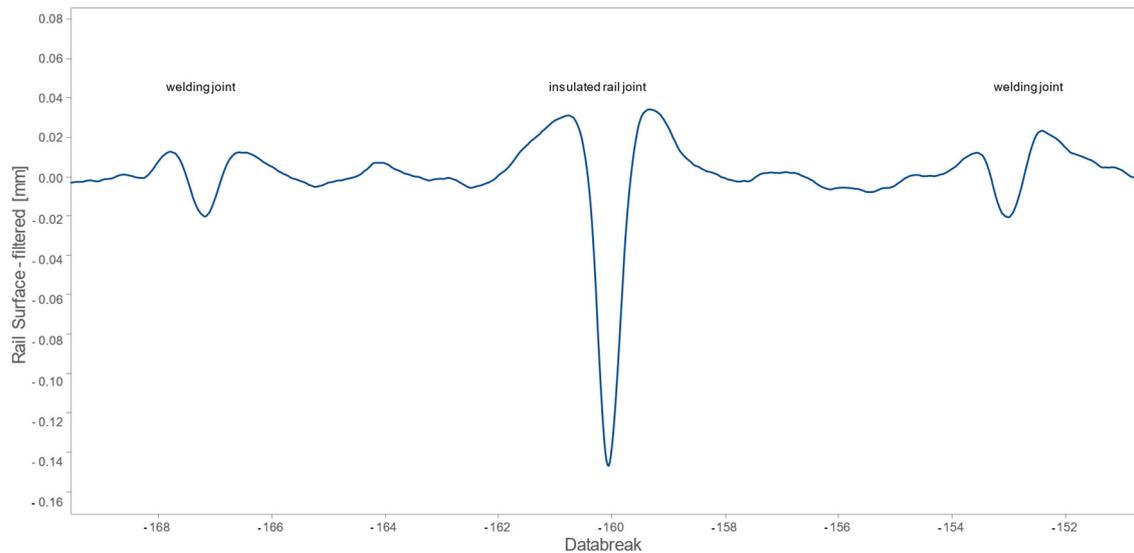
Figure 10 shows the typical characteristics of the filtered rail surface signal of an insulated rail joint and the welding joints of one measurement run. In this case, the insulated rail joint is already well worn.

Figure 10. Typical characteristics of an insulated rail joint in the rail surface signal.

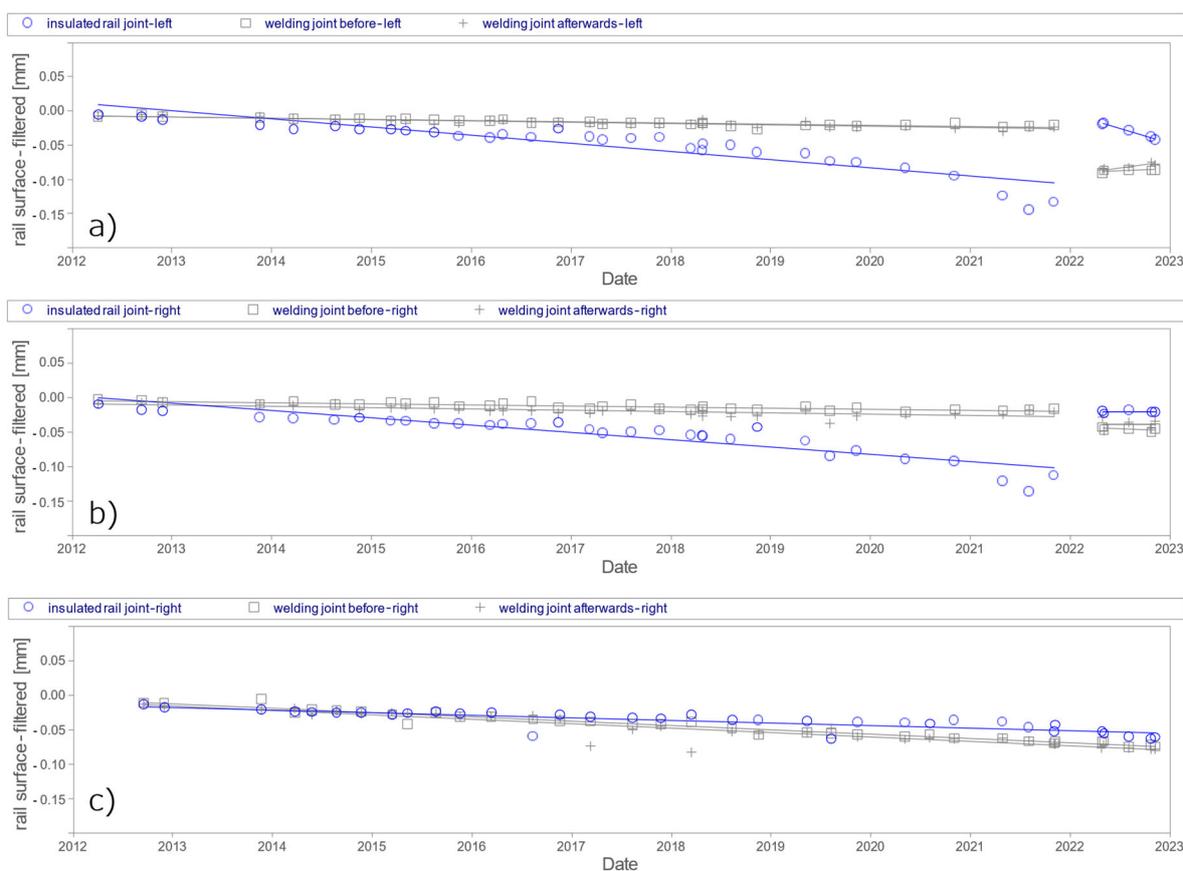
Figure 11. Time series of insulated rail joint T_R4F_21 left (a), T_R4F_21 right (b) and T_R4F_25 (c).

When looking at the time series, it can be seen that in 2022 the insulated rail joints at T_R4F_21 were exchanged, which led to a jump in the trend. It can also be noted that the insulated rail joints at T_R4F_21 behave worse (Figure 11a,b) than at T_R4F_25 (Figure 11c). This is verifiable using the gradient of the linear regression, which is considered as the deterioration rate of the joints. Table 2 includes these rates for the period before and after the exchange of the joints at T_R4F_21.

In the period before the exchange, the rates are about 3 times as high for the insulated rail joints at T_R4F_21 as for those at T_R4F_25. Furthermore, after the exchange, the right joint of the first turnout has virtually no deterioration, while the rate of the left joint is nearly 4 times as high as before. Why the left insulated rail joint behaves in this way is not clear from the data available. But it can be said that it will soon lead to necessary maintenance works or even to another exchange of the joint.

In addition, it is noticeable in the time series of Figure 11 a,b that the welding joints are in a worse condition after the exchange. This poor condition probably derives from welding work itself. By looking at the welding joints in Figure 9, grinding marks on the rails above the welding joints are visible. They most likely result from grinding by hand, which left the rail surface in bad condition.
