# Quality Behaviour of Turnouts: Comparison, Problem Specification and Recommendation of Measures

**Abstract:** For future requirements, asset management of turnouts needs to rely on data-based assessment tools. These tools must enable the quantification of quality behaviour of turnouts and identify causes of poor behaviour. In this paper, we provide a toolbox addressing these requirements. We use track geometry as the main criterion for quality behaviour in combination with additional indicators, each associated with a different component, to understand turnout performance. The toolbox is applied to five similar turnouts to compare their performance. It is revealed that one of the turnouts performs significantly worse than the others. A deeper analysis can identify worn ballast in several areas of the turnout as the cause of poor performance. Problems in the ballast bed can be attributed to worn insulated rail joints as well as to stiffness changes in the transition areas of the turnout.

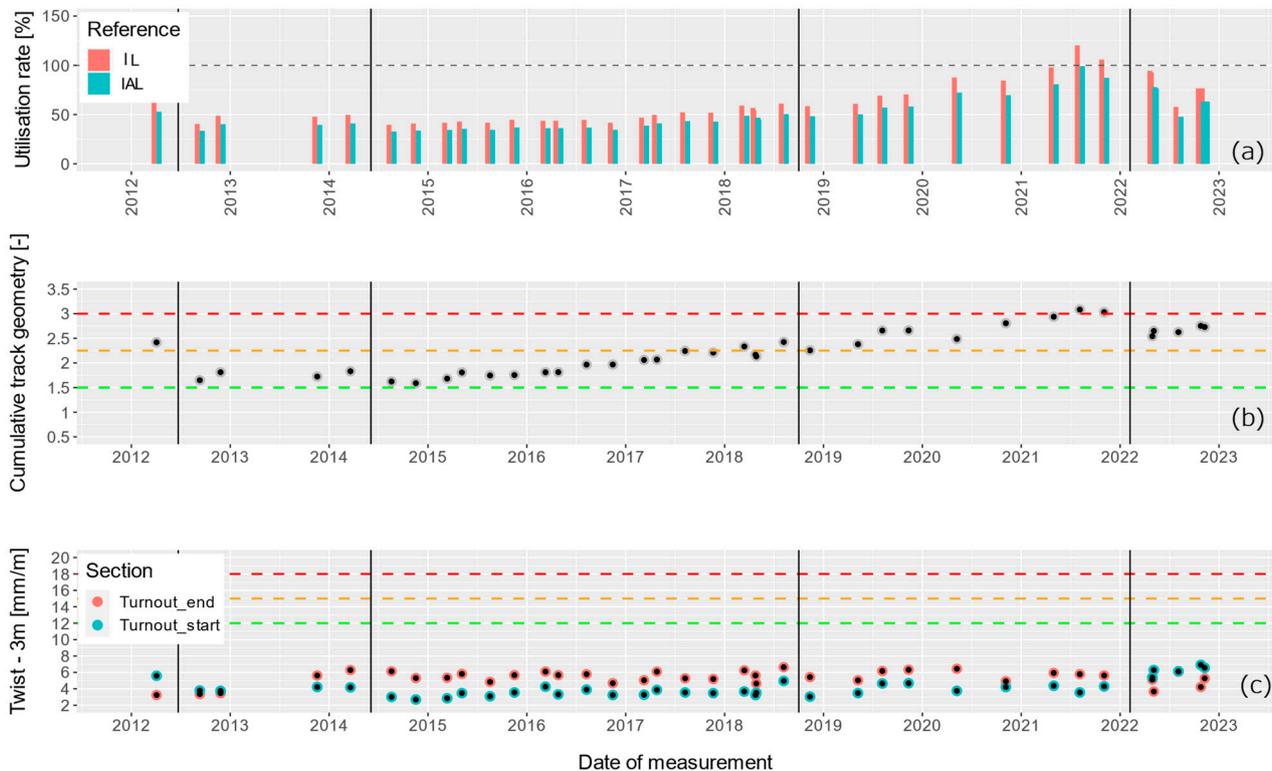
As the turnout was renewed in 2011, the x-axis of the plot starts there. The index (grey dots) increases over time, reflecting deterioration of track geometry due to wear and tear. The coloured horizontal lines reflect quality ranges from excellent (green) to poor (red). These limits are an average over the turnouts analysed so far and are neither finalised nor directly linked to intervention recommendations. Nevertheless, solid approximations can be made with this classification. Vertical lines reflect tamping interventions carried out in the past. Some of these tamping measures have been documented in a database of ÖBB, while others have been detected by signal features using an algorithm developed for this purpose. Details on the detection algorithm can be taken from [31].

and are restored by tamping. In 2021.6, even a utilisation of 100% (grey dashed line) is reached for this turnout, which means that the IAL has been exceeded there. Subsequently, an immediate measure has ensured continued safe operation.

**Figure 2.** Utilisation rates for IL and IAL (a), cumulative track geometry index (b) and twist values (c) of turnout T\_R4F\_21.

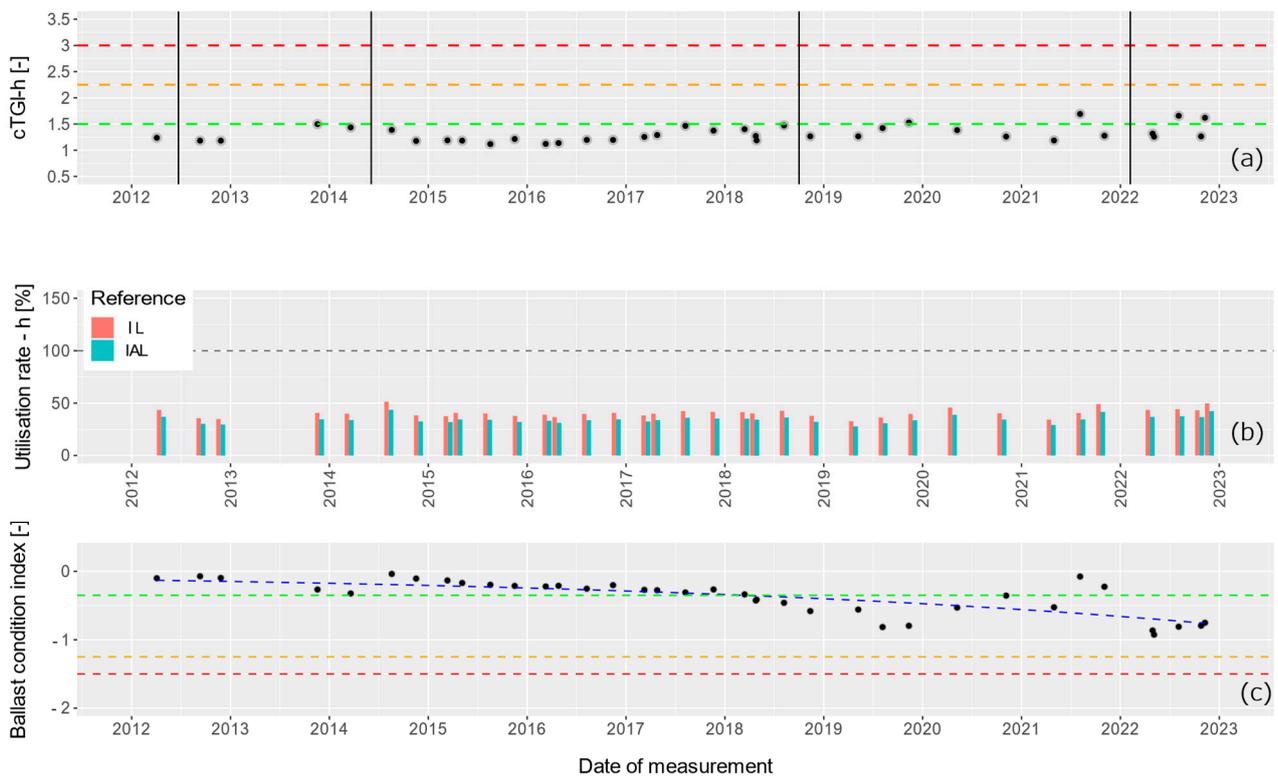
Two inferences can be made from the example. (1) The utilisation rarely reaches 50% over the entire measurement period so that limits are apparently not easily reached. The horizontal level therefore does not seem to be a critical parameter for the turnout under evaluation. (2) No clear deterioration of the horizontal level can be observed. Furthermore, tamping processes, which are clearly visible within the longitudinal level, do not seem to have any effect on the average horizontal level. However, as the quality of the horizontal level is good over the entire observation period, this is not a problem. Track geometry in the horizontal direction is also not a problem for the other turnouts analysed. For this reason, we will not include the horizontal quality parameters in the comparison. However, it is to be expected that these parameters be relevant for some other, presumably older, turnouts.

**Figure 3.** Cumulative track geometry index (horizontal) (a), utilisation rates (horizontal) for IL and IAL (b) and ballast condition index (c).

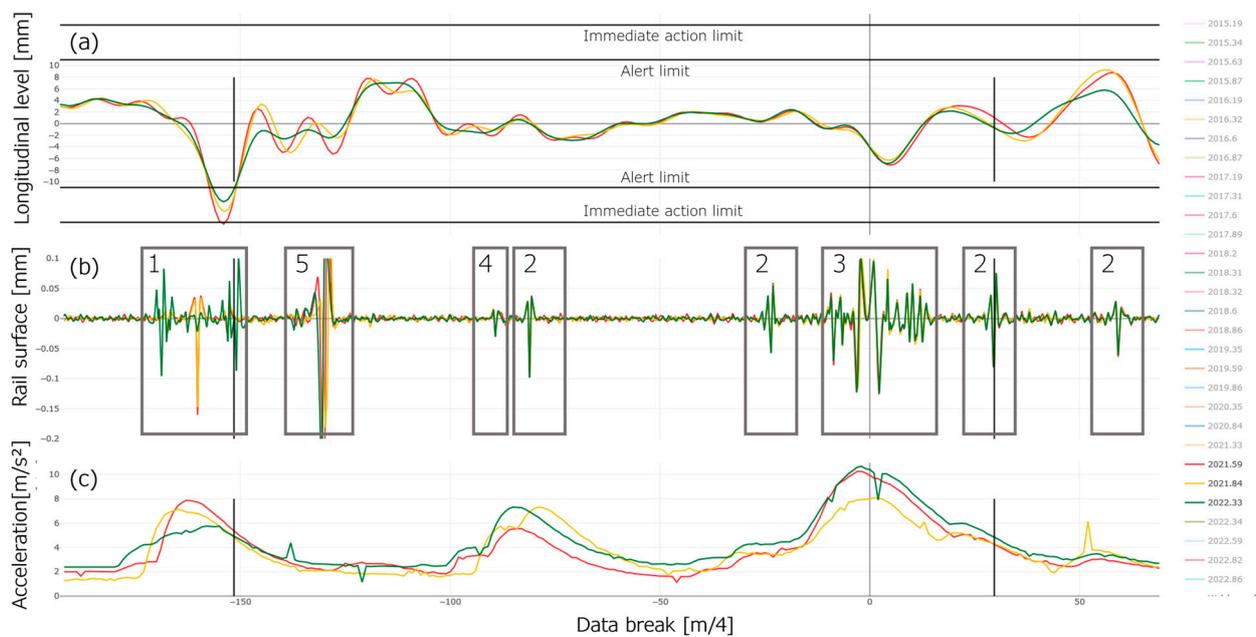
**Figure 4.** Longitudinal level (a), rail surface (b) and axle-box accelerations (c).

runs are faded in. Measurement run 2021.59 (red line) is the one where the immediate intervention threshold was exceeded (as discussed for Figure 2a). From the raw data, the exact position of the failure can be determined at the transition area in front of the turnout. The following measurement run 2021.84 (orange line) shows that a local measure was taken at this point, and the isolated defect of track geometry was reduced. However, this was merely a local emergency measure. The third measurement run 2022.33 (green line) shows continuous tamping, which improves track geometry quality of the entire turnout. It is also obvious that a measure was taken at the insulated rail joint close to the critical failure, which is evident from the rail surface signal (Figure 4b).

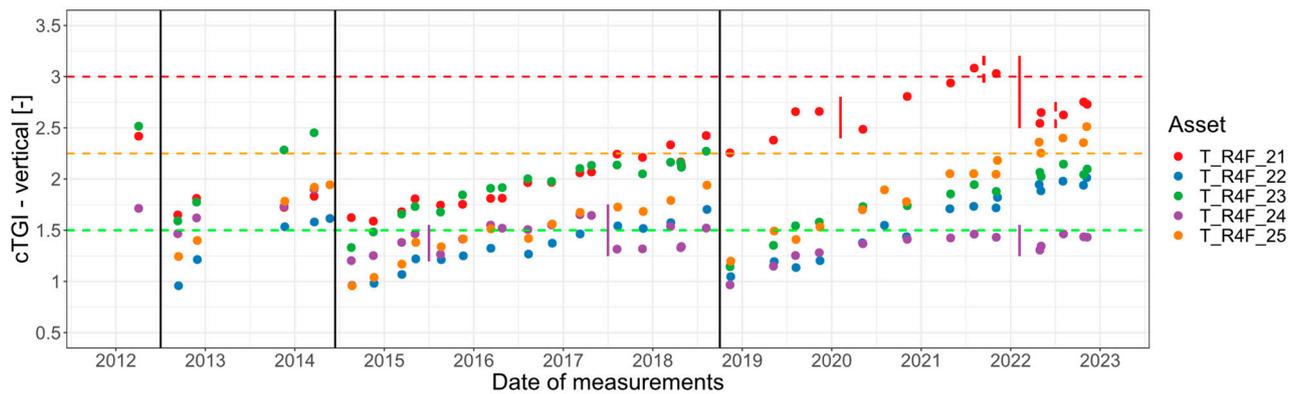
**Figure 5.** Development of the cumulative track geometry index—comparison of analysed turnouts.

The horizontal dashed lines represent the same quality levels as introduced in Figure 2b. Maintenance actions affecting the track geometry are represented by vertical lines, with black lines representing the tamping of each turnout, coloured solid lines representing the tamping of the respective turnout and coloured dotted lines representing local actions at critical spots. It can be seen that the average vertical track geometry of the turnouts behaves similar from 2012 to 2018.75. In the first years, track geometry deteriorates relatively quickly, but after tamping in 2014 quality of each turnout is good, and deterioration is also not excessive. A closer look at the period between 2014.5 and 2018.75 shows that two turnouts behave slightly worse than the others, namely T\_R4F\_21 and T\_R4F\_23. Their average track geometry is at a slightly higher level, and their deterioration rates are also slightly higher. Considering the daily load shown in Figure 1, this is not surprising as it is higher for these turnouts than for T\_R4F\_22 and T\_R4F\_25. However, it is surprising that T\_R4F\_24, which has a similar daily load to T\_R4F\_21/23, behaves better than T\_R4F\_22/25. When looking at the evolution of T\_R4F\_24, improvements can be seen in 2015.5 and 2017.5. Using interactive raw data visualisation confirms the assumption that there must have been additional tamping actions for this turnout. These actions cannot be explained with the available tools but do explain the quality behaviour of T\_R4F\_24.

Due to tamping work at the end of 2018, track geometry of all turnouts besides T\_R4F\_21, but especially that of T\_R4F\_23, could be brought back to a good quality. Since then, T\_R4F\_21 has behaved significantly worse than the other turnouts. Even an additional tamping task in 2020 could not solve the problem. Only after a tamping task in 2022.0 could track geometry of T\_R4F\_21 be slightly improved. Nevertheless, the average quality of T\_R4F\_21 is still worse than the quality of the other turnouts. Looking at utilisation rates and twist values improves the understanding of the described development. Figure 6 shows maximum twist values over time for the turnouts examined.

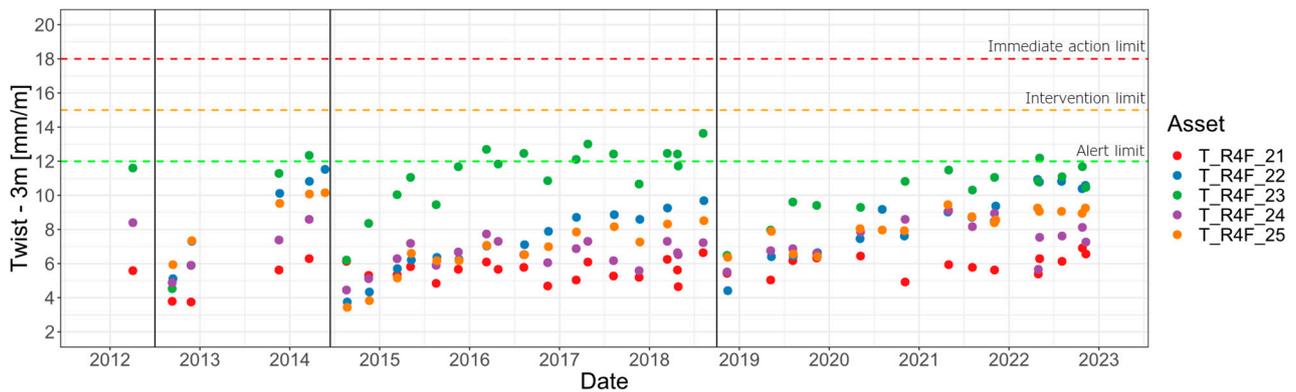
Figure 6. Development of maximal twist failure.

By including twist failures, it becomes clear why the average track geometry of turnout T\_R4F\_21 and turnout T\_R4F\_23 behaved similarly before 2018 and differently after tamping in 2018. For T\_R4F\_23, twist was the main problem until 2018; the alert limit was reached here. By eliminating the twist error in 2018, the main cause of poor track geometry was removed, and therefore average track geometry has improved significantly and sustainably. T\_R4F\_21, on the other hand, was not a problem for track workers in 2018, and no limits were reached. This is also confirmed by the utilisation rates, which are summarised in Table 1.

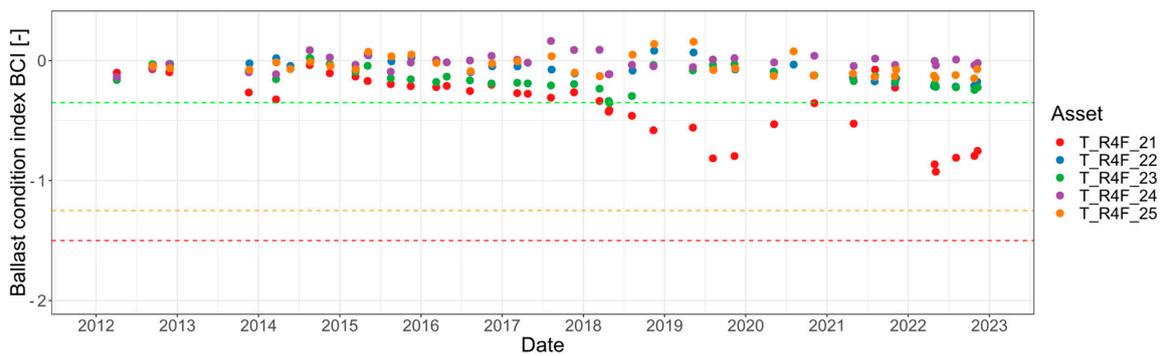
Figure 7. Ballast condition index; comparison of the analysed turnouts.

Horizontal dashed lines within the figure describe the quality areas described in chapter 2.1.2. While the indicators for the other turnouts are above the green line, the plot clearly shows that the ballast of T\_R4F\_21 has shown anomalies since 2018. This corresponds exactly to the previously analysed behaviour of track geometry, as problems at the turnout have been visible since 2018. The poor ballast condition explains both higher deterioration rates of track geometry and low effectiveness of tamping measures. As the turnout is relatively young and the trend of ballast deterioration is exponential, a solution to the problem cannot be achieved by tamping measures alone. The author’s recommendation is to carry out ballast cleaning and thus stabilise system behaviour. However, consideration must be given to the cause of rapid ballast deterioration.

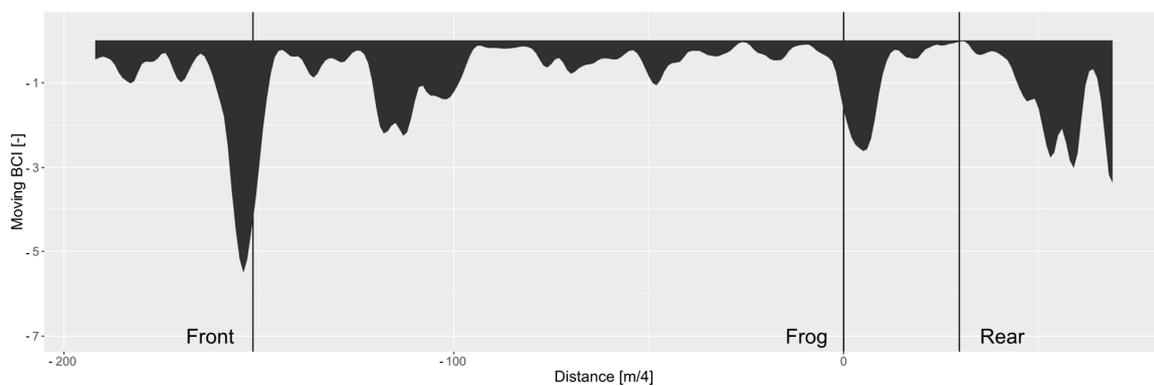
Figure 8. Sliding calculation of the ballast condition index.

Four critical areas can be identified with especially poor ballast condition. (1) The area around the crossing nose, (2) the transition zone in front of the turnout, (3) the transition zone to the rear of the turnout and (4) a spot within the switch panel of the turnout. Area 2 has the most serious problem and is therefore discussed in detail. Figure 9 contains footage from the ÖBB track component video and shows the transition area in front of the turnout.

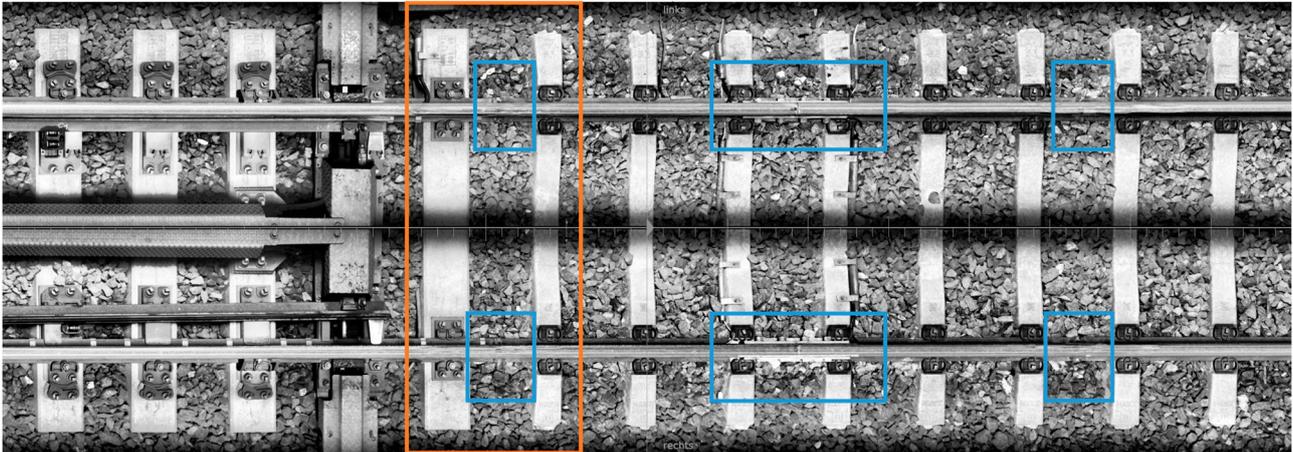
**Figure 9.** Transition area of turnout T\_R4F\_21.

The track component video shows two possible causes for a rapid degradation of the ballast: (1) a change in sleeper geometry with a corresponding change in system stiffness (orange rectangle) and (2) an insulated rail joint with its associated welds (blue rectangles), for each rail. One of the welds is located directly at the transition zone from track sleepers to turnout sleepers. The condition of the insulated rail joint can be evaluated with the rail surface signal.

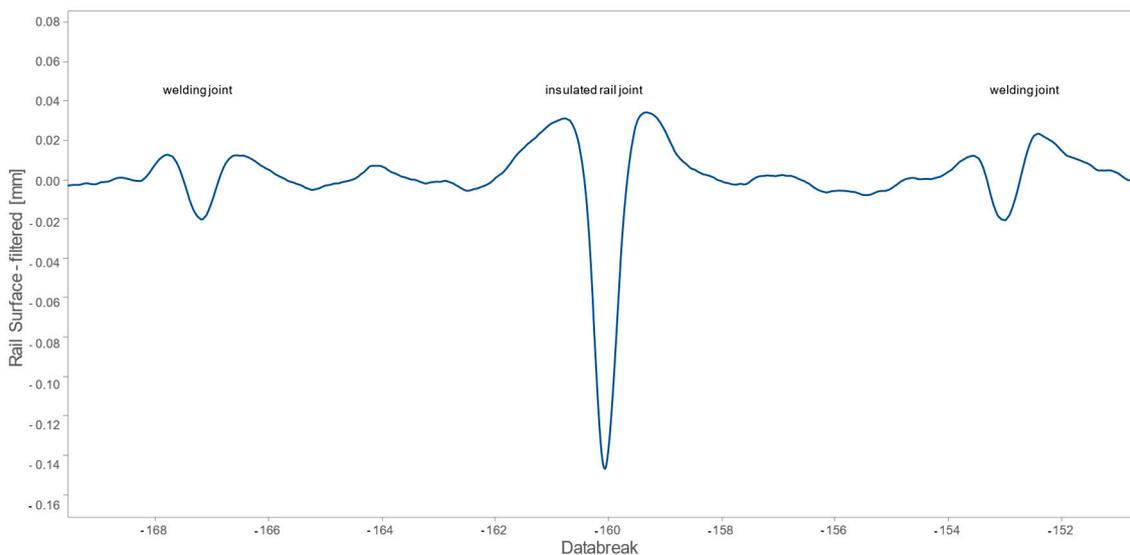
Figure 10 shows the typical characteristics of the filtered rail surface signal of an insulated rail joint and the welding joints of one measurement run. In this case, the insulated rail joint is already well worn.

**Figure 10.** Typical characteristics of an insulated rail joint in the rail surface signal.

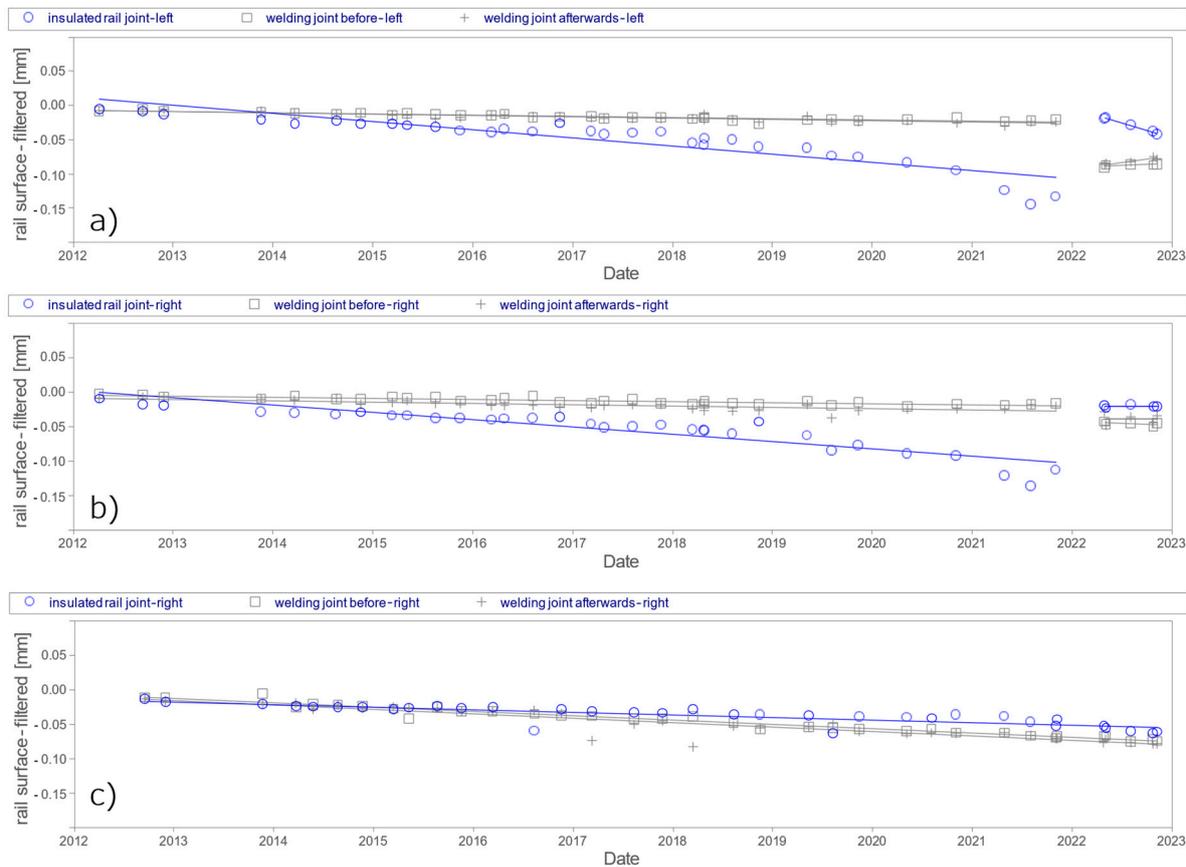
**Figure 11.** Time series of insulated rail joint T\_R4F\_21 left (a), T\_R4F\_21 right (b) and T\_R4F\_25 (c).

When looking at the time series, it can be seen that in 2022 the insulated rail joints at T\_R4F\_21 were exchanged, which led to a jump in the trend. It can also be noted that the insulated rail joints at T\_R4F\_21 behave worse (Figure 11a,b) than at T\_R4F\_25 (Figure 11c). This is verifiable using the gradient of the linear regression, which is considered as the deterioration rate of the joints. Table 2 includes these rates for the period before and after the exchange of the joints at T\_R4F\_21.

In the period before the exchange, the rates are about 3 times as high for the insulated rail joints at T\_R4F\_21 as for those at T\_R4F\_25. Furthermore, after the exchange, the right joint of the first turnout has virtually no deterioration, while the rate of the left joint is nearly 4 times as high as before. Why the left insulated rail joint behaves in this way is not clear from the data available. But it can be said that it will soon lead to necessary maintenance works or even to another exchange of the joint.

In addition, it is noticeable in the time series of Figure 11a,b that the welding joints are in a worse condition after the exchange. This poor condition probably derives from welding work itself. By looking at the welding joints in Figure 9, grinding marks on the rails above the welding joints are visible. They most likely result from grinding by hand, which left the rail surface in bad condition.
