# Analysis of Unexpected Leaks in AISI 316L Stainless Steel Pipes Used for Water Conduction in a Port Area

**Abstract:** This paper clarifies the causes of a corrosion process observed in austenitic stainless-steel pipes, grade 316L, used for conducting freshwater in a port area. During the pressure test of the installation, before it was put into service, about five months after its construction, a loss of pressure was detected due to leaks of the fluid contained and the presence of corrosion damage on the wall of the tubes, in some cases even passing through the thickness of the tube. An analysis of the chemical composition of the pipe material was carried out, as well as semi-quantitative analysis of the chemical composition of the deposits in the defects, and a culture of sulfate-reducing bacteria (SRB) in Kliguer medium of the stagnant waters within the facility. All this makes it possible to conclude that the observed process fits within the so-called microbiologically induced corrosion (MIC), and, in all probability, it can be affirmed that this process is promoted by the presence and proliferation of sulfate-reducing bacteria (SRB).

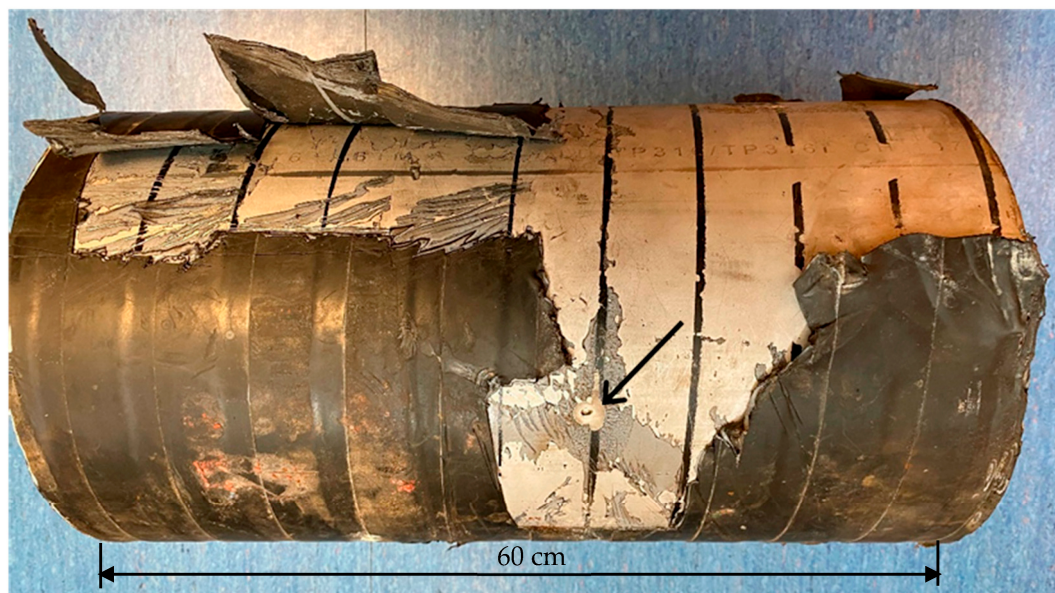
In order to clarify the causes of the aforementioned corrosion phenomenon in the AISI 316L stainless steel port piping facility, one 0.6 m long section of the pipe, shown in Figure 1, was extracted from the system. This section contains clear evidence of the commented processes, including a through-wall pitting. Additionally, as it can be observed, for better protection, the pipes were covered with a 0.3 mm thick rubber coating glued to the external surface, which had to be removed for the subsequent analysis trying not to damage the outer face in case it needed to be inspected.

**Figure 1.** Sample of pipe extracted from the port piping system; a through-wall pitting can be observed in the center (black arrow).

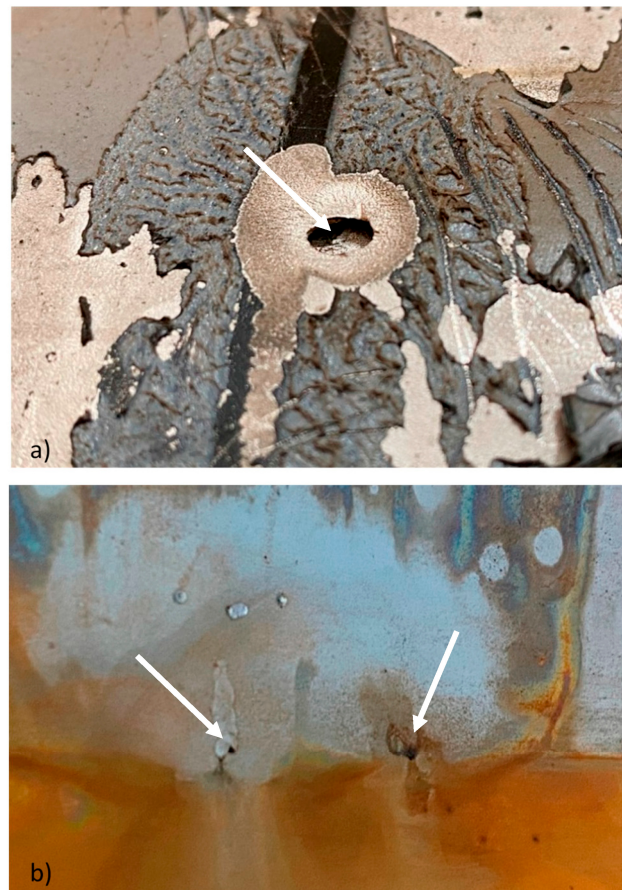
**Figure 2.** Through-wall pitting in the sample. (a) Through-wall pitting in the sample, outer face; (b) through-wall pitting and other pitting onsets, inner face of the sample. The arrows indicate the observed pits.

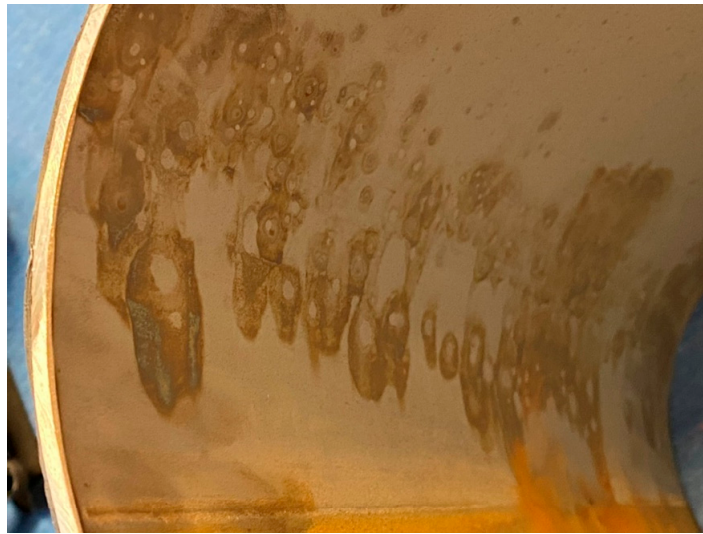
These defects, as shown in Figure 3, are present to different degrees along the whole inner wall of the sample; however, as observed in Figure 4, they were mainly located in the zone covered by the stagnant water and in a belt just above it, but only on one side. It is noteworthy that the same pattern seems to be observed in all these pitting initiations: pitting surrounded by “clean” material (i.e., non-corroded stainless-steel tone) that extends to an outermost surface crown with evidence of oxidation.

**Figure 3.** Multiple pitting onsets on the inside of the tube.

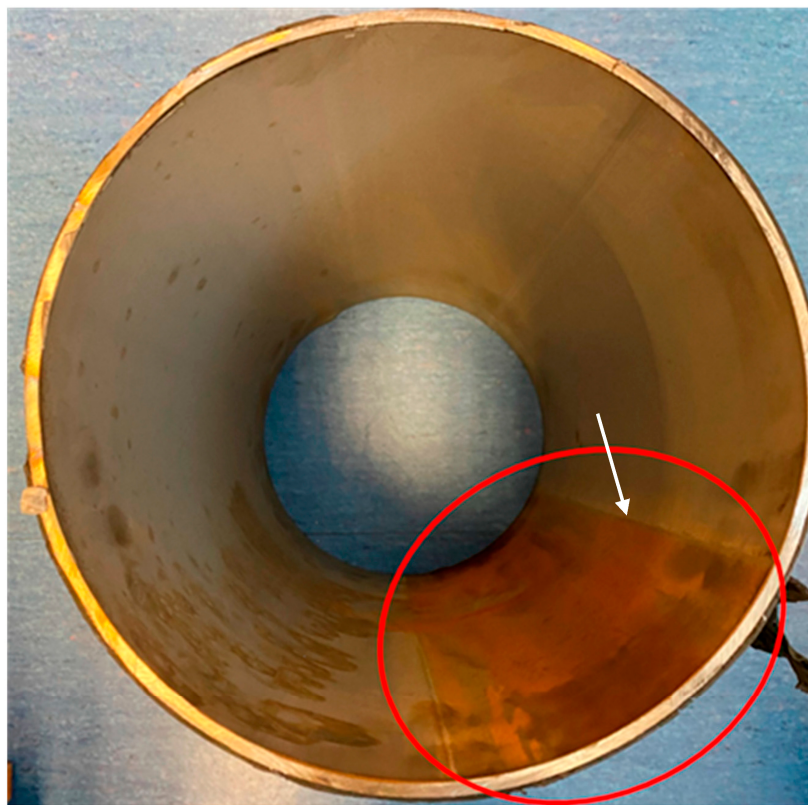
Additionally, in the inner surface of the tube, the signs of corrosion products are evident, characterized by a reddish tone. These corrosion products are deposited in a sector of the pipe (see Figure 4) which may be indicative of an existing (stagnant) water level inside the pipe during some period of the process from the installation to the pressure test.

**Figure 4.** Area (red ellipse) with deposits of reddish corrosion products; inner face of the tube. The arrow indicates a straight line identified as the level achieved by the stagnant water.

The analysis performed here also allows different recommendations to be provided in order to avoid similar problems. The main one consists of avoiding the presence of stagnant water in the system, given that this is the final cause of the MIC corrosion process. Additionally, other alternatives, such as the use of inhibitors, could be considered, as it has been successfully applied in other corrosive contexts (e.g., [35,36]).

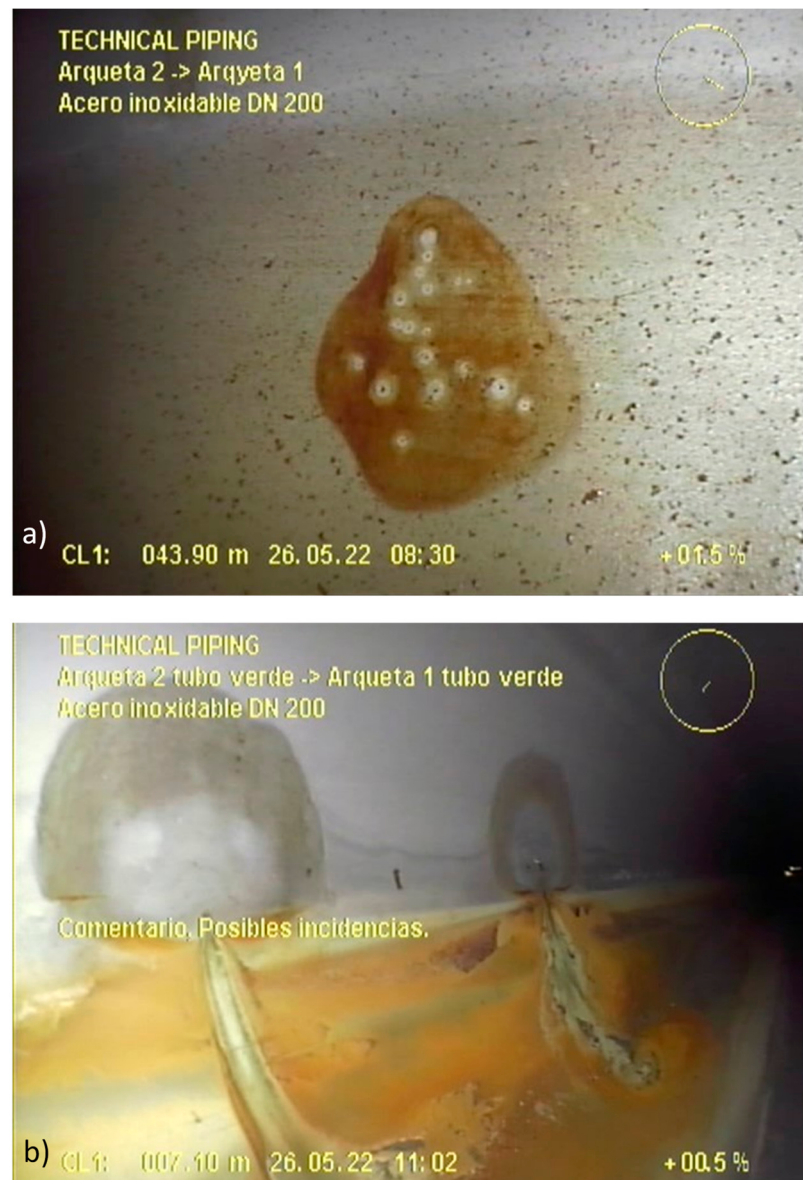
Figure 5 shows examples of the results of the inspections carried out. These records make it possible to verify that the corrosion was a very extended process, with a general

level of damage that can be classified as very advanced. Although it can be seen that the level of damage varies from one section to another, there does not seem to be any section of the piping system that is free of the corrosion process. In many of the pits observed (e.g., Figure 5b), a “mushroom-shaped” mark around the defect is evident. These marks may be due to the generation of gas during the corrosion process, which accumulates in pockets, bubbles, or tubercles around the defect and finally bursts (perhaps during the pressure test), leaving the aforementioned “mushroom-shaped” mark printed on the tube wall.

**Figure 5.** Video-inspection image of the interior of the piping system. (a) Detail of pitting; (b) detail of “mushroom-shaped” marks around two pits.

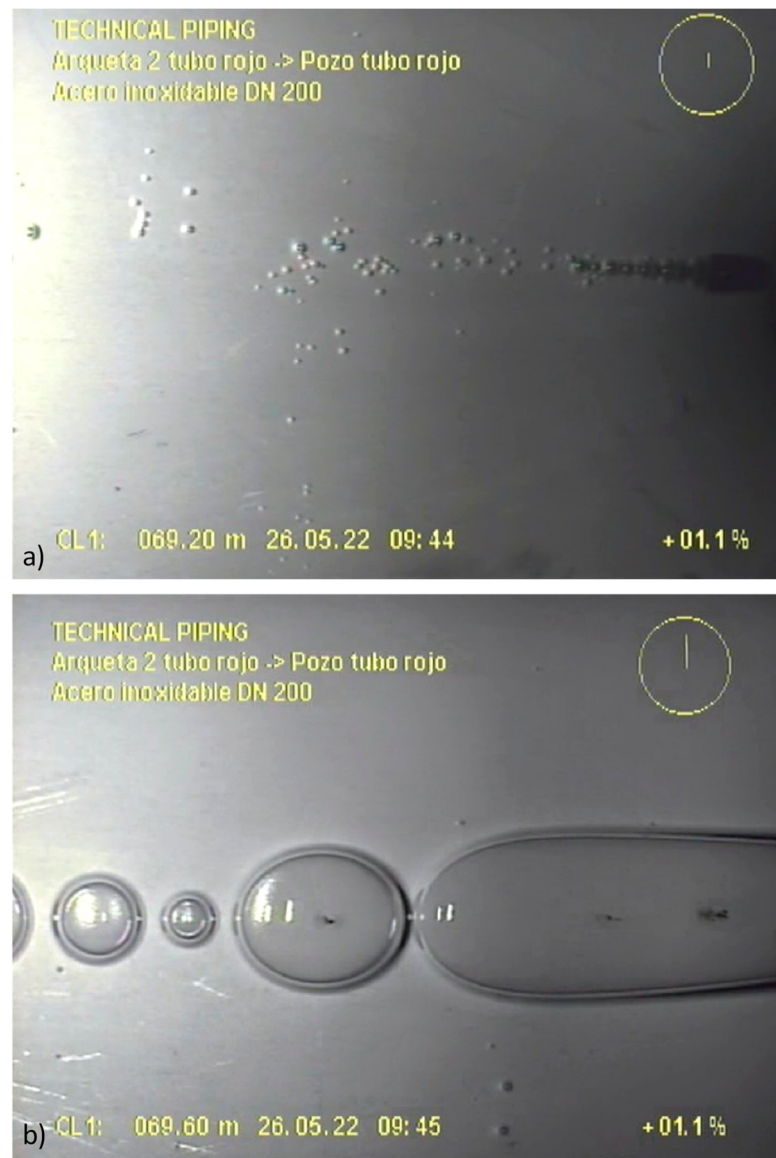
Supporting the previous observation, as presented in Figure 6, in some sequences of the inspection videos, the presence of gas bubbles attached to the inner surface of the pipe can be observed. Here, it is important to note that the figure shows images of parts of the piping system where the water level inside meant that the camera had to be submerged. A more detailed observation of these bubbles reveals the existence of a corrosion pitting in the center of each one of them, as presented in Figure 6b. At the same time, for there to be a separation between gas and water, the existence of a film or membrane that separates both media must be considered.

**Figure 6.** Video-inspection image of the interior of the piping system. (a) Gas bubbles; (b) detail of gas bubbles, right over some pitting defects.

H<sub>2</sub>S, probably corresponding to the gas pockets shown in Figure 6. This hydrogen sulfide can then be used by sulfur chemolithotrophic bacteria, which cannot be detected with the culture medium used in this case, and which oxidizes it, generating the acidification of the medium.

Sulfate-reducing bacteria (SRB) comprise several groups of bacteria that use sulfate (which in this case must be present in the water) as an oxidizing agent, reducing it to hydrogen sulfide  $H_2S$ , which is a gas with a high corrosive capacity. The process generally takes place under anaerobic conditions, favored by the formation of a sheet of biological material itself (biofilm) or other elements of the system (sludge, coatings, oils). The accumulation of  $H_2S$  gives rise to the formation of pockets [23], which justify the existence of bubbles and also tubers as the ones observed in Figure 6.

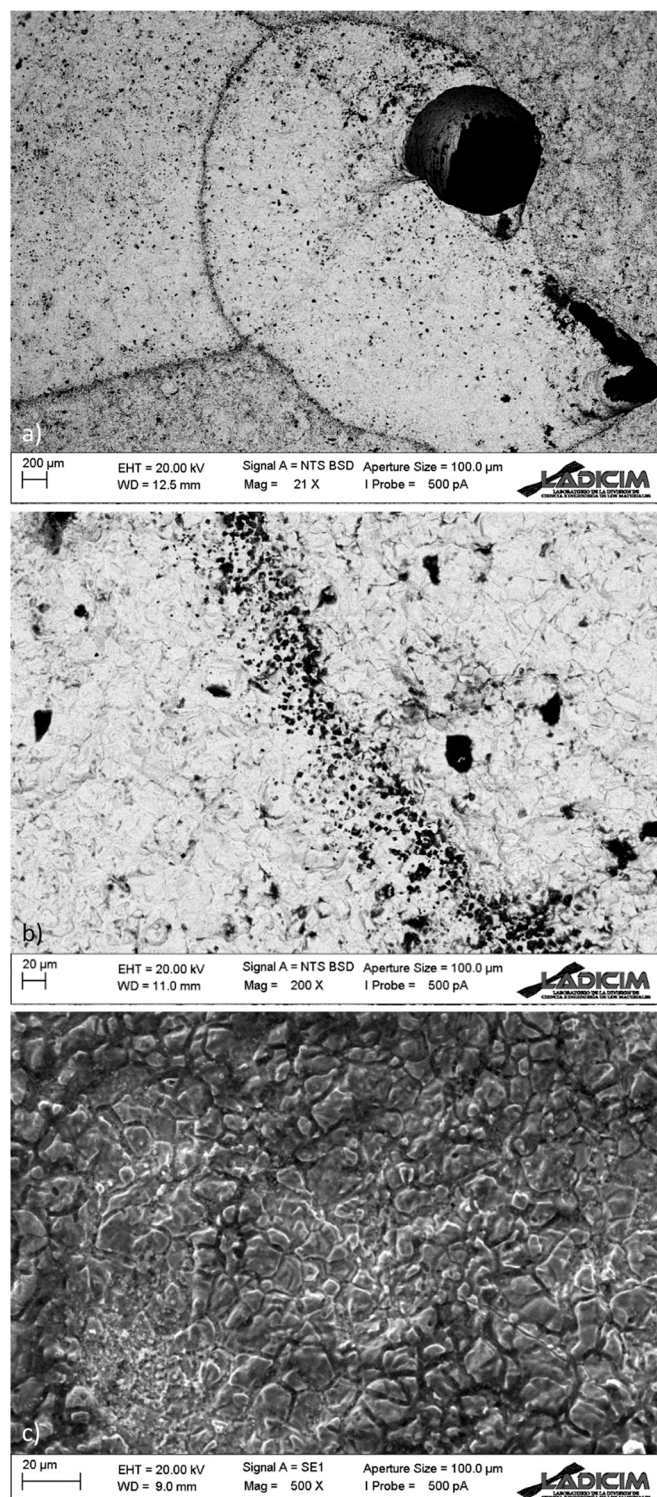
Figure 7a shows an image obtained by means of SEM of the through-wall pitting of the sample (inner face). In this image, the areas in which the process has advanced in depth, connecting with the outer surface, can be clearly distinguished. Additionally, a second region adjacent to the perforations can also be observed (see Figure 7b), where a loss of material was clear to the naked eye. In this region the tube has lost part of the surface material and grain boundaries are noticeable, pointing to a process that advances preferentially along such grain boundaries. Finally, Figure 7c shows an area attached to the through-wall pitting where no metal loss was observed by the naked eye, but where an advanced level of damage at grain boundaries can be seen through the SEM image, supporting the previous observation about the preferential attack at the grain boundaries.

**Figure 7.** (a) SEM image of a through-wall pitting on the inner face of the tube sample; (b) surrounding area with metal loss observed by naked eye; (c) surrounding area without metal loss to naked eye.

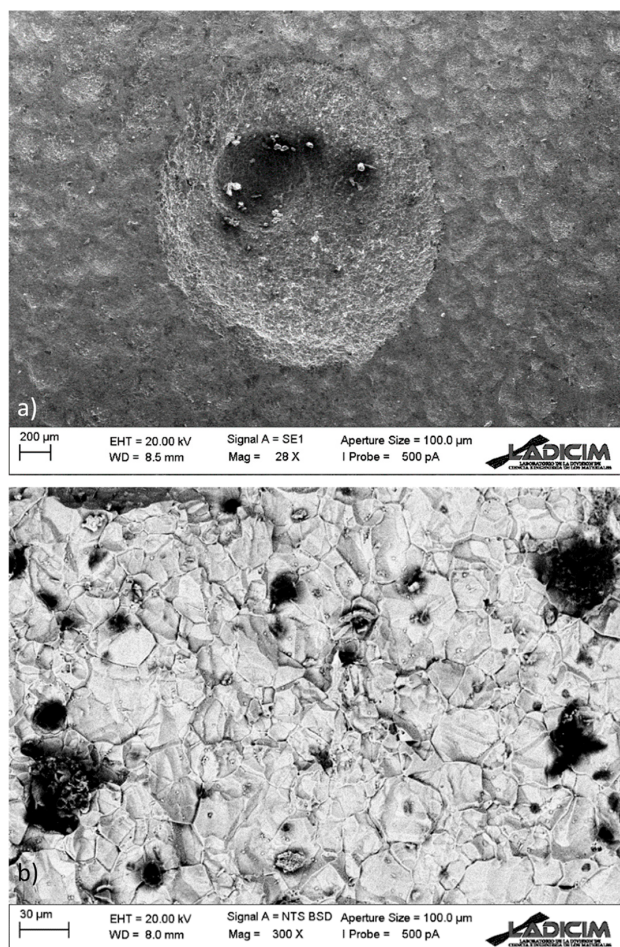
Meanwhile, Figure 8a presents another pitting from the second sub-sample, which is in an earlier stage of the process. It can be observed that it is not a through-wall pitting. In this case, the observation at higher magnification, shown in Figure 8b, makes it possible to once again confirm the existence of the same type of processes that advances preferentially through the grain boundaries.

**Figure 8.** (a) SEM image of a pitting in an early stage of the process on the inner face of the sample; (b) detail of the pitting in an early stage.

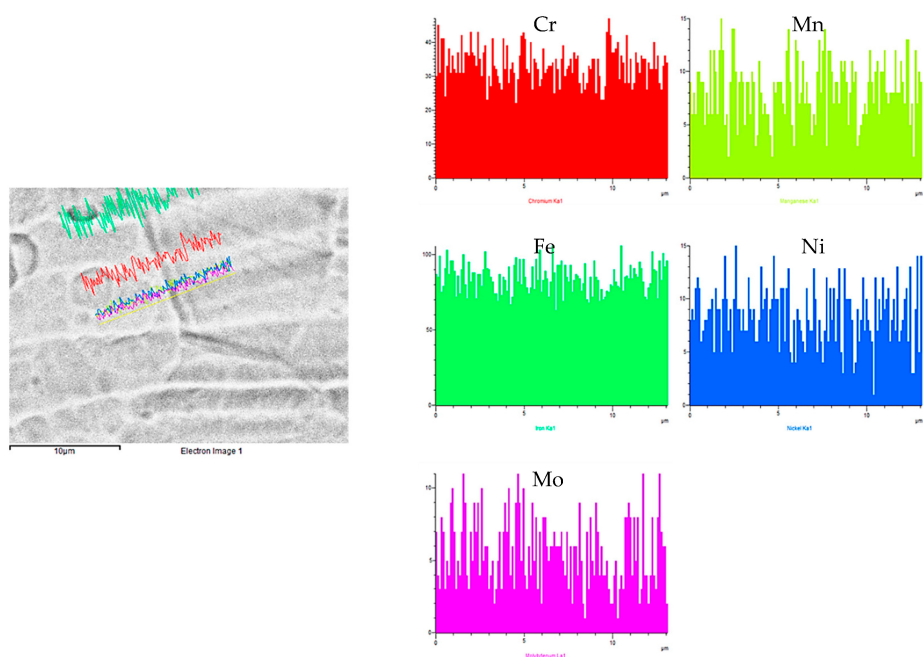
In any case, to rule this out, a semi-quantitative chemical composition scan was carried out using SEM, with an example of the results found being shown in Figure 9 (chemical composition scan in a non-damaged area) and Figure 10 (chemical composition in a particular grain boundary within a damaged area). In all cases, no peaks of Cr were observed. If these analyses had detected abnormally low Cr percentages, they would have been indirectly indicative of chromium carbide precipitation at the grain boundary (the zone close to the precipitates becomes depleted of Cr to feed the carbides). With all this, steel sensitization (precipitation of chromium carbides at the grain boundary) can be ruled out as the main cause of the corrosion phenomena being analyzed.

**Figure 9.** Grain boundary semi-quantitative chemical composition scan by means of SEM; Cr in red. Non-damaged area.

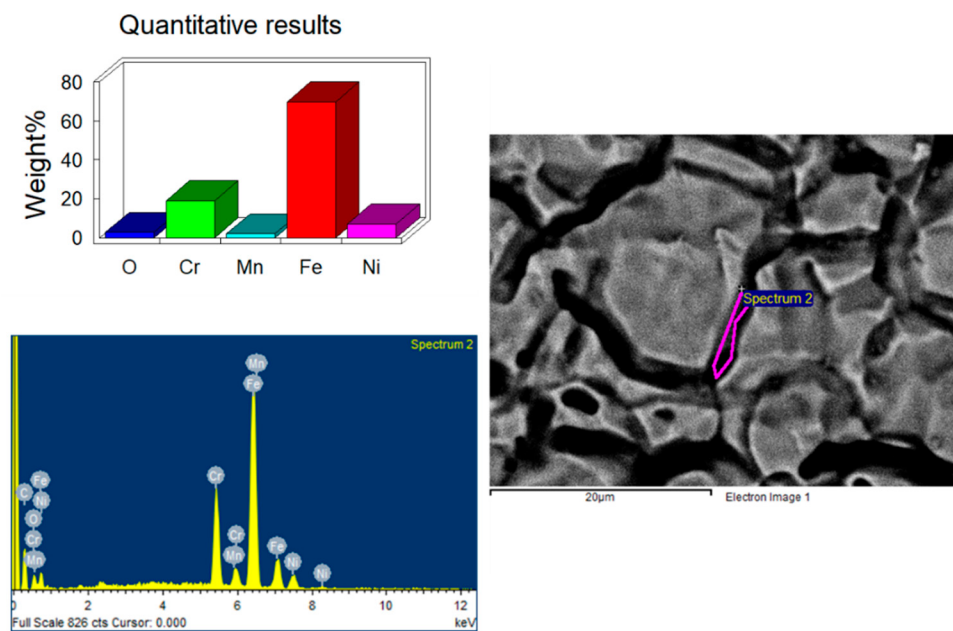
**Figure 10.** Spot analysis of semi-quantitative chemical composition by means of SEM in damaged grain boundary; Cr content is around 16%.

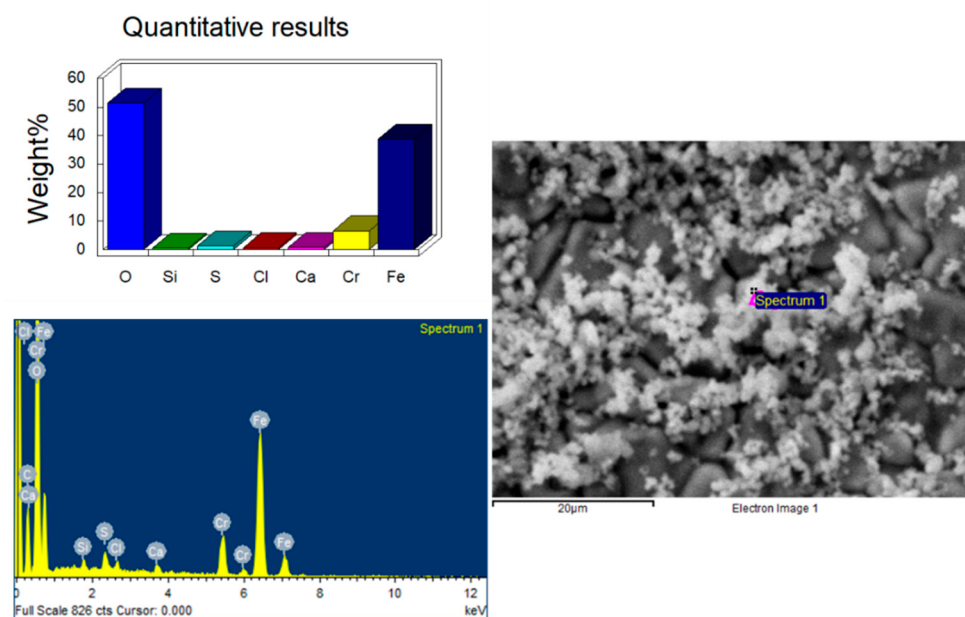
Finally, a SEM semi-quantitative analysis of the chemical composition of the corrosion products deposited in the sample was carried out in the area presented in Figure 3, where onset pitting and corrosion deposits can be observed. The results, which are presented in Figure 11, show the presence of sulfur (S) in non-negligible percentages, which cannot come

from the small amount of sulfur existing in the steel (see Table 1 with a  $<0.008\%$  S content). Thus, necessarily, sulfur has been provided externally, quite likely by the corrosive agent.

**Figure 11.** Chemical analysis (SEM) of corrosion products in the tube.

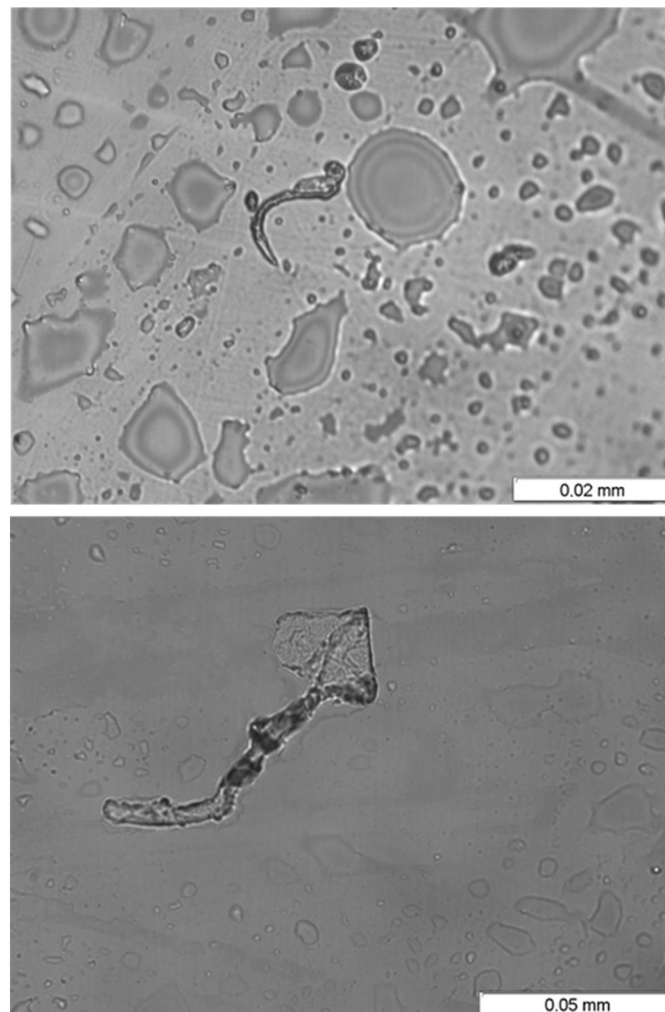
Despite the fact that DNA sequencing is required for the exact determination of the type of SRB bacteria, an observation of the water samples under an optical microscope allowed organisms to be detected that probably correspond to the type of bacteria that proliferated during the culture, as shown in Figure 12.

**Figure 12.** Organisms (probably SRB) observed in the culture.
