Lightning Damage Testing of Aircraft Composite-Reinforced Panels and Its Metal Protection Structures

Abstract: In order to investigate the lightning damage behavior of an aircraft carbon fiber/epoxy composite-reinforced panel and its protection structures, four types of panels were selected to carry out a lightning experiment. Panels were without protection, with a full-sprayed aluminum coating, a local-sprayed aluminum coating, and a full-embedded copper mesh filling, respectively. Their surface and internal damage was detected via ultrasonic C-scanning. Results showed delamination damage for the protected and unprotected specimens due to substantial lightning Joule heat, thermal shock, and internal explosion. The aluminum coatings and the copper mesh had good shielding performance against anti-lightning strike damage. The protection method with a full-sprayed aluminum coating is more effective compared with the other two methods. This study is valuable to investigate the protection effectiveness of metal covers when aircraft composite structures are struck by lightning.

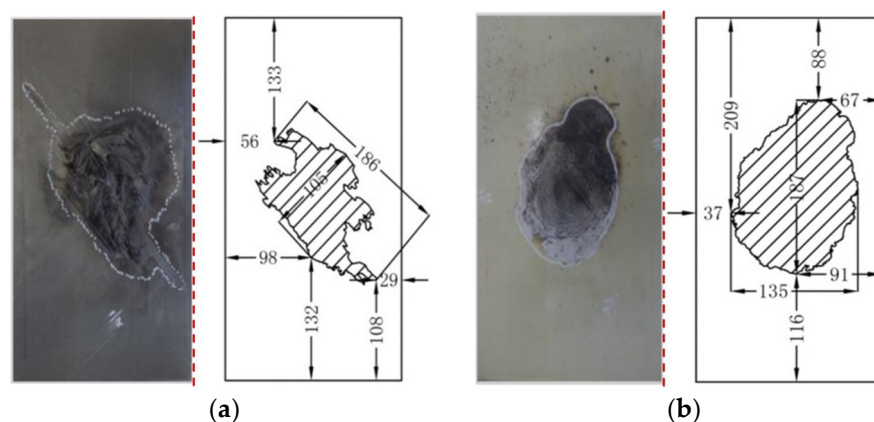
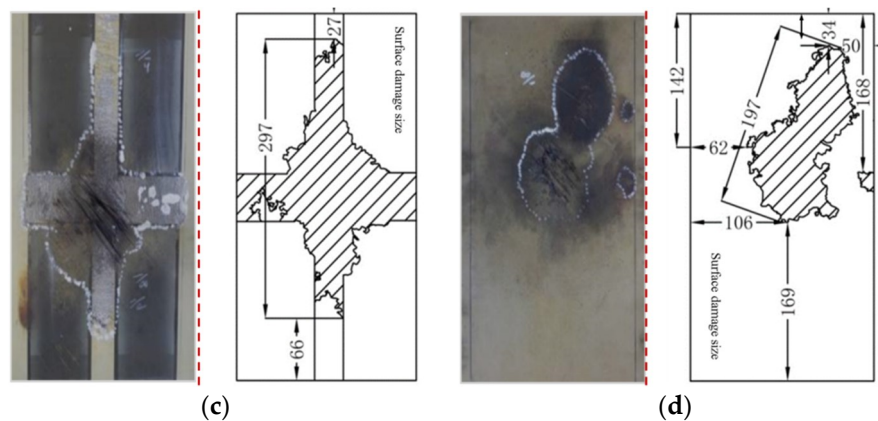
For the four different types of aircraft carbon fiber/epoxy composite-reinforced panels, the surface damage pattern and size due to lightning strikes is shown in Figure 6. The composite panel without protection was the most serious, caused by fiber fracture and matrix cracking, resin vaporization, delamination, etc. Lightning damage propagated significantly along the fiber direction. For lightning protection structures, lightning strikes can result in the melting of metal covers, and composite damage is inevitable. The melting of the metal coating was propagated outward from the attachment point of the lightning arc. The surface damage area of four different types of composite-reinforced panels is given in Table 4. It can be seen that the surface damage area of the lightning protection structures was larger than that of structures without protection, and the local-sprayed aluminum coating had the largest damage area. Although the metal covers were damaged, the composite-reinforced panels underneath were protected from lightning strikes, and composite damage was decreased to some extent. Therefore, the internal lightning damage state of composite structures under metal covers needs to be further evaluated by non-destructive testing method such as ultrasonic C-scanning in our present study.

Structure (a)	Structure (b)	Structure (c)	Structure (d)
Damage area	10,359 mm ²	17,942 mm ²	20,139 mm ²	11,502 mm ²
Percentage	13.28%	23.00%	25.81%	14.75%

Figure 6. Surface damage pattern and size of four different types of composite-reinforced panels: (a) composite-reinforced panel without protection; (b) composite-reinforced panel with a full-sprayed aluminum coating; (c) composite-reinforced panel with a local-sprayed aluminum coating; (d) composite-reinforced panel with a full copper mesh filling. (Unit: mm).

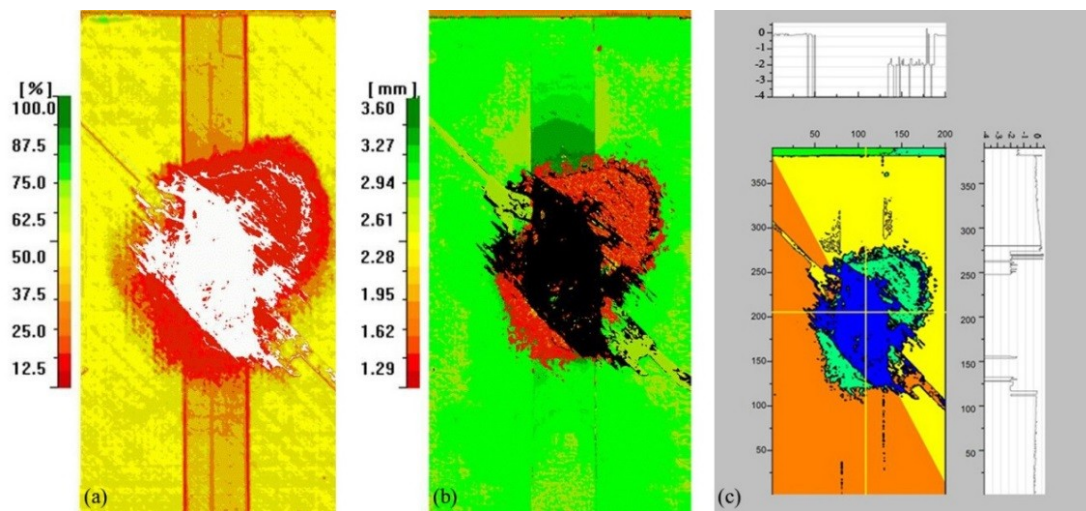
Part of the central lightning attachment zone is shown in white and red in Figure 7a. Vast surface carbon fibers were fractured or sublimated, and appeared to have unconstrained conditions, and an epoxy resin matrix had a carbonized decomposition based on visible detection. The white and red zones distributed along the 45 degree fiber direction on the top lamina and a narrow fiber fracture belt ran throughout the entire specimen, which is symmetrical with respect to the attachment point of impulse electrical current. An approximate elliptical damage appeared irregularly around the white and red zones, and was mainly formed in the deterioration zone. Delamination damage is distinguished by abrupt color changes in Figure 7b. Damage location data in Figure 7c show that the specimen surface was slightly tilted and that the deterioration depth was about 2 mm apart from the top lamina.

Figure 7. Echo amplitude, echo location, and location data for composite-reinforced panel without protection: (a) echo amplitude; (b) echo location; (c) location data (Unit: mm).

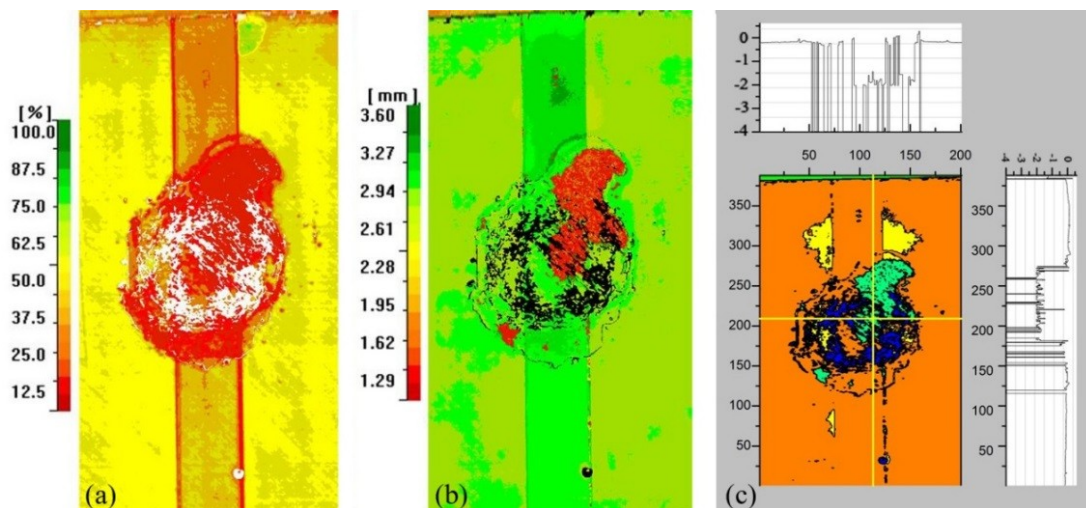
Approximate circular attachment damage appears irregularly in the central zone in Figure 8a, in which a small part is presented in white and the other in red. The reason may be that the thickness of the sprayed aluminum coating is not constant along the specimen surface due to the spraying craft limit, which results in a non-uniform electrical charge distribution. The isotropic aluminum layer was uniformly distributed, and electrical current was conducted along its surface. Comparison with visible detection shows that the aluminum layer was intensely melted and vaporized in the central zone. Many carbon fibers were broken up, and the epoxy resin matrix had carbonized decomposition in this zone. Figure 8b further shows the damage zone, presented in red and black, and was used to assess delamination damage. The white damage spot on the lower composite panel shown in Figure 8a, which corresponds to the black spot shown in Figure 8b, might have been produced by the broken carbon fibers and carbonized resin matrix. Damage location data in Figure 8c show that the specimen surface was tilted slightly and that the deterioration depth was about 1.8 mm apart from the top lamina. The yellow zone in Figure 8c, when

comparing it with that in Figure 8b, shows that delamination damage may have appeared. The green might correspond to the red carbonized damage zone shown in Figure 8b.

Figure 8. Echo amplitude, echo location, and location data for composite-reinforced panel with a full-sprayed aluminum coating: (a) echo amplitude; (b) echo location; (c) location data (Unit: mm).

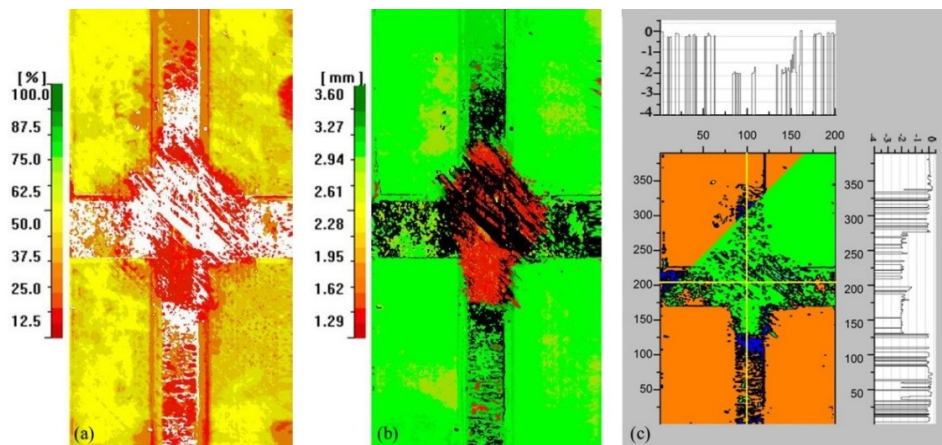
The lightning electrical current was a priority to conduct along the aluminum layer direction. Attachment damage mainly appears in the cross-shaped sprayed aluminum zone in Figure 9a, distributed along the 45 degree fiber direction on the top central lamina, which is presented in white and red, and the area around this zone is presented in yellow. Comparison with visible detection shows that the aluminum layer in the damage zone was also melted and vaporized, carbon fibers were broken up, and the epoxy resin matrix had carbonized decomposition in part on the sprayed aluminum coating and in part on the aluminum zone without spraying. It can be seen in Figure 9b that there is an irregular red zone along the 45 degree direction on the top central lamina, where the fiber fracture belt does not run throughout the whole specimen, which implies that not only does the surface specimen appear to have a fiber fracture but the internal specimen also has carbonized deterioration. Delamination damage was assessed by the obvious change in color in Figure 9b. Damage location data in Figure 9c show that the deterioration depth was about 1.8 mm apart from the top lamina.

Figure 9. Echo amplitude, echo location, and location data for composite-reinforced panel with a local-sprayed aluminum coating: (a) echo amplitude; (b) echo location; (c) location data (Unit: mm).

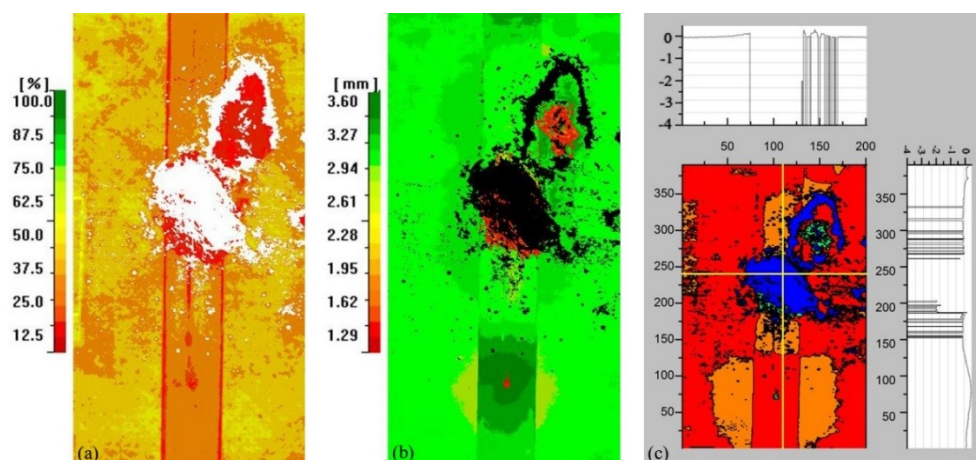
Both elliptical lightning attachment damage zones mainly appear in the center and top right corners in Figure 10a, which are connected and presented in white and red, and the area around these zones is presented in yellow. It was easy to induce and accumulate an electrical charge on the specimen surface with the coarse copper mesh, and this charge resulted in point discharge. Comparison with visible detection shows that the copper mesh in the damage zone was broken up, melted, and vaporized. A large number of carbon fibers were fractured, and the epoxy resin matrix had carbonized decomposition. Part of the damage zone was distributed with multiple irregular spots. The yellow zone might have been produced by the oxidized copper mesh, which was peeled off of the surface specimen. More of the damage zone of the broken carbon fibers and carbonized resin matrix is shown in Figure 10b, presented in red and black, was used to assess delamination damage. The red spots shown in Figure 10b correspond to the orange spots shown in Figure 10a and can be seen on the lower surface composite panel, where the copper mesh was not oxidized or peeled off. The center point of different irregular concentric circles, inherent flaws and lightning damage, is presented in a different color. The latter might have been produced when lightning impulse electrical currents were conducted along the copper mesh and entered the composite panel to release energy at this location. Damage location data in Figure 10c show that the surface specimen was slightly tilted and the deterioration depth was about 1.8 mm apart from the top lamina. It can be seen that the lightning damage zone in Figure 10c presented in blue corresponds to that in Figure 10b presented in black.

Figure 10. Echo amplitude, echo location and location data for composite-reinforced panel with full copper mesh filling: (a) echo amplitude; (b) echo location; (c) location data (Unit: mm).
