Brief Report

Covering Layers on Granite Buildings of Northwestern Iberian Peninsula: When Observable Characteristics and Lab Characterization Do Not Match

Patricia Sanmartín ¹,* , Jorge Sanjurjo-Sánchez ² and Beatriz Prieto ¹

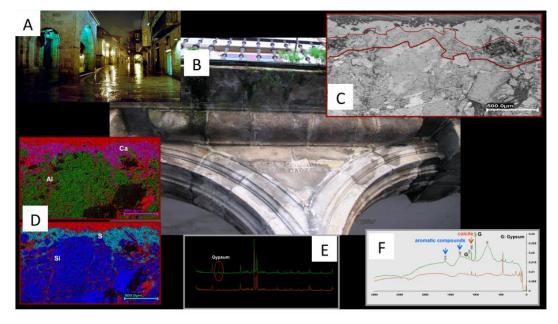
Three case studies in the old town of Santiago de Compostela [7] were considered. The first concerns the exterior wall of a house (Number 2) in Toural Square (8°32'42.0" W, 42°52'39.6" N, WGS84) on which a dark layer that is difficult to separate from the granite substrate had formed (Figure 1). It was identified on site as a patina according the ICOMOS-ISCS glossary. Further examination of samples of the material by electron microscopy revealed two layers of variable thicknesses: a superficial layer of thickness between 82 and 260 μm and an inner layer of thickness between 50 and 470 μm (Figure 1C). The inner layer was interspersed between the mineral grains and the diffuse boundary, making it very difficult to distinguish the material from the underlying rock. Furthermore, the covering layer was almost exclusively formed by inorganic particles (including gypsum crystals in their characteristic habit. Given that gypsum was present in the joint mortar, the most likely hypothesis is that it moved to the ashlar forming part of the layer). Element distribution mapping (Figure 1D) identified S and Ca as the main components (components of calcium sulphate, i.e., gypsum), with Al and Si appearing in the underlying granitic material [5]. Biological characterization did not show any evidence of the presence of organisms [8]. Thus, because this layer actually consisted of two different layers (a case not included in the ICOMOS-ISCS glossary), it could be described as a film, a deposit (the most superficial layer), or a crust (the inner layer), but in no case a patina since exogenic materials are involved. Whatever the term used, none of the present ICOMOS glossary allows for a suitable description of this covering layer.

Figure 1. Covering layer on the exterior wall of Number 2 Toural Square (Santiago de Compostela). (**A**) Entrance to the Toural Square, (**B**) detail of the sampled area, (**C**) SEM picture of a cross-section of the covering layer, (**D**) EDS of the cross-section, (**E**) XRD spectra of the covering layer (green line) and of the granite underneath the covering layer (brown line), and (**F**) IR/Raman spectra of the covering layer (green line) and of the granite underneath the covering layer (brown line).

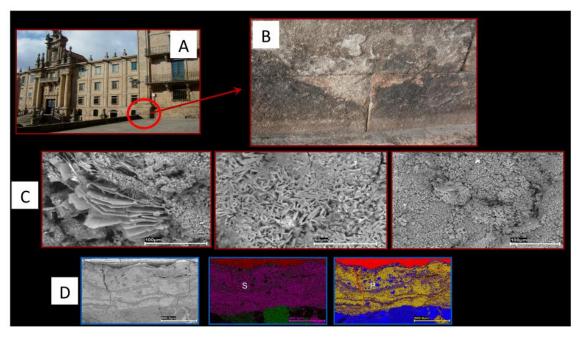
In the second case (Figure 2), the covering layer from the Monastery of San Martiño Pinario (8°32'40.4" W, 42°52'56.1" N, WGS84) also seemed to be a patina after on-site identification (Figure 2B). In the lab characterization (Figure 2C,D), it presented S (forming gypsum crystals in their characteristic habit) and P, although it was not possible to determine in what form. In other related studies, the presence of phosphorus was associated with accumulations of apatite, carbonate apatite, and hydroxyapatite [7], and its accumulation was referred to as the deposition of atmospheric particles, the residues left by soaps used in cleaning treatments, the residues of stone conservation treatments based on mixtures of soluble phosphates and silicates, or the mineralization of organic preservatives used in preservation containing phosphorus compounds, especially milk derivatives and casein salts [7]. This may also have a biological origin, as some bacterial colonies increase the phosphate in the solution present in the pores of the rock, causing the local precipitation of apatite, and also, phosphates can come from animal excrements, which is very rich in these compounds. However, apatite can also be present in granite rocks, and P can also be found in low concentrations in K- and alkali feldspars, and some accessory minerals of granite rocks such as monacite and xenotime, making it difficult to assess if its origin is exogenic or endogenic. In any case, while the observed gypsum and calcite could be exogenous, there are significant doubts about the other components such as P, making it difficult to use the glossary again for this case.

Figure 2. Covering layer on Monastery of San Martiño Pinario (Santiago de Compostela). (**A**) Area of the wall on the main entrance where the covering layer was taken, (**B**) detail of the sampled area, (**C**) SEM pictures of the covering layer, and (**D**) SEM picture (left) and EDS pictures (middle and right) of the cross-section of the coating.

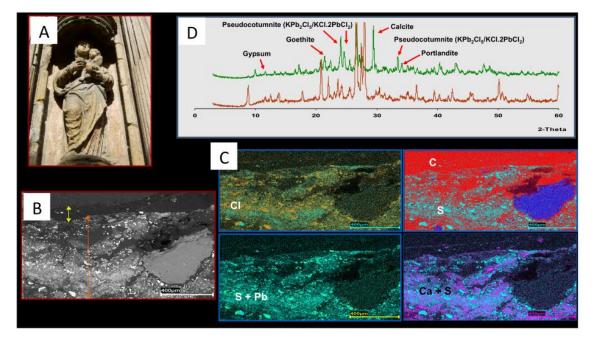
The third case (Figure 3) concerns a covering layer on the façade of Fonseca Palace (8°32′43.3″ W, 42°52′47.3″ N, WGS84) taken from a sculptural element (Figure 3A). The layer was dark-grey and of a compact, waxen aspect, identified as a patina on site. Examination of samples of the material by electron microscopy revealed two layers of a very different composition to the underlying rock, which were clearly separate from the rock (marked with yellow and orange line segments, Figure 3B). The most superficial layer was of a thickness of about 100 µm and the main element was carbon, although some highly electron-reflective particles, mainly composed of Pb, were also detected [5]. Analysis of the material by IR-Raman spectroscopy [7] allowed us to assign the origin to beeswax, which was commonly used in the early 1960s in Galicia to treat the surface of valuable monuments with the aim of preventing the erosive action of atmospheric agents [9]. The inner layer also contained C, along

with S, Ca, Pb, and Cl (Figure 3C). Examination of samples of the layer by XRD analysis revealed the presence of gypsum, calcite, portlandite, goethite, and pseudocotumnite (a compound consisting of potassium, lead, and chlorine), as is shown in Figure 3D.

Figure 3. Covering layer on the façade of Fonseca Palace (Santiago de Compostela). (**A**) Full view of the sculpture where the covering layer was taken, (**B**) SEM picture of a cross-section of the covering layer, (**C**) EDS from different zones of the inner layer surface, and (**D**) XRD spectra of the covering layer (green line) and of the granite underneath the covering layer (brown line).

Taking all of these findings into account, the outer part of this covering layer (but not the inner part) could be described as a film. The inner part could be described as a deposit, crust, or even as soiling, or as none of these.

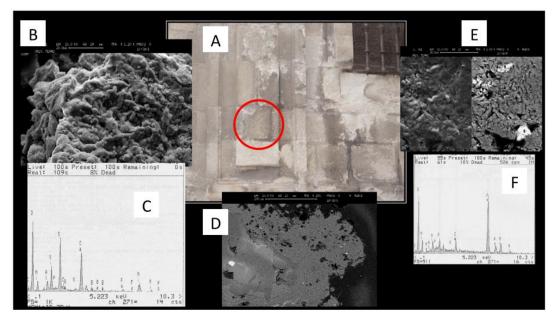
Case studies of two buildings in the center of the city of A Coruña are also considered: the Church of the Capuchinas (8°23′57.22′′ W, 43°22′21.45″′ N, WGS84) and the Colegiata de Santa Maria del Campo. (8°23′33.26′′ W, 43°22′14.8″′ N, WGS84). Both buildings are made from granite. The layer in question covered most of the main façade of the Church of the Capuchinas (Figure 4A), which overlooks a road with heavy traffic. On site this could be classified as a patina or a film. The layer was dark-grey, porous, and 100-200 µm thick (Figure 4B–D). It was composed of gypsum crystals and airborne soil particles (organic particles and silicate minerals), including particulate air pollution (C-rich spheres, Fe- and –Ba rich aggregates) (Figure 4E,F). It was very difficult to determine whether or not the materials are of completely exogenic origin, and therefore the terms crust, film (as it contains organic carbon), and soiling (the layer has a dirty appearance and contains soot) could all be applied to this covering layer, but not the term patina.

Figure 4. Covering layer on a wall of the Church of the Capuchinas (A Coruña). **(A)** Area of the wall where the covering layer was taken, **(B)** surface SEM picture, **(C)** EDS of the surface, **(D)** SEM picture of a cross-section of the covering layer, **(E)** Fe-rich particle, and **(F)** EDS of the particle.

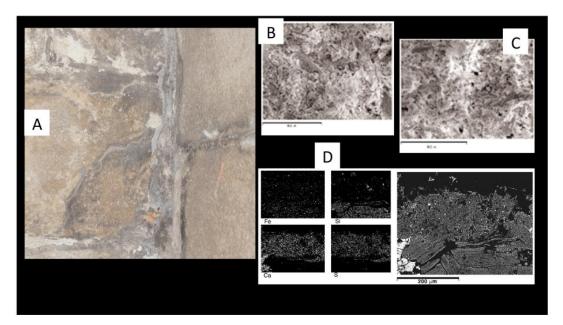
The covering layer on the south façade of Colegiata de Santa Maria del Campo (Figure 5A) seemed to be a film. It was a dark-grey layer of thickness $100{\text -}150~\mu m$ (Figure $5B{\text -}D$). It was composed of airborne soil particles (organic particles and silicate minerals) and gypsum crystals and also contained halite crystals and a Ca-S-C-rich amorphous material. The building is located 200~m from the coastline and the façade overlooks a road with almost no traffic. The location explains the presence of exogenic halite, but the silicate minerals identified are the same as those found in the underlying granite rock, as observed in other patinas on the same building [10]. Therefore, this cannot be considered to be a film.

Figure 5. Covering layer on the façade of the Colegiata de Santa Maria del Campo (A Coruña). (**A**) Detail of the area on the wall where the covering layer was taken, (**B**,**C**) SEM pictures of the covering layer surface, and (**D**) cross-section and X-ray map of the covering layer.

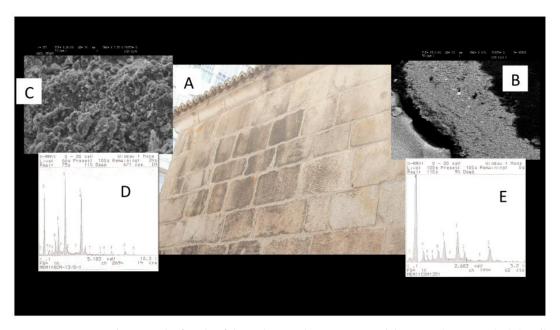
The final case considered was a black layer, 100–150 µm thick, on the east façade of the same building (Figure 6A,B). This seemed to be a patina to the naked eye. However, the layer was composed of a porous matrix (Figure 6C) of airborne soil particles (organic particles and silicate minerals), gypsum crystals, halite, and Ba- and Fe-rich aggregates, with traces of P (Figure 6D,E). The building is located 1200 m from the coastline and the façade overlooks a road with little traffic. Again, it is not easy to assign any of the terms in the ICOMOS-ISCS glossary to this covering layer. This could be a crust, patina, film, or soiling, and, according to a single field observation, it could be classified as a patina.

Figure 6. Covering layer on the façade of the Colegiata de Santa Maria del Campo (A Coruña). (**A**) Full view of the façade where the covering layer was taken, (**B**) SEM picture of the cross-section of the layer, (**C**) SEM picture of the surface of the layer, and (**D**,**E**) EDS of the layer surface.
