Health and Durability of Protective and Thermal Barrier Coatings Monitored in Service by Visual Inspection

Abstract: Protective and Thermal Barrier Coatings (TBC) applied on gas-turbine blades gradually degrade due to oxidation, aluminum depletion and impacts of environmental particles. Among various non-destructive coating testing methods (NDT), visual inspection can be undertaken regularly in service, but it provides little quantitative information, and only surface defects can be detected. This work aims at in-service monitoring of turbine blades with multilayer coatings applied by atmospheric plasma spraying (APS) in a few variants. They were validated during a series of accelerated mission tests of a retired military turbofan engine in a test cell together with five other technologies. The fifty-hour rainbow test focused on assessing coating durability. Between engine runs, 12 borescope inspections were conducted to monitor the health of the blades. Finally, the blades were disassembled and examined using computed tomography (CT) and metallographic methods. Throughout the testing, 31 newly-coated blades (66%) withstood the tests, producing results comparable to the reference

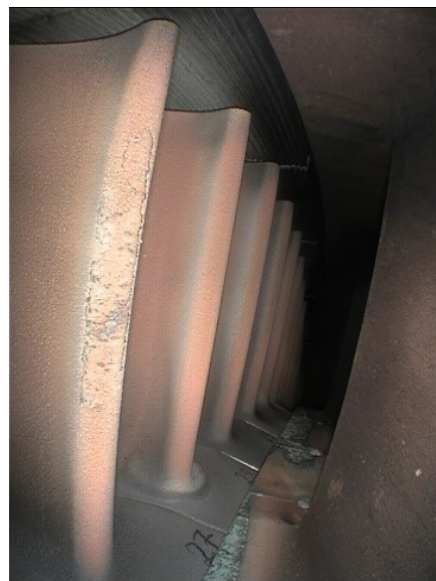
Figure 5. C-coated blade 27 viewed through the borescope at the 12th inspection.

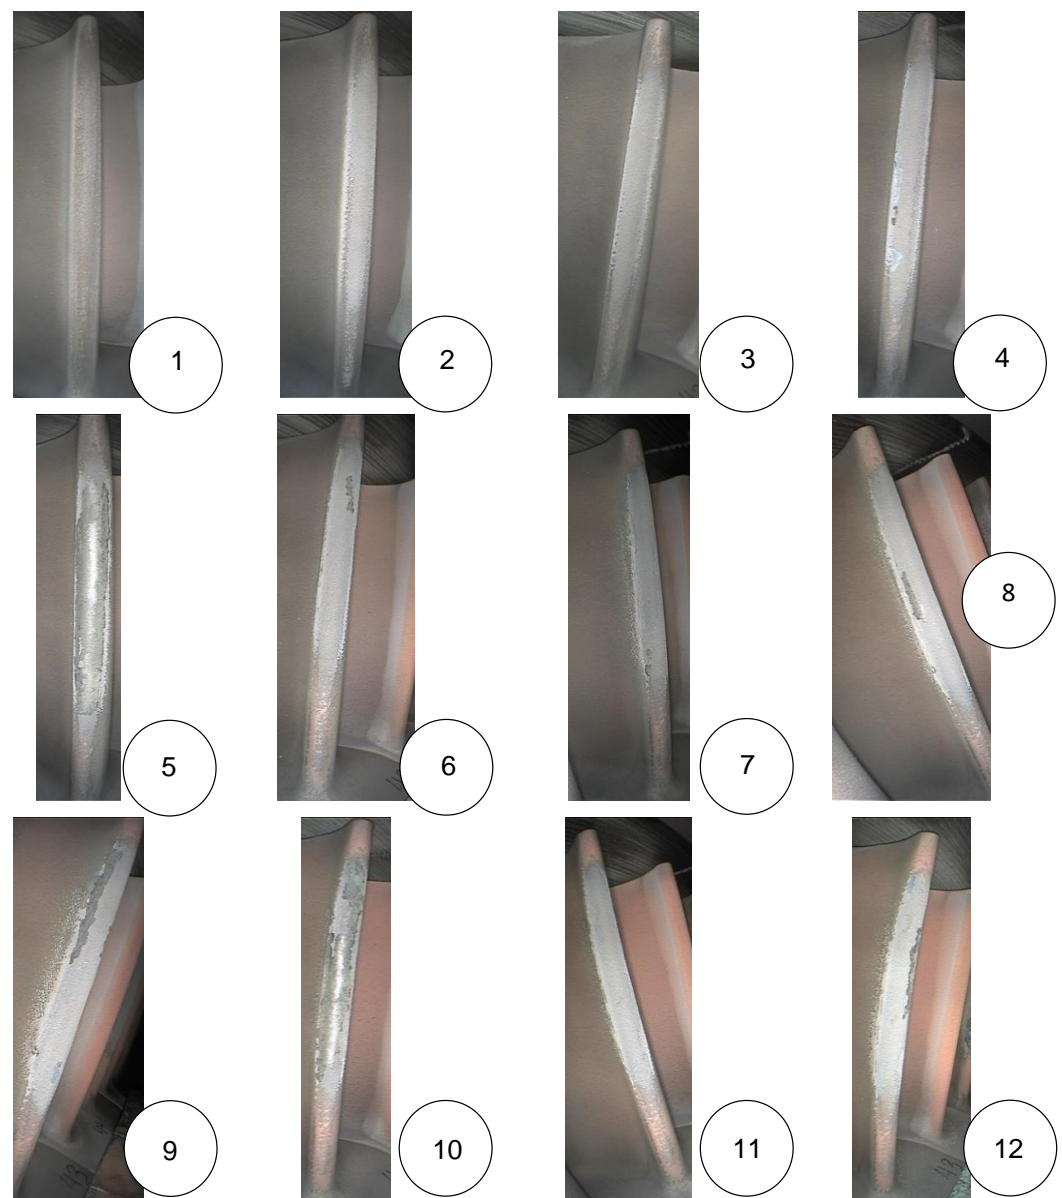
Coating B (CVD) was applied to 5 blades (No 1, 7, 43, 45 and 47). The first, noticeable flaws were found during the first inspection (Figure 6). The flaws developed during the initial engine run, before the main test program. During the subsequent test cycles, the destruction of the coating was found to progress in a characteristic way in relation to other tested coatings. The damage was observed on LE along the entire height of the airfoil and on the concave side, especially along the tip and in the trailing edge zone.

Figure 6. Deterioration of blade 43 observed at successive inspections (1-12).

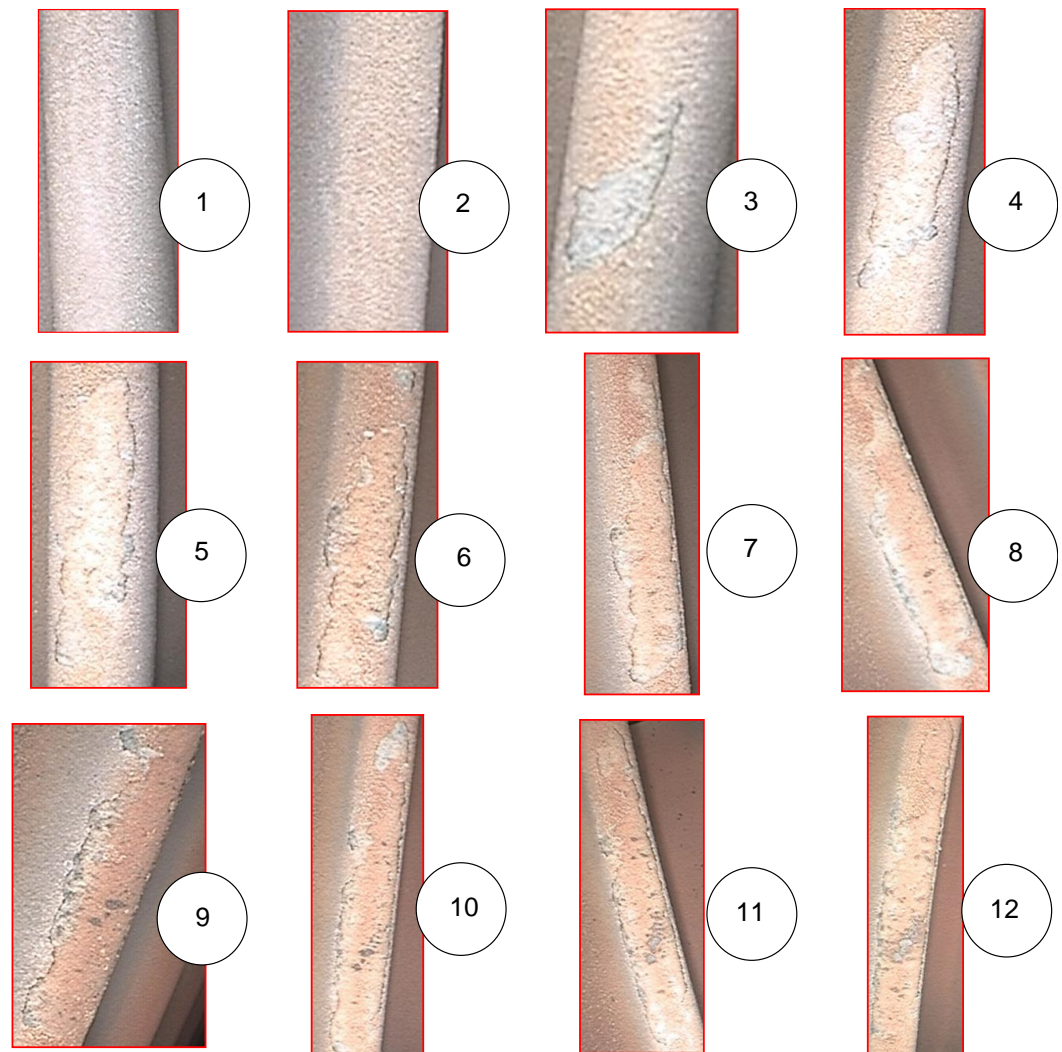
Coating C (APS + VPA) was applied to eight blades, but only blade 27 did not pass the test (Figure 7). During the third inspection, local chipping of the coating from LE was detected. The total area of this defect increased with the number of test cycles so that during the 12th and last inspection, the damage was observed along approximately 60% of the total height of the airfoil. Other C-coated blades were healthy, so it may, for example,

indicate that before the destruction of the LE coating started, blade 27 could have been hit (or rubbed) by a foreign object.

Figure 7. Deterioration of blade 27 observed at successive inspections (1-12).

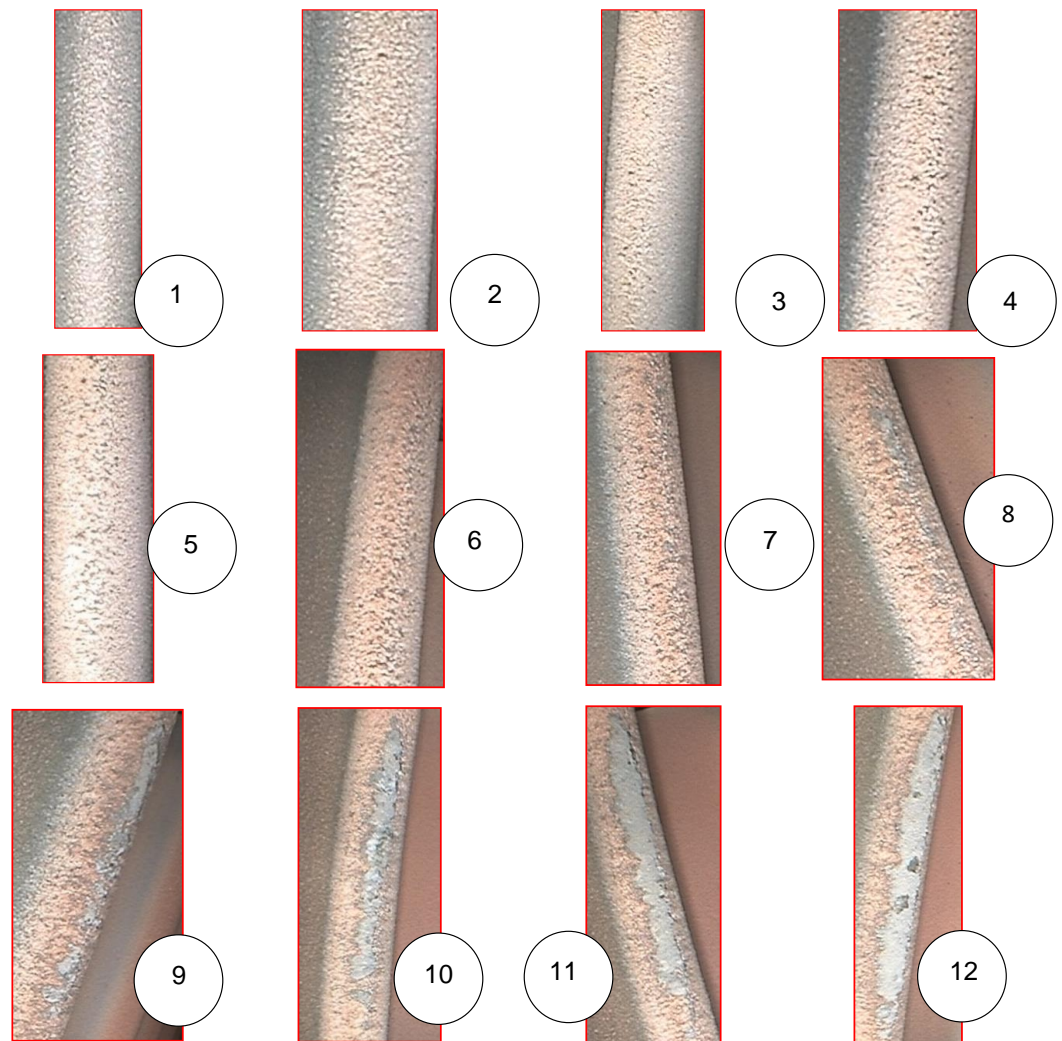
Coating E (APS) was put onto six blades, and three of them did not pass the test. Throughout the testing, it was found that the surface roughness increased compared to the standard blades (Figure 8). The leading edges of blades 11, 65 and 71 were damaged. However, the initial deterioration symptoms were found on the LE of the remaining three blades, which were similar to the previous ones. The lack of clear-cut damage symptoms for these three blades may indicate that the applied coating may be, for example, thicker than those on the other three.

The increase in the porosity of the coating at LE observed in subsequent inspections is due to the gradual oxidation of the coating material. This is one of the characteristic symptoms of failure in this type of coating. During the eighth inspection (Figure 8), the appearance of a bond coat at LE (in the midspan of the airfoil) was found. It has also been noticed that the damaged area increases along the height of the blade due to gradual chipping and further oxidation of the material. Thus, this coating is gradually depleted by the hot gas flow. For example, during the last, twelfth inspection, locations at the LE of blade 65 were found which would indicate a complete loss of coating.

Figure 8. Deterioration of blade 65 observed at successive inspections (1-12).

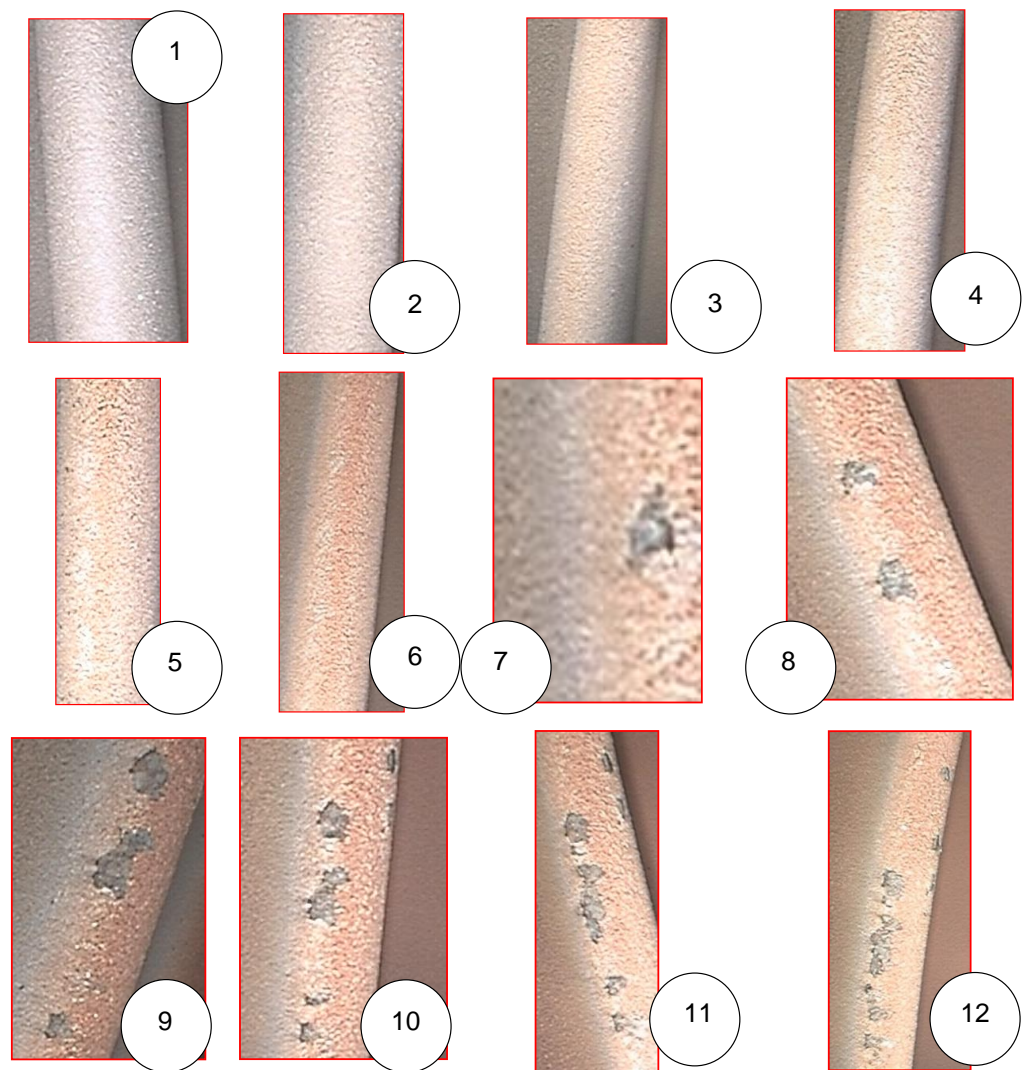
Five blades (No 13, 55, 57, 61 and 79) were coated with F coating (APS + SLURRY), and all of them were damaged prior to carrying out 128 of the 250 planned test cycles. During the seventh inspection (after the 128th cycle), local chipping of the LE coating was found in the midspan of blade 13 (Figure 9). Throughout subsequent inspections, an increase in the total area of the wound (along the height of the airfoil) was observed as a result of the gradual chipping of the material.

What is characteristic of this type of coating is that it is damaged locally via the formation of several LE flaws, which are separated (blade 13) or gradually merge, after some test cycles (other F-coated blades). Another characteristic feature of this damage is the fact that the first noticeable flaws occur at the LE arc where the concave side starts. The LE flaws observed later at the point of transition to the convex side are located slightly above those previously identified.

Figure 9. Deterioration of blade 13 (APS + SLURRY) observed at successive inspections (1-12).

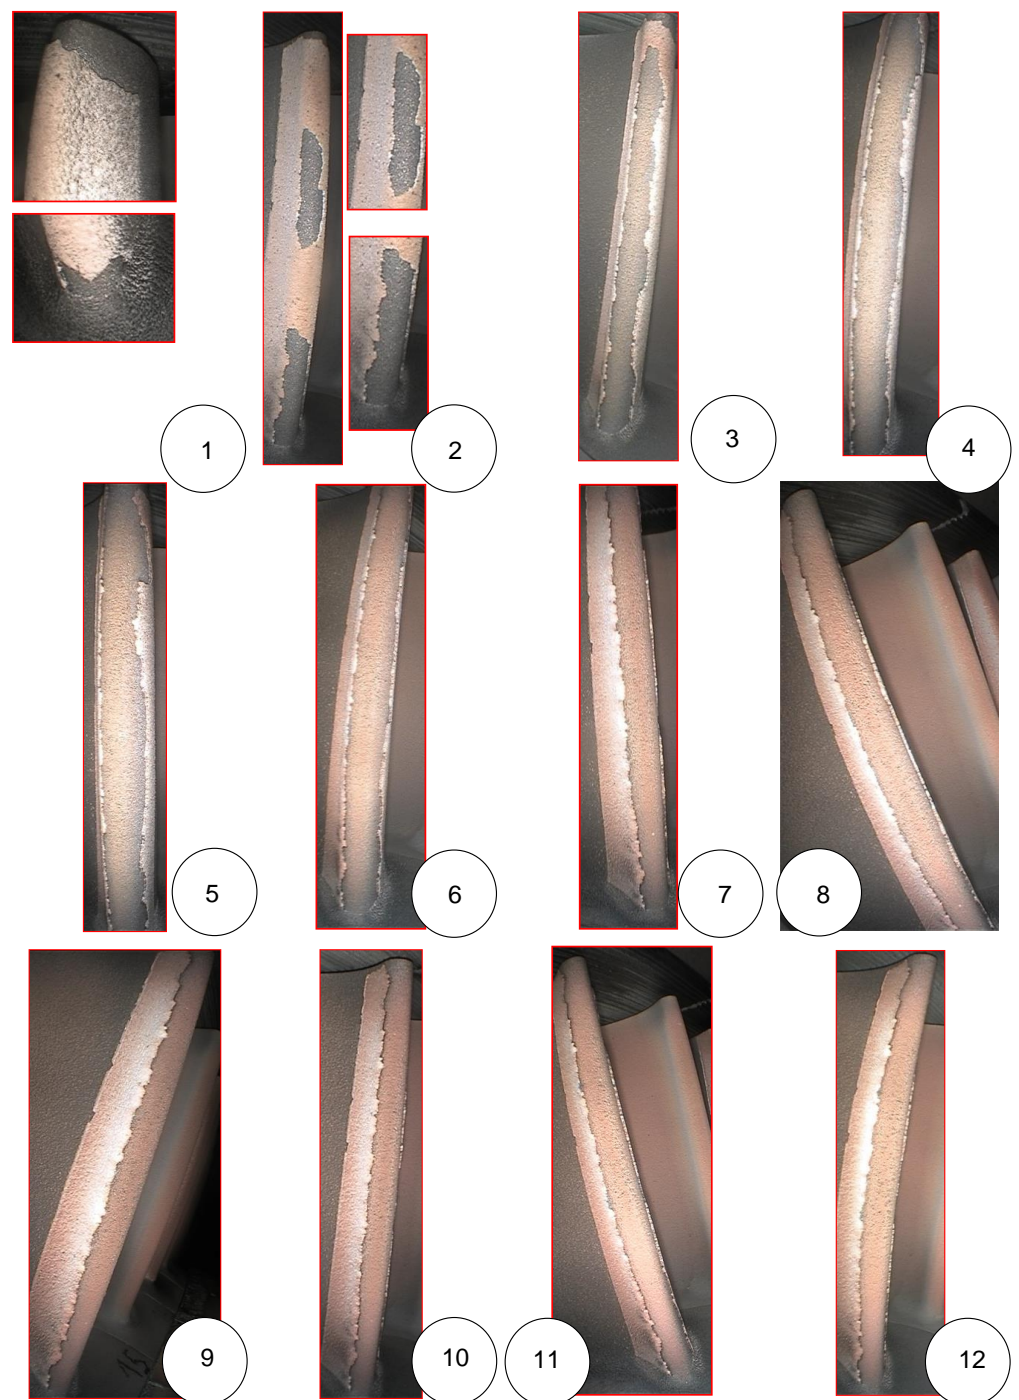
Coating G (APS + TBC) was applied to three blades (15, 17 and 21), and two did not pass the test. During the verification of the blades before their installation in the disc, minor flaws of the ceramic topcoat were found in blades 17 and 21 at their LEs, in the near-edge zone, both on the concave and convex side. The second inspection revealed an increase in the total area of coating damage in blade 15 along its height (Figure 10). This process accelerated, as during the fourth inspection, the LE of this blade was found to have no coating along the entire height of the blade.

Figure 10. Deterioration of blade 15 (APS + TBC) observed at successive inspections (1-12).
