Research of ZnO Arrester Deterioration Mechanism Based on Electrical Performance and Micro Material Test

Keywords: EMU; arrester; explosion; microscope test

Citation: Zhang, Q.; Wang, S.; Dong, X.; Liu, M.; Ou, Q.; Lv, F. Research of ZnO Arrester Deterioration Mechanism Based on Electrical Performance and Micro Material Test. *Electronics* **2021**, *10*, 2624. <https://doi.org/10.3390/electronics10212624>

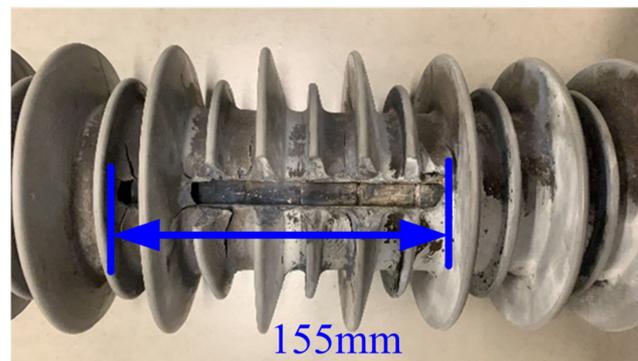
Figure 1. Exploded arrester.

The factory test data of the burst arrester is unknown. It is important to mention that the weather was fine when the fault occurred, the train did not operate the pantograph (a lifting device to realize the connection between train and catenary), the circuit breaker was not opened or closed, and the overvoltage waveform was not recorded. A photo of the pressure relief part of the burst arrester test object is shown in Figure 1.

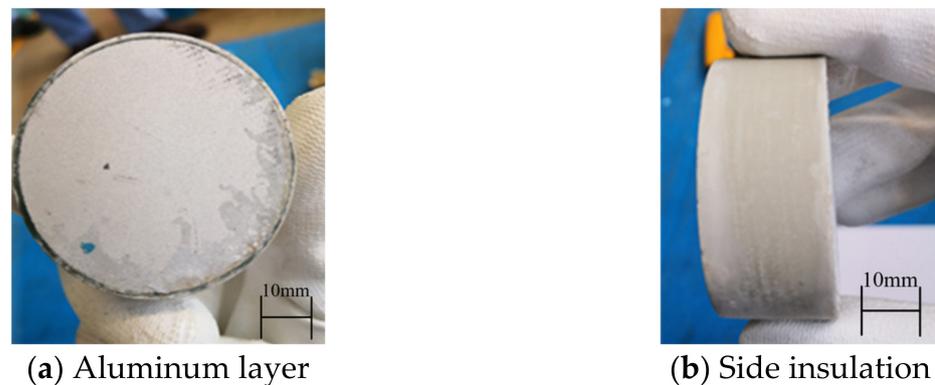
Figure 5. Typical appearance of a defective arrester varistor.

It can be seen that the varistor appearance near the high voltage end of the defective arrester is different from that of the normal arrester. Suspected chemical corrosion traces appeared at the edge of the aluminum electrode layer. The roughness of the side insulating layer of the varistor increases, and the color unevenness of the insulating layer also increases. The appearance of the burst arrester varistor is shown in Figure 6.

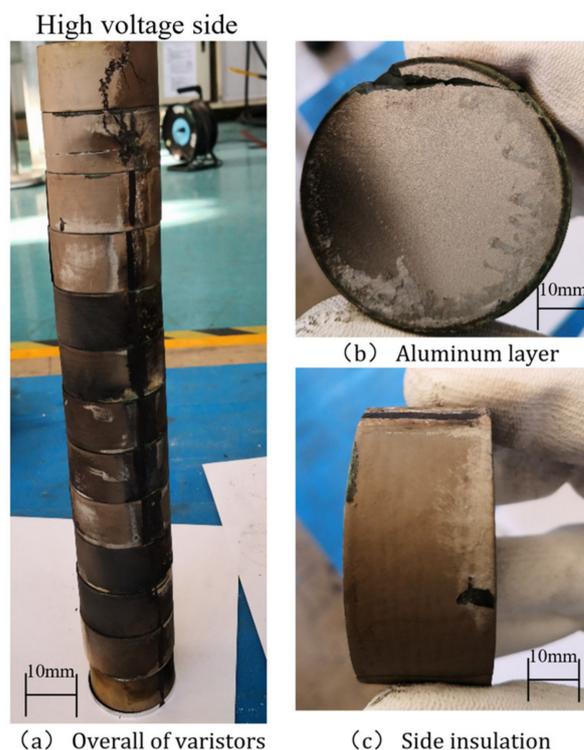
Figure 6. Typical appearance of a defective arrester varistor.

It can be seen from Figure 6a that the side insulating layer flashover first occurs on the varistor near the high-voltage end of the arrester. When the number of side flashover varistors reaches four, the remaining varistors bear all the voltage at both ends of the arrester, exceeding the varistor thermal limit. This results in a thermal collapse of the varistor. It can also be seen that there are suspected chemical corrosion traces on the edge of the aluminum electrode layer of the varistor. This is similar to the appearance of the aluminum electrode layer of the defective arrester. In addition, the morphology of

the insulating layer on the side of the varistor is similar to that of the defective varistor, while the color of the insulating layer is inconsistent.

In conclusion, the suspected corrosion traces at the edge of the aluminum electrode layer, and the morphological changes of the side insulation layer, may be the internal causes of the arrester failure. The EMU can timely disconnect the circuit breaker and lower the pantograph when the power frequency voltage is greater than 30 kV, but the EMU cannot monitor the impulse current and impulse voltage and the train often suffers from overvoltage during operation. The EMU cannot operate the circuit breaker and the pantograph to avoid overvoltage attack, and can only absorb overvoltage energy through the roof arrester. There are several methods in the surge protection industry to detect and disconnect defective arresters [30–33]. It is necessary to carry out relevant research to realize the on-line monitoring of roof arresters and reduce the occurrence of explosion accidents.

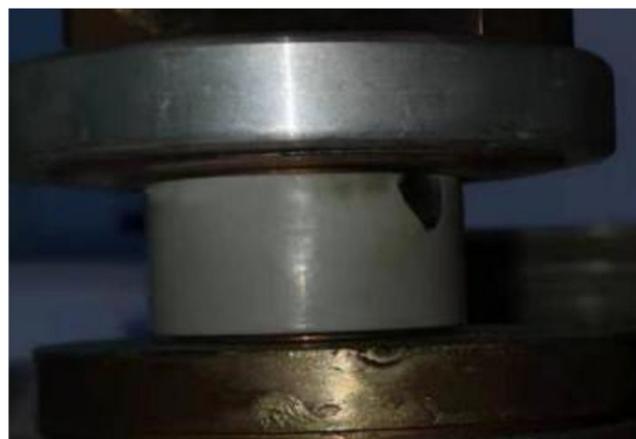
Figure 7. Surface breakdown of a varistor under a high current impact.

It can be seen from Table 4 that both defective varistors have passed the 2 ms square wave test. This indicates that the defective valve piece can meet the flow capacity requirements of the arrester when subjected to a continuous high current impact. Varistor No. 3 had a surface breakdown in the first high current impulse test, while varistor No. 4 had a surface breakdown in the second high current impulse test, and therefore it failed to pass the high current withstand test. To sum up, the varistor defect of the arrester is mainly reflected in the decline of the side insulation performance. When the arrester is impacted by a large current, the defective varistor is more prone to surface breakdown of the side insulation layer. The surface breakdown trace of the varistor in the high current impact test is shown in Figure 7.

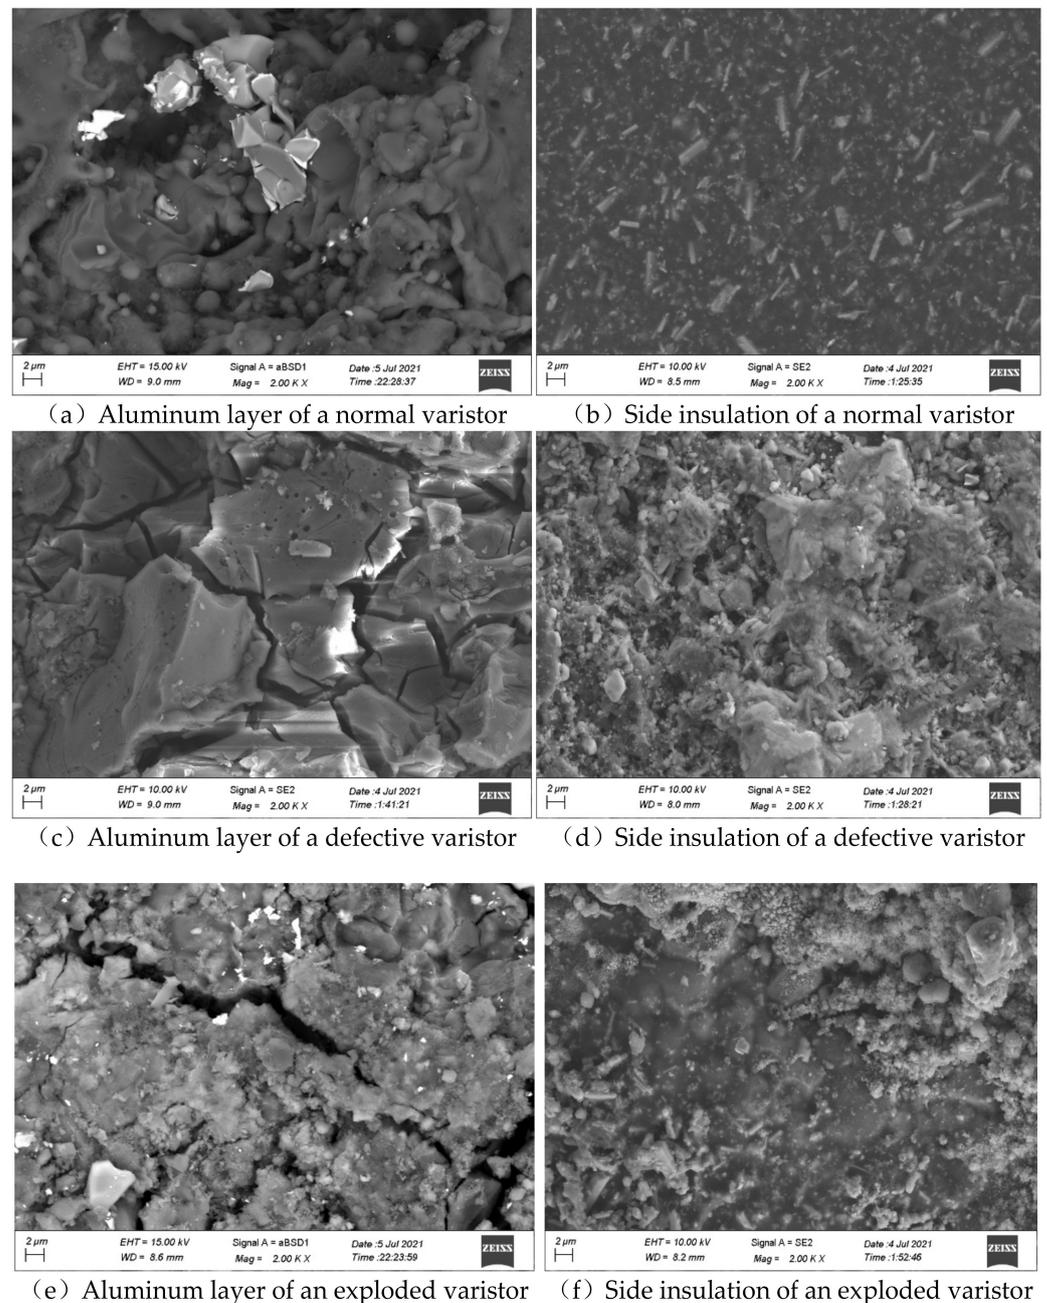
Figure 8. SEM test of arrester varistors.

It can be seen from Figure 8 that there are great differences in the micro morphology of the aluminum electrode layer of the arrester varistor in the three states of normal, defect,

and burst. The surface morphology of the aluminum electrode layer of the normal varistor is flat. A plurality of film structures is formed on the surface of the aluminum electrode layer of the defective varistor. In addition, the scale of large films can reach $10\ \mu\text{m}$. A gully with a width of $1\ \mu\text{m}$ exists between the films. Compared with the defective varistor, the film size of the aluminum electrode layer of the burst varistor is highly increased. The width and length of the gully between the films are also increased. The insulating layer on the side of the normal varistor is flat, while the strip packing is evenly distributed. The side insulating layer of the defective and cracked arrester varistor has no visible strip filler, and the morphology is uneven. Finally, the formation of a thin film of aluminum electrode layer and the roughness of the side insulation layer may be the reasons for the deterioration of the arrester varistor performance. The reasons for the difference in the micro morphology of the aluminum electrode layer of the varistors in different states will be discussed in Section 4.2.

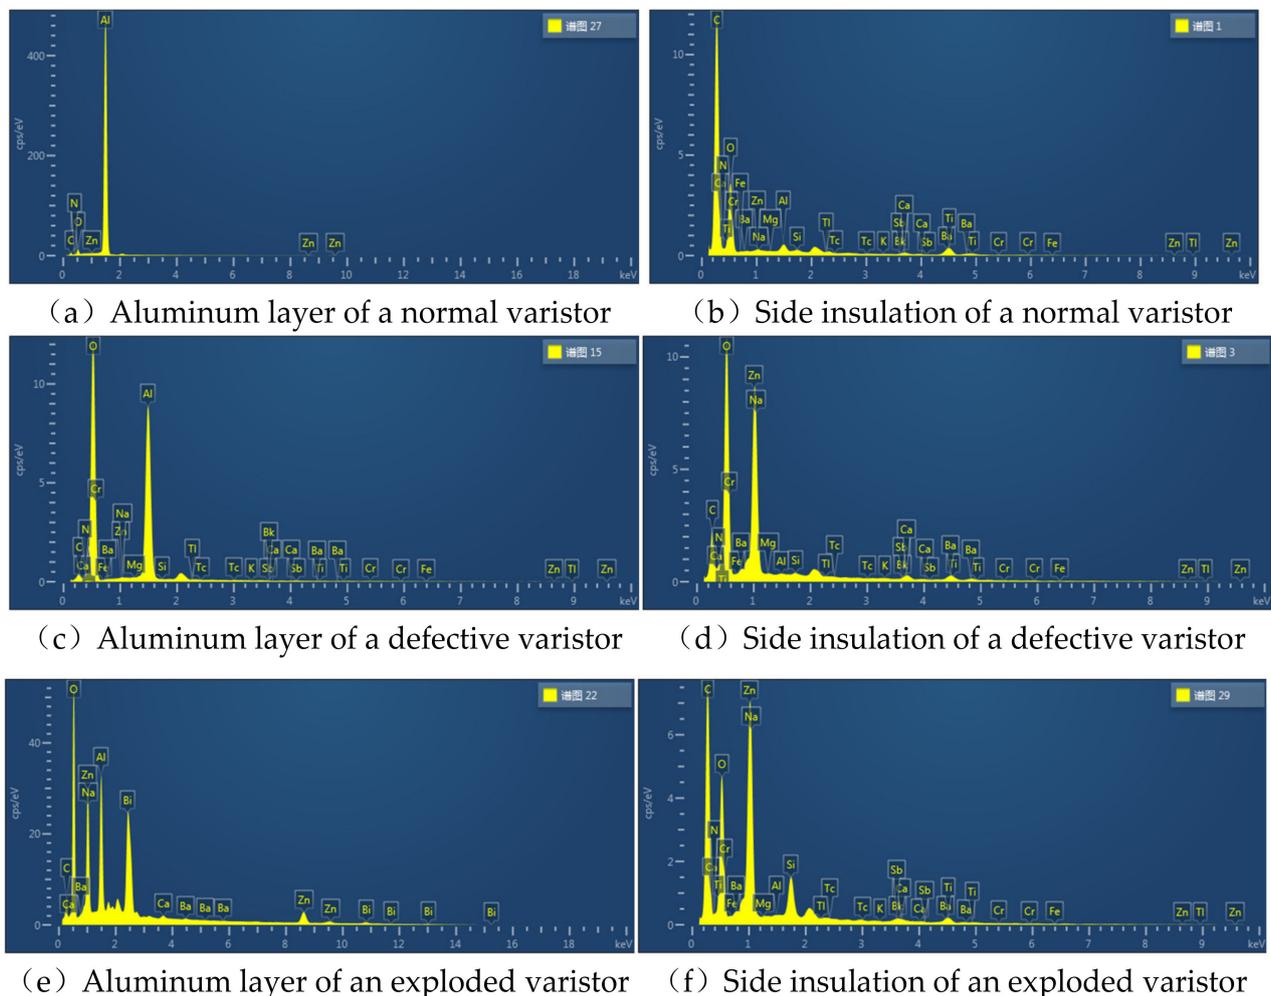
Figure 9. EDS test of arrester varistors.

It can be seen from Figure 9 that the main element of the aluminum electrode layer of the normal arrester varistor is Al. On the contrary, a large number of O elements appear in the aluminum electrode layer of the defective and cracked arrester valve varistors. The main element in the side insulation layer of the normal arrester valve varistor is C, while the content of O in the side insulation layer of the defective and burst arrester valve

varistors significantly increases. The insulating layer on the side of the burst arrester has broken down. Therefore, the Zn element inside the varistor is detected on the insulating layer. According to Figure 9c,e and Figure 8c,e, the film composition on the surface of the aluminum layer is alumina. There may be two reasons for the size difference between the alumina film and the film gap of the defective varistor and the exploded varistor: (1) With the development of the oxidation reaction, small films are connected into larger films; (2) When the exploded varistor flows through a large current, it produces a large amount of heat, and the thermal stress may increase the gap between the alumina films.

Based on the results obtained by the SEM and EDS tests, it can be deduced that the main reason for the internal arrester defects is the moisture. The O element enters the arrester in the form of water vapor, while a chemical reaction occurs in the aluminum electrode layer and side insulation layer of the varistor. Consequently, an oxide film appears at the edge of the aluminum electrode layer and the insulation effect of the side insulation layer is reduced. The existence of the oxide film leads to the electric field distortion at the edge of the aluminum electrode layer of the varistor, which easily results in a partial discharge. Simultaneously, due to the deterioration of the side insulating layer, a discharge may develop along the insulating layer, resulting in the surface flashover of the varistor. Finally, the arrester may have thermal collapse under the combined action of external overvoltage and internal insulation defects.

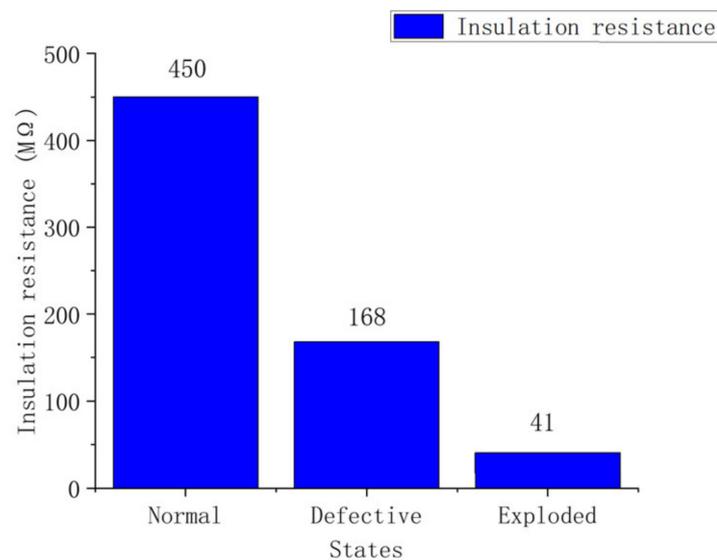
Figure 11. Insulation resistance of different states varistors.

With the change of varistor states, the side insulation resistance also changes. Compared with the normal varistor, the insulation resistance of the defective varistor is significantly lower, and the insulation resistance of the exploded varistor is the lowest. Combined with the SEM and EDS test results, it can be seen that there are defects in the sealing performance of the arrester, resulting in damp in the internal varistors. After the varistors are dampened, the aluminum electrode layer and side insulation layer are chemically reflected, and the surface morphology and chemical composition are constantly changing. A symptom of varistor moisture is the reduction of insulation resistance. The deeper the varistor deterioration, the lower the insulation resistance. Finally, the varistor with low side insulation resistance is prone to surface flashover under the action of overvoltage, and even cause the explosion failure of the roof arrester.
