Foundation Pit Collapse on 8 June 2019 in Nanning, China: A Brief Report

Abstract: This short communication reports on the recent incident of a foundation pit collapse at a construction site on 8 June 2019 in Nanning City of Guangxi Province, China. There were no injuries or casualties reported for this incident. This report presents the incident background, management measures taken after the incident, and a brief discussion of the causes of the incident. Some mitigation measures are suggested to prevent similar incidents in the future based on the preliminary analysis.

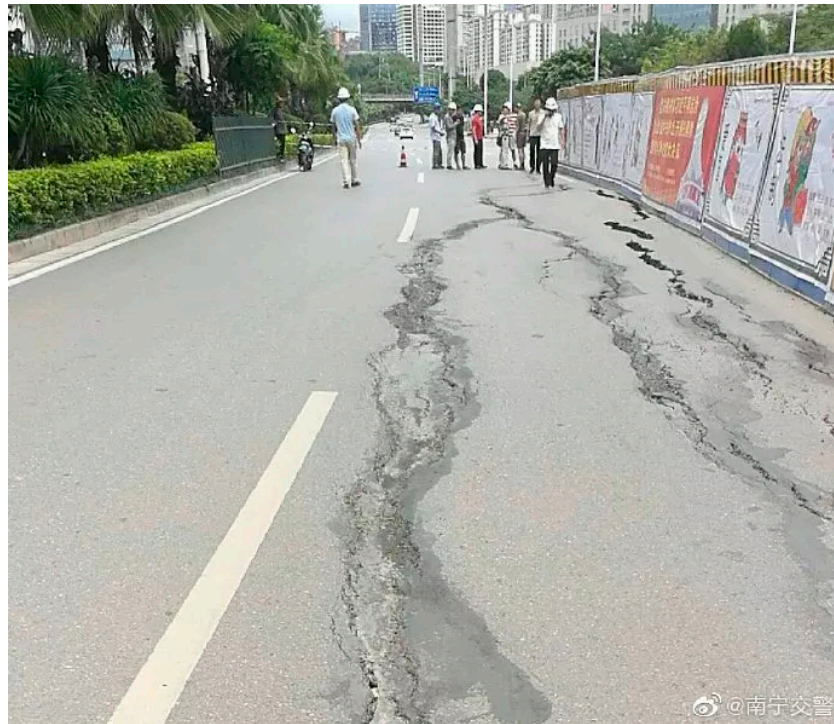
One day before the incident (7 June 2019), construction workers reported cracks on the road pavement around the foundation pit. The cracks, which were 40 cm in width and covered a distance of 20 m, were formed due to subsidence of the ground layer (Figure 2). After receiving the report, construction work on the entire site was ceased while relevant experts carried out site investigation and monitored the cracks for any further deformation. The construction work continued after the experts considered that the situation was still safe.

Figure 2. Cracks on the surface of Dongge Road prior to the incident (source: https://mp.weixin.qq.com/s/nMGCnVwHjIqVq_np9ITXwg).

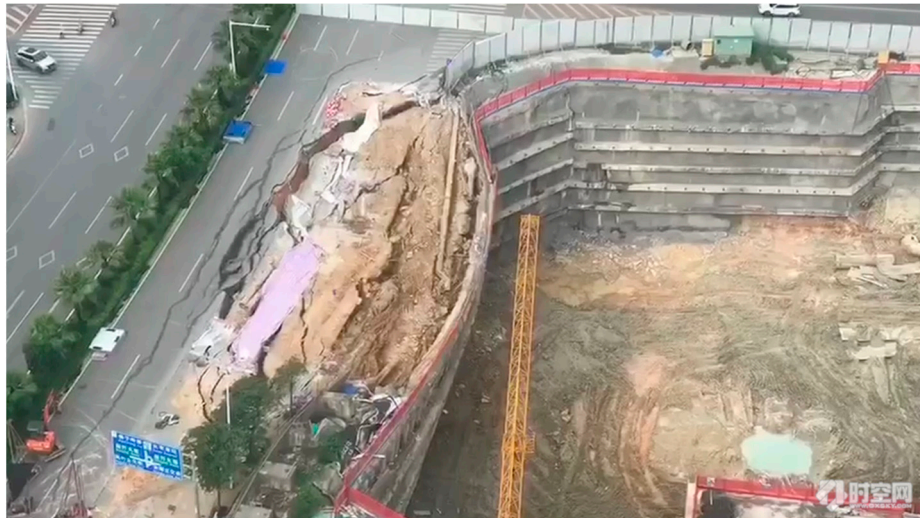
However, at 11:30 am (8 June 2019), the monitoring data showed a tangible change. The relevant authorities, including the Construction Management Centre of Housing Construction Bureau, Nanning City, were notified about the potential for incident. The authorities performed mitigation measures to ensure personnel safety. They closed off a part of Dongge Road near the site to prevent public access, and the site and people within its vicinity were evacuated. Control measures were also taken onsite to minimize the effect of the collapse. About an hour prior to the incident, the cracked road surface began to sink, forming a large pit, and cracks formed in the foundation walls (Figure 3). At around 5:30 pm local time, the retaining wall collapsed (Figures 4 and 5).

Figure 3. Road surface prior to the collapse (source: <http://bbs.gxsky.com/forum-viewthread.php?mod=viewthread&tid=17158735&page=1>).

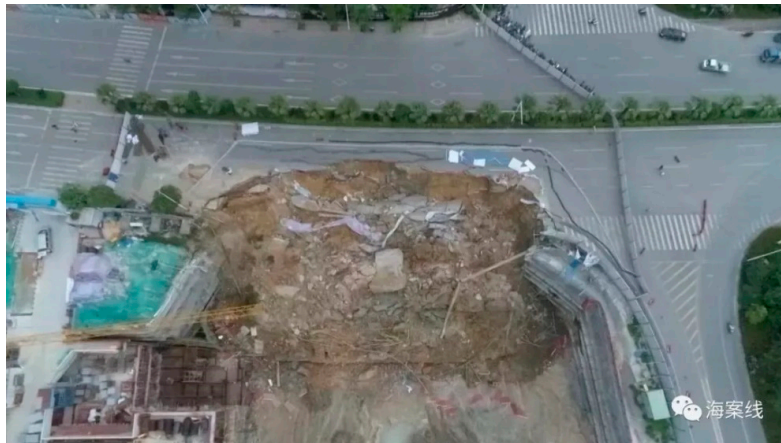
Figure 4. Collapsed foundation (plan view) (source: <https://mp.weixin.qq.com/s/U9TbiDpfHVxxUqvq3Gw0iw>).

An onsite investigation was conducted by the Construction Management Centre of Housing Construction Bureau, Nanning City. Relevant authorities confirmed that the main reason for this collapse was the deformation of the retaining wall, which led to a loss of soil. Municipal water pipes of 500 mm diameter that were sitting on the soil was found to suffer from long-term leakage, which caused the soil around them to soften and settle around the foundation pit. The cumulative loss of soil underneath the water pipes led to a burst of the unsupported water pipes. As a result of the bursting water pipes, the anchor cable structure failed and the foundation pit support further deformed, eventually leading to the collapse of the pit.

To avoid any post-disaster incidents, the Construction Management Centre of Housing Construction Bureau, Nanning City, commissioned third-party monitoring agencies to monitor the roads and buildings around the collapsed road. Backfilling was executed immediately to prevent any further collapse or erosion of the soil. As this incident happened during the rainy season, rainwater had to be diverted from the road surface and prevented from infiltrating the site. With the help of the local waterworks department, the water flow from the municipal rainwater pipes was intercepted. Additionally, additional anchor supports for the retaining walls were designed and are to be implemented onsite as soon as possible.

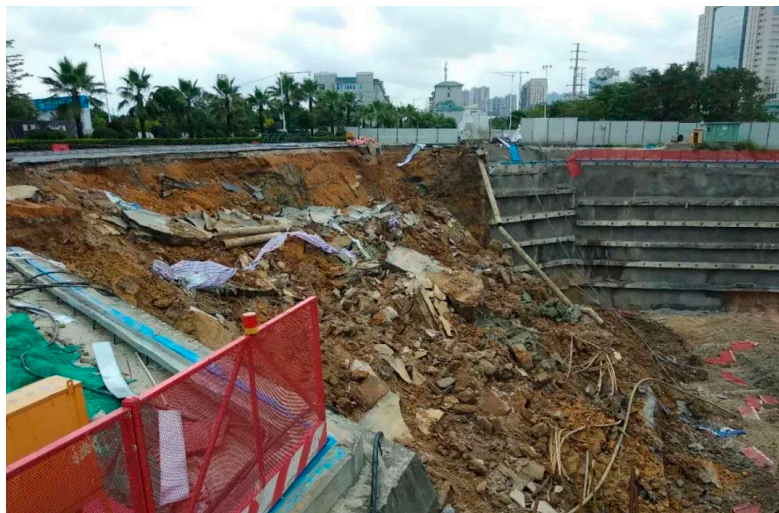
Figure 5. Collapsed foundation (side view) (source: https://mp.weixin.qq.com/s/nMGCnVwHjIIVq_np9ITXwg).

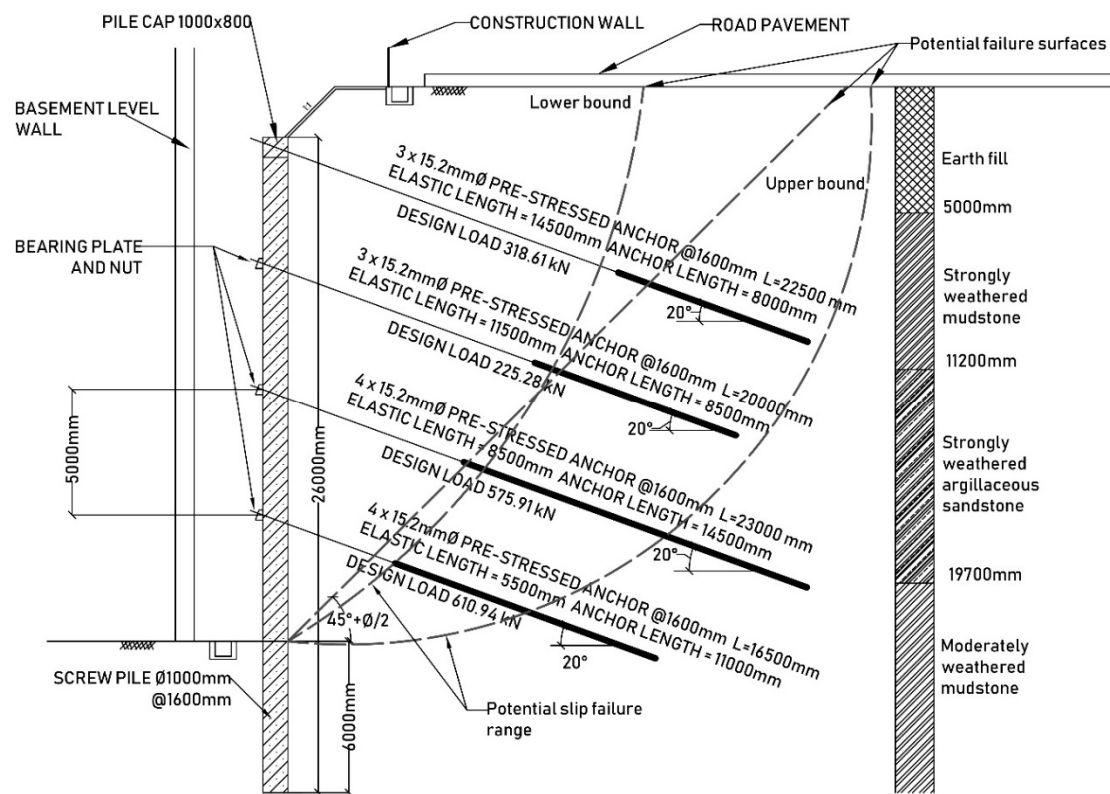
Figure 6. Cross-section of retaining wall with anchoring details.

Although the collapse has been mainly attributed to the deformation in the retaining wall due to movement of soil, there are some other important factors that could have affected the occurrence of this incident. For example, one key point was the insufficient length of the anchor supporting the retaining wall. Officials released a copy of a technical drawing showing a cross-section of the retaining wall. A reproduced version of the drawing is shown in Figure 6. As shown in Figure 6, the retaining wall was supported by a combination system of pile foundations and horizontal ground anchors. The 150 mm diameter anchors had a lateral spacing of 5 m and a lock-off load of zero. Further design details of the anchors are shown in Figure 6. The potential failure surfaces due to active failure and shear failure are also shown in the figure, where the curved lines correspond to the upper and lower bounds of failure by shearing and the straight line corresponds to failure by pullout. The upper and lower bounds were established based on the slip surfaces with the highest factor of safety (F.O.S) and lowest F.O.S respectively, where the F.O.S is influenced by factors like active earth pressure and soil properties [21]. As shown in Figure 6, the anchor head of the top layer was near the failure surface due to pullout, which indicates that the anchor length was insufficient [21–23]. Thus, the deformation at the top of retaining wall was large. The leakage from the pipe caused an increase in pore water pressure acting on the back of the wall, which reduced the safety factor of the retaining wall. After being pulled out, the anchor collapsed with the soil mass due to the forces induced by the movement of the soil mass. Jet mixing the anchor piles is another option that would have helped to control the deformation and ensure the stability of the retaining wall [24–26]. The distance between each pile could have been reduced to allow for more stability. Moreover, the interior bracing system should have been designed to prevent large deformation during excavation [14,27].

The soil profile of the slope behind the retaining wall was made up of 5 m of earth fill, followed by 6.2 m of strongly weathered mudstone, 8.5 m of strongly weathered argillaceous siltstone, and moderately weathered mudstone, as shown in Figure 6. The layers of clayey soil had high water retention properties, which swelled when exposed to the leaking pipe water. This phenomenon resulted in the deformation of the retaining wall and could also provide a possible explanation as to why the leaking water pipes went unnoticed. Thus, a dewatering system should have been installed to pump out the groundwater and the leaked water from the pipe system, as dewatering is a useful technique for prevention of large deformation and failure [9,24,26,28–30]. Therefore, from a technical aspect, a supporting system (retaining pile, anchor, bracing support), dewatering system, and soil properties should be considered in an optimized way [15,31,32].
