Analysis of Characteristics of Fire Incident on 24 July 2021 in Jilin Province, China

Abstract: At 15:48 on 24 July 2021, a fire accident occurred in Changchun City, Jilin Province, China, resulting in 15 deaths and 25 injuries. After the accident happened, Jilin Province comprehensively organised an emergency rescue, saving more than 100 trapped people. Given the dangers posed by these events, it is recommended that we must strengthen our risk awareness. Combined with the general background and scene of the fire, in this study, we analysed the causes of the accident and described the on-site rescue actions. The direct cause of the accident was an arc fault, and the indirect cause was the dereliction of duty in the laying and installation of the circuit and the subsequent fire supervision. From our case analysis of electrical fires in public buildings, we found that electrical failure, human factors (illegal operation), ageing and short circuits of wires, poor contact of wires, and ignition of other combustibles by electrical appliances are the main factors causing electrical fire accidents in public buildings. To avoid serious fire accidents caused by arc faults, we proposed sugg

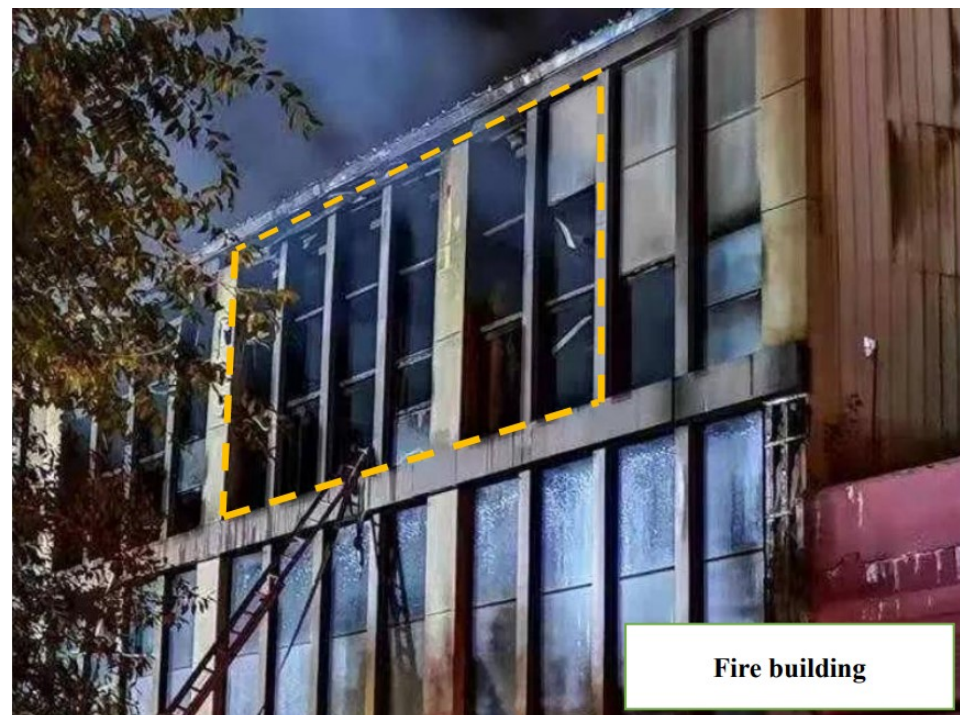
Figure 3. Electrical fires: burned buildings (picture source: [18]).

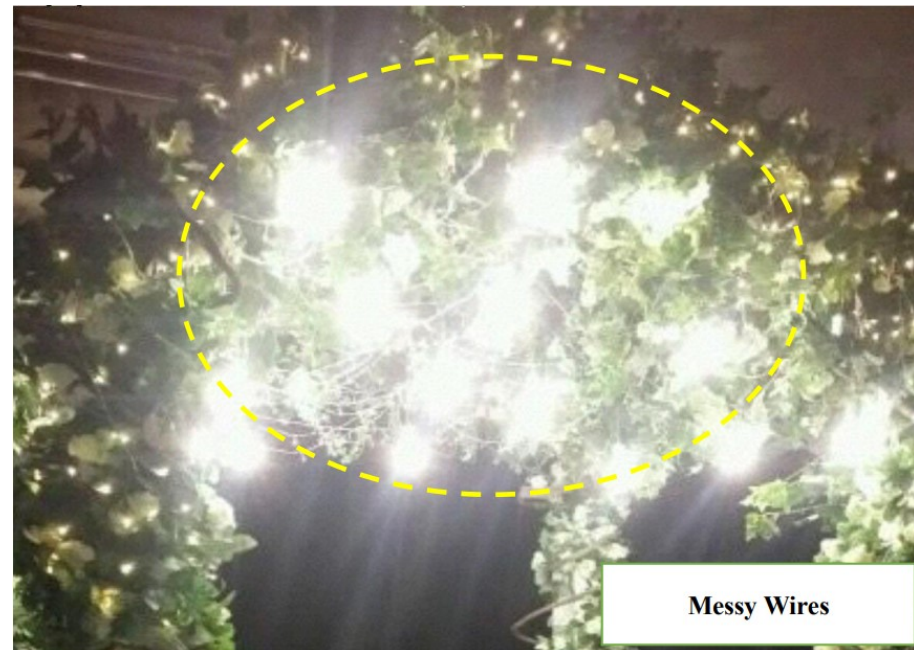
Figure 4. Electrical fires: Messy Wires on Photography base roof (picture source: [19]).

After the accident, the fire department made a thorough investigation into the cause of the fire [25]. The results of the survey show that the electrical fire accident was caused by the leakage of lighting lines, breakdown of threading metal pipes, and ignition of the surrounding combustibles [26]. The temperature of the contact point of the conductor owing to poor contact causes severe heating at the contact point of the conductor and increases the resistance of the contact point, which exacerbates the heating [27]. The heated conductor in turn heats the external plastic insulation material of the conductor near the contact point, which greatly reduces its insulation capacity and causes electric leakage [28]. The roof of the wedding shop was difficult to find in the first place because the roof was covered by inflammable materials such as green plants. Its fire extinguishing mechanism is as follows: (1) vaporization, heat absorption, and radiation blocking [29]; (2) smoke and dust removal, surface infiltration; (3) three-dimensional movement, horizontal fire extinguishing. Fire extinguishing agent is famous for water and cheap materials; the fire extinguishing mechanism is cooling and asphyxiation, the fire extinguishing effect is good, it is not easy to reignite after fire; under the condition of water supply guarantee, it can be reused, applicable to the wedding dress shops and other shops related to fabric [30]. In serious cases, an electric arc occurs, causing an electrical fire. Most of the wires in the wedding dress shop were old and damaged. Due to poor contact of wires, it is easy to leak through the insulation layer and cause a fire. The circuit layout of the wedding dress shop was extremely disordered, with intertwined lines. Furthermore, there were no electrical design drawings and the electrical construction did not meet the specifications [31]. Polyurethane foam was used for thermal insulation in violation of regulations, and fire prevention treatment was not performed, resulting in the rapid spread of the fire [32]. In addition, the local government departments did not perform their assigned duties, but only supervised and inspected the approved construction projects, and neglected the long-standing illegal reconstruction and expansion of Li's Wedding Dress Dream City. The inventory of "two violations" was not conducted thoroughly, the hidden dangers of Li's Wedding Dress Dream City were not detected, and there were deficiencies in investigation and rectification [33]. Owing to single person law enforcement in the fire supervision and inspection department, the rectification of hidden dangers was not monitored, items requiring rectification were overlooked, and law enforcement was incomplete.

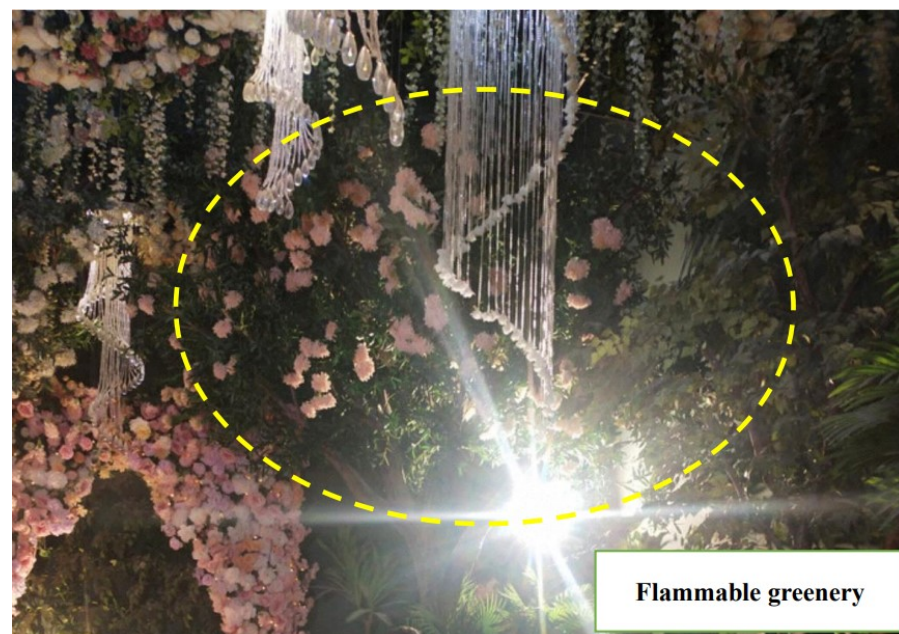
Figure 5. Electrical fires: combustible decorations in the wedding dress shop (picture source: [20]).
