# Degradation and Sustainability: Analysis of Structural Issues in the Eduardo Caldeira Bridge, Machico

Raul Alves <sup>1</sup>, Sérgio Lousada <sup>2,3,4,5,6,7,\*</sup>

This paper presents a detailed analysis of the severe structural anomalies that led to the urgent rehabilitation of the Eduardo Caldeira Bridge in Machico, Madeira. Situated in a challenging coastal environment with complex volcanic geology, the bridge exhibited a critical failure of its bearing devices, which were assigned the highest defect severity rating (Grade 5). A multidisciplinary diagnostic methodology, combining visual inspection data, non-destructive testing, and geotechnical analysis, was employed to identify the root causes of this degradation. The investigation concluded that the bearing failure was not due to widespread material deterioration but was directly linked to significant lateral structural displacements, exacerbated by localized geotechnical instabilities. This paper details the data-driven rehabilitation strategy that was subsequently implemented, including the complete replacement of the bearings and substructure stabilization measures. The study provides a valuable case study of a comp

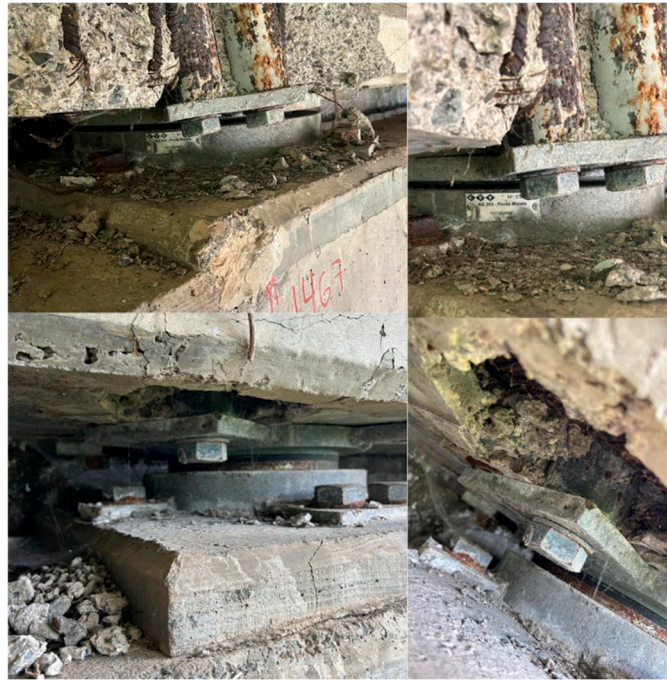
The most severe damage was observed on the northernmost pier, where the bearing elements were effectively destroyed (Figure 12). This critical failure is directly attributed to the challenging soil characteristics and potential instability at this location, leading to movements that exceeded the bearings' capacity.

**Figure 12.** Close-up view of the two bearing elements on the northern pier.

- **Substructure and Bearing Replacement:** The most critical intervention was addressing the failed bearings. This required deck lifting operations at both abutments, costing €17,700.00 per abutment. The G5-rated bearings were completely replaced with new fixed and unidirectional pot bearings. To address the underlying stability issues, work was performed on 17 permanent anchorages in the adjacent containment wall, and the deck was recentred over the south abutment at a cost of €21,200.00.

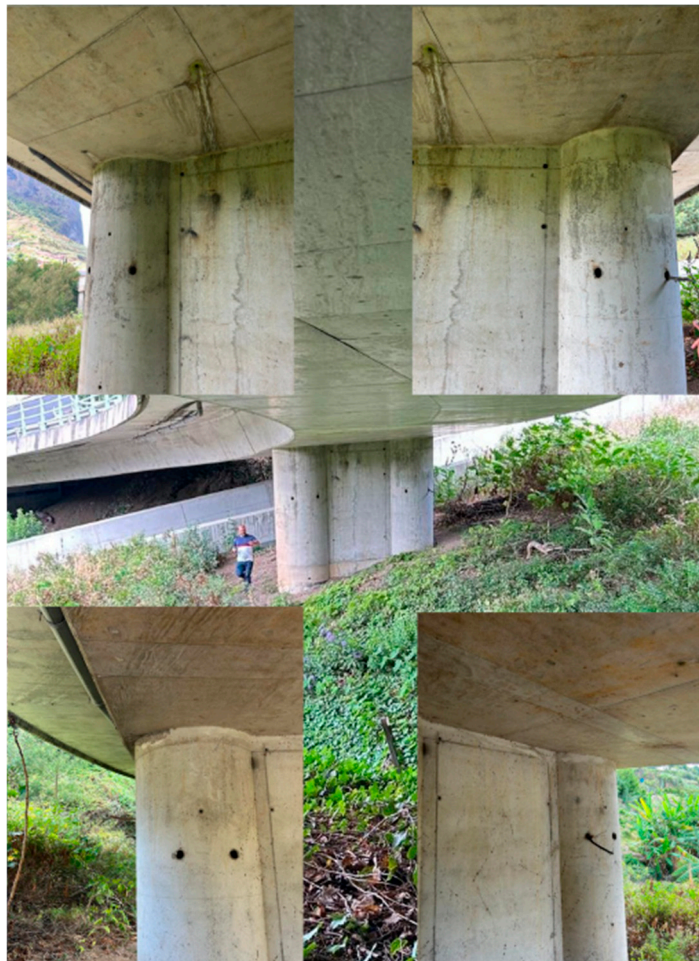
In stark contrast, the central pier was found to be in excellent condition, showing no visible problems (Figure 13). This provided a crucial benchmark, indicating that the original concrete structure was performing well where foundation conditions were stable.

**Figure 13.** View of the bridge's central pier, in excellent condition.

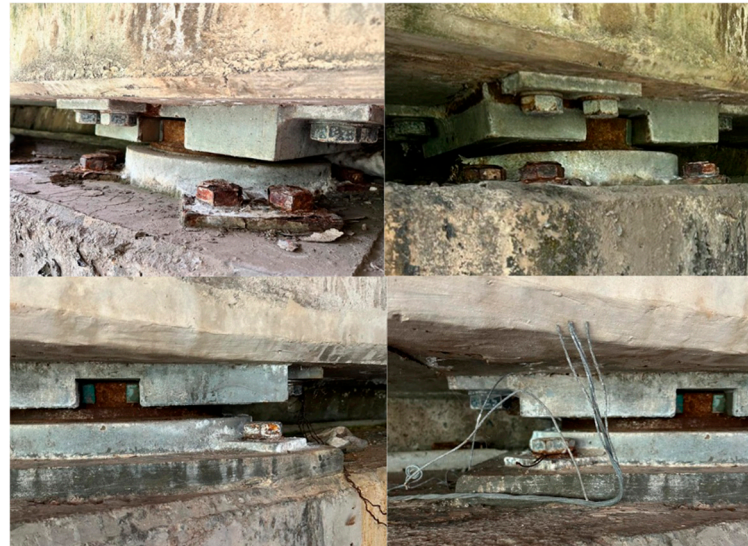
The southernmost pier's support mechanisms, while not destroyed, exhibited significant surface oxidation (Figure 14). This degradation was attributed to inadequate drainage, which was further evidenced by visible rainwater runoff stains on the underside of the bridge deck (Figure 15). These findings highlight a secondary degradation mechanism: prolonged water exposure leading to corrosion, a common but critical maintenance challenge.

**Figure 14.** Support mechanisms of the southern pier, showing surface oxidation due to rainwater.

- **Surface and System Maintenance:** General cleaning of exposed concrete surfaces (172 m<sup>2</sup>) was carried out, along with specific maintenance and cleaning of the drainage system to mitigate the water-related degradation observed.

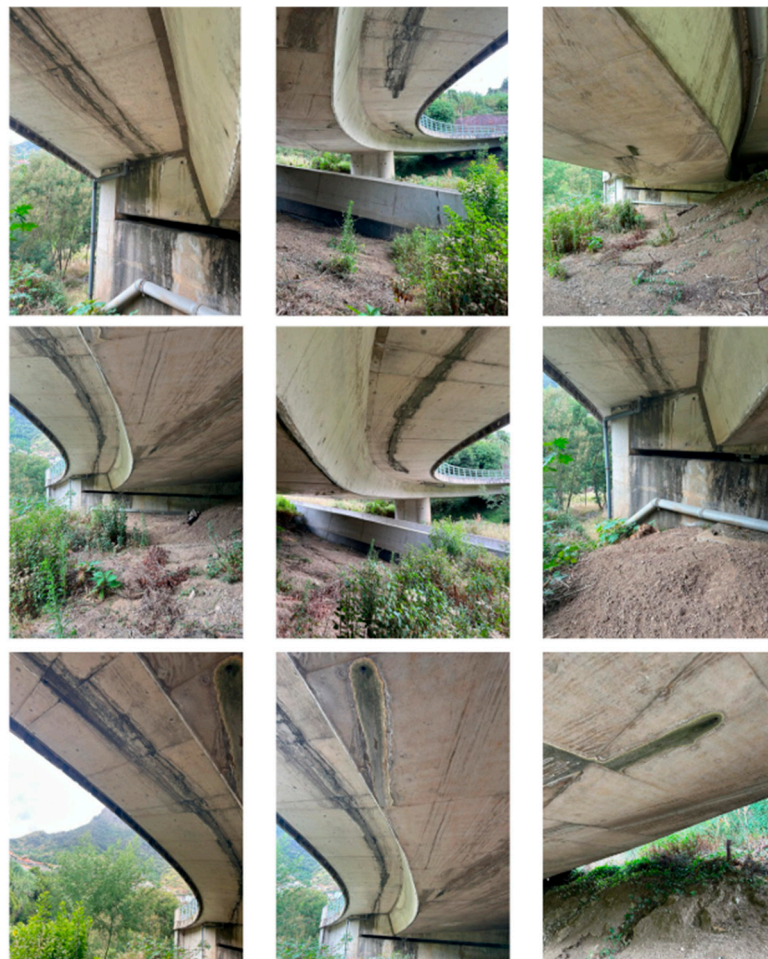
**Figure 15.** Rainwater runoff on the bridge deck, viewed from below, southern Ribeira do Junçal area.
