## Case Report

# Risk and Resilience at the Oroville Dam

Lucien X. Hollins<sup>1</sup>, Daniel A. Eisenberg<sup>1,2</sup> and Thomas P. Seager<sup>1,\*</sup>

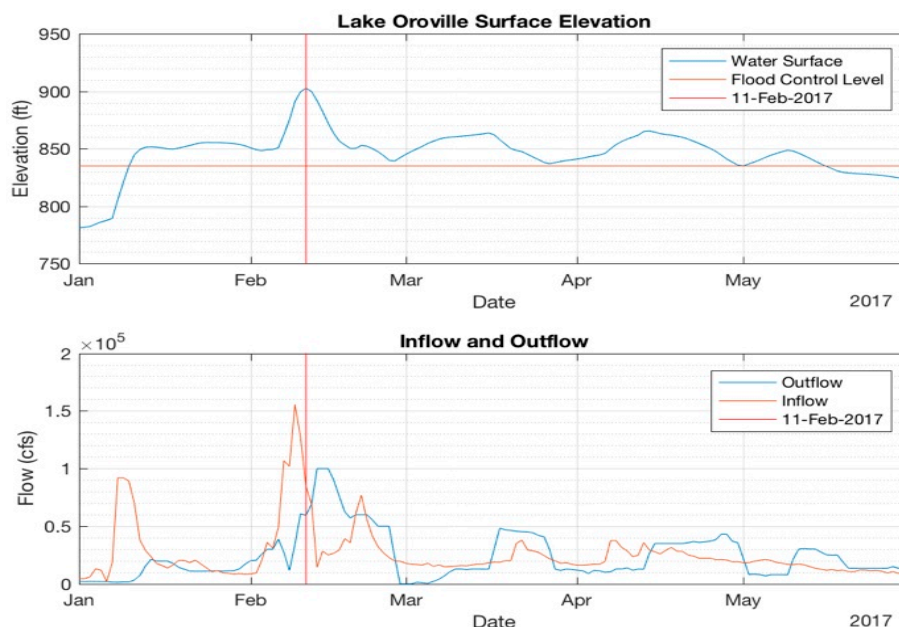
**Figure 2.** Oroville sensor data for surface elevation, inflow, and outflow. The flood control level is the level above which USACE flood control guidelines take over. The ungated spillway weir is at approximately 901 feet above sea level. Heavy inflow and a failure to maintain outflow caused the level to briefly rise beyond this height on 11 February.
