The Selected Issues of Adaptation of 19th and 20th Century Post-Industrial Buildings in Łódź [†]

Tadeusz Urban and Michał Gołdyn *

Abstract: The paper deals with selected technical problems related to the adaptation for new uses of the structure of existing post-industrial buildings from the turn of the 19th and 20th centuries. A major difficulty is the fact that the strength and geometric properties of cast-iron, steel, and masonry elements often differ significantly from the values characterizing contemporary materials. Due to uncertainty regarding the load-carrying capacity of historical structures, in many cases there is a need to carry out destructive tests of elements taken from the buildings. As the example of cast-iron girders in the former spinning mill of “I. Poznański” demonstrated, such tests can prove a significant margin of load-carrying capacity and confirm the possibility of adapting the structure to new purposes. The paper also presents examples of strengthening the existing wooden ceilings by joining with the reinforced concrete structure, which allowed the keeping of the original elements and an increase of the allowable load. Selected problems related to the a

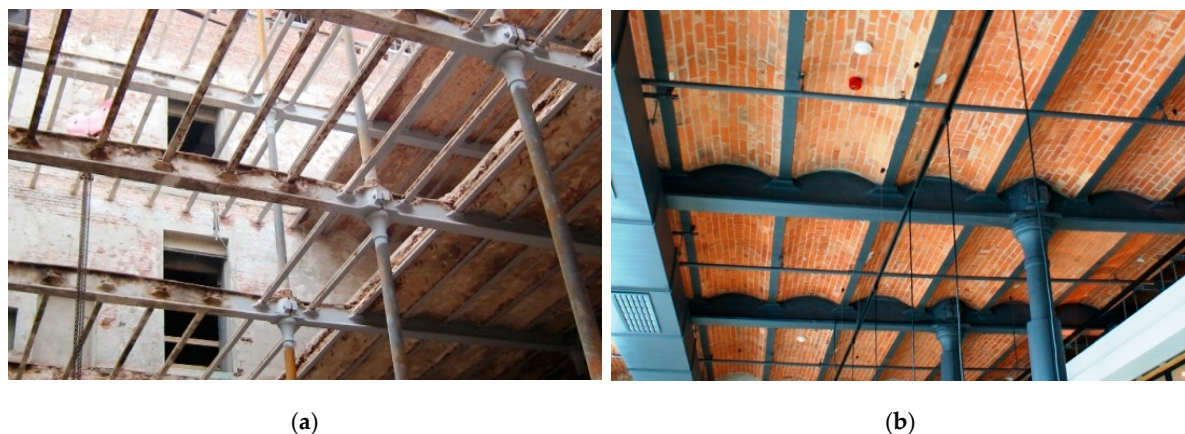
This building was erected in the years 1878–1880. It is a masonry building with five above-ground storeys, and a partial basement. Jack arch floors supported on cast-iron girders were used, which were based on cast-iron columns and masonry external walls. The span in the transverse direction of the building is 6.0 m, and the spacing of the girders along the longitudinal axis is 3.27 m. Steel beams (ribs) with a rail cross-section (probably recovered rails) are supported on the cast-iron girders. The spacing of the secondary beams is about 0.86 m. The building is currently located in the “Manufaktura” complex in Łódź, and from 2009 performs hotel functions (Andel's Hotel). Figure 8 shows a fragment of the building structure during the reconstruction works and after their completion.

Figure 8. A cast-iron and steel structure of the former *Poznański's* spinning mill: (a) during and (b) after the completion of the restoration works.

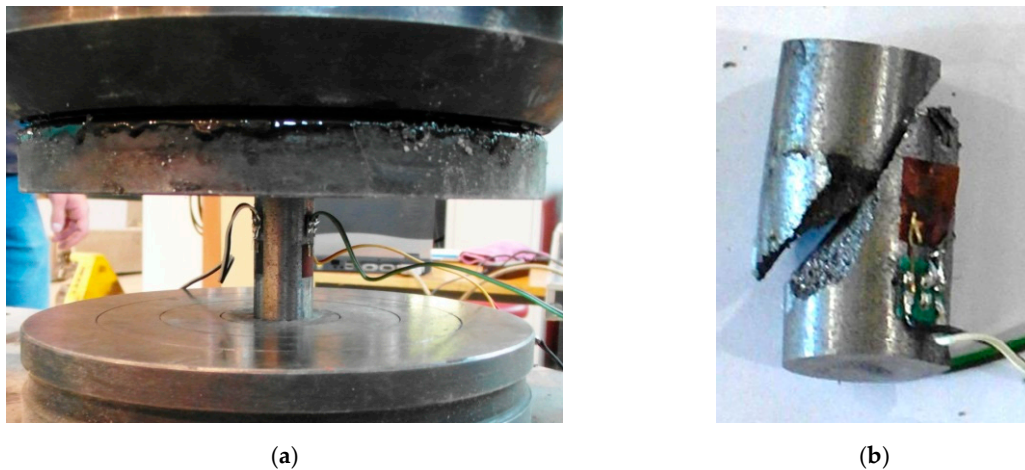
The failure of the compressed cast-iron sample took place in a manner characteristic for a brittle material. At failure cracks on the side surfaces, inclined at an angle close to 45° with respect to the sample axis were observed. They defined the shear-slip plane, which can be visible in Figure 11.

Figure 11. View of cast-iron specimen in the compression test: (a) in the test setup, (b) after failure.

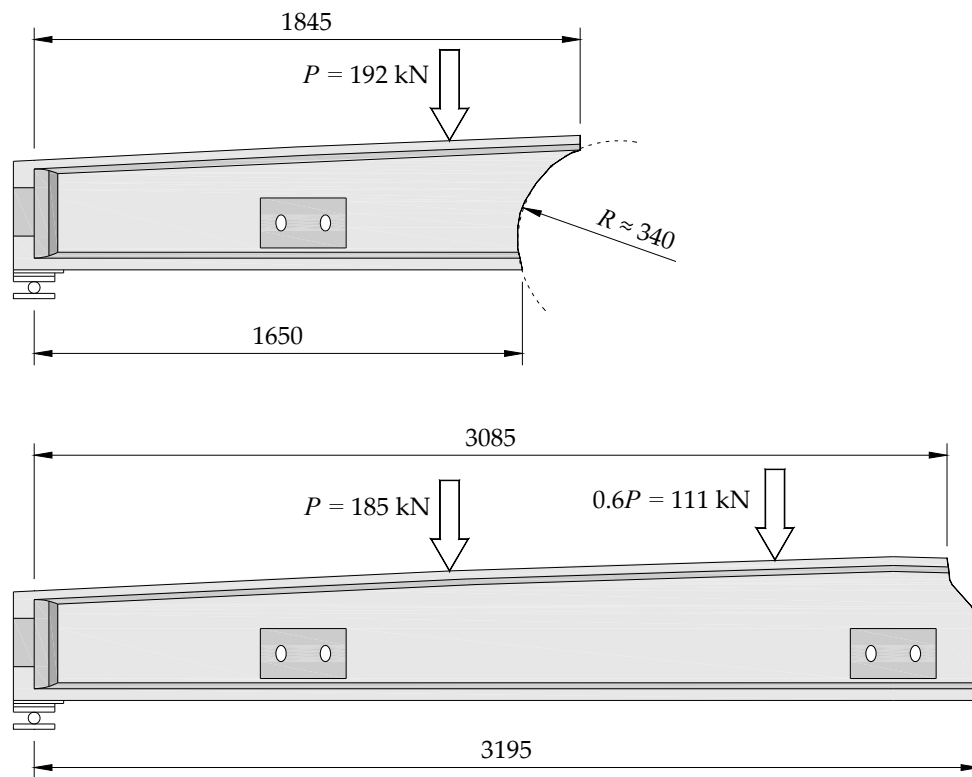
The girders failed in a violent manner, not signaled by a significant increase in deflections, at the forces P equal to 192 and 185 kN. This corresponded to flexural capacities equal to 565 and 544 kNm, respectively. On this basis, an evenly distributed load of approximately 130 kN/m (above the self-weight) was estimated. It corresponded to a characteristic uniformly distributed load of about 40 kN/m², calculated by assuming a spacing of girders equal to 3.27 m. The flexural resistance of both girders was similar (difference of about 4%) although the critical cross-sections were located at different distance from the support axis (see Figures 14 and 15). This situation is a consequence of

the intentional design and manufacture of girders with a variable height of cross-section (curvilinear shape of the upper flange). The shape of the girders was chosen so that the deformations of the upper and lower flanges were similar at most of the central part of the element.

Figure 14. View of the girders after failure (location of the critical section was marked).

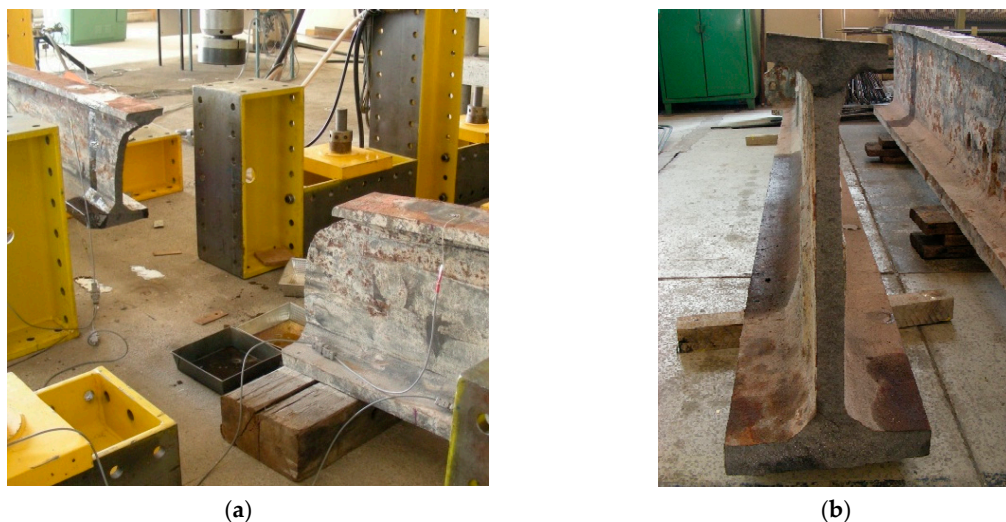
Figure 15. View of the critical sections of: (a) the girder no. 1, (b) the girder no. 2.

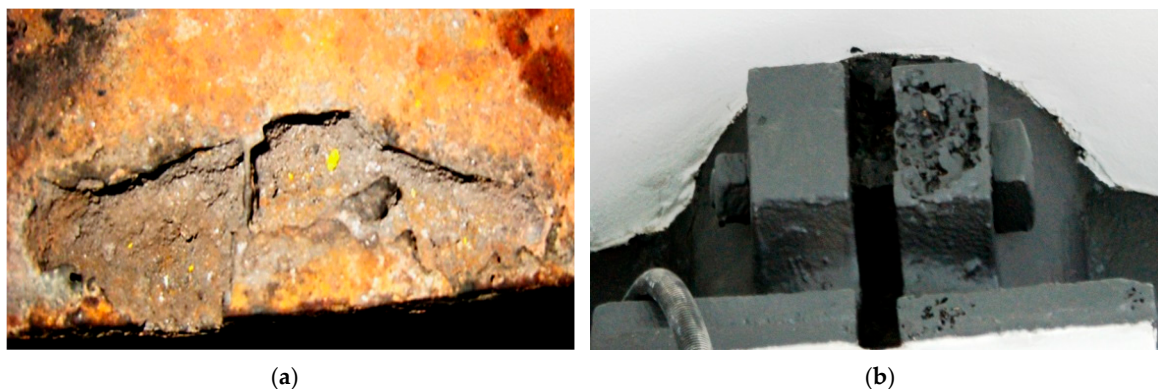
It is also important that the tensile strength of the material was not reached at the failure ($\sigma_{max} = 87.3 \text{ MPa} < R_t = 128 \text{ MPa}$). The stress achieved were only about 68% of the strength obtained in the tensile test. This fact can be explained by inhomogeneity of cast-iron, because on the surface of the girders numerous defects due to the imperfections of the casting process (inclusions and voids) were noticed—see Figure 17.

Figure 17. Casting defects of the cast-iron girders: (a) gas blowhole, (b) slag inclusion.

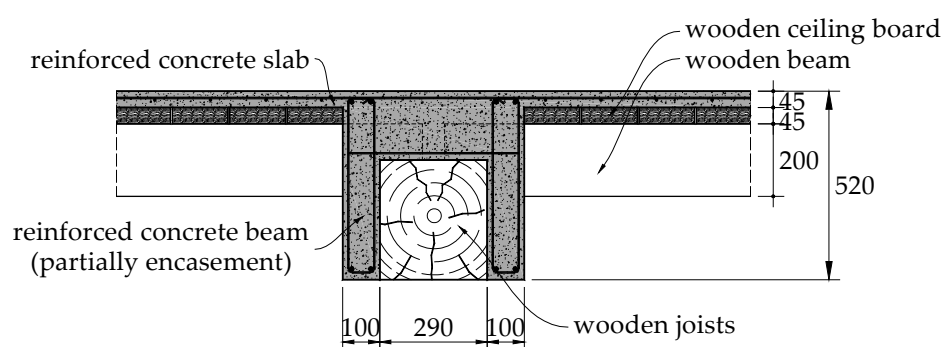
Until the end of the 1990s, the building was used continuously for production purposes. As a result of political transformation, the new owner of the post-industrial complex has become the Lodz University of Technology, which has made efforts to adapt it to new functions—now this building houses three faculties of the university. The change of the purpose forced the adaptation of the structure for new functions. Despite over 100 years of operation, the structure of wooden ceilings in the building turned out to be in good technical condition. Only the beams were characterized by insufficient load-carrying capacity to transfer the increased loads. The designers decided to strengthen them by a partial encasement with reinforced concrete [11], as shown in Figure 22.

Figure 22. Strengthening of the existing wooden joists by reinforced concrete encasement.

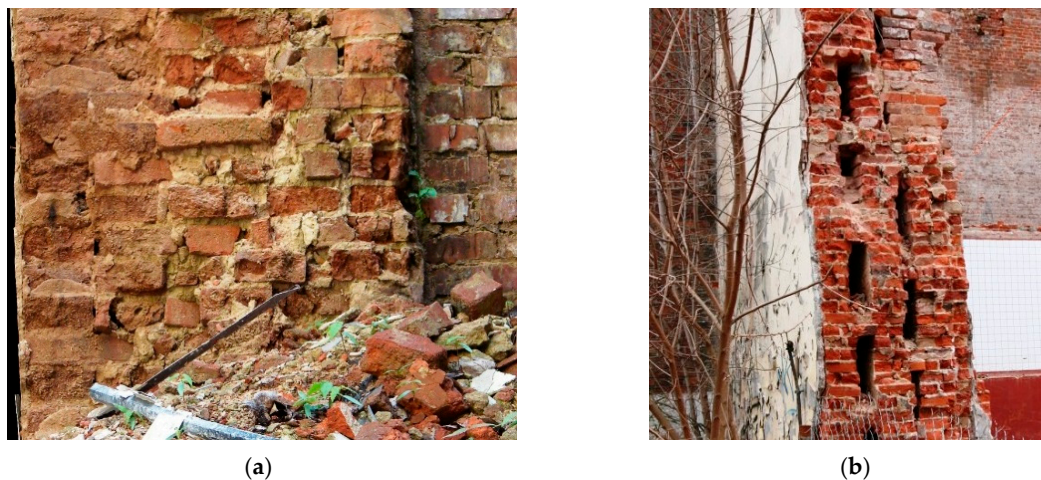
The observations mentioned before should be carefully considered before undertaking any actions related to the historical buildings. Due to low strength of historical bricks and mortar used to connect them (mainly lime mortar), historical walls are characterized by relatively high deformability as well as low compressive strength, which, according to contemporary design regulations, could be estimated as approximately 0.5 MPa. Additionally, the possibility of improper workmanship (Figure 24a) and occurrence of atypical structural solutions that are invisible during visual inspection carried out from the outside (e.g., voids, see Figure 24b) should be taken into account.

Figure 24. Examples of 19th century masonry walls: (a) careless workmanship, (b) hidden voids.

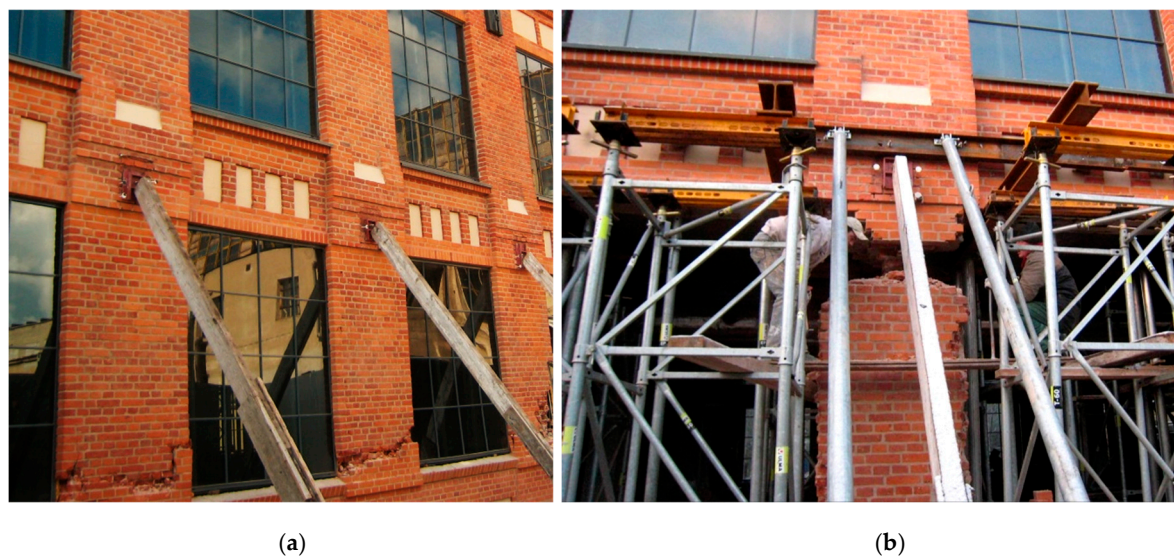
The problem of load-carrying capacity of post-industrial masonry walls is often marginalized, as evidenced by the examples of failures that took place in Łódź in the first decade of the 21st century. One such incident took place in the former “Muller” and “Seidel” factory. As a result of exceeding the load-carrying capacity of the masonry piers in a four-story building, three of them were damaged at the level of the ground floor—see Figure 25.

Figure 25. View of the masonry piers: (a) after failure, (b) during repair (photographs by J. Kozicki).

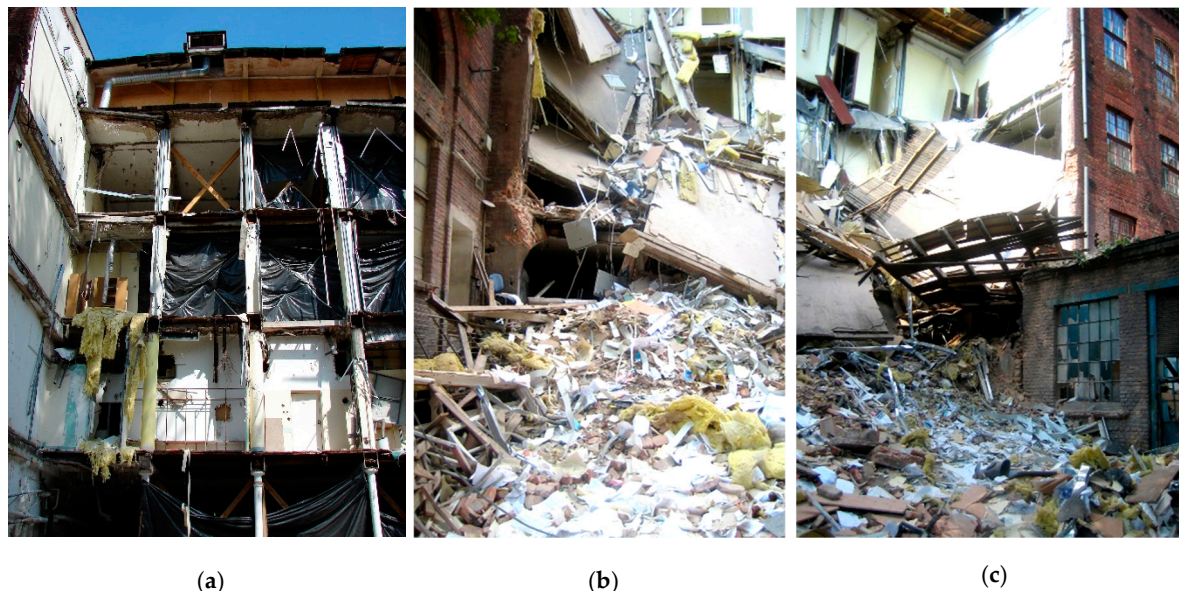
In May 2005, works were carried out inside the building to replace the windows in the southern wall on the ground floor level and cleaning works from the outside of this wall. Heavy equipment (loaders) was used to load the elements remaining after the demolition of the partition walls. The loader operator picked up rubbish while driving perpendicular to the wall. During the works the machine operator was warned about some cracks in the masonry piers between the windows. The works were continued despite the appearance of additional vertical cracks, which were noted by the workers. Soon after, the southern wall collapsed on the section of 5 window openings. Together with the wall, all of the inter-story ceilings collapsed. As a result of the structural failure, two people died, and a dozen were injured. The view of the partially collapsed building is shown in Figure 27.

Figure 27. View of the building from the south side after the collapse: (a) remained load-bearing structure (visible cast-iron columns of the longitudinal bay), (b) collapsed inter-story ceilings, (c) collapsed external masonry wall (photographs by J. Kozicki).

Due to the negligence committed by the owner of the facility, as well as by the people conducting construction works, it is difficult to pinpoint a clear cause of the event. There was no doubt, however,

that the walls of the building erected in the second half of the 19th century were in poor technical condition and did not meet contemporary requirements regarding the load-carrying capacity. The assessment of the wall elements after the disaster showed that the bricks were characterized by a significant change in shape (dimensions). The way the walls were made also left a lot to be desired (see Figure 24a). Laboratory tests showed that the average strength of the bricks was about 5.5 MPa (with a coefficient of variation of 14%), which is a very low value compared to the contemporary ceramic bricks (usually 10–20 MPa). Additionally, the strength of the lime mortar of 0.2–0.8 MPa was significantly lower than the lowest mortar class currently predicted by the standards $f_m = 1$ MPa (for M1 class).

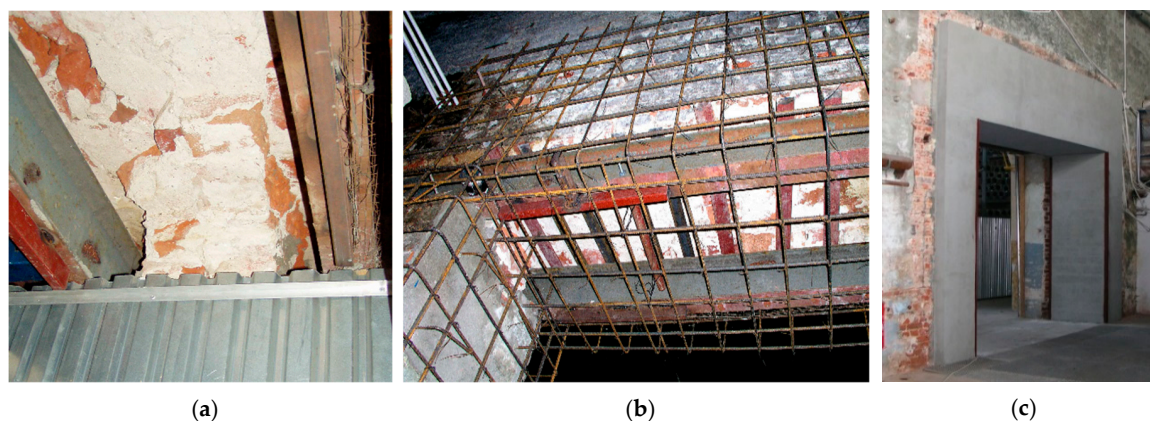
The aforementioned effect prevented the wall collapse in the former boiler house of the “Grohman’s” factory complex in Łódź [15]. As part of the reconstruction works, an opening with dimensions of 3.3 × 4.0 m was made in the load-bearing wall. Two lintel beams of I240-section were introduced as a strengthening element—see Figure 29a. However, the works were carried out extremely carelessly, as the sections were loosely mounted in the wall sockets, which did not protect them against rotation (no anti-torsional stiffening). During the inspection, many loose bricks were found above the steel beams. Several of them became detached, injuring a passing person. Such an accident was, however, inevitable, taking into account the ineffectiveness of steel lintels, high deformability, and very low tensile strength of the wall. In the literature some analytical procedures can be found [16,17], which allow for designing the lintels with including contribution of the masonry wall. In the case under consideration, however, a non-linear analysis was performed. In the Figure 30, the results of the nonlinear analysis for a wall fragment were presented. In the calculations, fracture elements were used, assuming tensile stress above 0.04 MPa as the failure criterion. The formation of a secondary structural system, resembling a vault, is visible, but almost all the elements between the supports failed (detached).

Figure 29. The opening in the masonry wall: (a) emergency condition, (b) during strengthening, and (c) after completion of the repairing works.

In the presented case, it was decided [15] to strengthen the lintel by making a reinforced concrete portal, joined with the masonry structure—see Figure 29b,c. Despite the difficulties with pouring concrete (due to the limited access to the wall on one side), the work was successfully completed, and it was possible to continue safely use of the building.
